## Release Notification

Site Name: Trinity 20 Federal Com 2	Site Type: Battery
Date Release Discovered: 4/26/2023	API# (if applicable)

# Liner Integrity Certification

CIMAREX ENERGY  
TRINITY 20 FEDERAL COM 2  
EDDY, NM

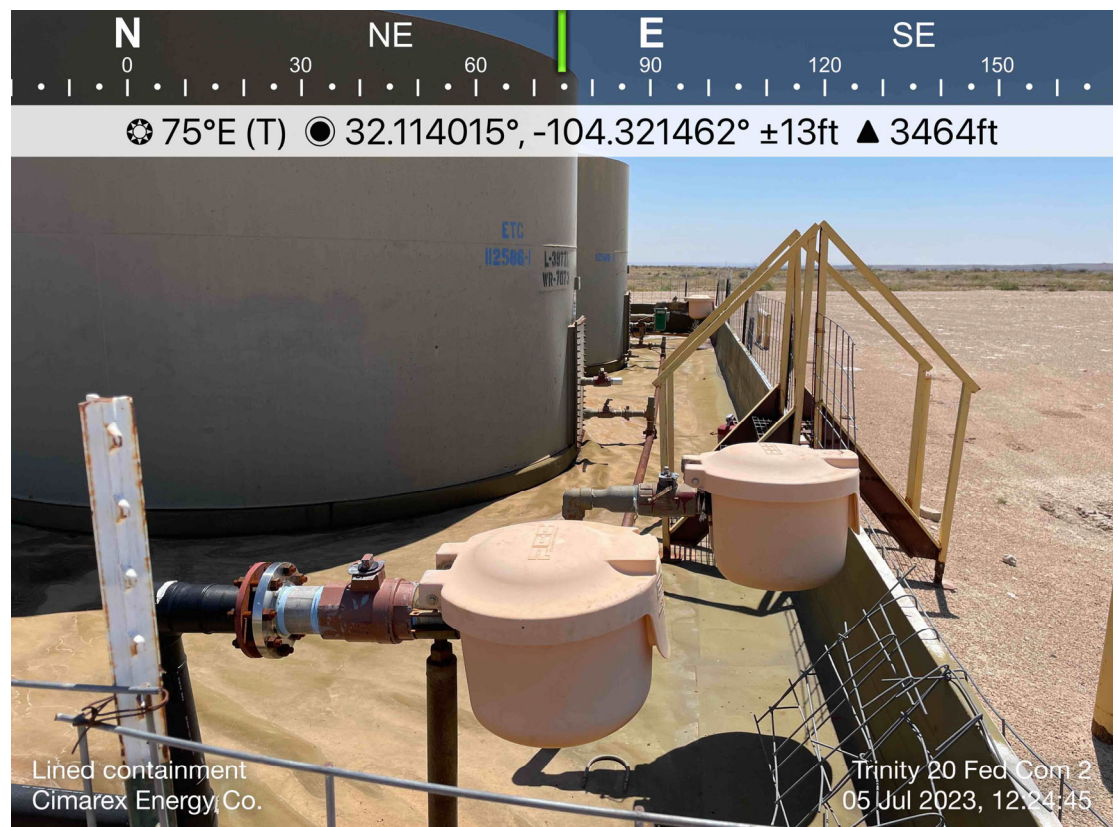
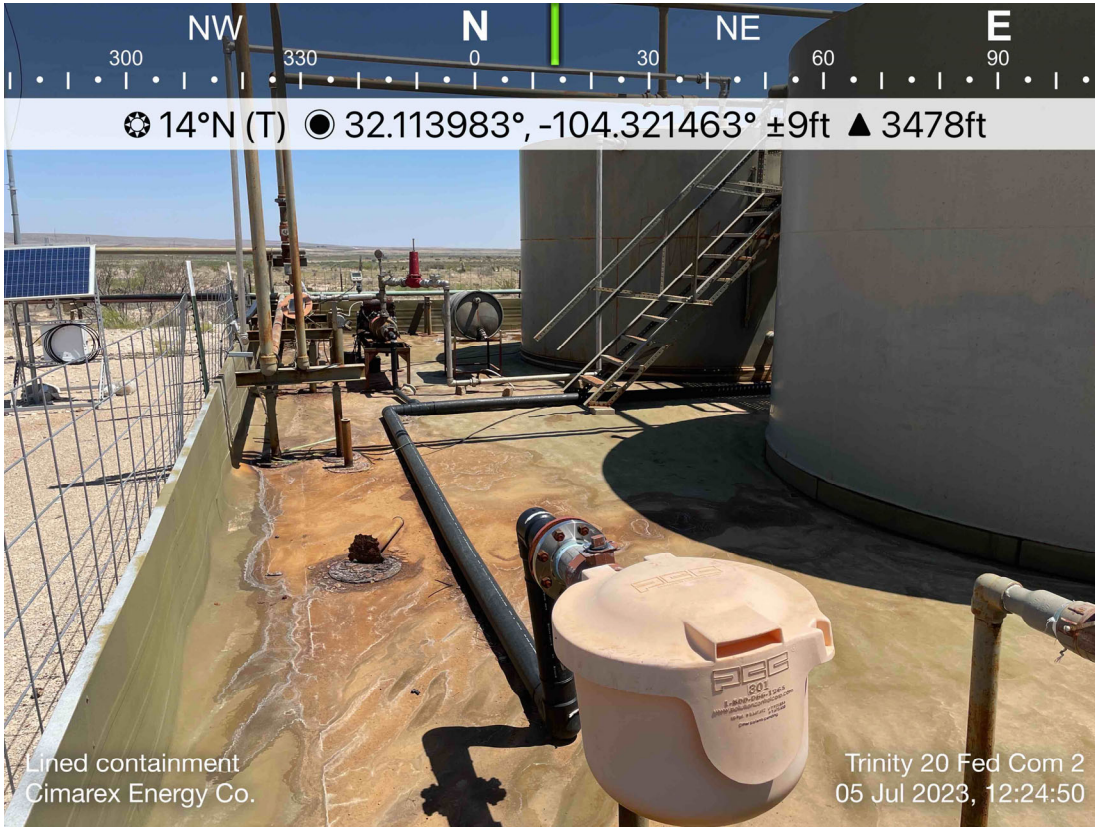
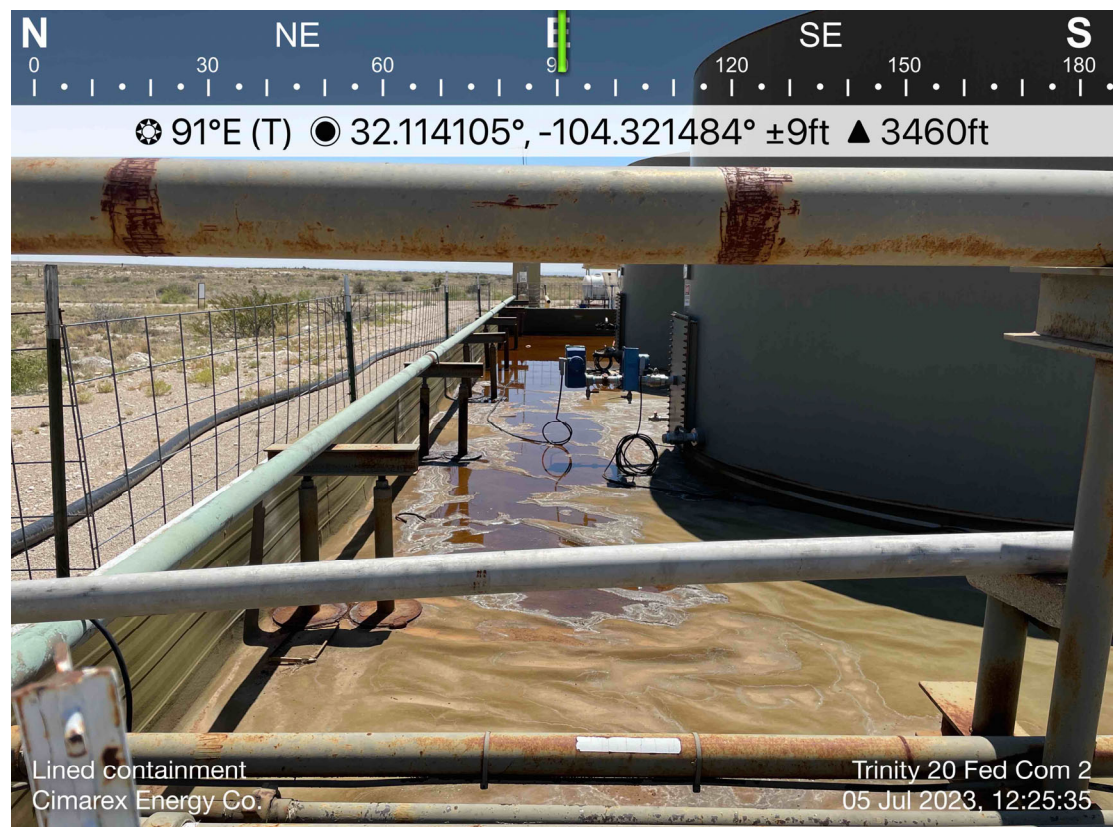
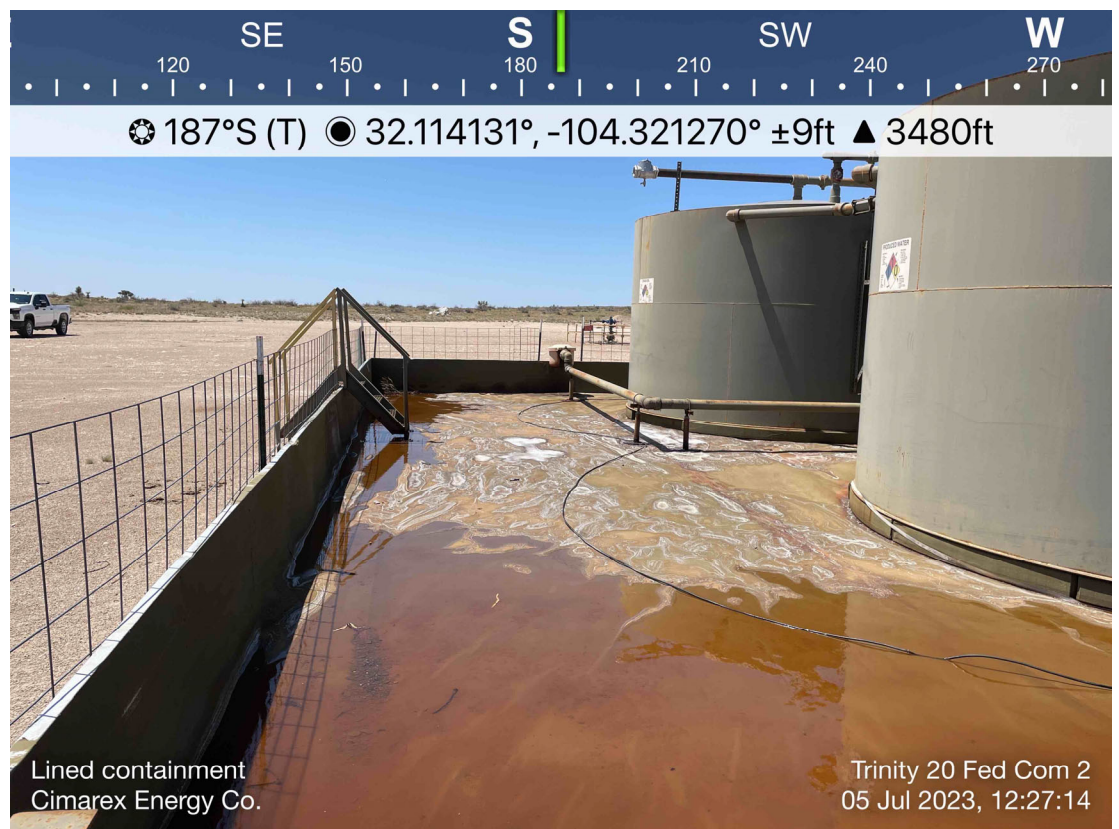
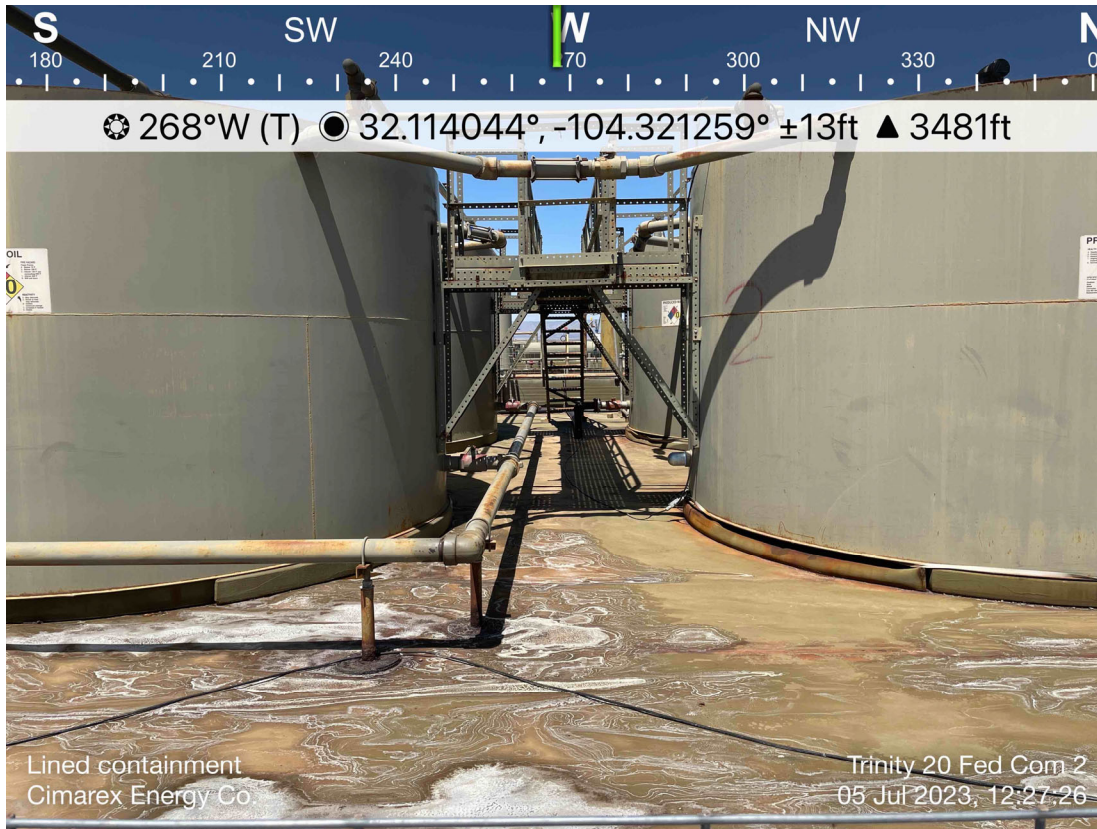
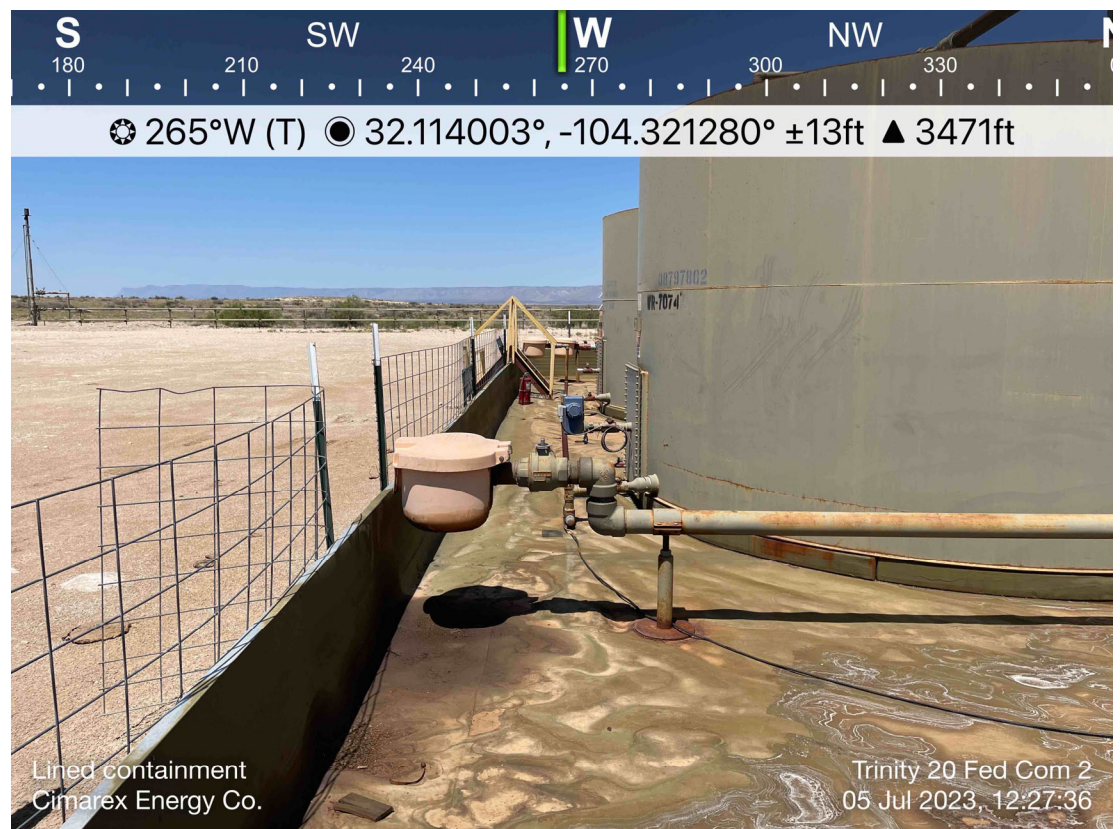
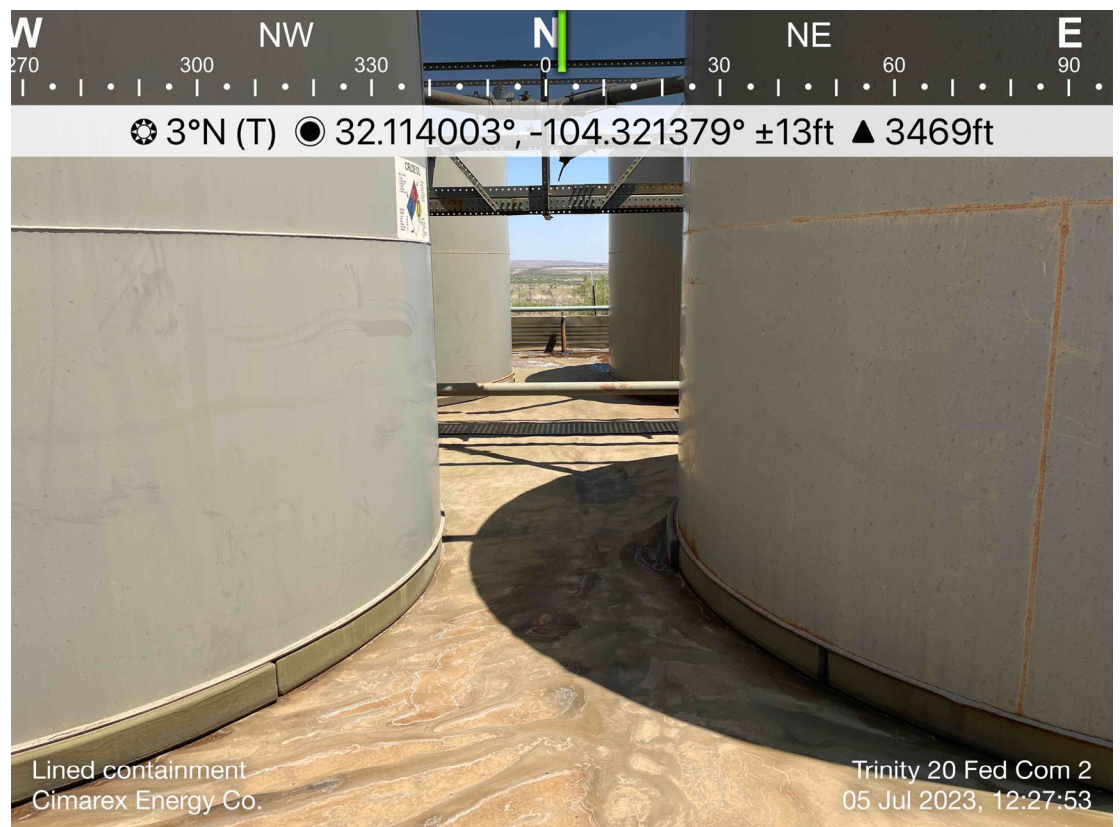
The following serves to verify that the affected liner has been inspected and found to be in serviceable condition in accordance with 19.15.29.11 A.(5)(a)(i-ii) of the New Mexico Administrative Code.

- ☒ Responsible Party has visually inspected the liner.
- ☒ Liner remains intact and was able to contain the leak in question.
- ☒ At least two business days' notice was given to the appropriate division district office before conducting the liner inspection.
- ☒ Photographs illustrating liner integrity are included.
