Re: Site Assessment, Remediation, and Closure Report
Cotton Draw Unit 167 CTB
API No. N/A
GPS: Latitude 32.167493 Longitude -103.732874
UL -- N, 36, T24S, R31E
Eddy County, NM
NMOCD Ref. No. NAPP2124337960

Pima Environmental Services, LLC. (Pima) has been contracted by Devon Energy Production Company, LP (Devon) to perform a spill assessment, remediation activities, and submit this closure report for a Crude oil and Produced Water release that occurred at the Cotton Draw Unit 167 CTB (Cotton). The initial C-141 was submitted on August 31, 2021 (Appendix C). This incident was assigned Incident ID NAPP2124337960 by the New Mexico Oil Conservation Division (NMOCD).

**SITE PHOTOGRAPHS
DEVON ENERGY
COTTON DRAW UNIT 167 BATTERY**

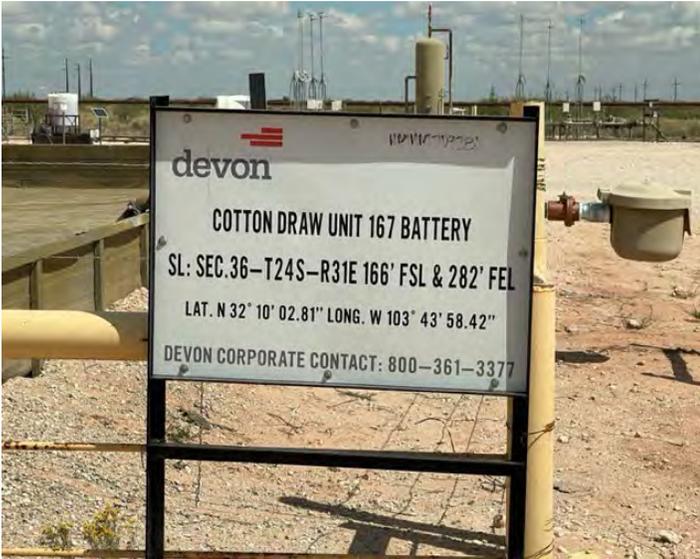
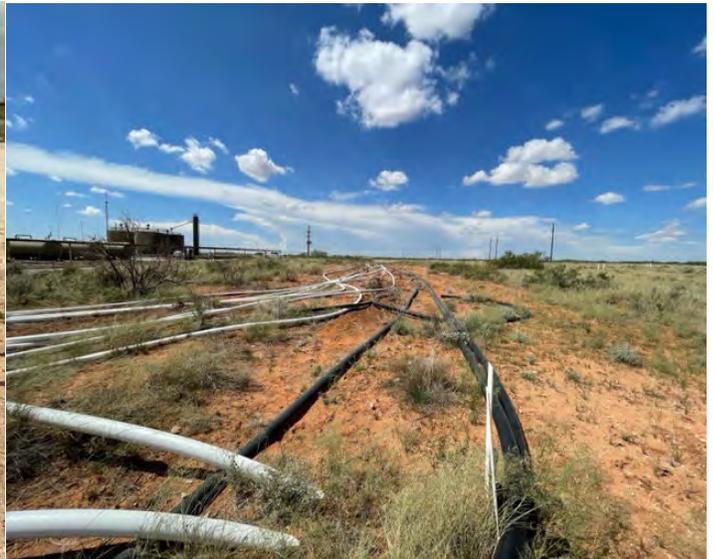
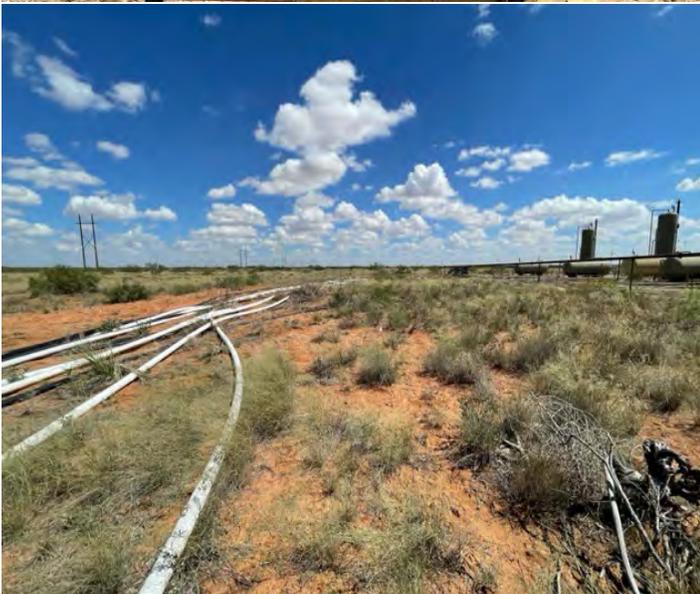
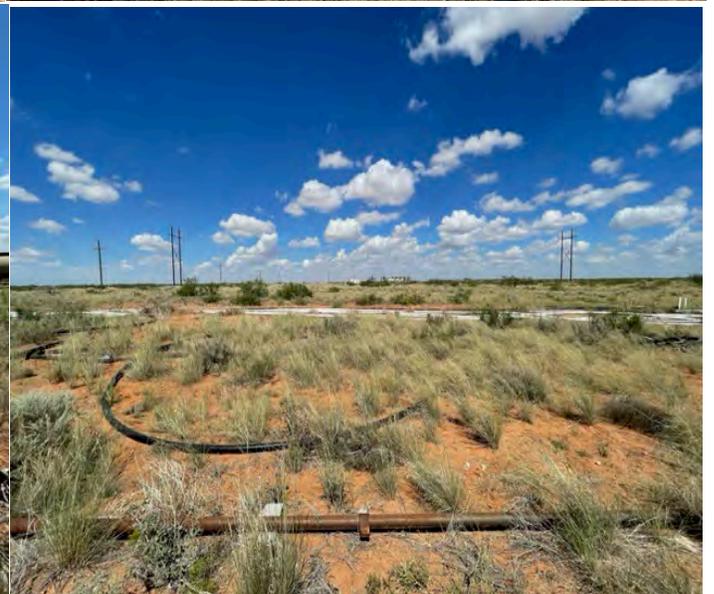
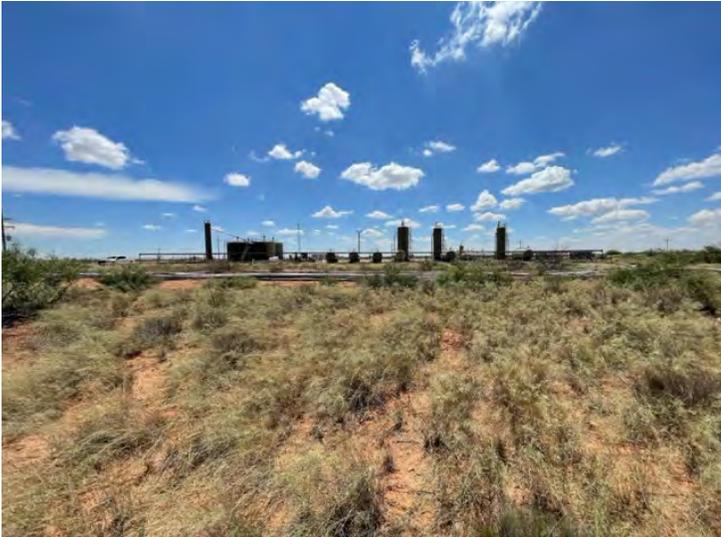
Site Assessment

September 19, 2022, Pima mobilized personnel to the site to begin collecting soil samples from spill area. The laboratory results of this sampling event can be found in the following data table. A Site Map can be found in Figure 4.

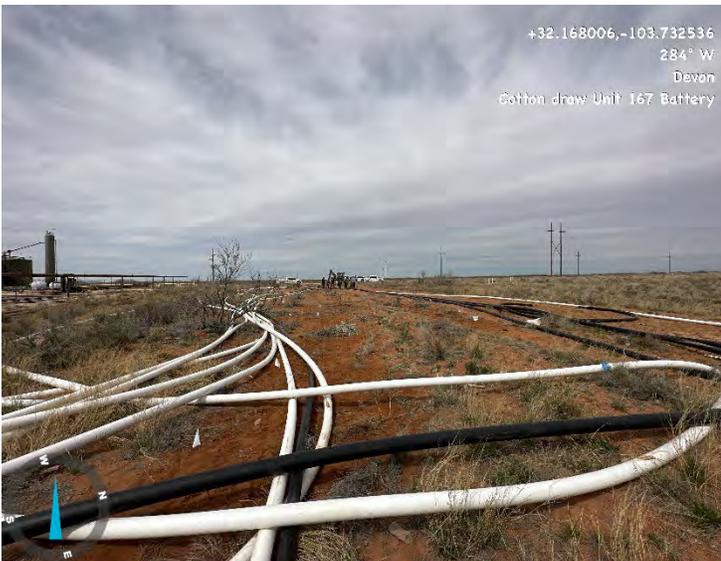
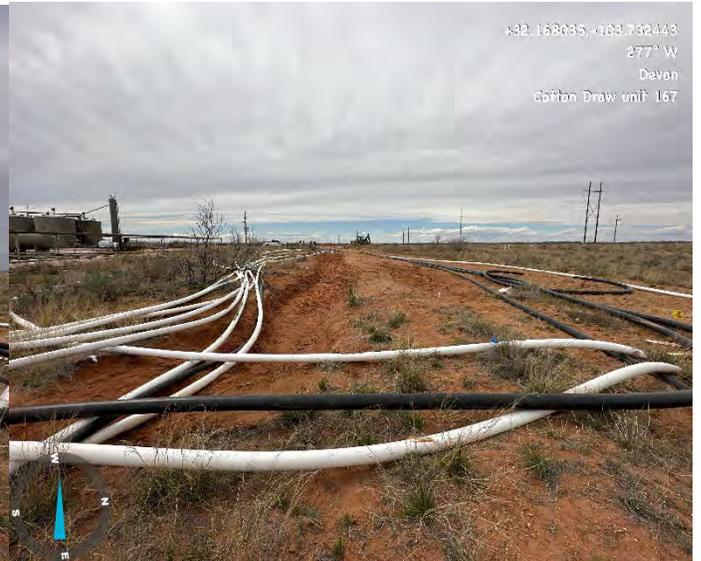
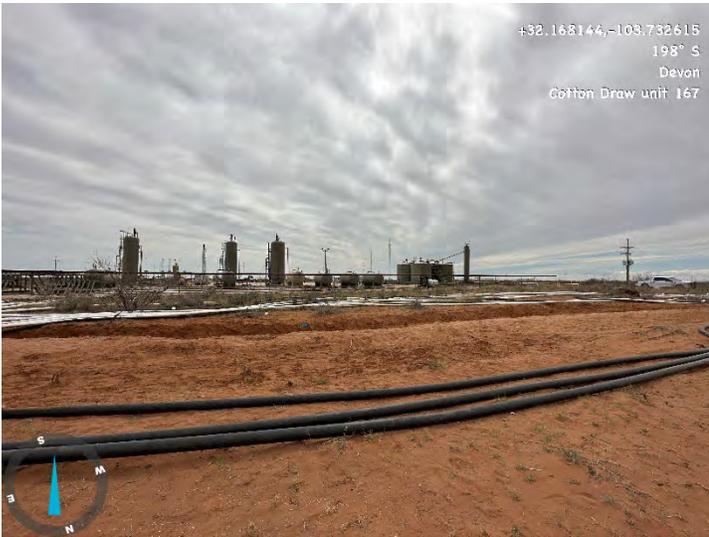
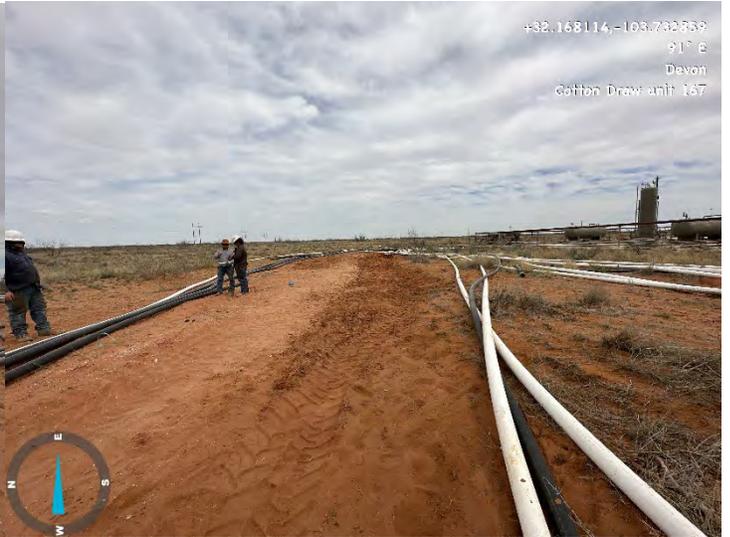
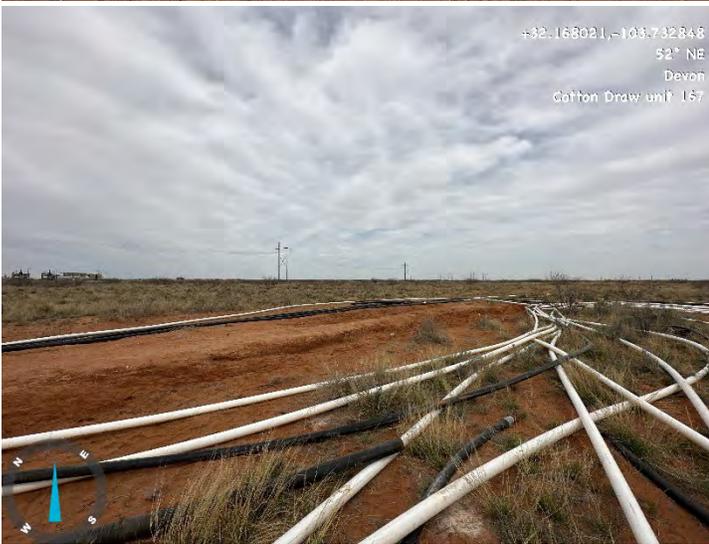
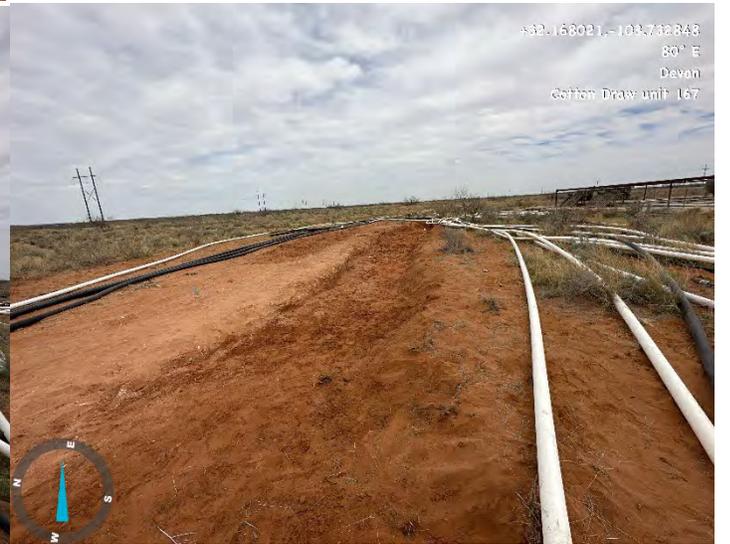
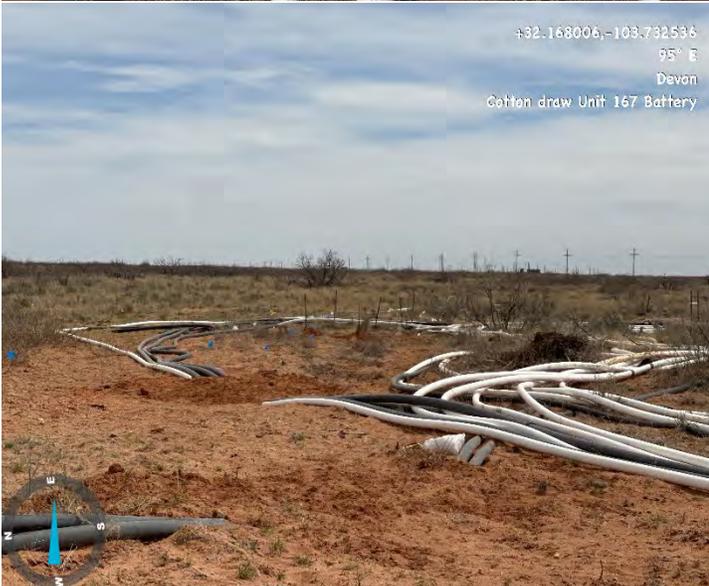
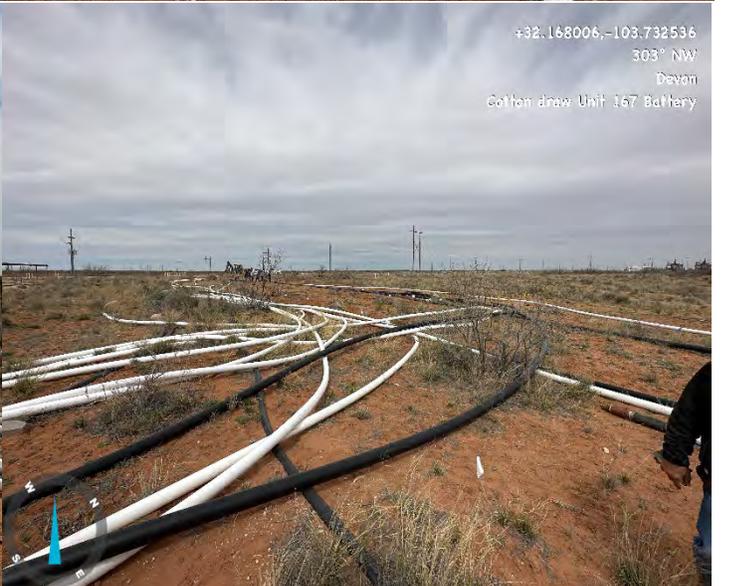
Excavation

On March 22, 2023, the Devon Construction Department mobilized personnel and equipment to begin remediation activities. They began excavating the area to an average depth of 3' BGS. Approximately 160 cubic yards of contaminated soil was hauled to an approved, lined disposal facility and clean backfill material was brought in.

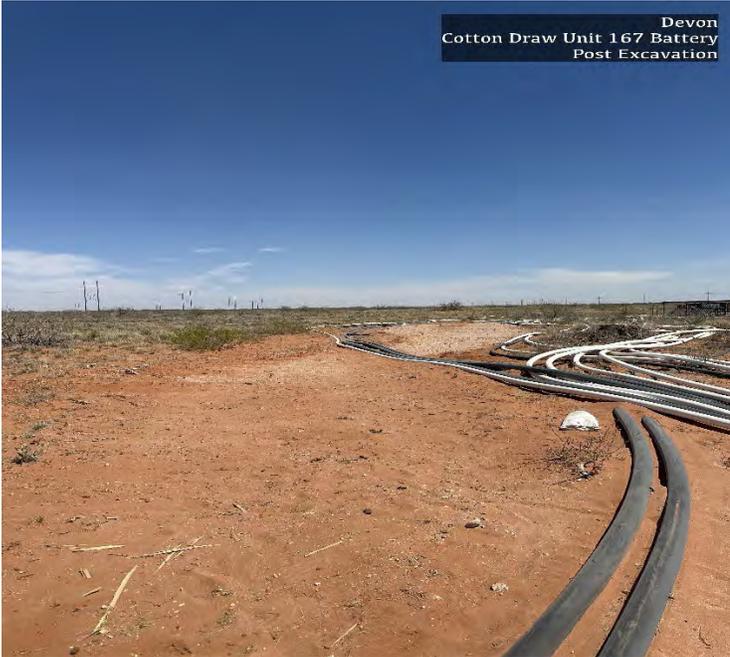
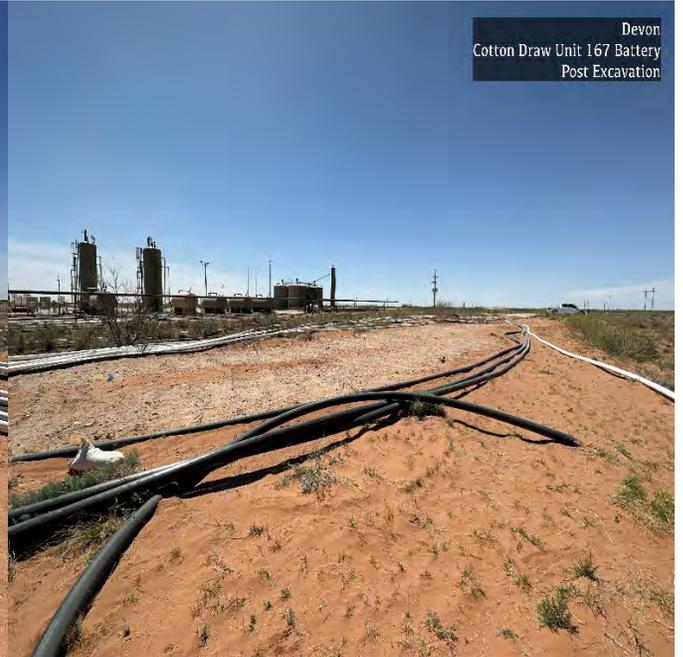
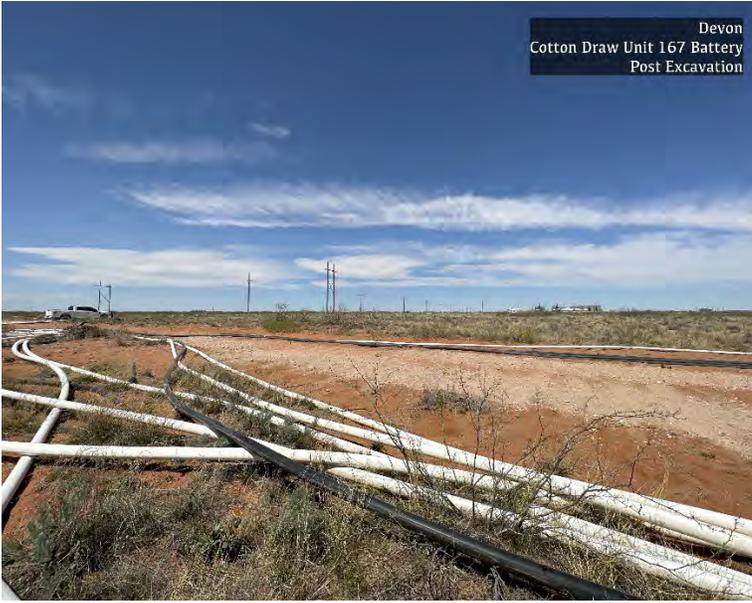
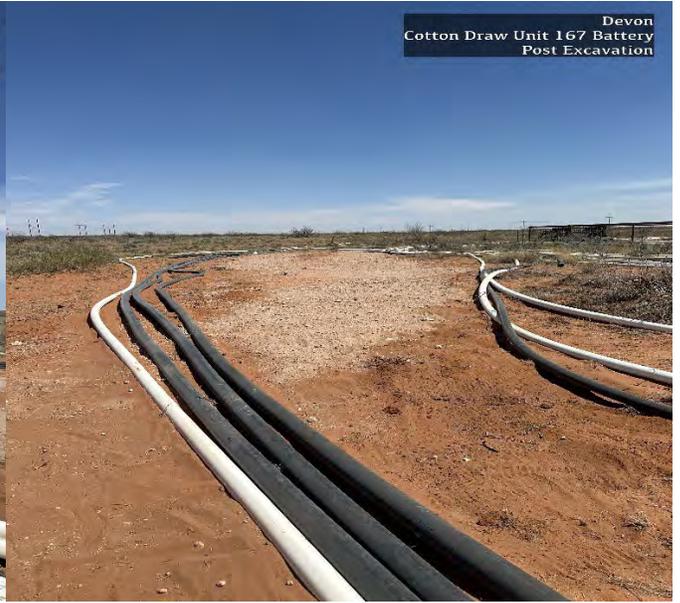
Post Excavation

Based on the sample results, the bottoms and sidewalls were below NMOCD Closure Criteria 19.15.29 NMAC. The contaminated material was sufficiently removed then transported to an NMOCD approved disposal site. The excavation was then backfilled with clean like material, machine compacted and returned to its previous state. See Appendix D for Photographic Documentation.
