May 28, 2021

Vertex Project #: 20E-00141-022

Spill Closure Report: Black Mamba 15 State Com 2H
Unit D, Section 15, Township 23 South, Range 33 East
County: Lea
API: 30-025-40173
Tracking Number: NRM2003436831

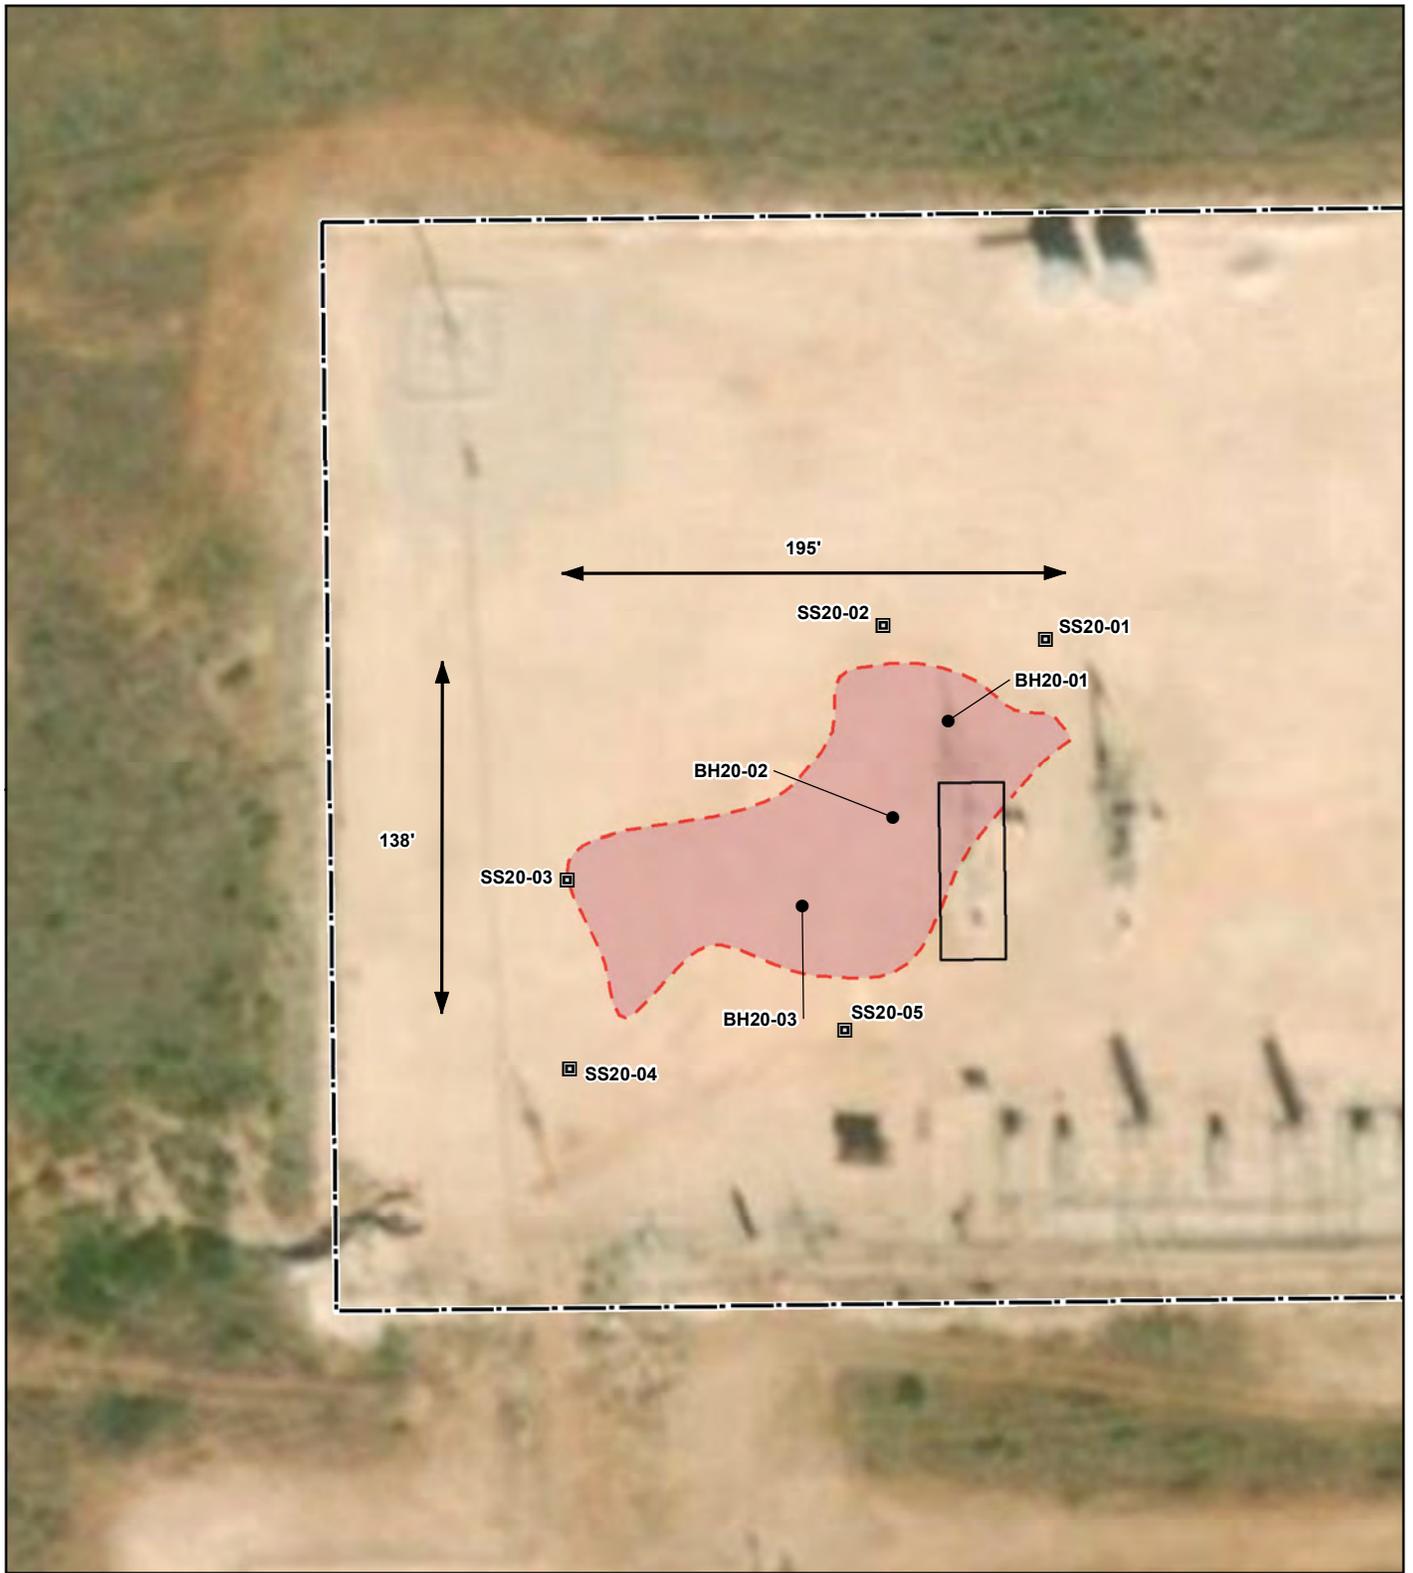
Document Path: \\vks-sf01.corp.intern.share\devps04 - Geomatics\1-Projects\US PROJECTS\Devon Energy Corporation\20E-001411022 - Black Mamba 15\Fig 1 Black Mamba 15 Initial Characterization (20E-00141-022).mxd

- Base Sample
- Surface Sample
- Pumpjack
- Approximate Lease Boundary
- Approximate Spill Extent (~ 9,383 sq.ft.)

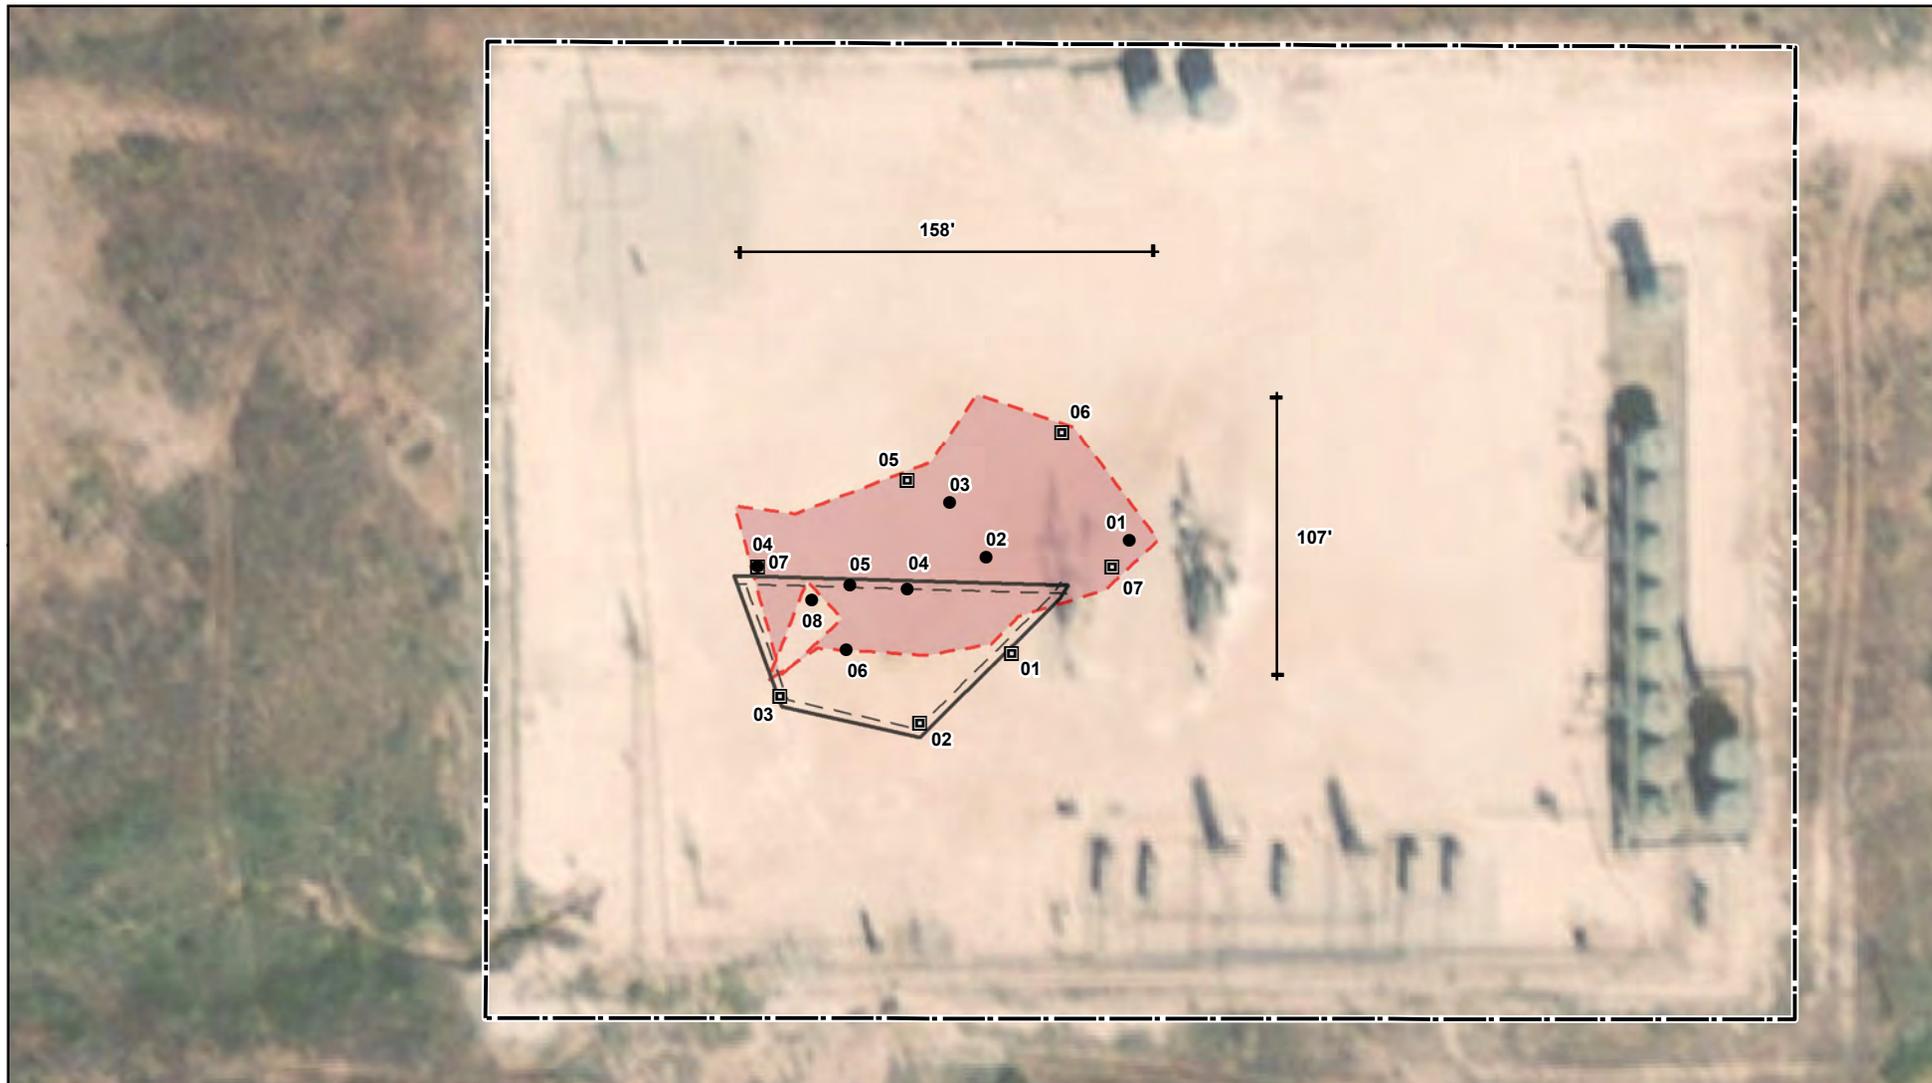
Document Path: G:\Projects\US PROJECTS\Devon Energy Corporation\20E-00141022 - Black Mamba 15\Figure 2 Confirmatory Schematic Black Mamba 15 State 2H.mxd

- Base Sample (Prefixed by "BS21-")
- Soil Sample (Prefixed by "SS21-")
- Approximate Lease Boundary
- ▭ Approximate Spill Extent (8,825 sq. ft.)
- ▭ Excavation

A GeoExplorer 7000 Series Trimble global positioning system (GPS) unit, or equivalent, was used to map the approximate center of each of the five-point composite samples. The confirmation sampling locations are presented on Figure 2 (Attachment 2). Relevant equipment and prominent features/reference points at the site are mapped as well.

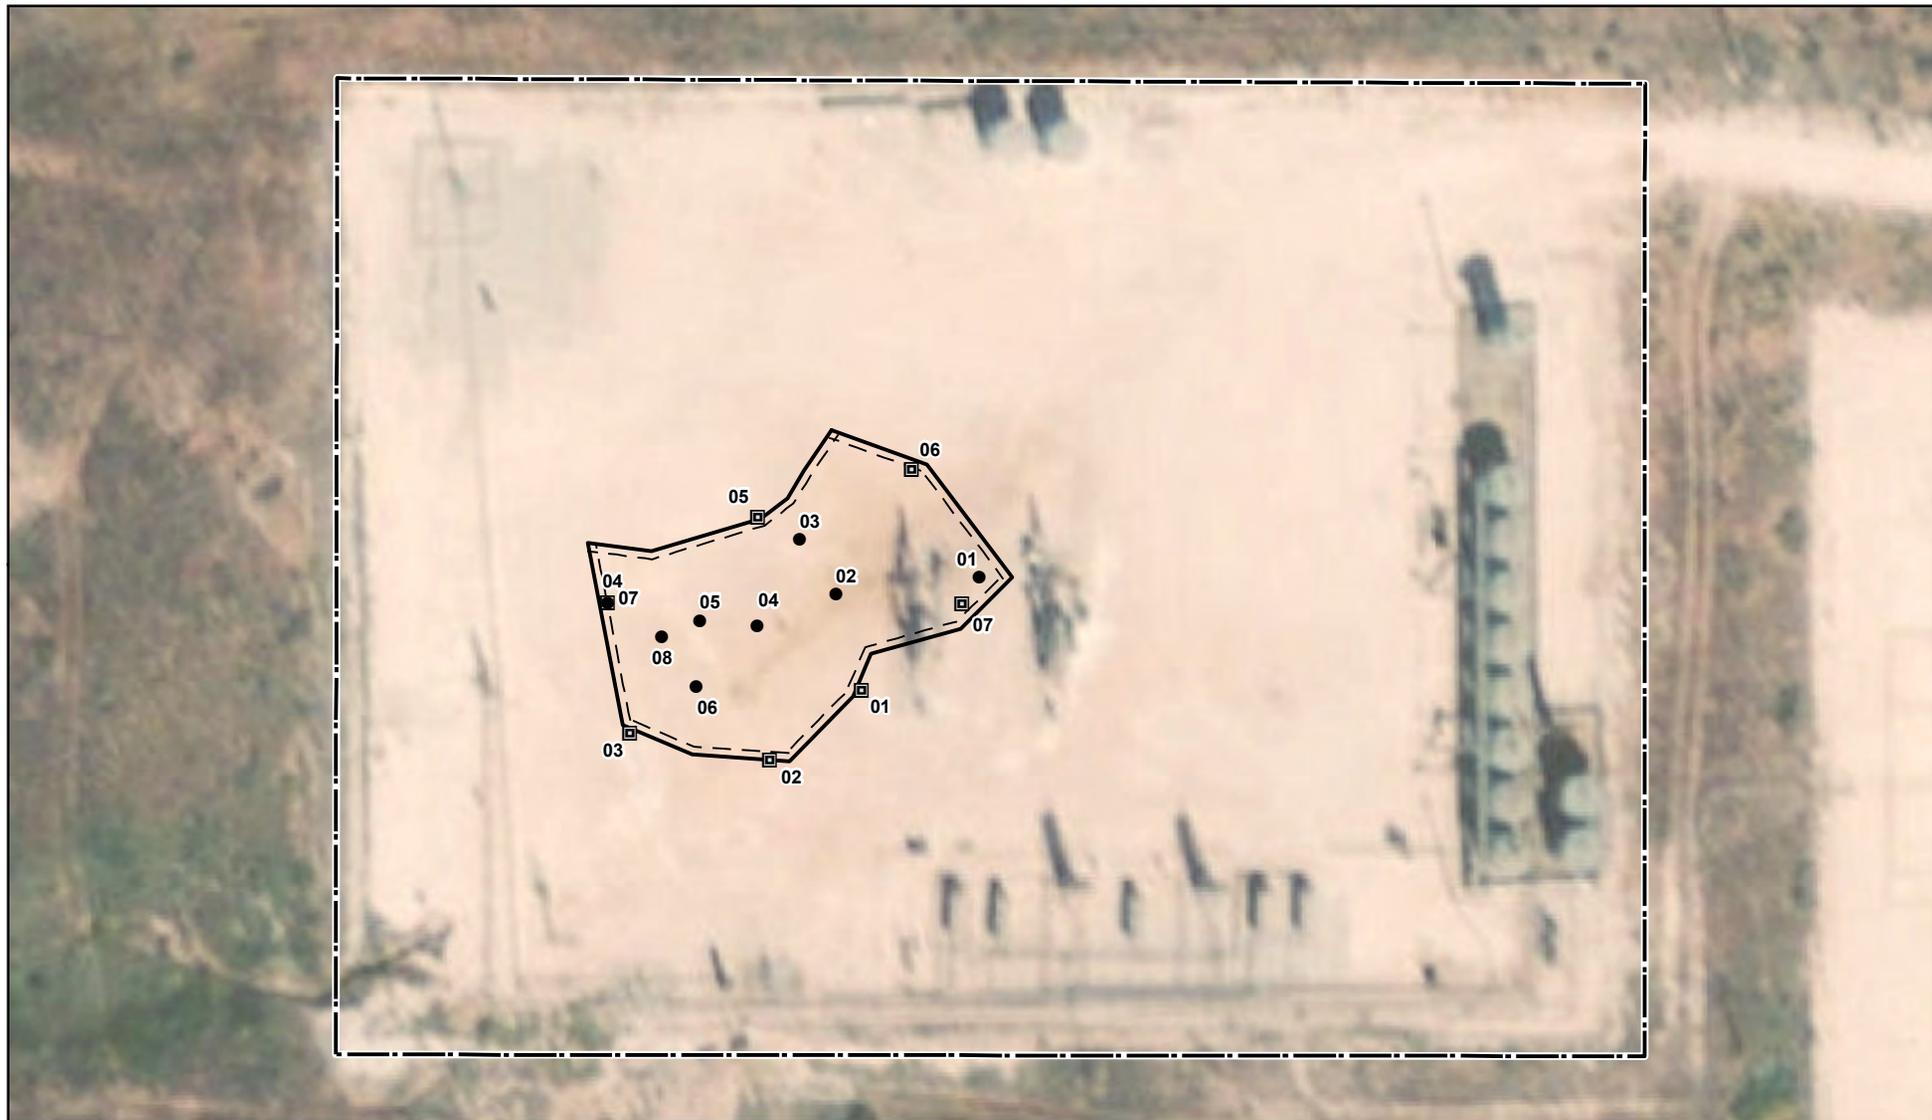
Document Path: G:\Projects\US PROJECTS\Devon Energy Corporation\20E-00141022 - Black Mamba 15\Figure 2 Confirmatory Schematic Black Mamba 15 State 2H.mxd

- Base Sample (Prefixed by "BS21-")
- Soil Sample (Prefixed by "SS21-")
- ⬡ Approximate Lease Boundary
- ⬢ Excavation

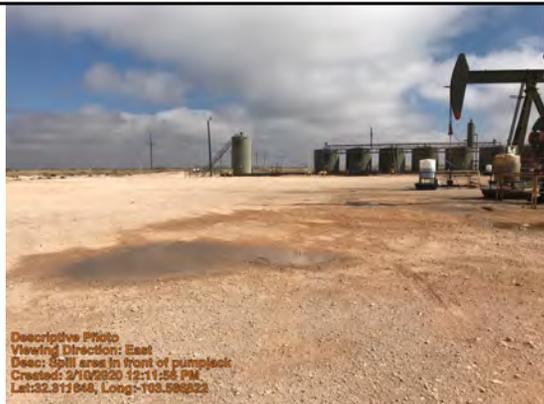
Descriptive Photo
Viewing Direction: East
Desc: Spill area in front of pumpjack
Created: 2/10/2020 12:11:56 PM
Lat:32.317848, Long:-103.588223

Spill area in front of pumpjack

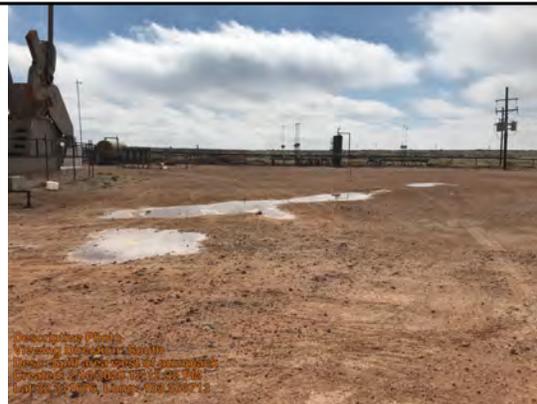
Descriptive Photo
Viewing Direction: South
Desc: Spill area west of pumpjack
Created: 2/10/2020 12:11:56 PM
Lat:32.317878, Long:-103.588713

Spill area west of pumpjack

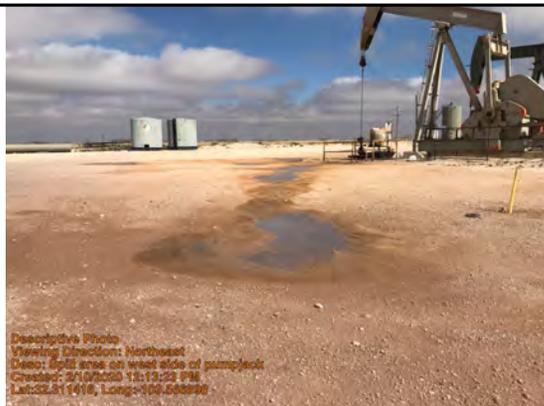
Descriptive Photo
Viewing Direction: Northeast
Desc: Spill area on west side of pumpjack
Created: 2/10/2020 12:13:22 PM
Lat:32.317416, Long:-103.588396

Spill area on west side of pumpjack

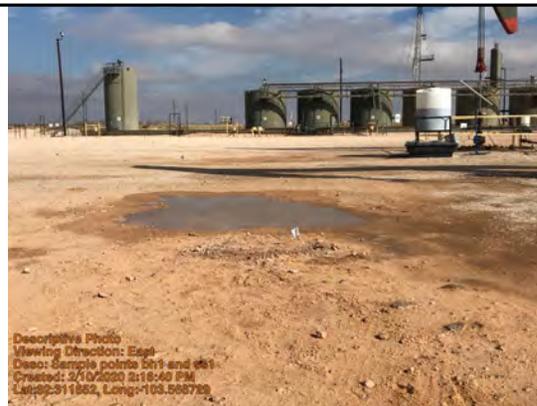
Descriptive Photo
Viewing Direction: East
Desc: Sample points bh1 and ss1
Created: 2/10/2020 2:16:40 PM
Lat:32.317852, Long:-103.588729

Sample points bh1 and ss1

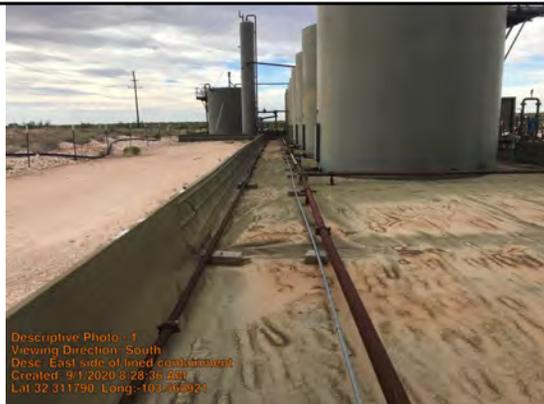
Viewing Direction: South

East side of lined containment

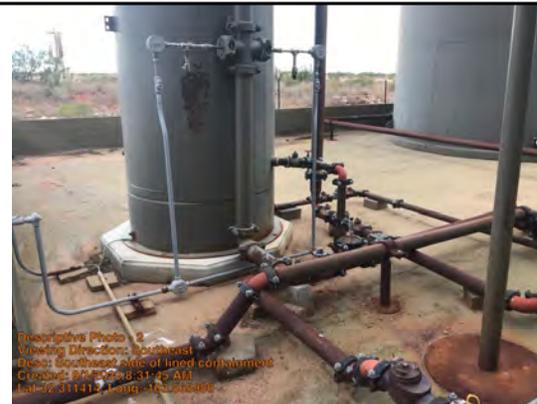
Viewing Direction: Southeast

Southeast side of lined containment

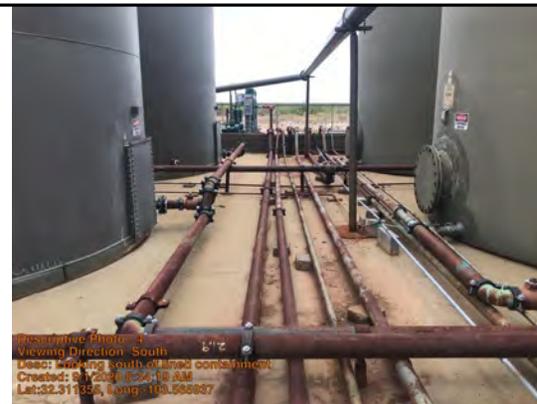
Viewing Direction: South

Looking south of lined containment

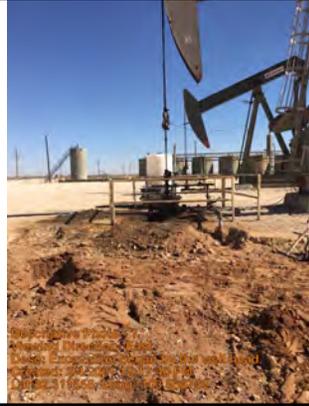
Descriptive Photo - 1
Viewing Direction: East
Desc: Excavation begun by the well head.
Created: 2/4/2021 2:37:24 PM
Lat:32.311450, Long:-103.566662

Excavation begun by the well head.

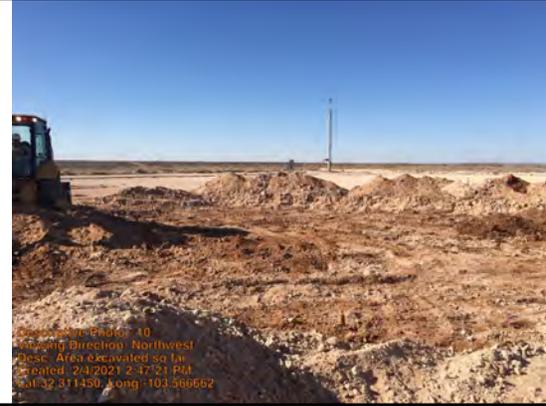
Descriptive Photo - 10
Viewing Direction: Northwest
Desc: Area excavated so far
Created: 2/4/2021 2:37:24 PM
Lat:32.311450, Long:-103.566662

Area excavated so far

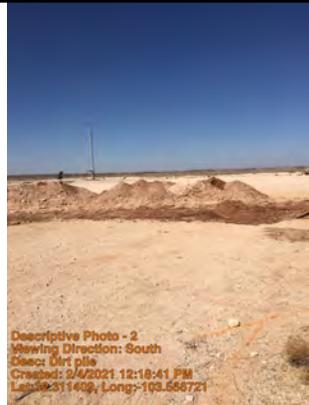
Descriptive Photo - 2
Viewing Direction: South
Desc: Dirt pile
Created: 2/4/2021 12:18:41 PM
Lat:32.311409, Long:-103.566721

Dirt pile

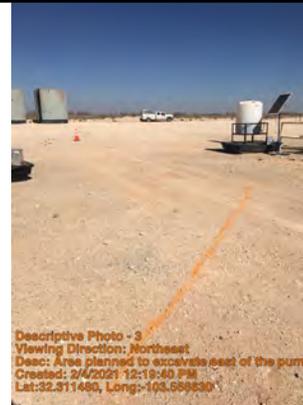
Descriptive Photo - 3
Viewing Direction: Northeast
Desc: Area planned to excavate east of the pump
Created: 2/4/2021 12:19:40 PM
Lat:32.311480, Long:-103.566830

Area planned to excavate east of the pumping unit.

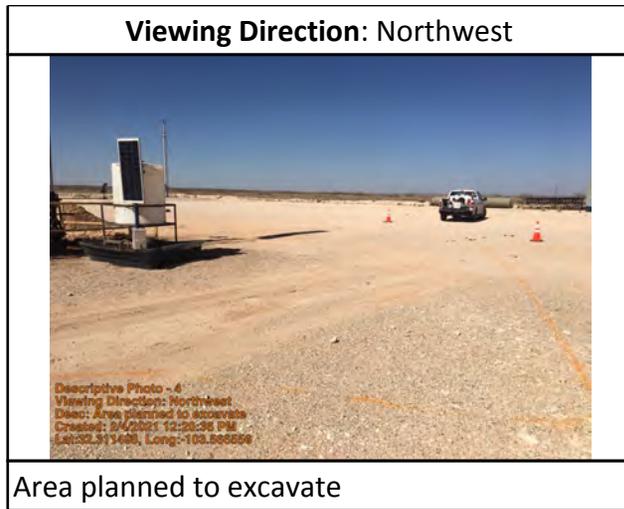
Area planned to excavate

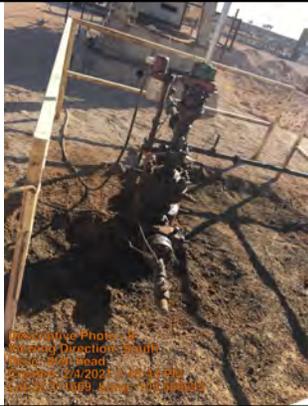
<p>Describe Photo - 0 Viewing Direction: South Name: Well head Created: 8/2/2021 2:44:43 PM Lat: 31.1179, Long: -103.8882</p>	
Well head

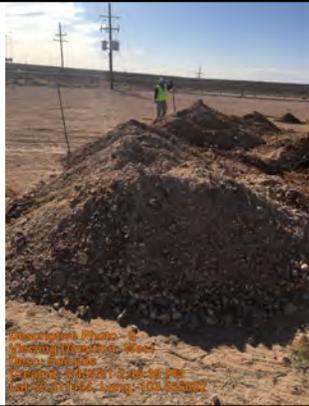
<p>Describe Photo - 0 Viewing Direction: West Name: Soil pile Created: 8/2/2021 2:48:38 PM Lat: 31.1144, Long: -103.8882</p>	
Soil pile

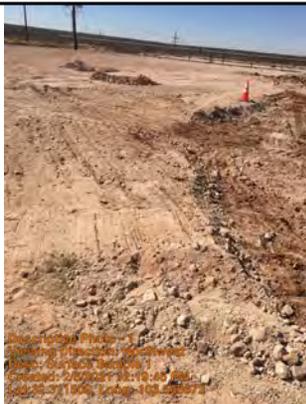
Viewing Direction: Northwest

Surface Sample 1

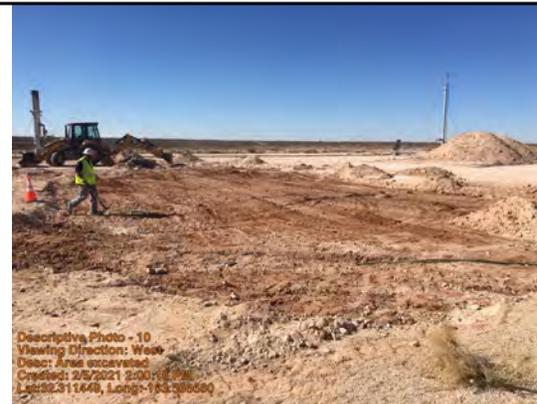
Viewing Direction: West

Area excavated

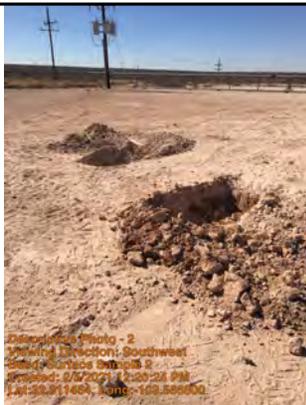
Viewing Direction: Southwest

Surface Sample 2

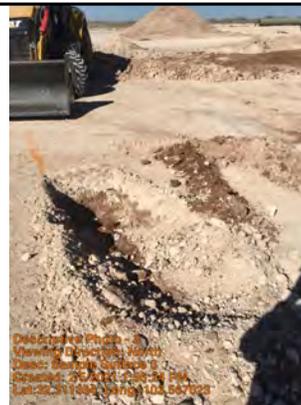
Viewing Direction: North

Sample Surface 3

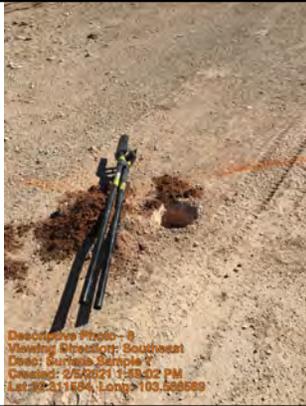
Descriptive Photo - 8
Viewing Direction: Southeast
Date: Surface Sample 7
Created: 2/5/2021 1:55:02 PM
Lat: 32.311694, Long: 103.598569

Surface Sample 7

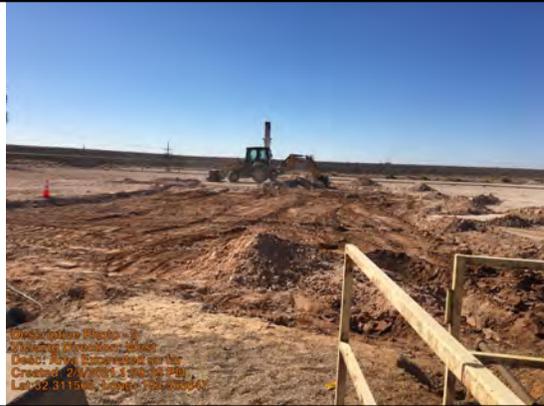
Descriptive Photo - 8
Viewing Direction: West
Date: Area Excavated so far
Created: 2/5/2021 3:06:18 PM
Lat: 32.311694, Long: 103.598569

Area Excavated so far

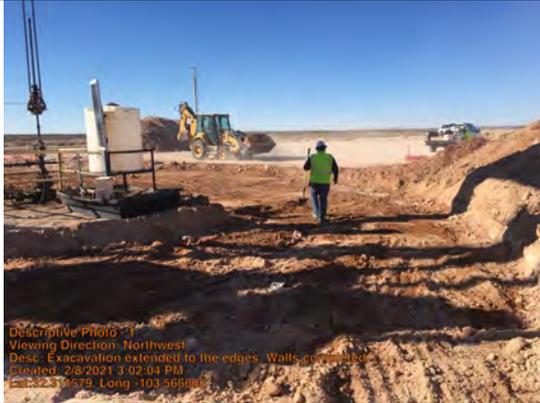
Descriptive Photo - 1
Viewing Direction: Northwest
Desc: Excavation extended to the edges. Walls completed
Created: 2/8/2021 3:02:04 PM
Lat: 32.311579, Long: -103.566868

Excavation extended to the edges. Walls completed

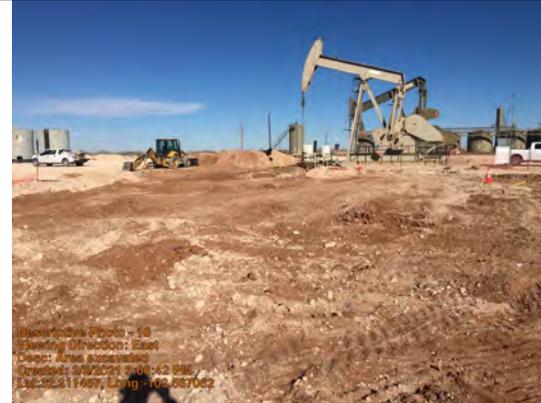
Descriptive Photo - 10
Viewing Direction: East
Desc: Area excavated
Created: 2/8/2021 3:06:42 PM
Lat: 32.311489, Long: -103.567062

Area excavated

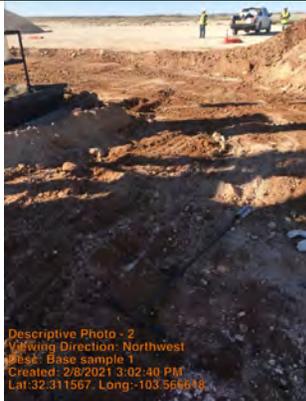
Descriptive Photo - 2
Viewing Direction: Northwest
Desc: Base sample 1
Created: 2/8/2021 3:02:40 PM
Lat: 32.311567, Long: -103.566848

Base sample 1

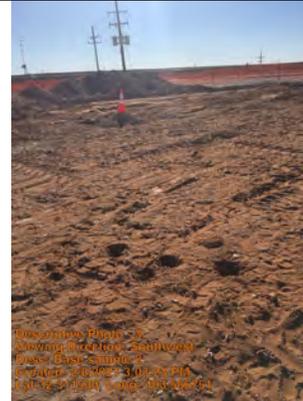
Descriptive Photo - 3
Viewing Direction: Southwest
Desc: Base sample 2
Created: 2/8/2021 3:03:20 PM
Lat: 32.311567, Long: -103.566848

Base sample 2

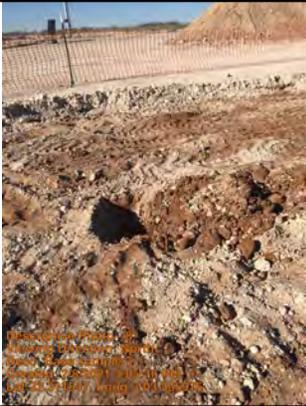
Viewing Direction: North

A photograph showing a dirt and gravel area with a fence in the background. A black marker is visible in the foreground. The image is oriented as if looking north. <p>Base sample 7</p>	
Base sample 7

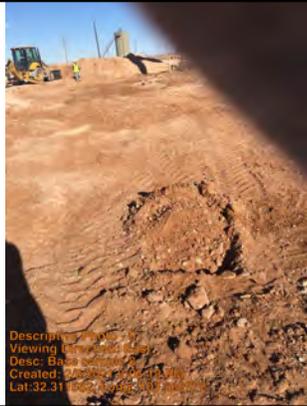
Viewing Direction: East

A photograph showing a dirt and gravel area with a yellow excavator in the background. A black marker is visible in the foreground. The image is oriented as if looking east. <p>Base sample 8</p>	
Base sample 8

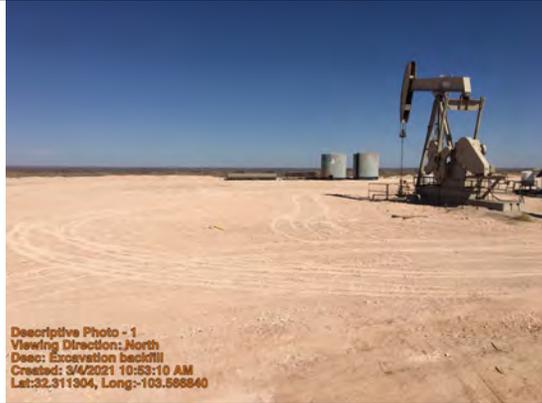
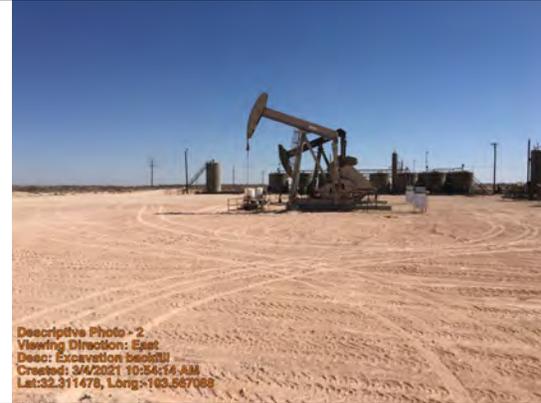
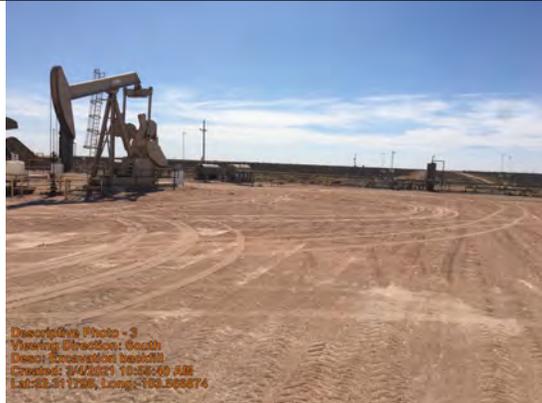
Excavation backfill

- 10:30** Arrived on site to re-collect failed confirmatory samples WS1 and BS8. Also to take photos of backfill.
- 11:52** Completed recollection of samples and got clean for both.
