**Spill Closure Report:** Black River SWD #1  
Section 31, Township 23 South, Range 28 East  
County: Eddy  
Incident Report: nAPP2303627366

**Prepared For:** San Mateo Midstream  
1500, 5400 LBJ Freeway  
Dallas, Texas 75240

2023 Spill Assessment and Closure  
April 2023

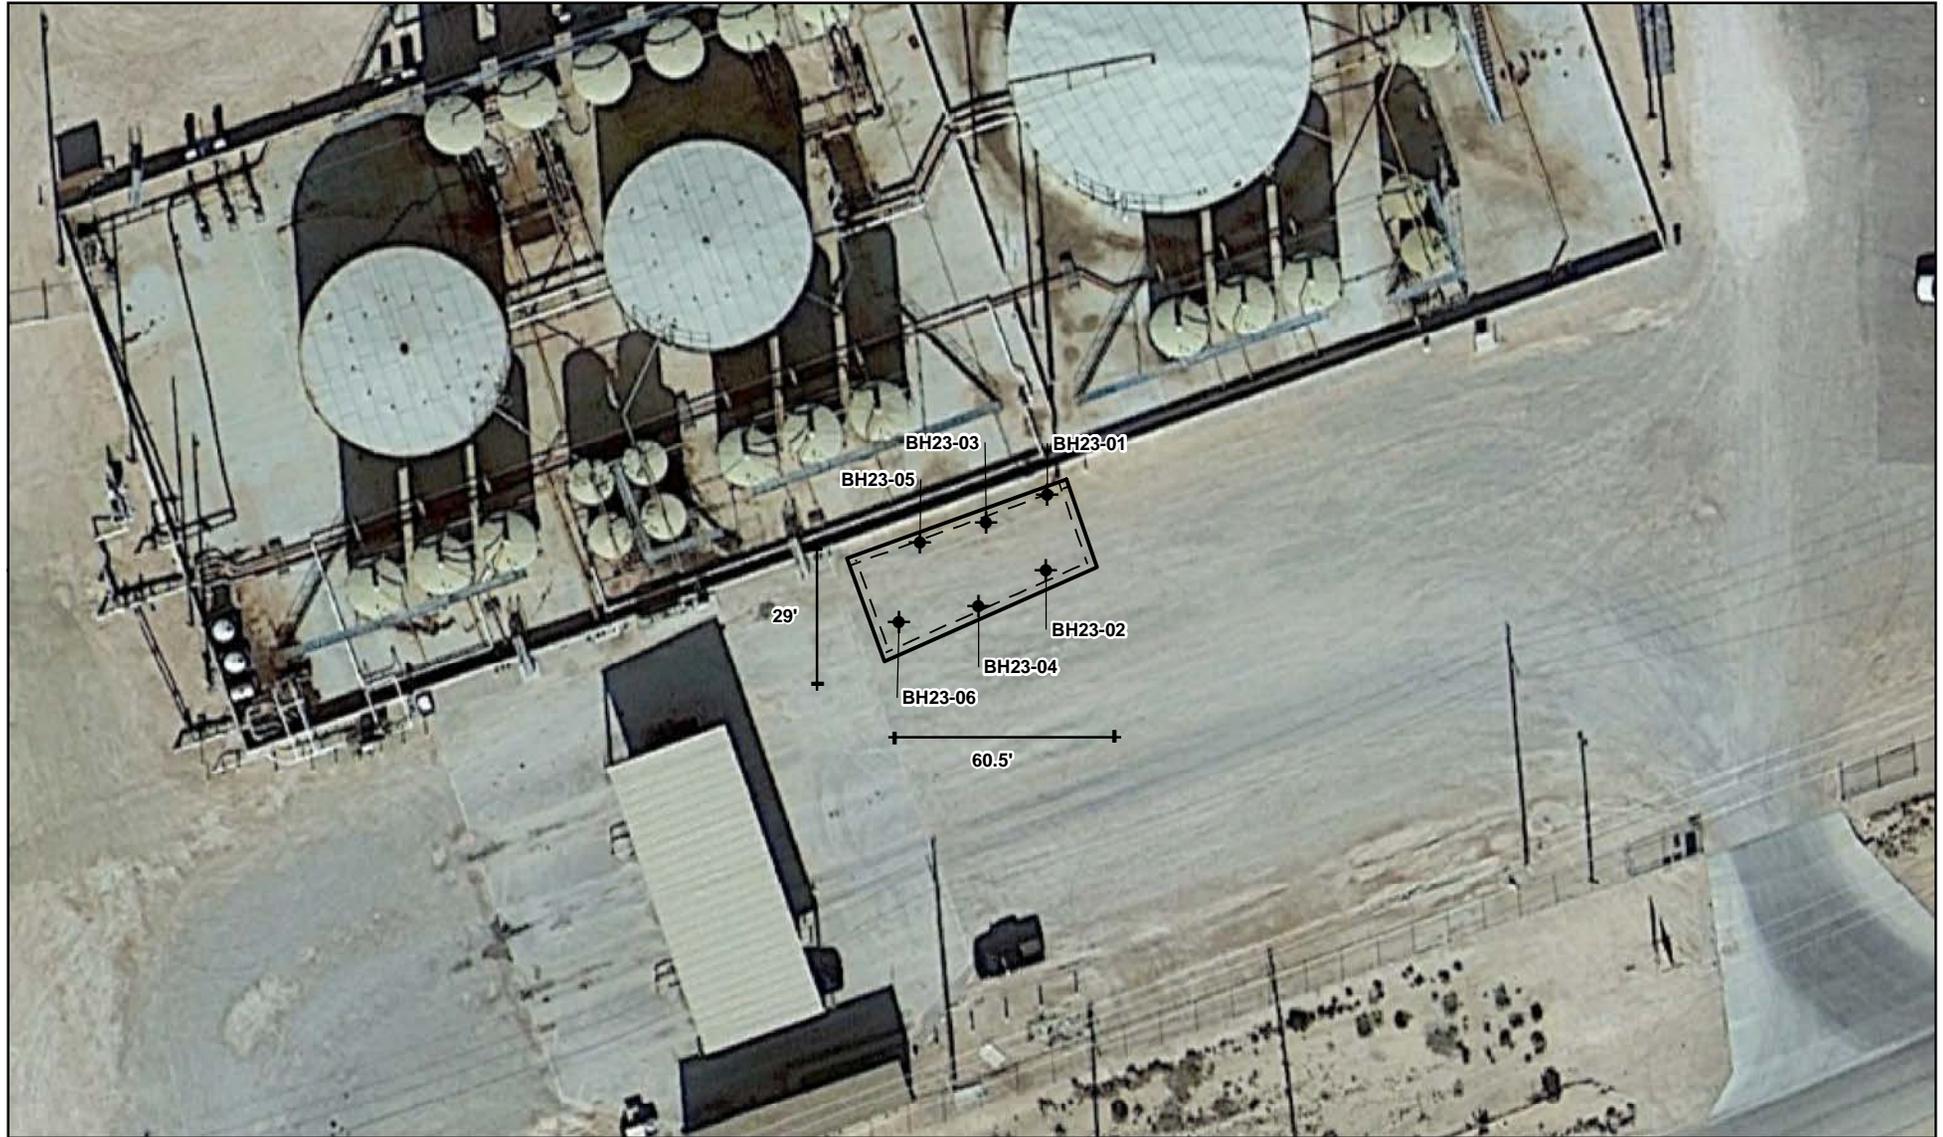
The site is located approximately 0.97 miles southwest of Loving, New Mexico (Google Inc., 2023). The legal location for the site is Section 31, Township 23 South and Range 28 East in Eddy County, New Mexico. The spill area is located on private property. An aerial photograph and site schematic are included on Figure 1 (Attachment 1).

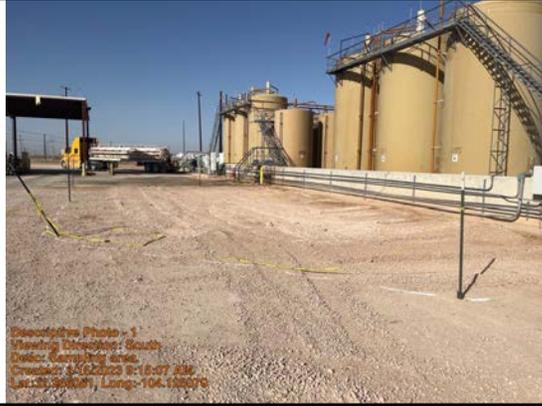
Descriptive Photo - 1  
Viewing Direction: South  
Topic: Sampling area  
Created: 2/15/2023 9:15:07 AM  
Lat:32.286091, Long:-104.125234

Sampling area.

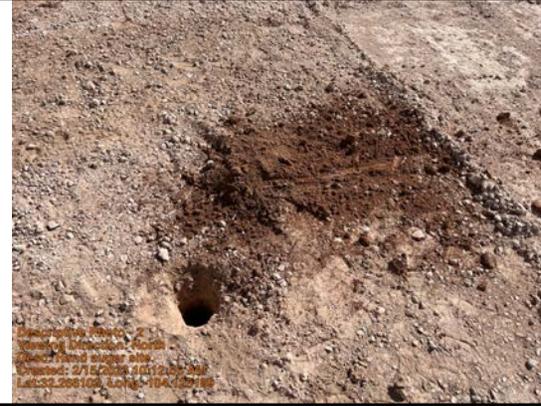
Descriptive Photo - 2  
Viewing Direction: North  
Topic: Hand auger site  
Created: 2/15/2023 10:12:58 AM  
Lat:32.286108, Long:-104.125169

Hand auger site.

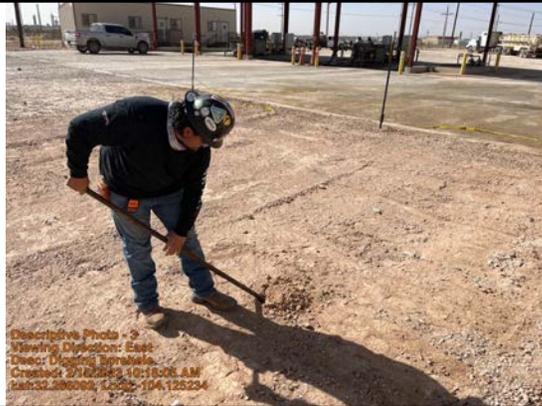
Descriptive Photo - 3  
Viewing Direction: East  
Topic: Digging borehole  
Created: 2/15/2023 10:18:05 AM  
Lat:32.286068, Long:-104.125234

Digging borehole.

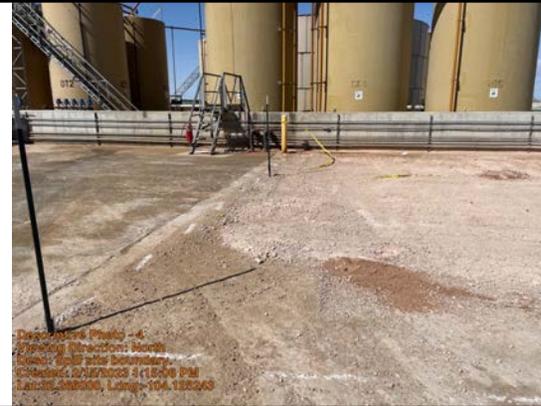
Descriptive Photo - 4  
Viewing Direction: North  
Topic: Spill site boundary  
Created: 2/15/2023 4:15:08 PM  
Lat:32.286098, Long:-104.125243

Spill site boundary.

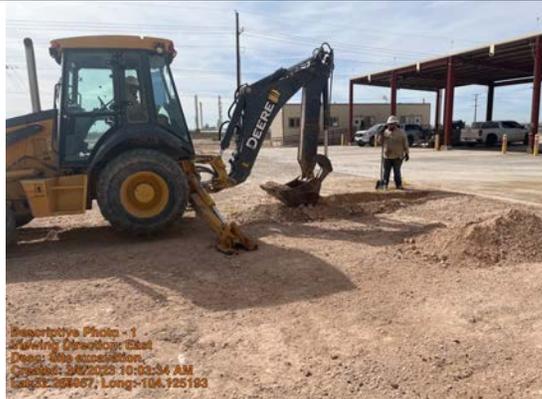
Descriptive Photo - 1  
Viewing Direction: East  
Desc: Site excavation.  
Created: 3/8/2023 10:33:34 AM  
Lat: 32.286067, Long: -104.125193

Site excavation.

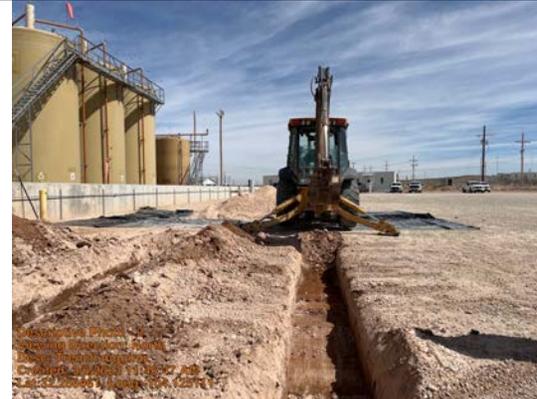
Descriptive Photo - 2  
Viewing Direction: North  
Desc: Trench digging.  
Created: 3/8/2023 11:30:37 AM  
Lat: 32.286067, Long: -104.125193

Trench digging.

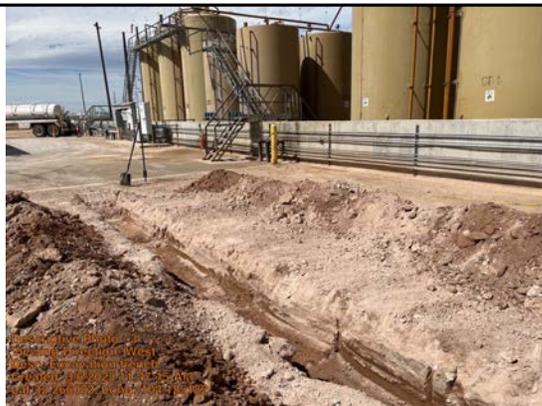
Descriptive Photo - 3  
Viewing Direction: West  
Desc: Excavation trench.  
Created: 3/8/2023 11:43:15 AM  
Lat: 32.286067, Long: -104.125193

Excavation trench.

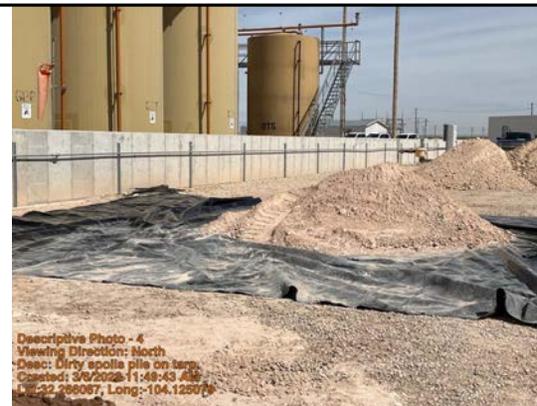
Descriptive Photo - 4  
Viewing Direction: North  
Desc: Dirty spoils pile on tarp.  
Created: 3/8/2023 11:48:43 AM  
Lat: 32.286067, Long: -104.125193

Dirty spoils pile on tarp.

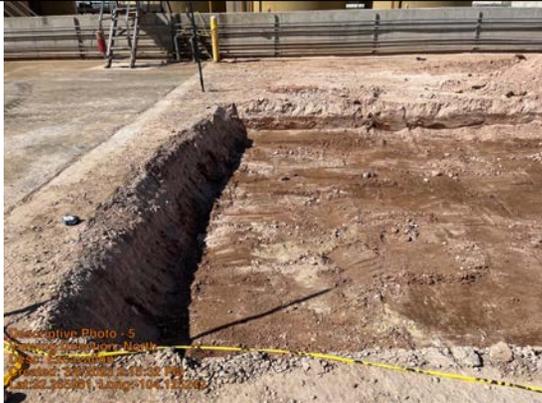
Western portion of excavation.

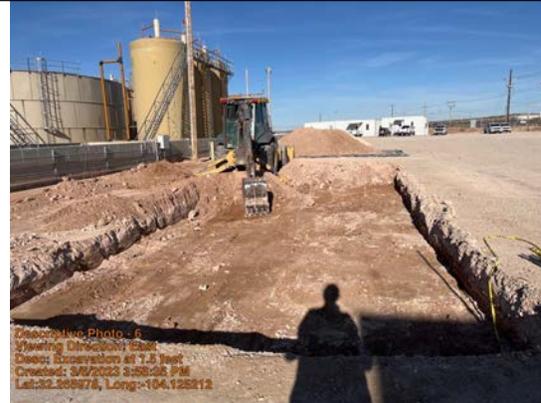
Excavation at 1.5 feet

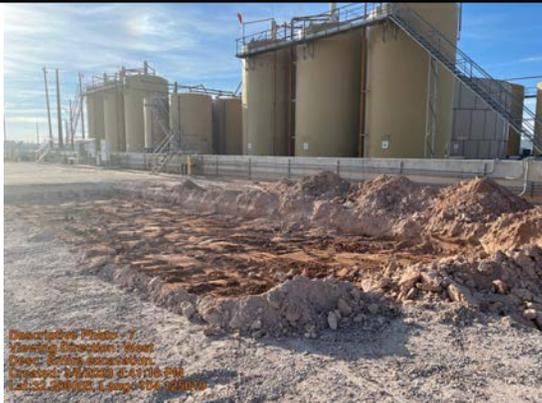
Entire excavation.

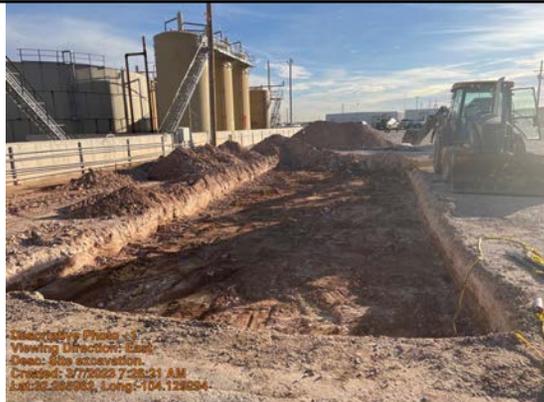
Descriptive Photo - 1  
Viewing Direction: East  
Desc: Site excavation.  
Created: 3/7/2023 7:28:21 AM  
Lat:32.282953, Long:-104.123264

Site excavation.

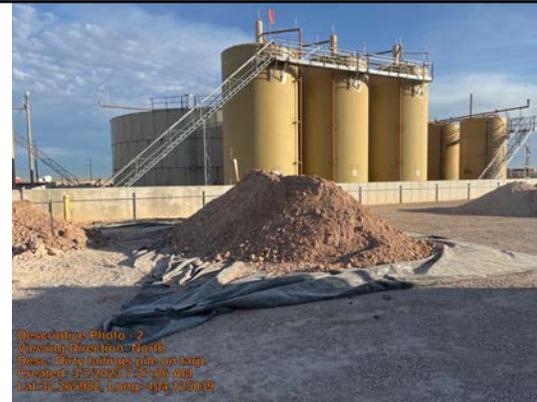
Descriptive Photo - 2  
Viewing Direction: North  
Desc: Dirty tailings pile on tarp.  
Created: 3/7/2023 7:27:06 AM  
Lat:32.282953, Long:-104.123264

Dirty tailings pile on tarp.

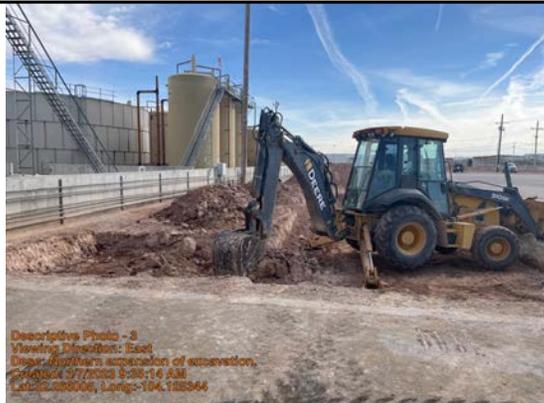
Descriptive Photo - 3  
Viewing Direction: East  
Desc: Northern expansion of excavation.  
Created: 3/7/2023 8:28:14 AM  
Lat:32.282953, Long:-104.123264

Northern expansion of excavation.

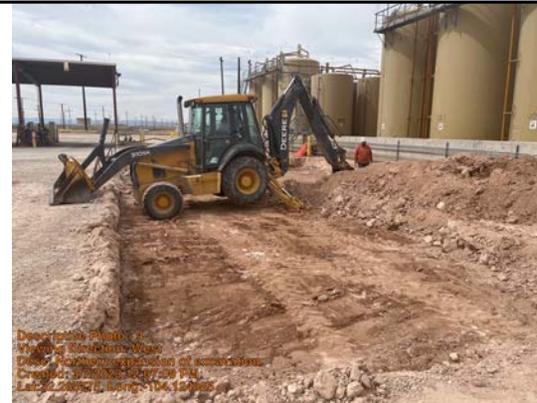
Descriptive Photo - 4  
Viewing Direction: West  
Desc: Northern expansion of excavation.  
Created: 3/7/2023 8:27:26 PM  
Lat:32.282953, Long:-104.123264

Northern expansion of excavation.

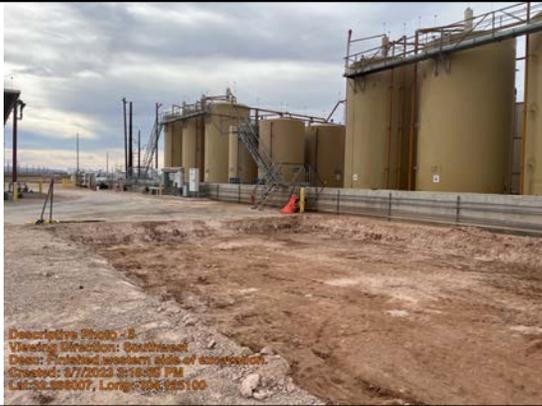
Descriptive Photo - 5  
Viewing Direction: Southwest  
Date: Finished western side of excavation.  
Created: 3/7/2023 3:18:35 PM  
Lat:32.289007, Long:-104.123100

Finished western side of excavation.

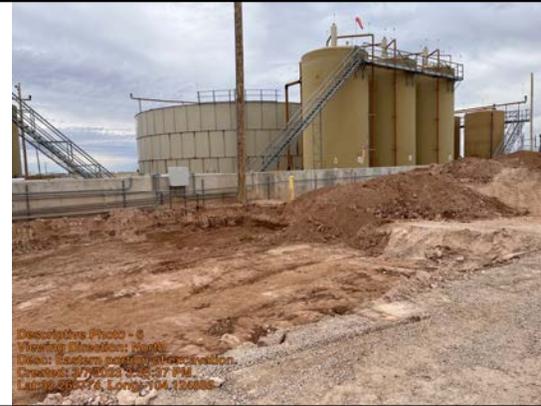
Descriptive Photo - 6  
Viewing Direction: North  
Date: Eastern portion of excavation.  
Created: 3/7/2023 3:28:37 PM  
Lat:32.289076, Long:-104.123088

Eastern portion of excavation.

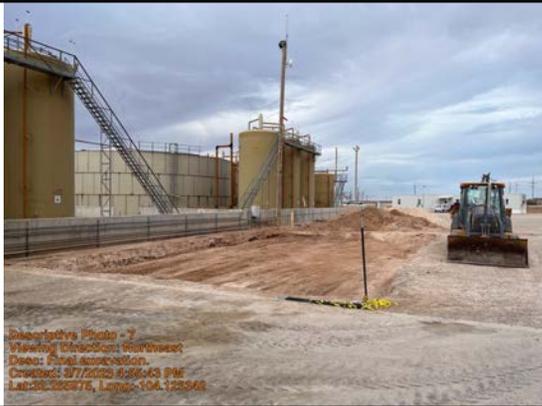
Descriptive Photo - 7  
Viewing Direction: Northeast  
Date: Final excavation.  
Created: 3/7/2023 4:26:43 PM  
Lat:32.289076, Long:-104.123048

Final excavation.

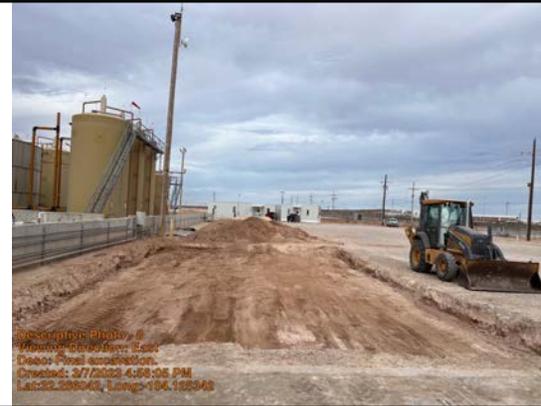
Descriptive Photo - 8  
Viewing Direction: East  
Date: Final excavation.  
Created: 3/7/2023 4:58:05 PM  
Lat:32.289049, Long:-104.123048

Final excavation.

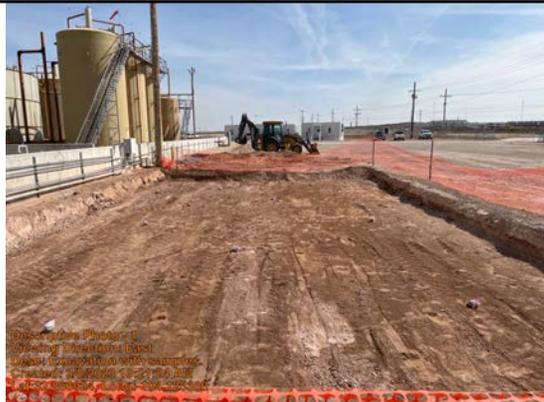
Descriptive Photo: 3  
Viewing Direction: East  
Date: 3/8/2023 11:56:27 AM  
Created: 3/8/2023 11:56:27 AM  
Lat:32.268348, Long:-104.125177

Excavation with samples.

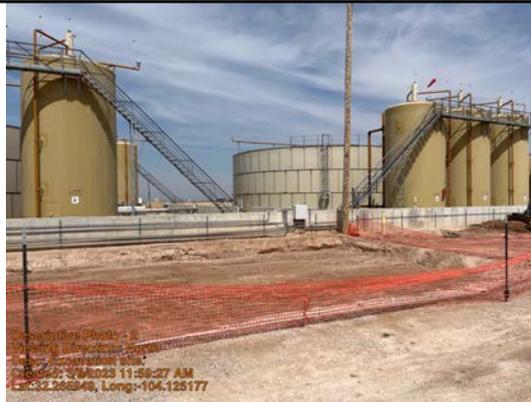
Descriptive Photo: 3  
Viewing Direction: North  
Date: 3/8/2023 11:56:27 AM  
Created: 3/8/2023 11:56:27 AM  
Lat:32.268348, Long:-104.125177

Excavation site.

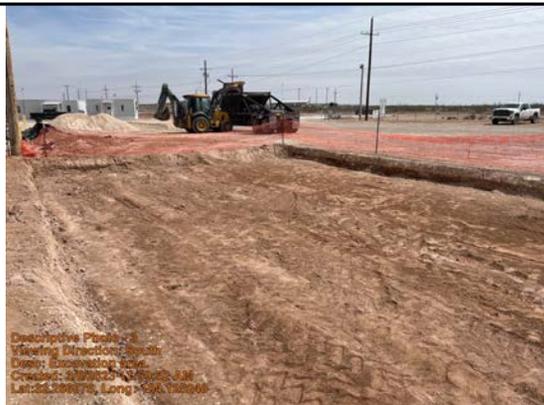
Descriptive Photo: 3  
Viewing Direction: South  
Date: 3/8/2023 11:56:27 AM  
Created: 3/8/2023 11:56:27 AM  
Lat:32.268348, Long:-104.125177

Excavation area.

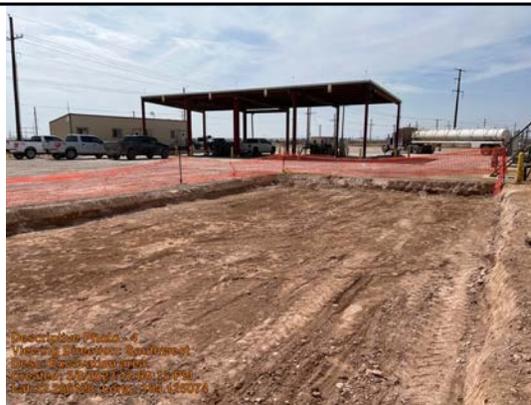
Descriptive Photo: 4  
Viewing Direction: Southwest  
Date: 3/8/2023 11:56:27 AM  
Created: 3/8/2023 11:56:27 AM  
Lat:32.268348, Long:-104.125177

Excavation area.

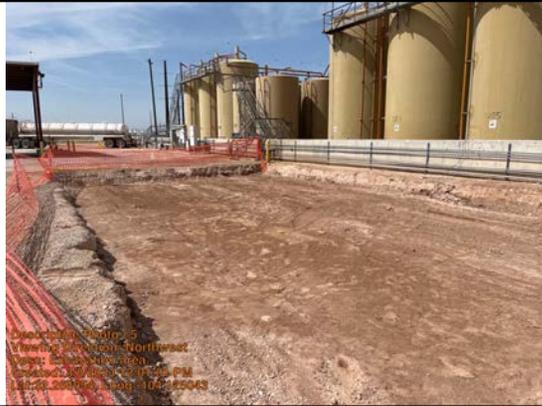
Excavation area.

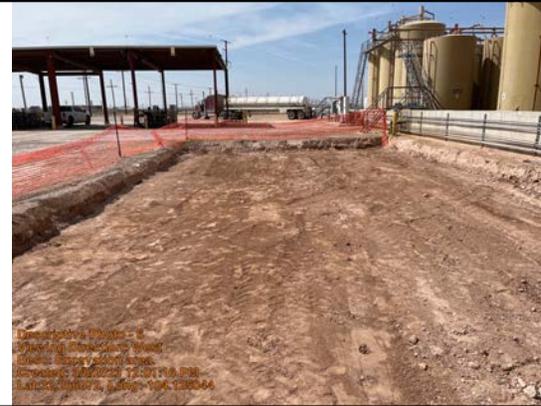
Excavation area.
