Incident ID	nAPP2319837015
District RP	
Facility ID	
Application ID

Re: NMOCD #nAPP2319837015
Big Lizard Compressor Station
32.307838, -103.620995
U/L H, Section 13, Township 23 South, Range 32 East

Big Lizard Photo Documentation

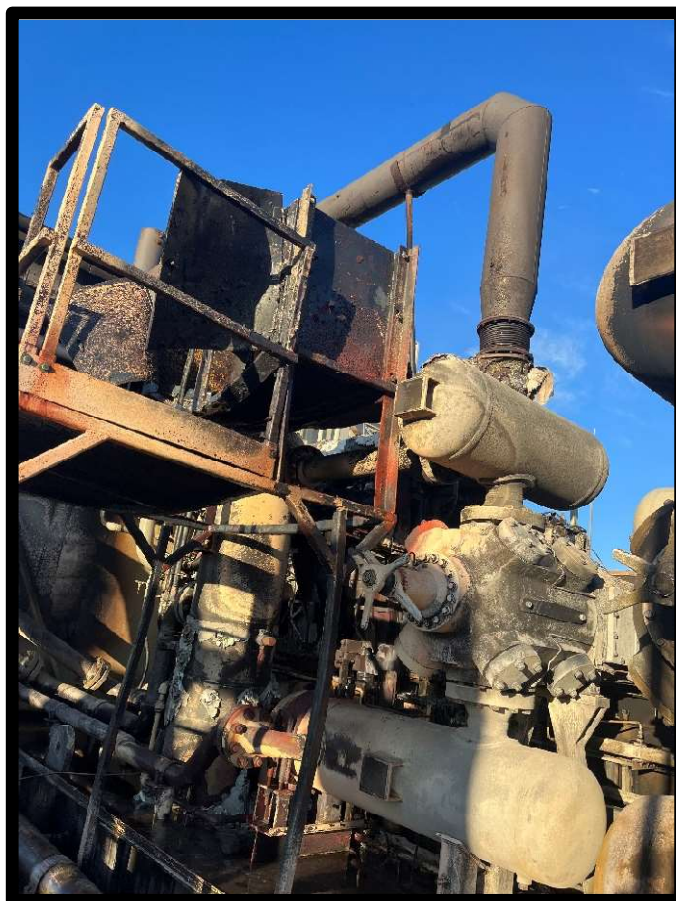
Compressor 3240 at Big Lizard compressor station unexpectedly caught on fire. The cause of this event was due to a failed nipple on the pulsation bottle. The failed nipple allowed for gas from the pulsation bottle to blow gas near the intake and the turbo, and the heat from the intake and the turbo caused this gas to combust. The facility was depressurized to protect personnel and equipment and the fire extinguished. This was a gas only event with no liquid impact to soil.

Big Lizard Unit C-103 Post-Fire

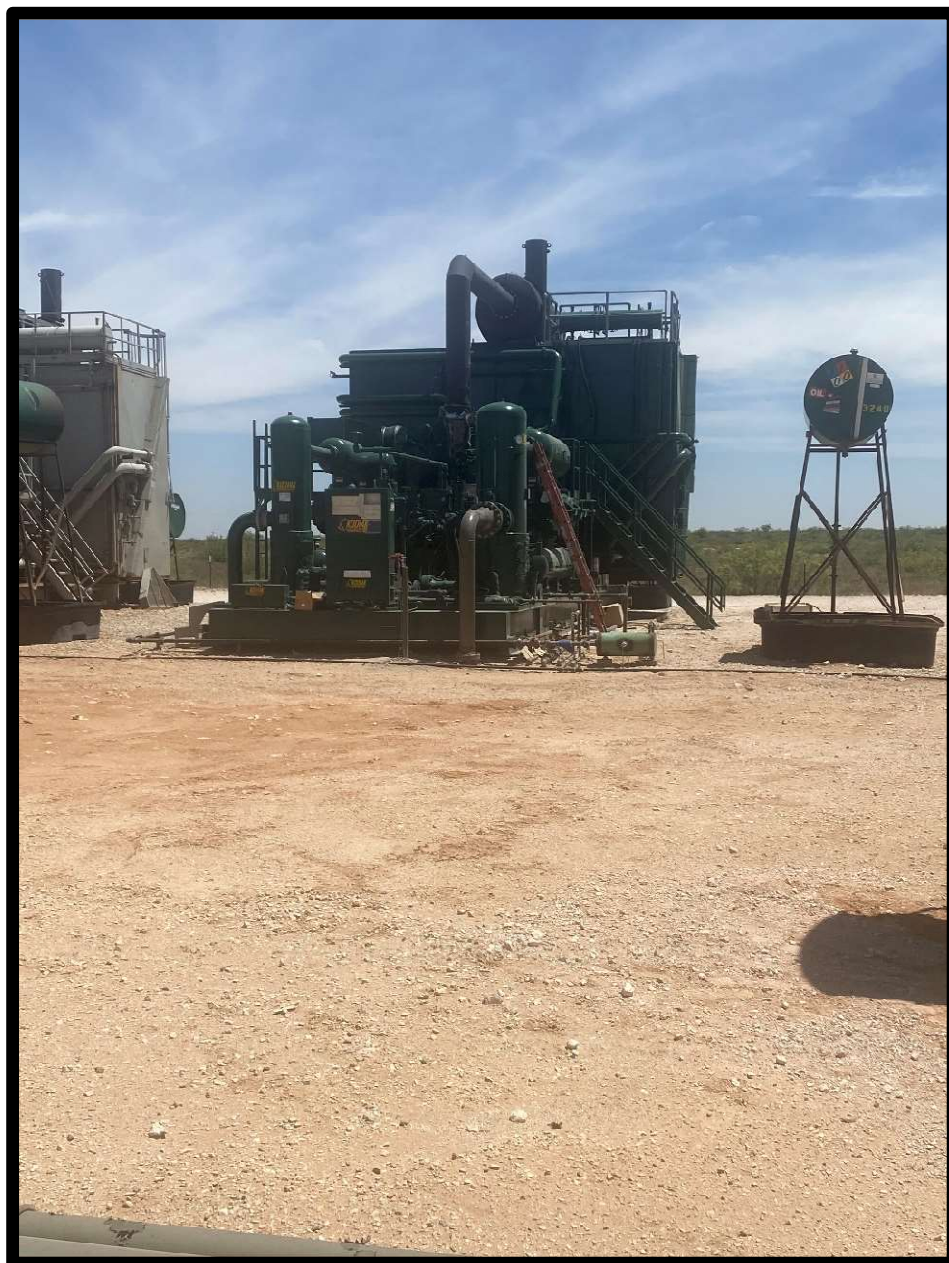
Big Lizard Unit C-103 Post-Fire, Replacement Unit Pictured
