Re: Closure Request NVA 260 Tracking #: NAPP2300550705

Trinity Oilfield Services (Trinity), on behalf of Cross Timbers Energy, LLC, hereby submits the following Closure Request in response to a release that occurred at the above-referenced location, and further described below.

Site Information			
Incident ID	NAPP2300550705		
Site Name	NVA 260		
Company	Cross Timbers Energy, LLC		
County	Lea		
ULSTR	C-13-17S-34E		
GPS Coordinates (NAD 83)	32.839616,-103.522048		
Landowner	Private

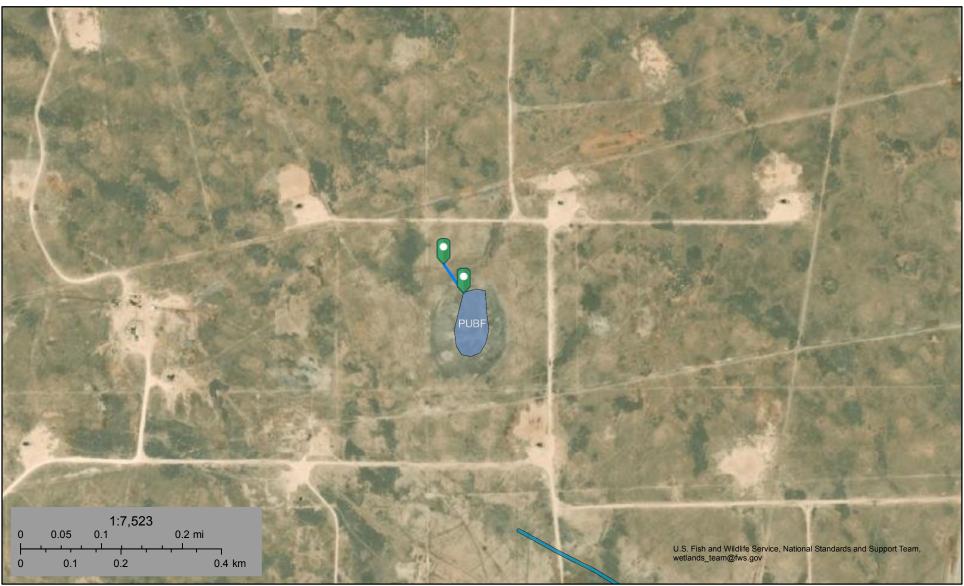
National Wetlands Inventory

Wetlands
