Incident ID	NAPP2227232943
District RP	
Facility ID	
Application ID

Site Assessment/Characterization

Based on laboratory analytical results and field activities conducted to date, Etech recommends H.L. Brown Operating, LLC, provide copies of this Remediation Summary and Soil Closure Request to the appropriate agencies and request closure be granted to the Fed Com 27 004 Site.

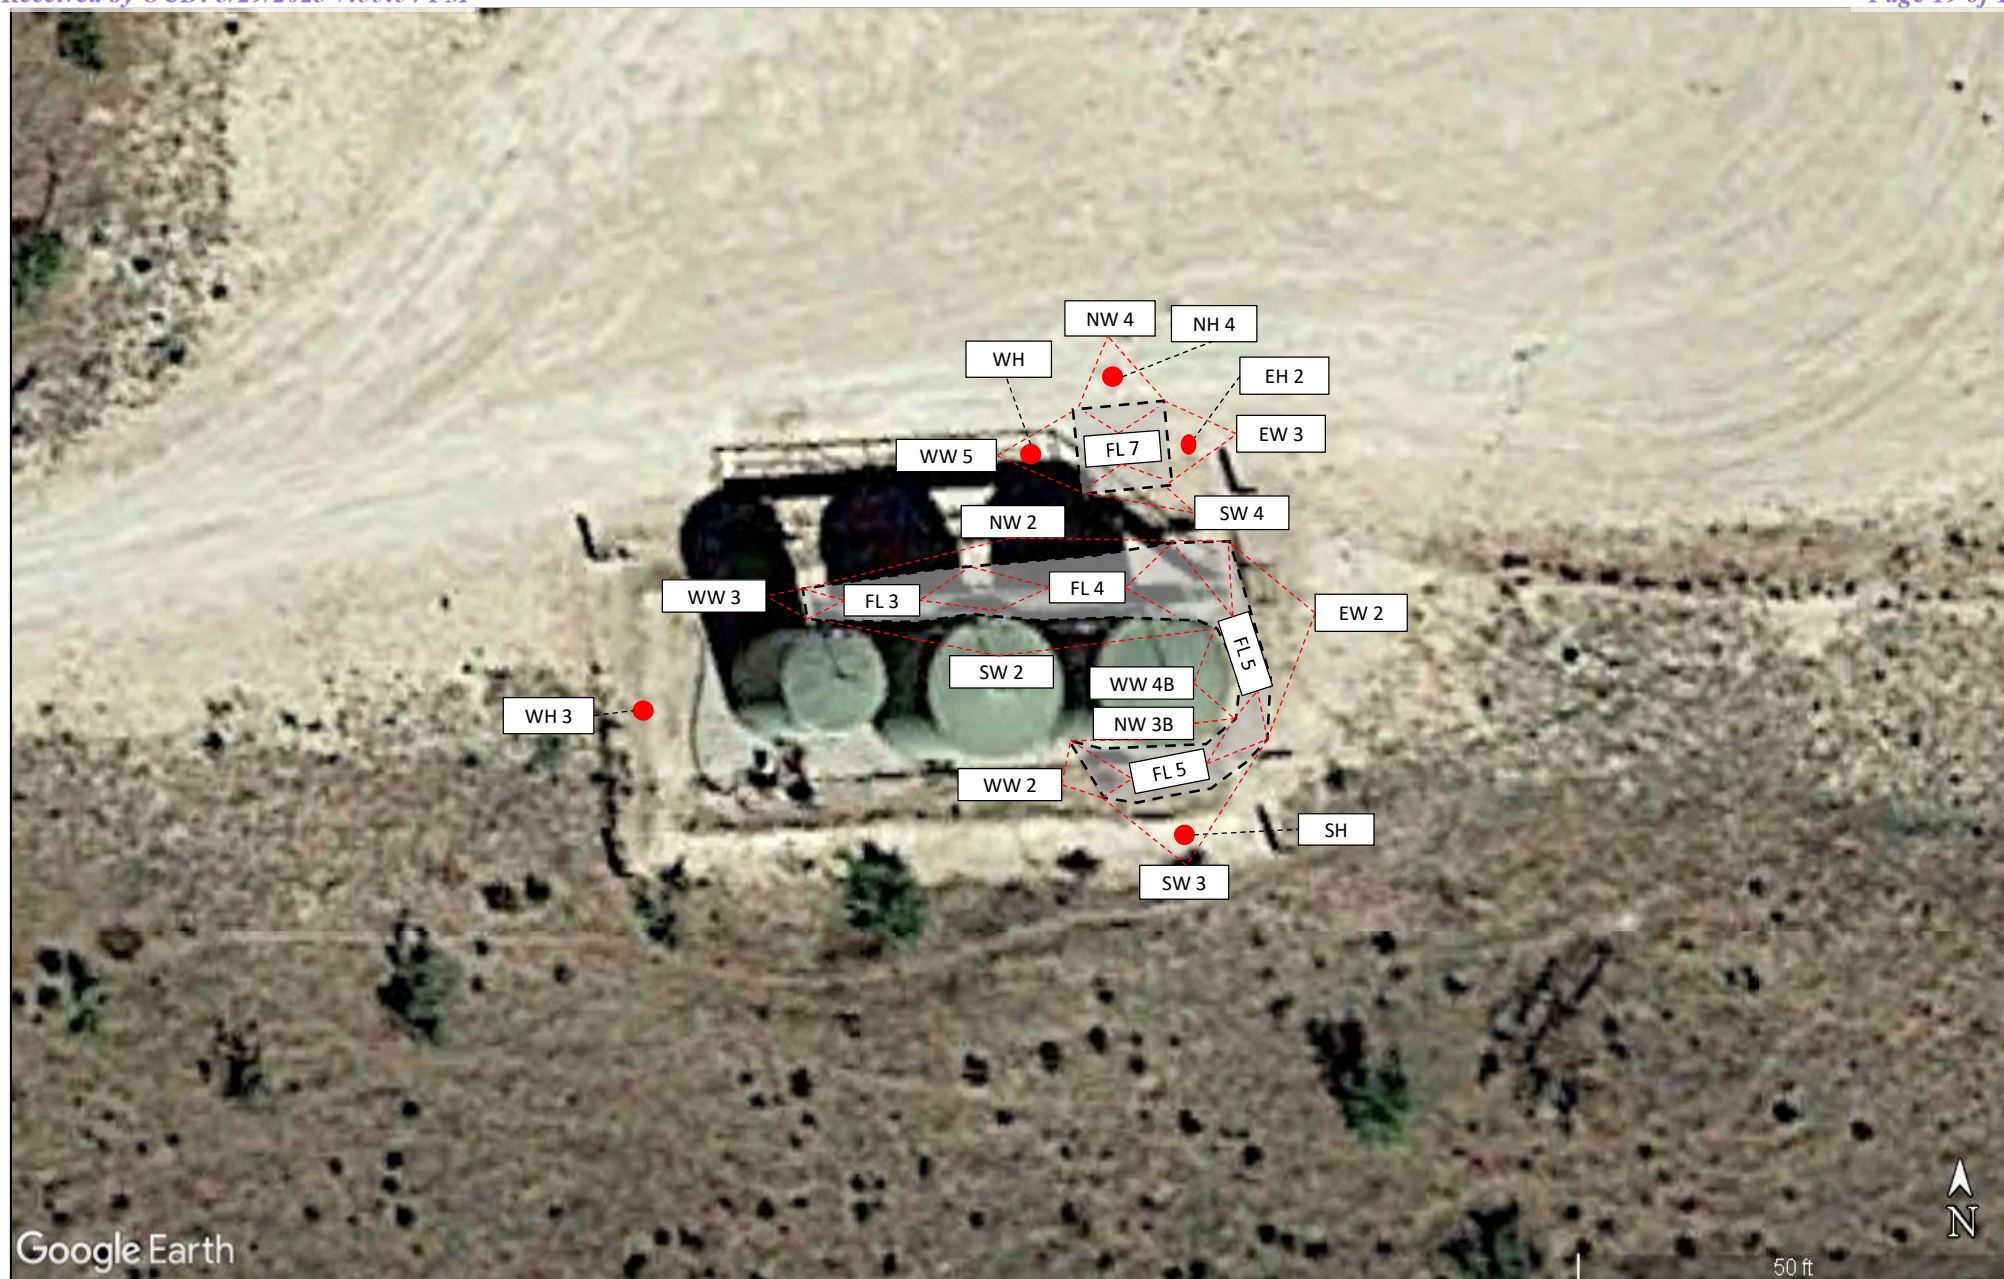
Figure 3A and Figure 3B Site and Sample Location Map

Red: NMOCD Reclamation Standard exceedance.

- Confirmation Sample Location
- Horizontal Delineation Sample Point
- Excavated Area
