Form C-141
Revised August 24, 2018
Submit to appropriate OCD District office

Site Name: San Juan 30-5 Unit 29M	Site Type: Well Site
Date Release Discovered: 7/19/2023	API# (if applicable): 30-039-26777

Executive Summary – Incident #: nAPP2321580132

San Juan 30-5 Unit 29M Wellsite
API #: 30-039-26777

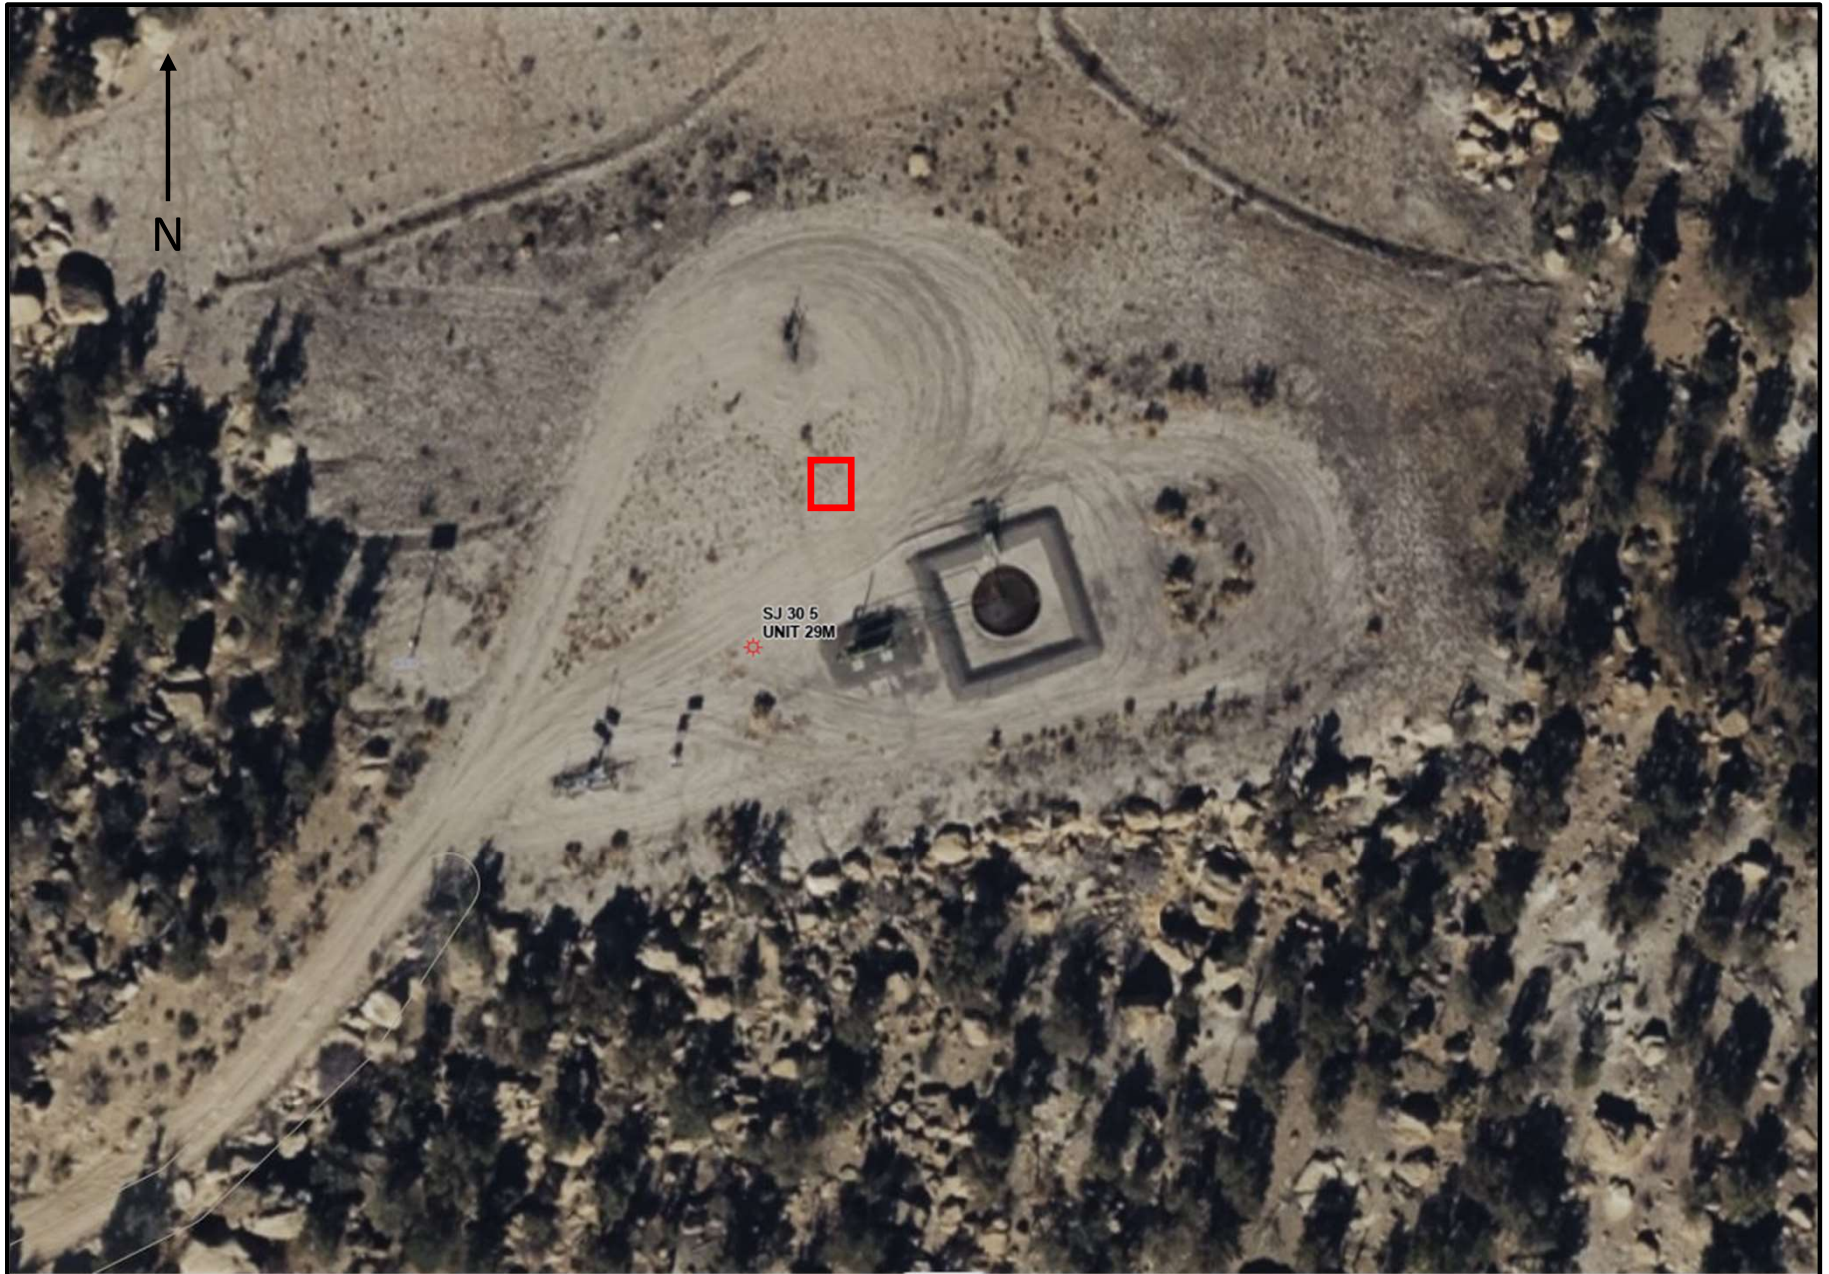
Scaled Site Map

Release Area

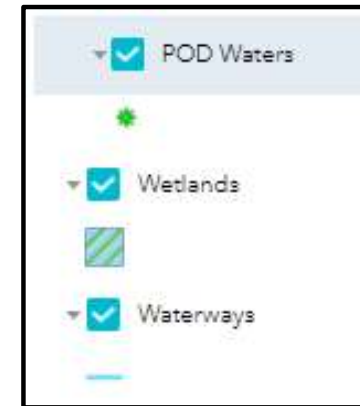
NMAC 19.15.29 Siting Criteria for Closure Standards

Facility is **not** shown to be within:

- 300 ft of any continuously flowing watercourse or any other significant water course.
- 200 feet of any lakebed, sinkhole or playa lake
- 300 feet of any occupied permanent residence
- 500 feet of a spring or private, domestic fresh water well.
- 1000 feet of any fresh water well
- 300 feet of a wetland
- Incorporated municipal boundaries
- Overlying a subsurface mine
- An unstable area
- A 100-year floodplain

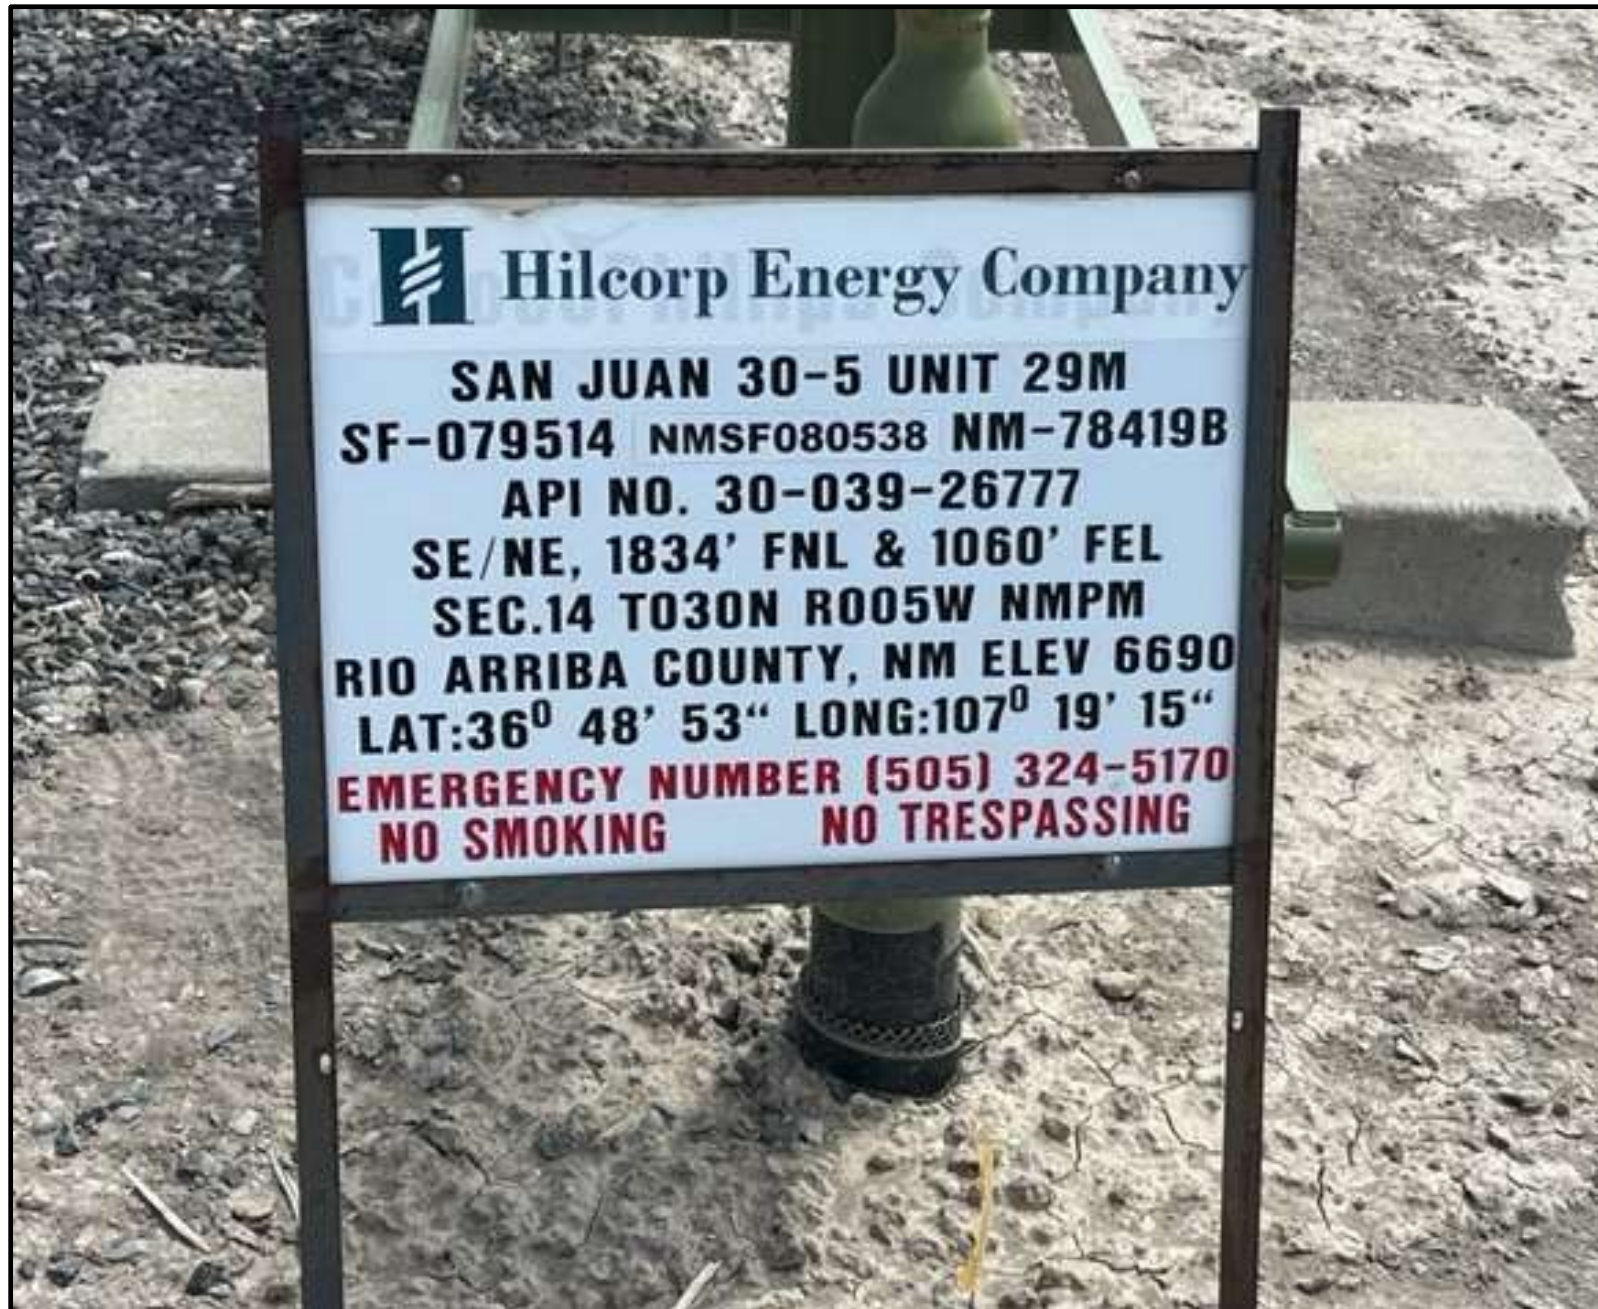
Initial Field Photos

A Hilcorp operator identified a wet spot at the San Juan 30-5 Unit 29M well site (API #: 30-039-26777) on 7/19/2023 due to a hole in the flowline caused by corrosion. The well was shut-in, and the flowline was isolated immediately upon discovery, stopping the leak. The line was then dug up and a new line was welded in to replace the corroded part of the flowline. Soil associated with digging up the flowline, along with any additional visibly impacted soil, was removed and transported off-site for disposal. A total of 220 MCF (@15.025 psi; 224 MCF @ 14.73 psi) of gas and 0.84 bbl of produced water was released from this event, and no fluids or gas were able to be recovered. There was no immediate danger to the public nor fire occurred because of this release.

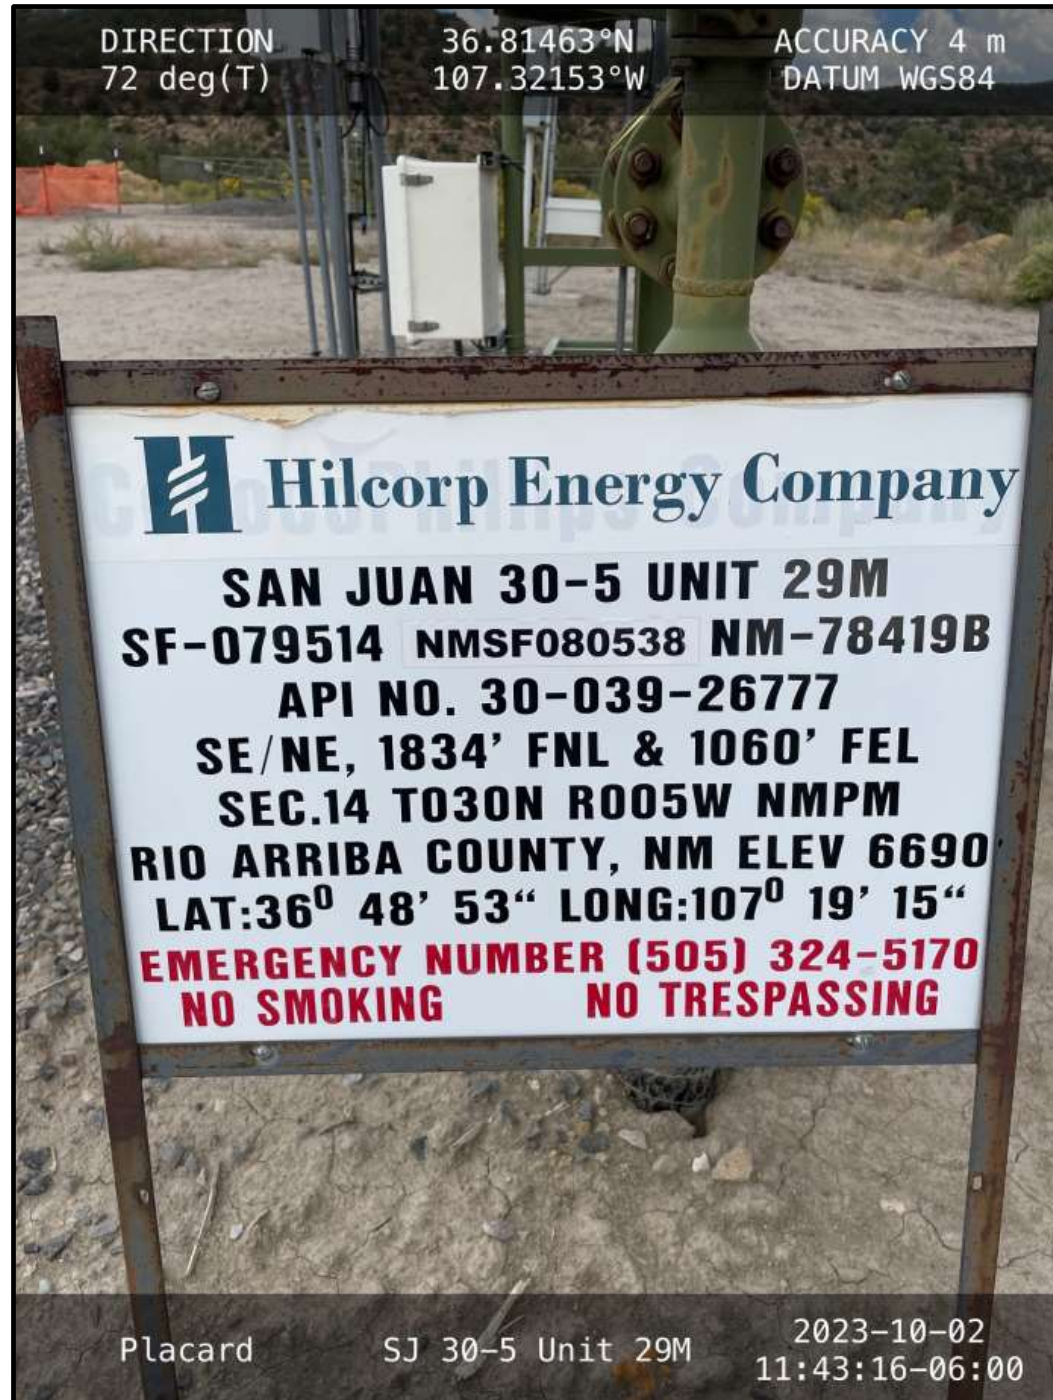
Field Sampling Photo

Agency notification of closure sampling was given on September 28, 2023, and a final 5-point composite sample was collected on October 2, 2023. Please see ensuing pages for a copy of the closure sampling notification to agency and a full copy of the referenced lab results. As demonstrated in the Data Table of Soil Contaminant Concentrations herein, the analytical results from this sampling event were all below NMOCD closure criteria noted in NMAC 19.15.29 Table 1. As such, Hilcorp requests closure of the release in accordance with NMAC 19.15.29.12.D.
