RE: Characterization Report and Remediation Workplan
Incident ID: NAB1822243840
Mobil 22 Federal
Project ID: 20180727-1300-mobil22fed

McNabb Partners LLC submits this characterization report and remediation workplan on behalf of Stephens and Johnson Operating Company (SJOC).

Incident Number NAB1822243840 is addressed in this report. The incident is located offsite, to the northwest of the active Mobil 22 Federal production site. The release occurred on July 27, 2018, from a leak at a surface oil flowline. The flowline was adjacent to the lease road, northwest of the Mobil 22 Fed production site. The release consisted of approximately 2 bbls of oil and 2 bbls of produced water and covered an area of approximately 300 square ft. The well was shut down and the flowline was repaired. Although the release is <5 bbls and non-reportable, a C-141 NOR was submitted to NMOCD on July 31, 2018. Within 24-hours of the release, an area of approximately 250 cubic ft of impacted soil was excavated and transported off-site to an approved disposal facility.

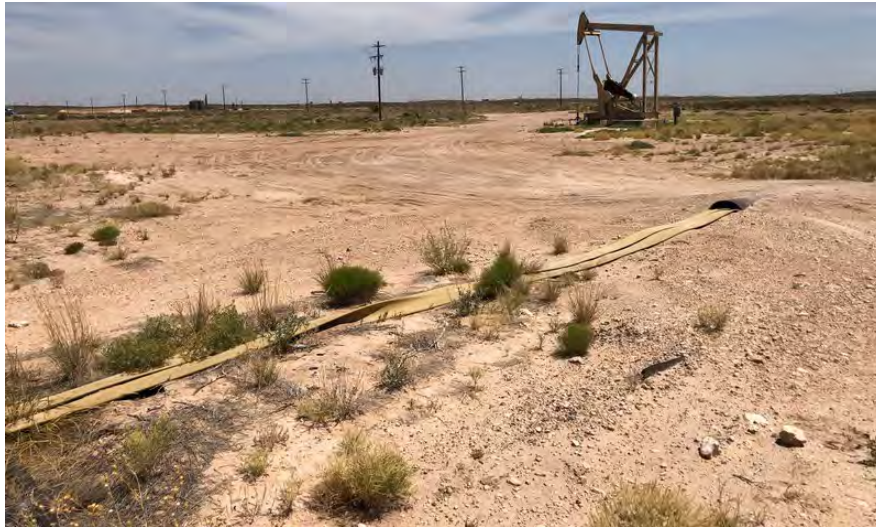
Figure 1: Southern portion of release facing south. (Additional site photos to be included with remediation/closure report). Date: 2023-07-20 14:21:03; GPS: 32.021361, -103.964578

SJOC proposes to excavate base grid G-03 until the base and wall samples meet the above closure criteria for off-site areas. As indicated in the 2-day sampling notice email to NMOCD on 09/17/2023, characterization/delineation sample points that met closure criteria will also be used as confirmation sampling for closure.
