Incident Number: nAPP2210967015

Release Assessment and Closure

Gem #4 Water Transfer Line

Vertex File Number: 22E-02120

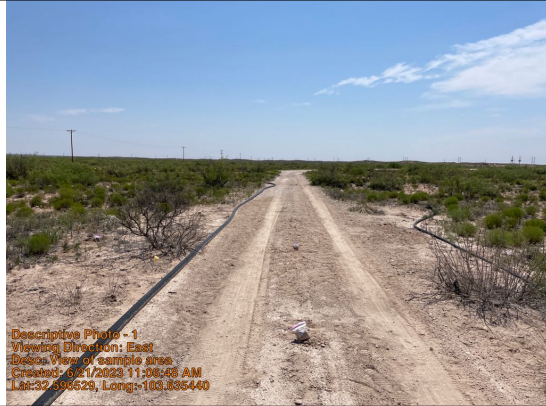
Viewing Direction: East

View of sample area

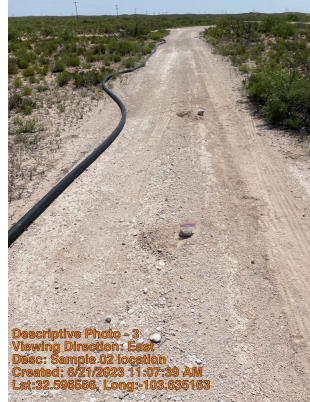
Viewing Direction: East

Sample 02 location

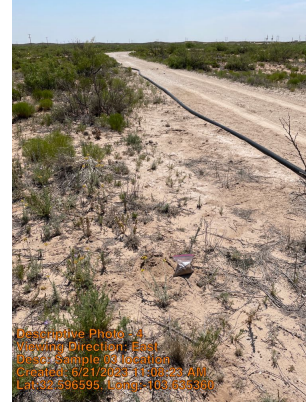
Viewing Direction: East

Sample 03 location

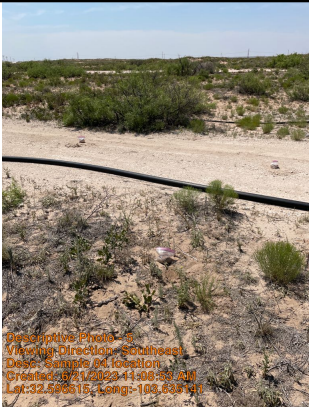
<p>Viewing Direction: Southeast</p>

<p>Descriptive Photo - 5 Viewing Direction: Southeast Desc: Sample 04 location Created: 6/21/2023 11:08:33 AM Lat:32.596515, Long:-103.635161</p> <p>Sample 04 location</p>	<p>Viewing Direction: Southwest</p>

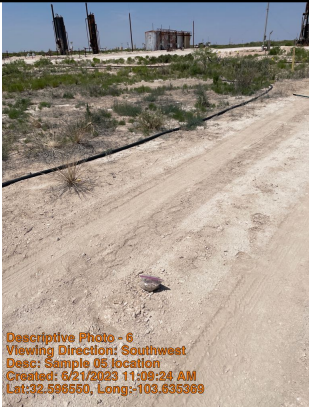
<p>Descriptive Photo - 6 Viewing Direction: Southwest Desc: Sample 05 location Created: 6/21/2023 11:09:24 AM Lat:32.596560, Long:-103.635369</p> <p>Sample 05 location</p>
<p>Viewing Direction: East</p>

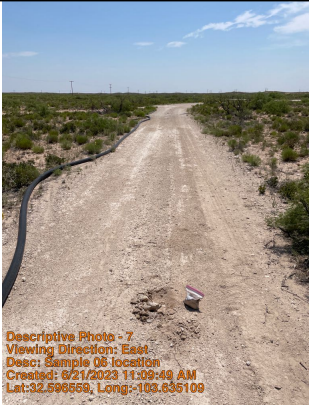
<p>Descriptive Photo - 7 Viewing Direction: East Desc: Sample 06 location Created: 6/21/2023 11:09:49 AM Lat:32.596569, Long:-103.635106</p> <p>Sample 06 location</p>	<p>Viewing Direction: North</p>

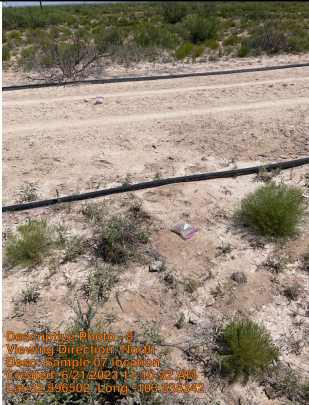
<p>Descriptive Photo - 8 Viewing Direction: North Desc: Sample 07 location Created: 6/21/2023 11:10:32 AM Lat:32.596502, Long:-103.635342</p> <p>Sample 07 location</p>

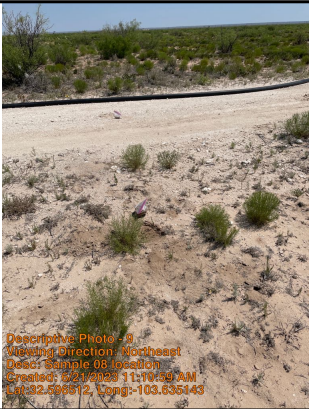
<p>Describe Photo: 08 Viewing Direction: Northeast Date: Sample 08 location Created: 6/21/2023 11:10:39 AM Lat: 32.696572, Long: -103.635143</p>
Sample 08 location

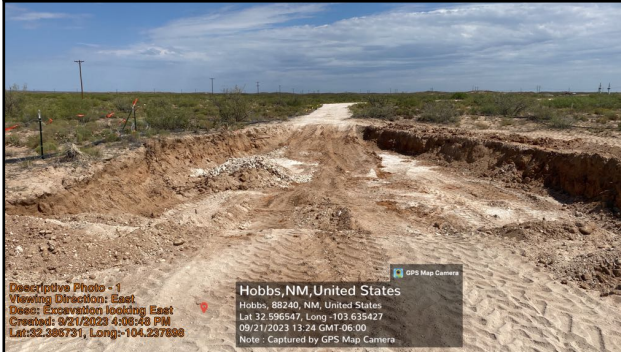
Viewing Direction: East

Excavation looking East

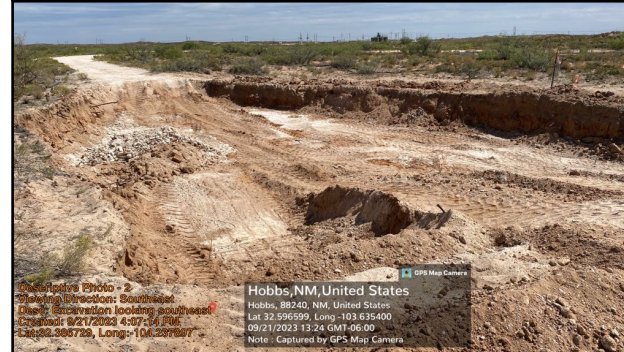
Viewing Direction: Southeast

Excavation looking southeast

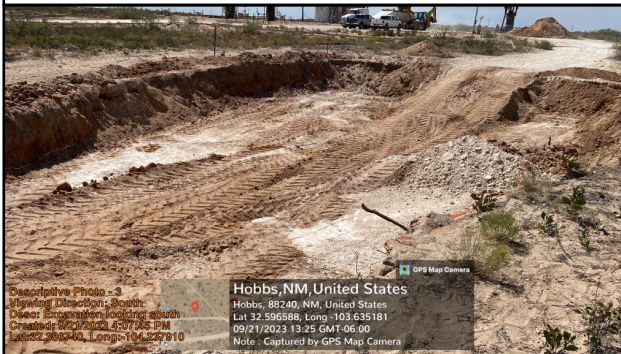
Viewing Direction: Southwest

Excavation looking southwest

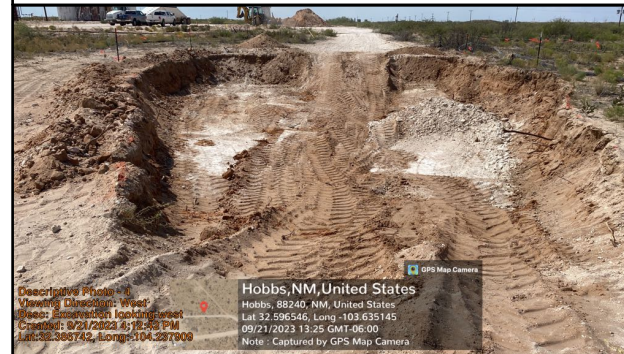
Viewing Direction: West

Excavation looking west

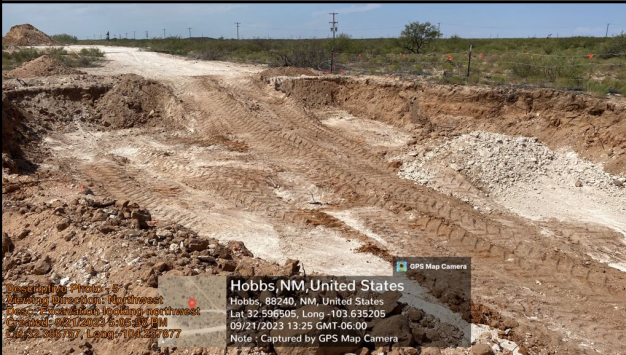
<p>Describe Photo - 8 Viewing Direction: Northwest Date: Excavation looking northwest Created: 9/21/2023 6:06:56 PM Lat: 32.596505, Long: -103.635205 Note - Captured by GPS Map Camera</p>

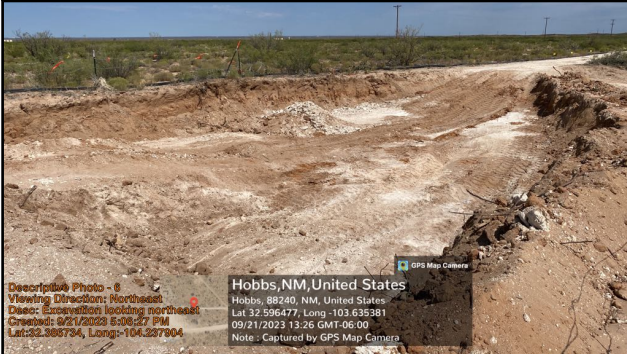
<p>Describe Photo - 8 Viewing Direction: Northeast Date: Excavation looking northeast Created: 9/21/2023 6:08:27 PM Lat: 32.596477, Long: -103.635381 Note - Captured by GPS Map Camera</p>
Excavation looking northwest	Excavation looking northeast
