**Re: Revised Characterization and Closure Request
ConocoPhillips
James E Well #15 Stuffing Box Release
Unit Letter L, Section 12, Township 22 South, Range 30 East
Eddy County, New Mexico
Incident ID# NKMW1035736062**

**JAMES E #015 STUFFING BOX RELEASE
TOPOGRAPHIC MAP**

**JAMES E #015 STUFFING BOX RELEASE
APPROXIMATE RELEASE EXTENT AND SITE ASSESSMENT**

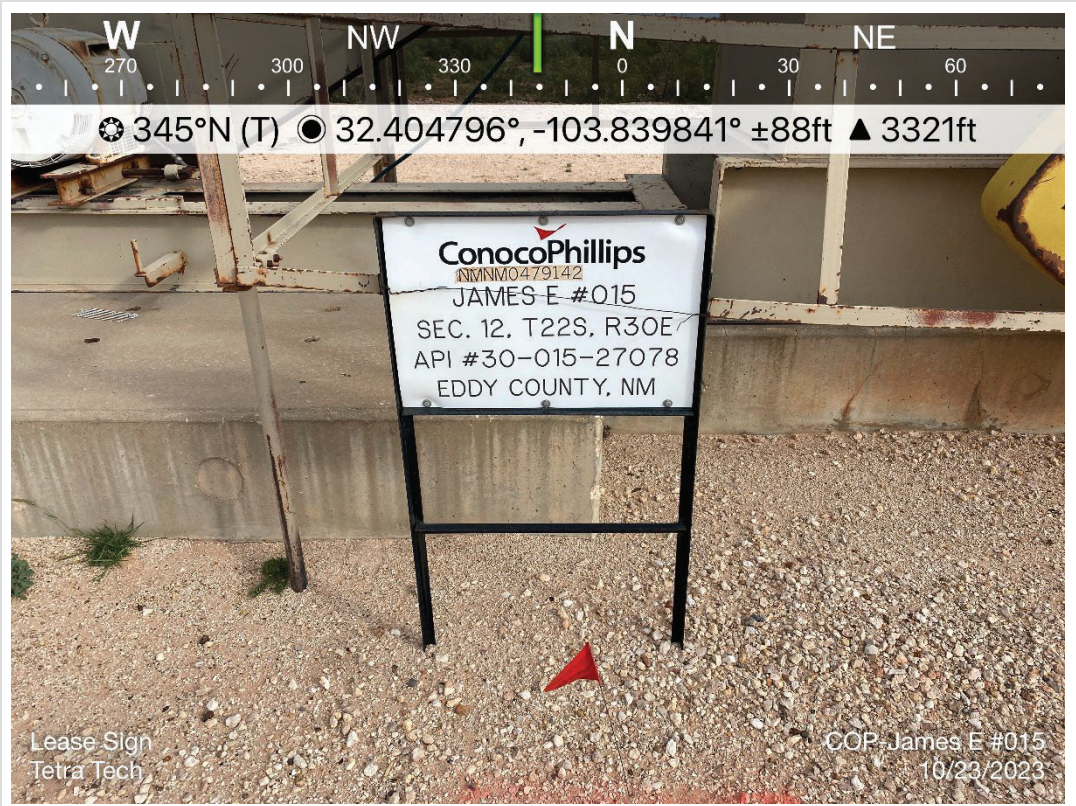
TETRA TECH, INC. PROJECT NO. 212C-MD-03247	DESCRIPTION	View north-northwest of sight signage. James E #015.	1
	SITE NAME	James E #015 Stuffing Box Release	10/23/2023
