Closure Report

Parkway State Com # 4
Eddy County, New Mexico
API ID # 30-015-37504
Incident # NRM2012234129

Cimarex Energy Co. of Colorado
6001 Deauville Blvd. Suite 300N
Midland, Texas 79706

June 2, 2023

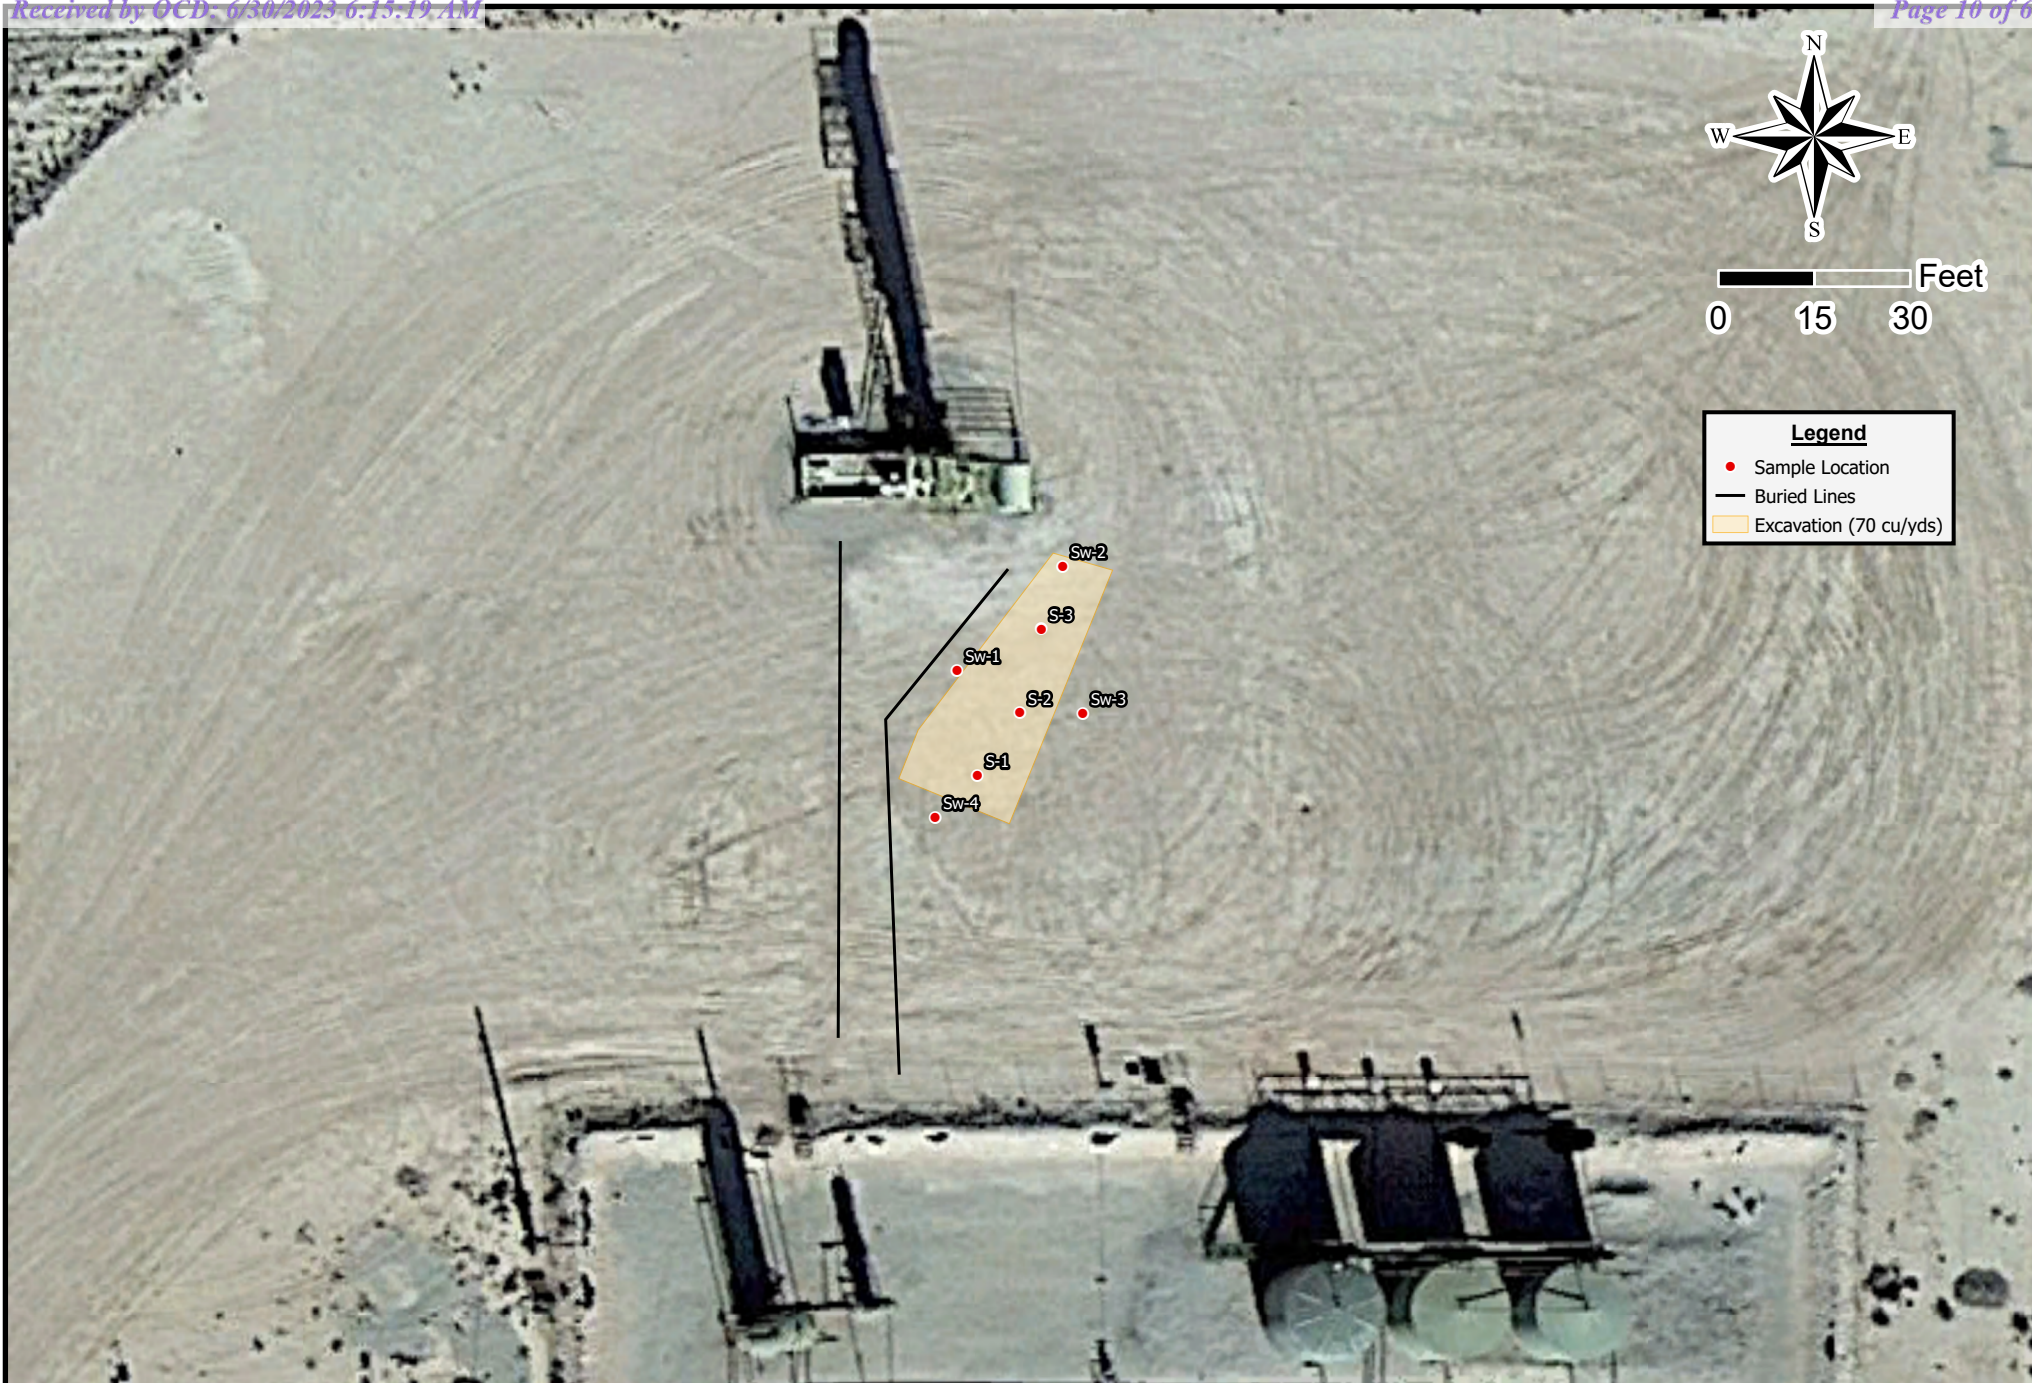
Cimarex Energy Co. of Colorado
Parkway State Com #4
Eddy County, New Mexico
Figure 2 - Confirmation Sample Map

The soil sample results from the laboratory analytical are summarized below. Sample locations are illustrated on Figure 2 ([Appendix I](#)) and complete laboratory analytical reports are presented in [Appendix V](#).

- The impacted areas on location were excavated to depths of four (4) feet bgs. Talon field titrated soil samples for total chlorides to guide the vertical and horizontal extents of the excavation process.
- Pursuant to NMOCD guidance, confirmation soil samples were collected at 200 square foot intervals and analyzed for TPH, BTEX and Total Chlorides to insure all other areas had reached NMOCD closure criteria.
- The excavated areas on the well pad were backfilled with new caliche, machine compacted and contoured to match the surrounding location.
- Approximately 70 cubic yards of excavated material was transported to Lea Land Disposal, a NMOCD approved solid waste disposal facility.
- Photographic documentation is provided in [Appendix IV](#).
- Copies of the Final C-141s are presented in [Appendix III](#).

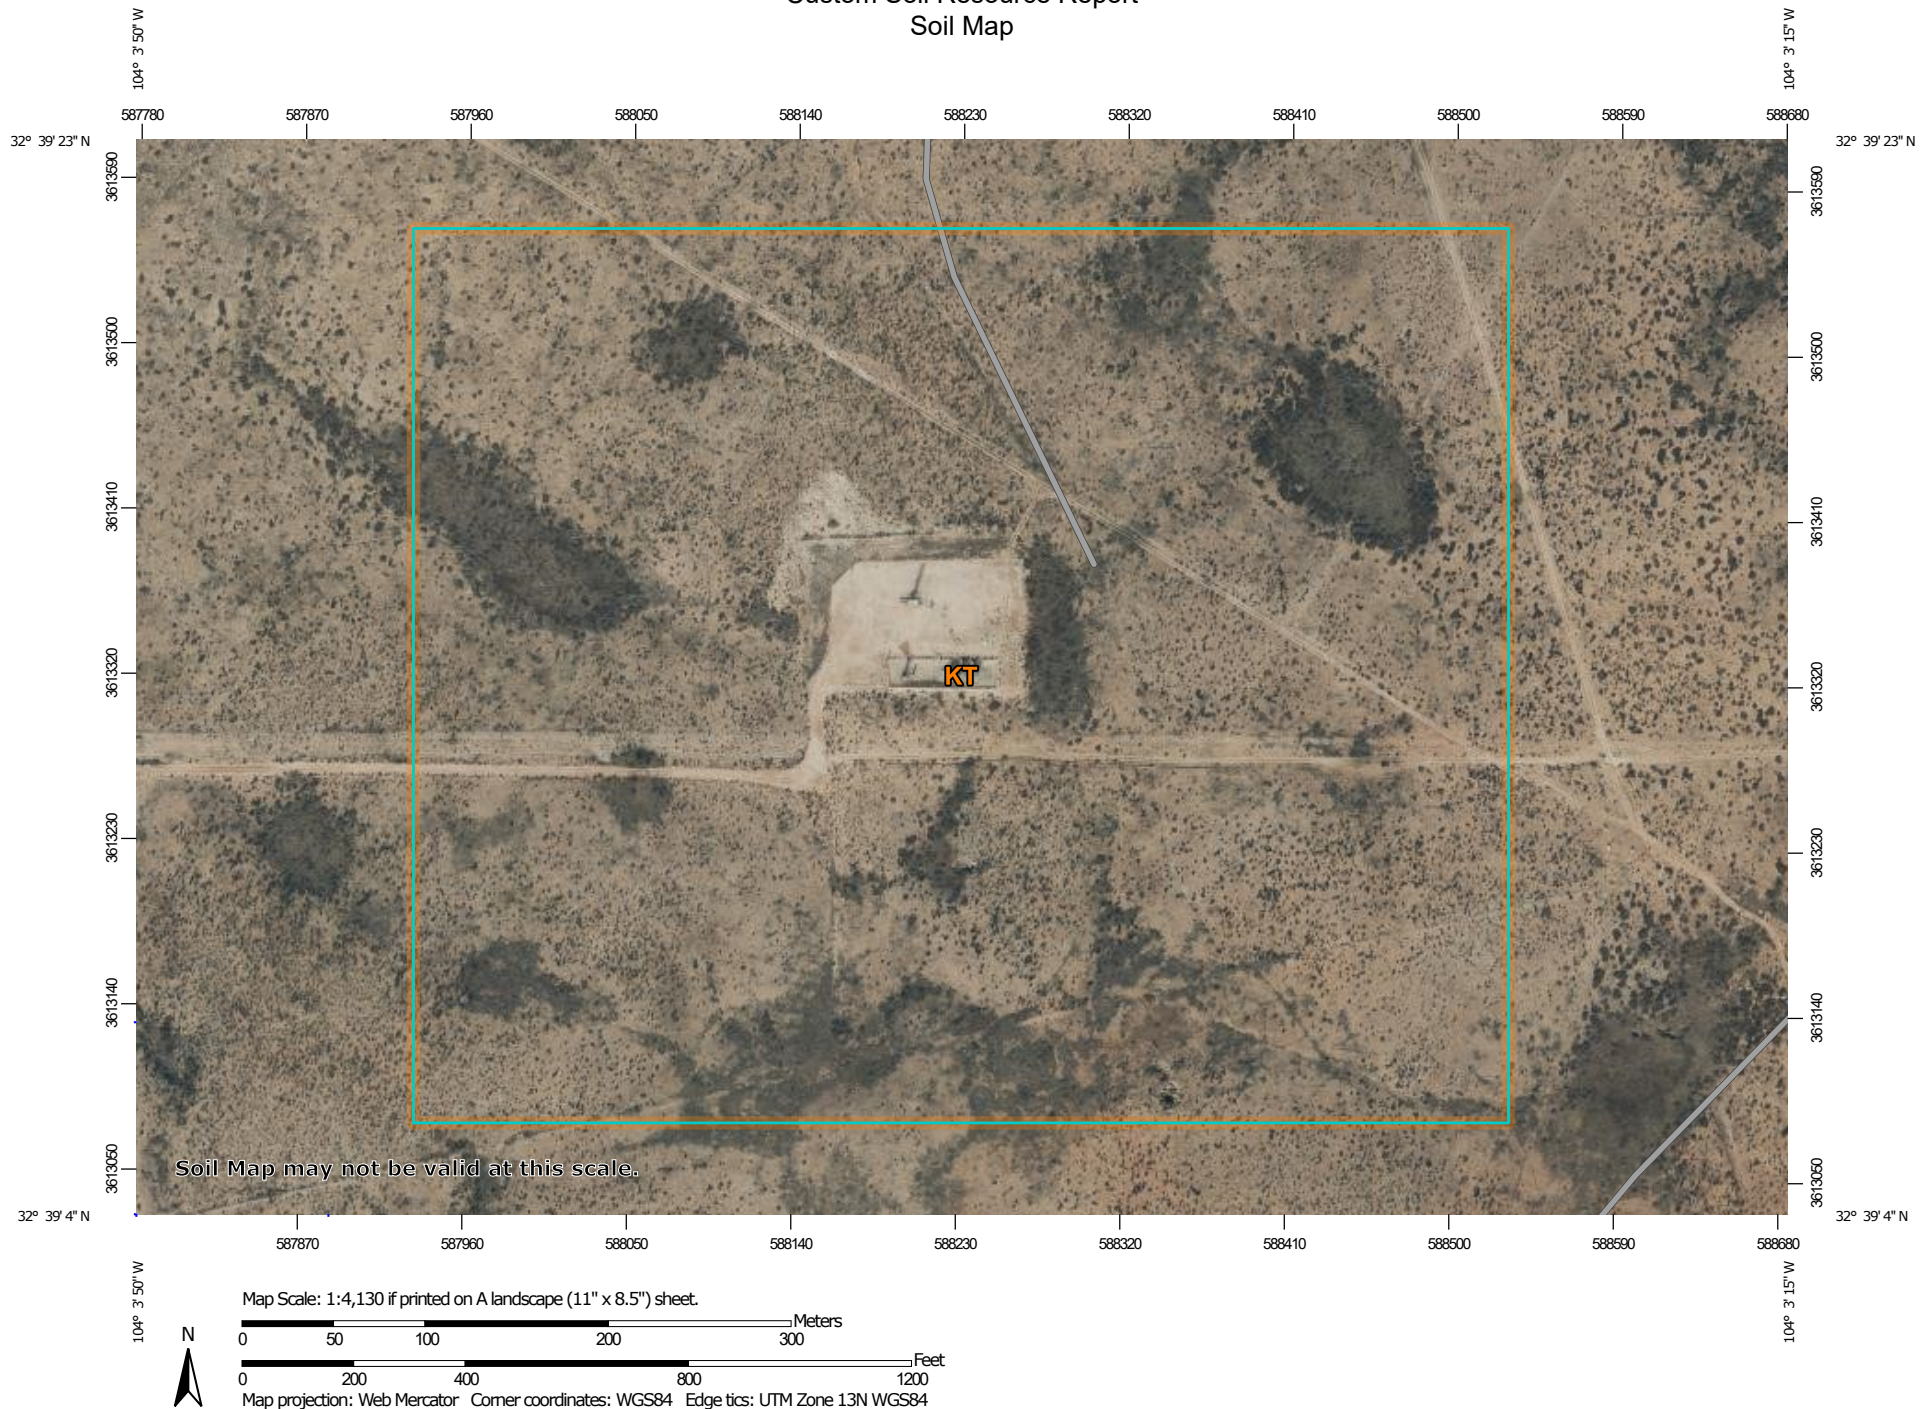
Custom Soil Resource Report Soil Map

The soil map section includes the soil map for the defined area of interest, a list of soil map units on the map and extent of each map unit, and cartographic symbols displayed on the map. Also presented are various metadata about data used to produce the map, and a description of each soil map unit.

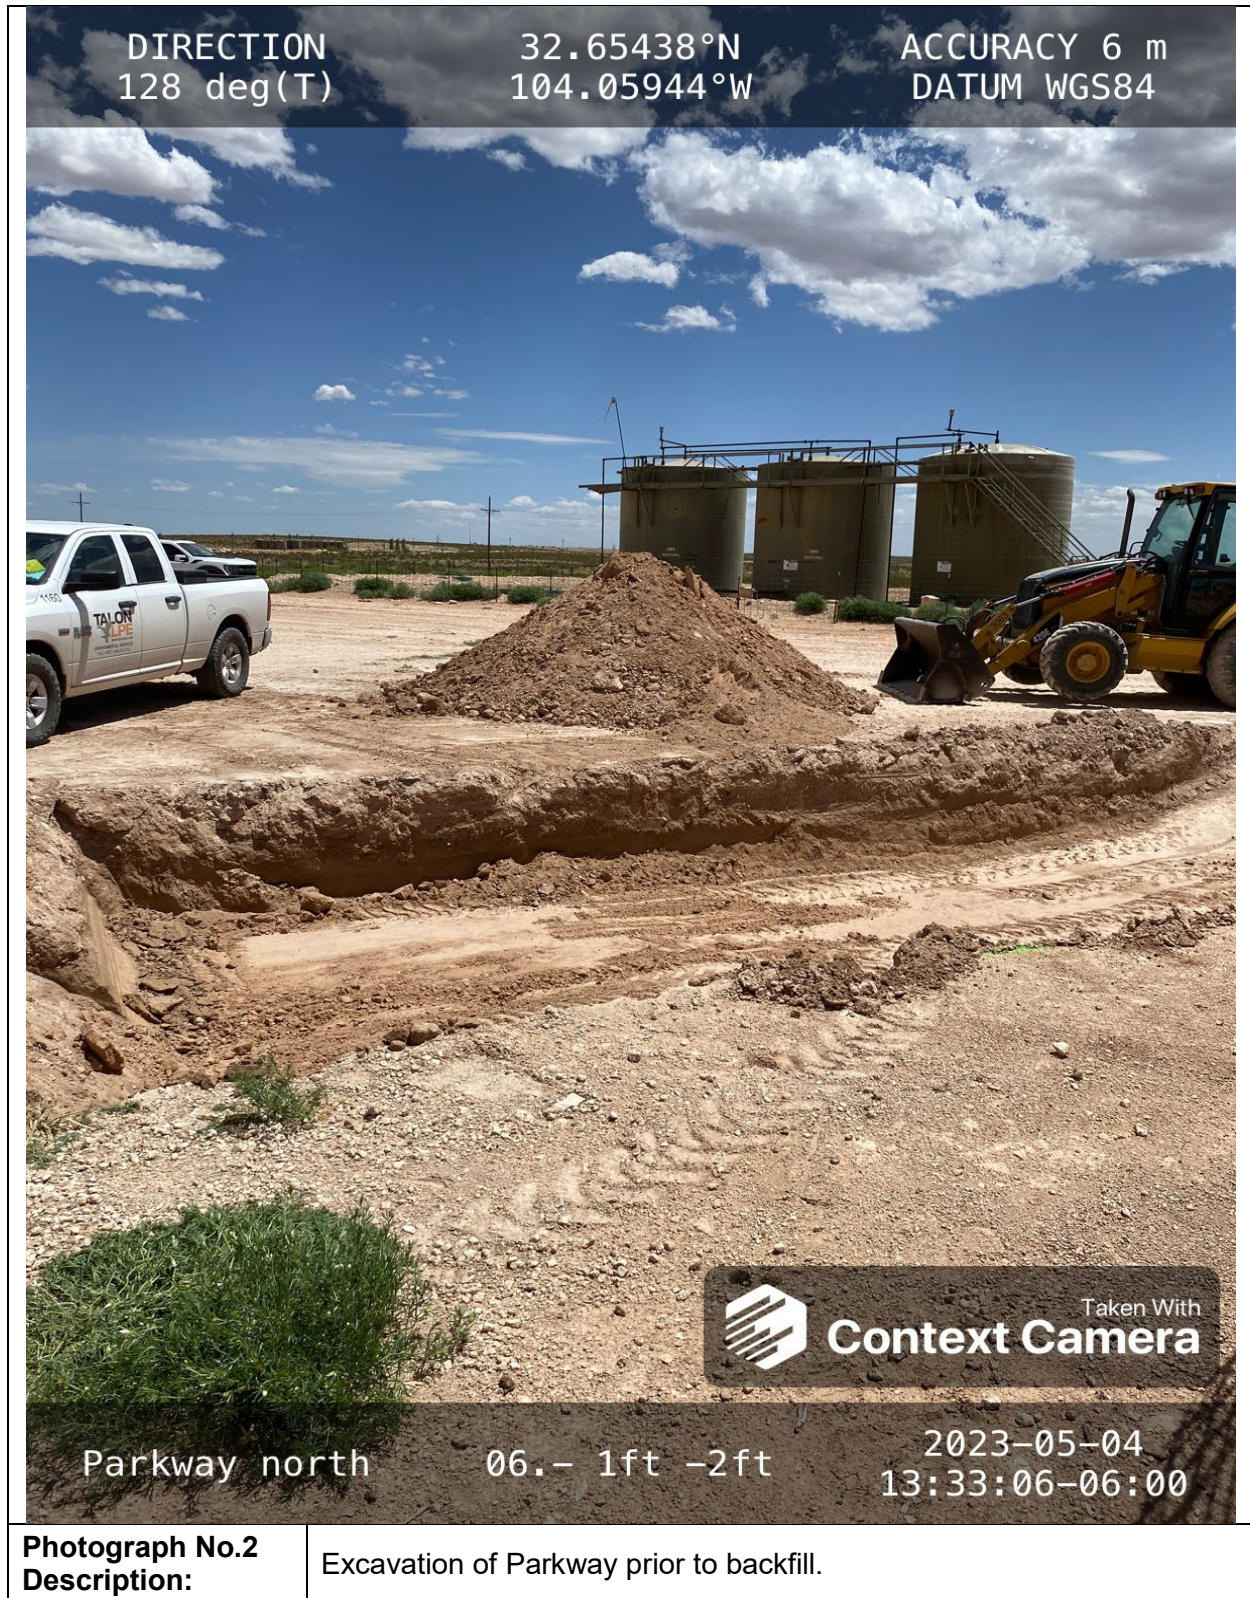
<div>DIRECTION 201 deg(T)</div> <div>32.65438°N 104.05933°W</div> <div>ACCURACY 7 m DATUM WGS84</div>		
A photograph showing a dirt road with a deep, rectangular excavation in the center. A yellow backhoe loader is parked on the left side of the road. To the right, there is an orange plastic safety fence supported by black posts. In the background, there are some industrial structures, including a tall vertical tank, and utility poles. The sky is blue with scattered white clouds.		
<div> Taken With Context Camera</div>		
Parkway east	06.- 1ft -2ft	2023-05-04 13:33:18-06:00
Photograph No.1 Description:	Excavation of Parkway prior to backfill.
