RE: **Release Investigation and Closure Report**
Chaves 6" and 10" Steel Line
Unit N, Section 12, Township 15 South, Range 29 East
33.0248282°, -103.9845827°
Chaves County, New Mexico
Terracon Project No. KH237024

Frontier Field Services, LLC
Chaves 6" Steel Line
33.0248282°, -103.9845827°
NMOCD Reference # nAPP2301231426
Terracon Project # KH237024

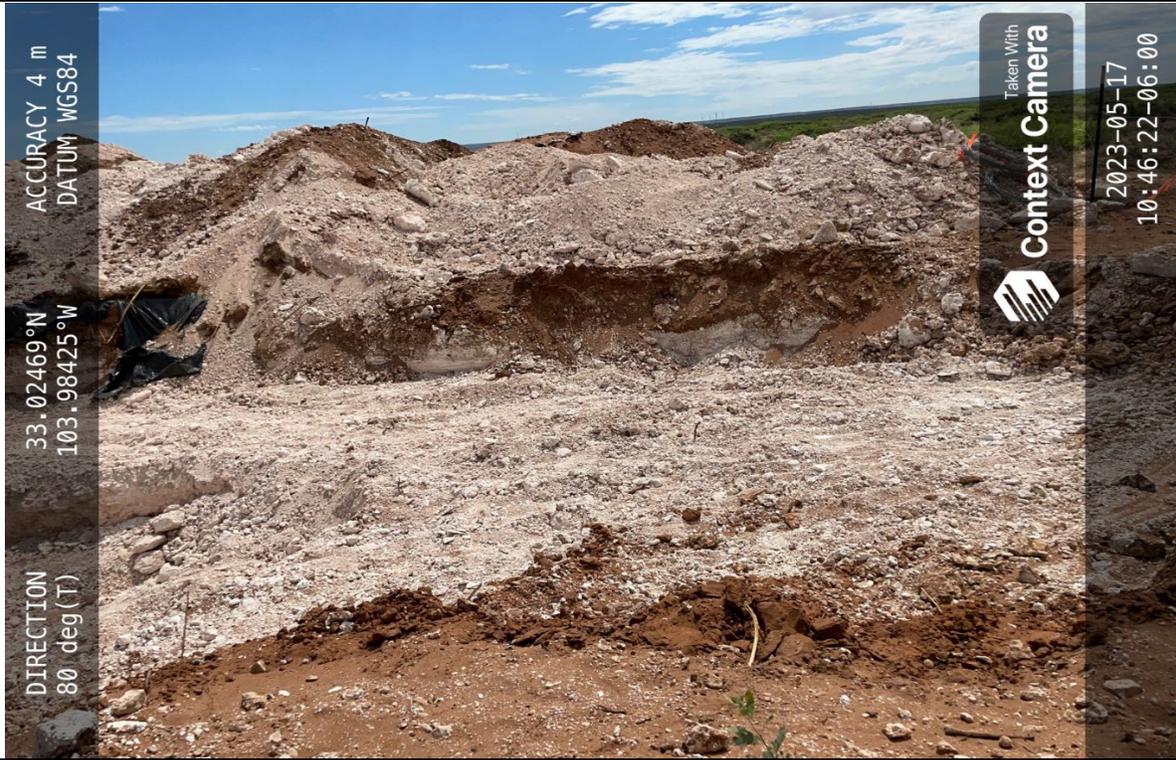
PHOTO 1: View of east wall after excavation

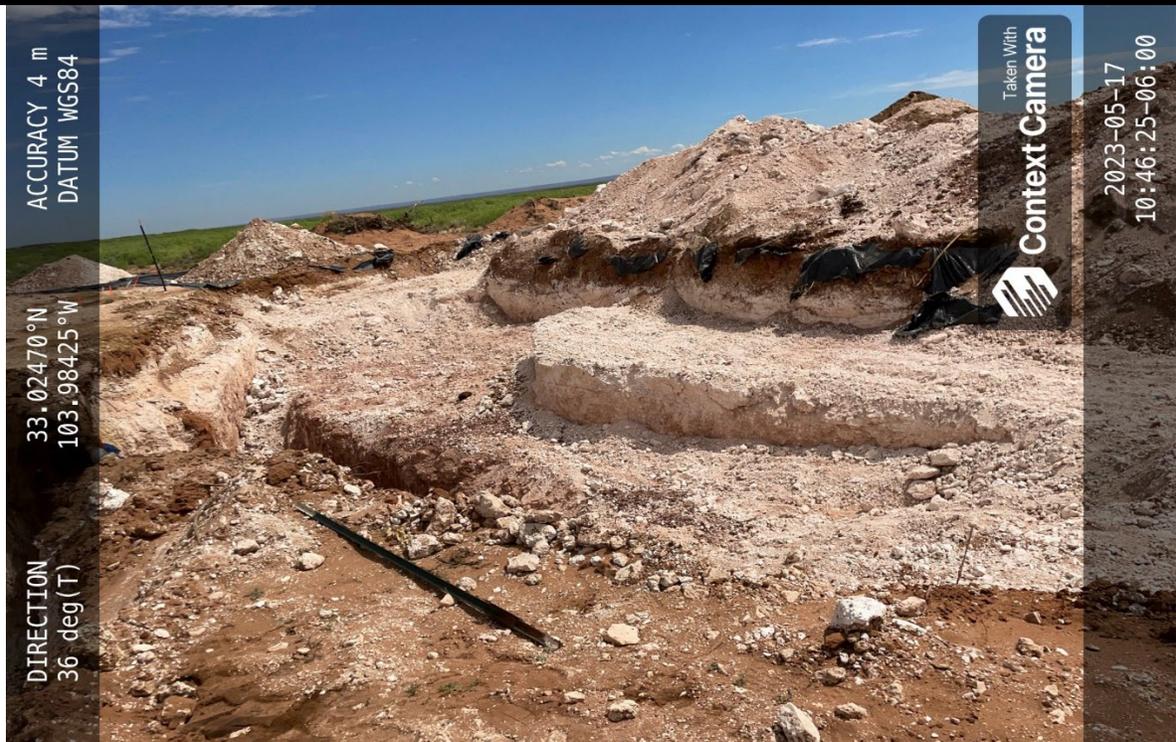
PHOTO 4: View of north wall after excavation

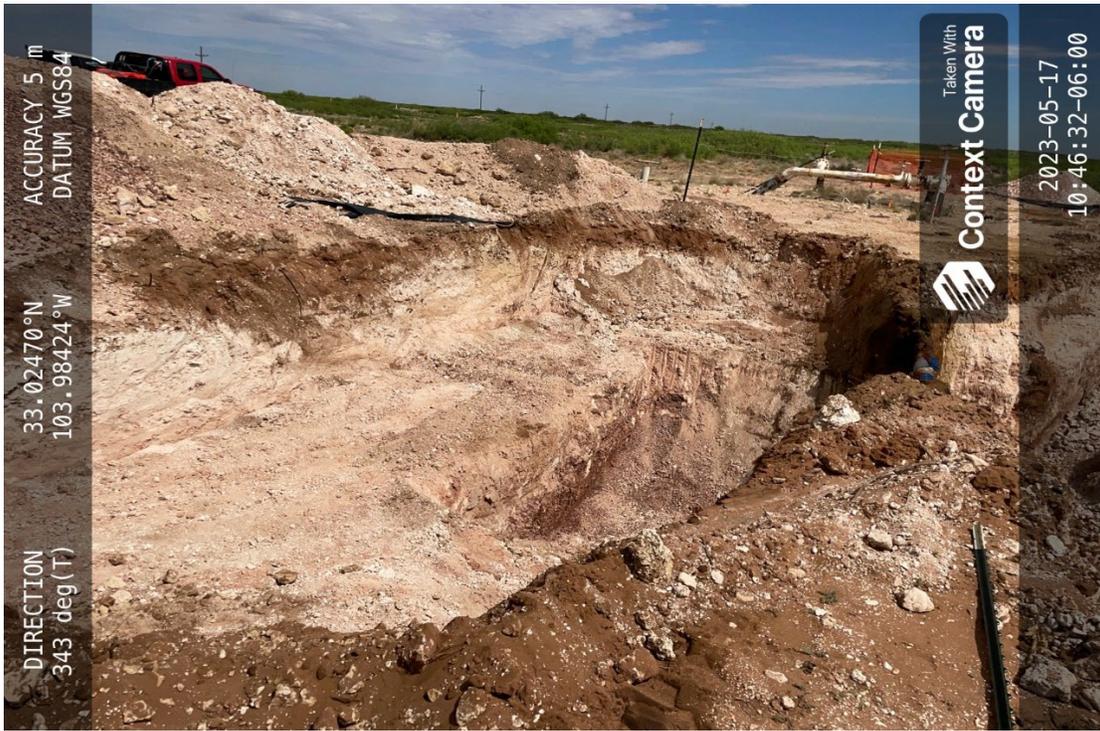
PHOTO 3: View of south and west walls after excavation

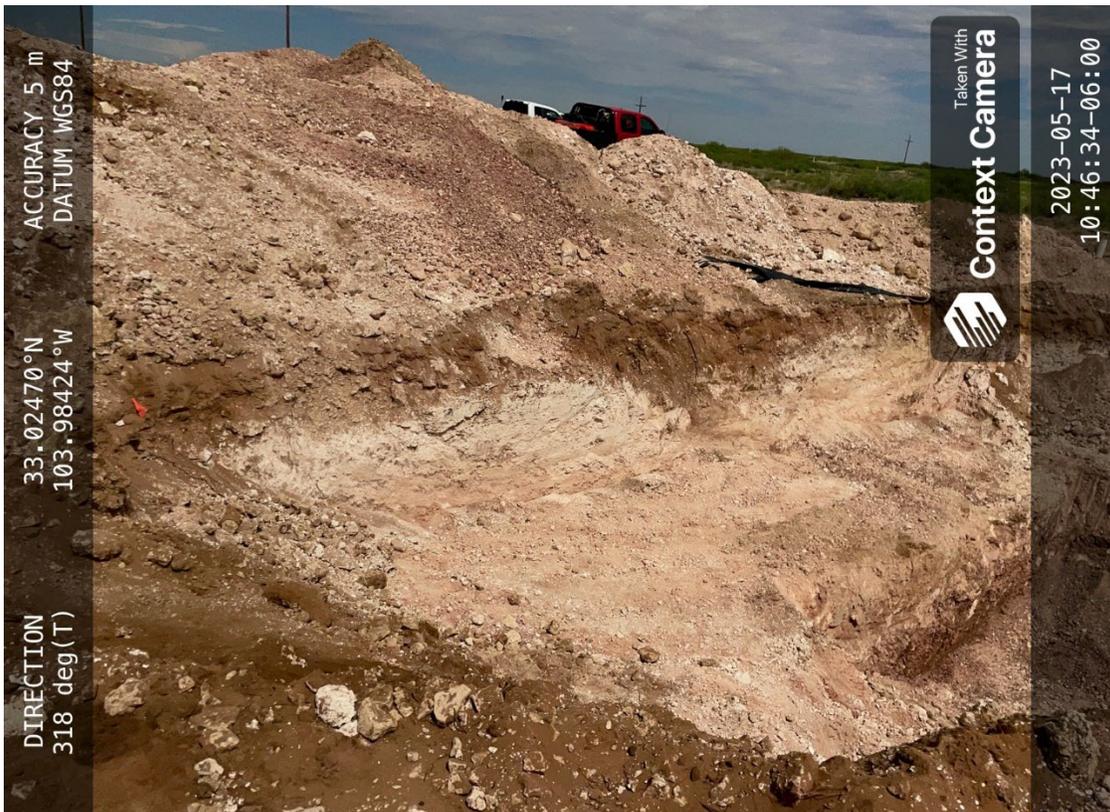
PHOTO 4: View of south wall after excavation

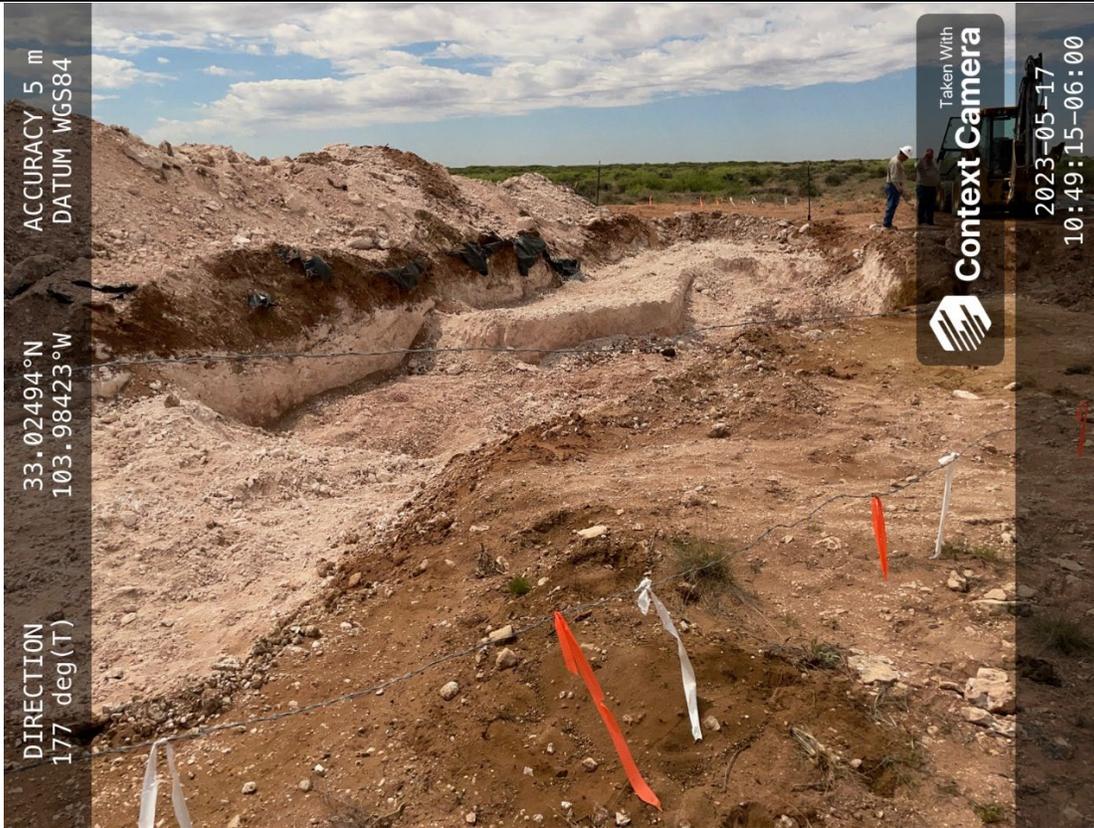
PHOTO 5: View of east wall after excavation
