Release Assessment and Closure

PLU Pierce Canyon 20-24-30 Battery

XTO Energy
PLU Pierce Canyon 20-24-30 Battery

Release Assessment and Closure
November 2023

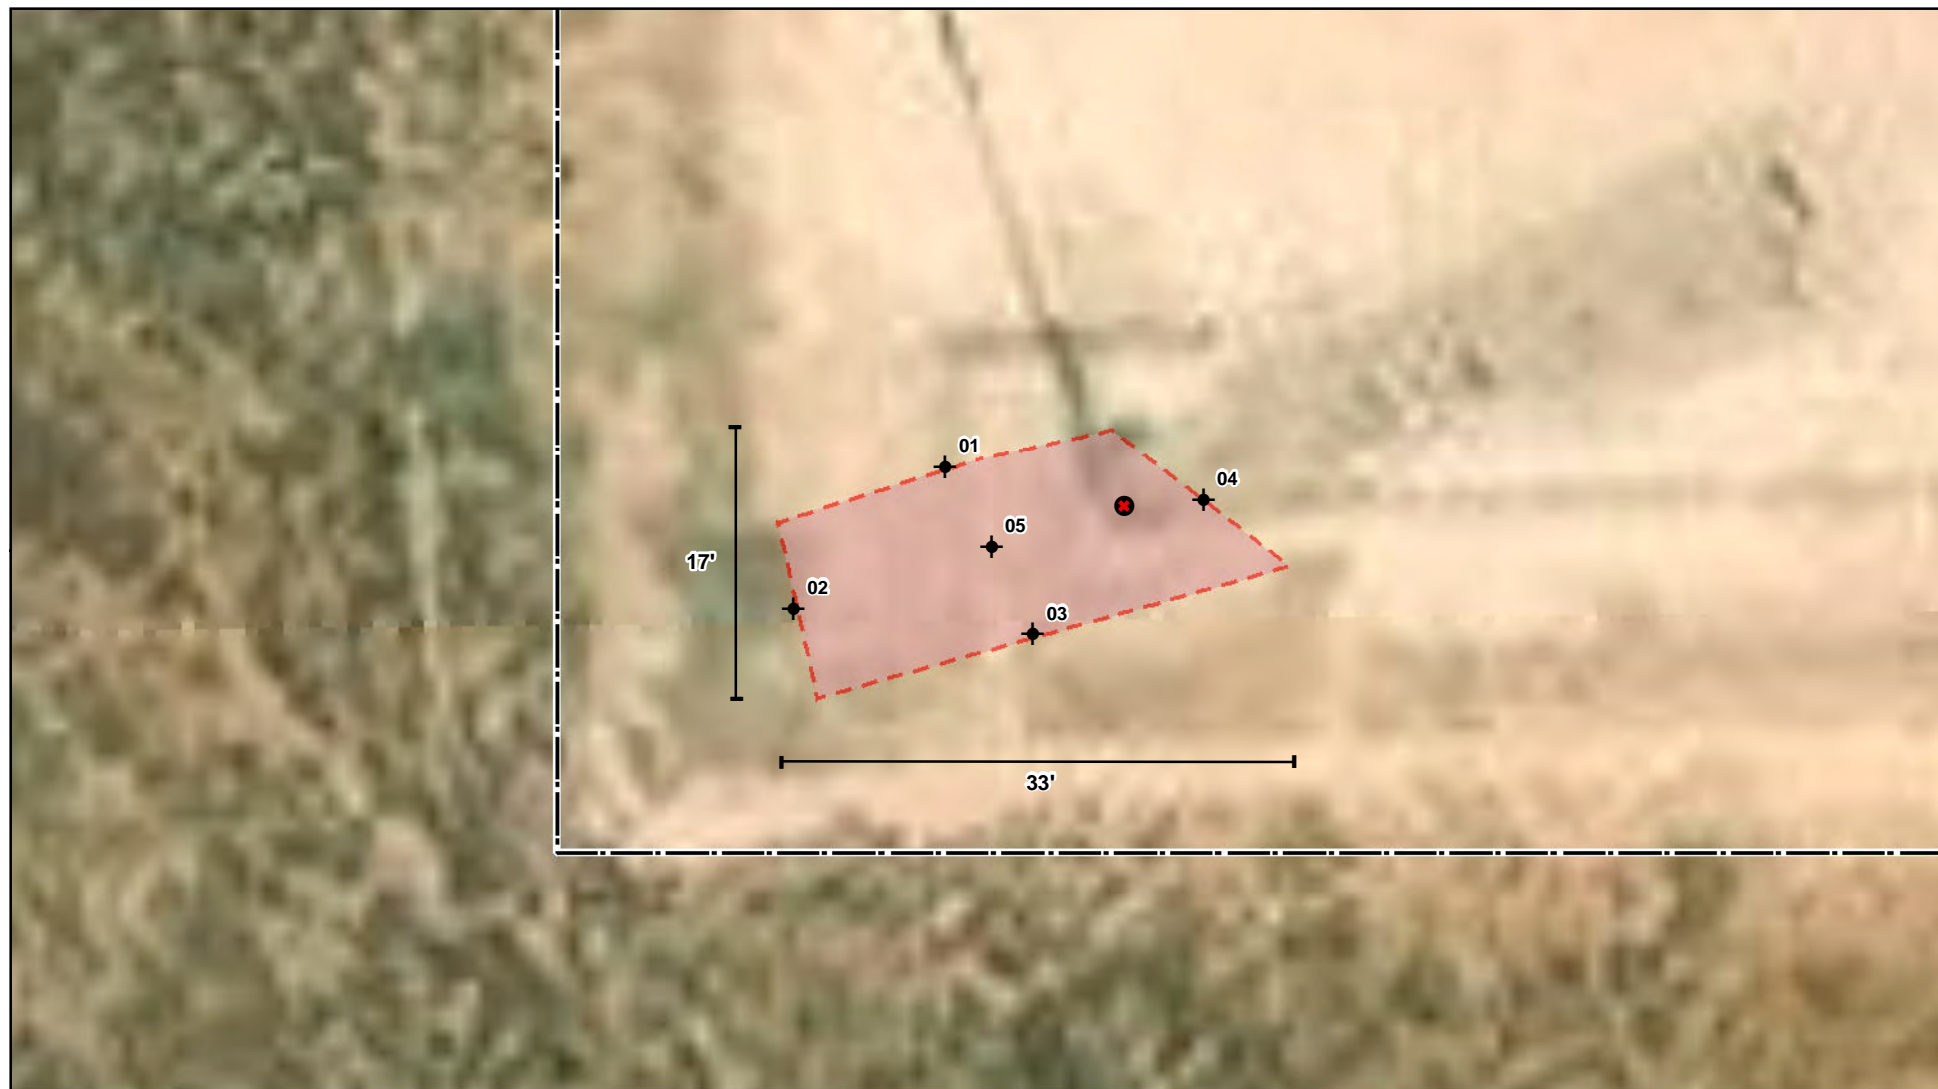
- ◆ Borehole (Prefixed by "BH23-")
 ● Point of Release
 ■ Approximate Release Area (~324 sq.ft.)
 □ Lease Boundary

The site is located approximately 10.14 miles east of Malaga, New Mexico. The legal location for the site is Section 20, Township 24 South, and Range 30 East in Eddy County, New Mexico. The release area is located on Bureau of Land Management (BLM) property. An aerial photograph and Characterization site schematic are presented in Figure 1. The location is typical of oil and gas exploration and production sites in the Permian Basin and is currently used for oil and gas production and storage. The following sections specifically describe the release area PLU Pierce Canyon 20-24-30 Battery on or in proximity to the constructed pad (Figure 1).

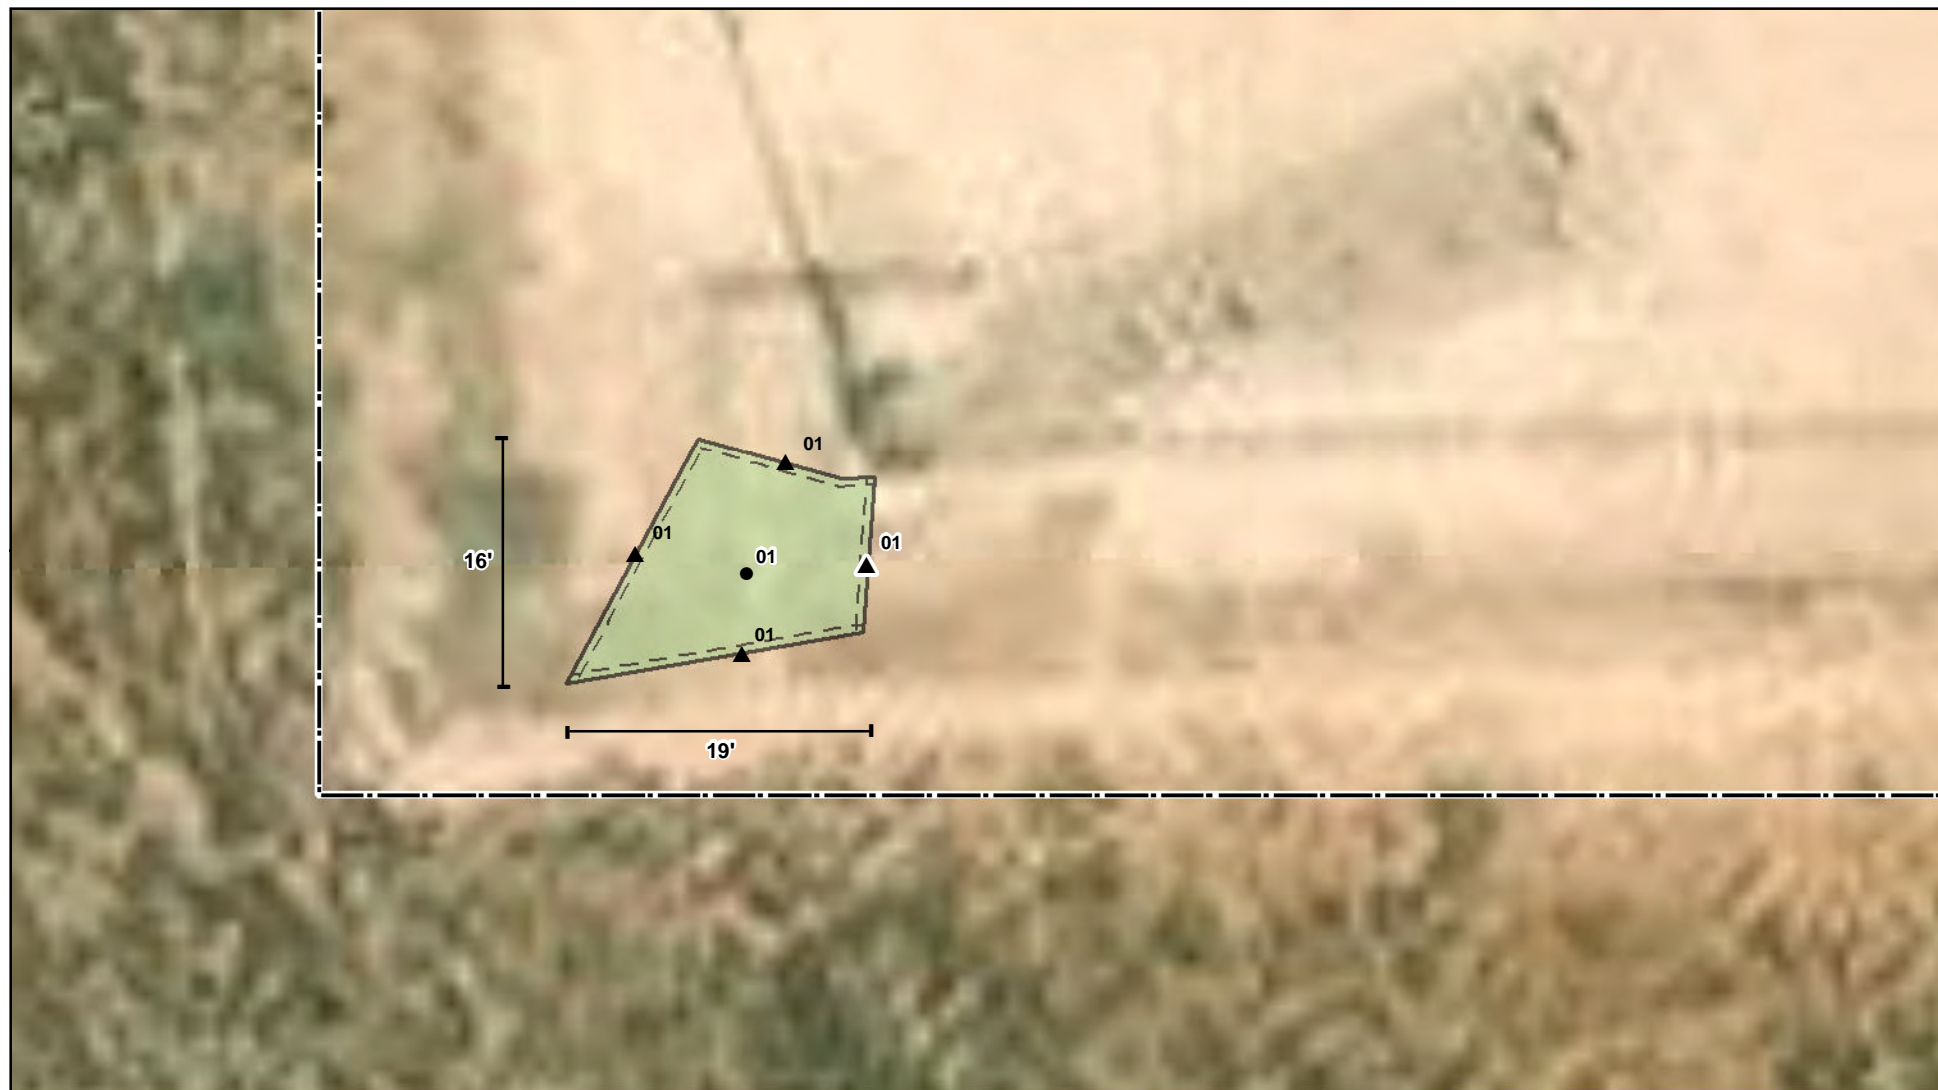
- Base Sample (Prefixed by "BES23-")
- ▲ Wall Sample (Prefixed by "WES23-")
- Lease Boundary
- Surface Scrape to 0.2' (~ 195 sq. ft.)

Notification that confirmatory samples were being collected was provided to the NMOCD on October 18, 2023, and is included in Appendix D. Confirmatory composite samples were collected from the base and walls of the excavation in 200-square-foot increments. Two samples were collected for laboratory analysis following NMOCD soil sampling procedures. One of the samples represented the base of the scrape while the other was collected as a composite wall sample to represent all four cardinal directions within the scraped area. Samples were submitted to Eurofins Xenco under chain-of-custody protocols and analyzed for BTEX (EPA Method 8021B), total petroleum hydrocarbons (GRO, DRO, MRO – EPA Method 8015D) and total chlorides (EPA Method 300.0). Laboratory results are presented in Table 3, and the laboratory data reports are included in Appendix E. All confirmatory samples collected and analyzed were below the closure criteria for the site.

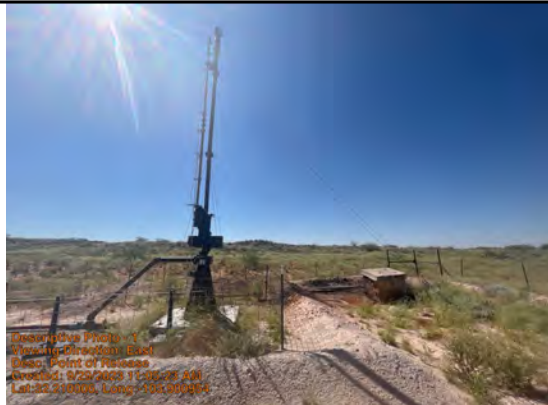
Point of Release

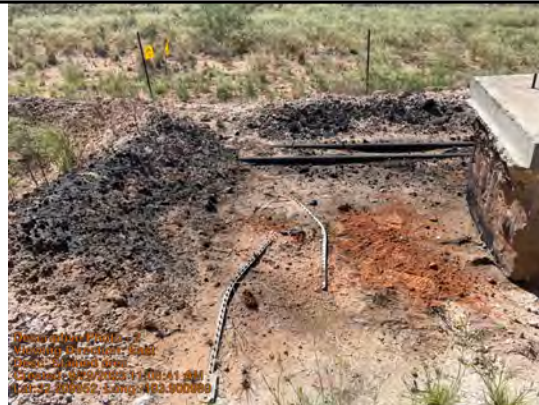
Stained area.

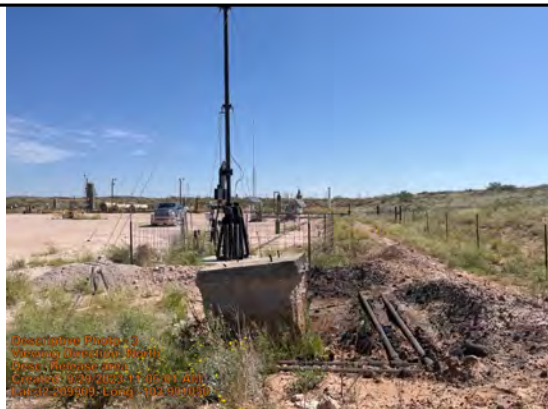
Release area

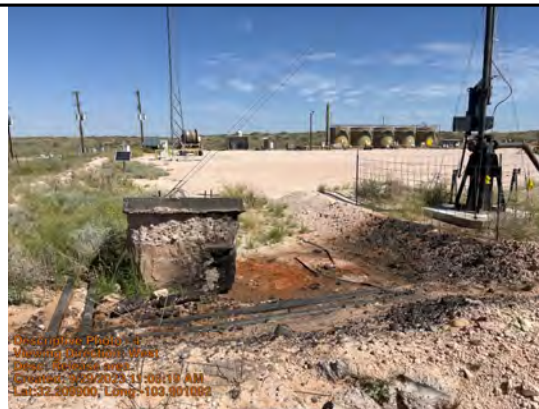
Release area.

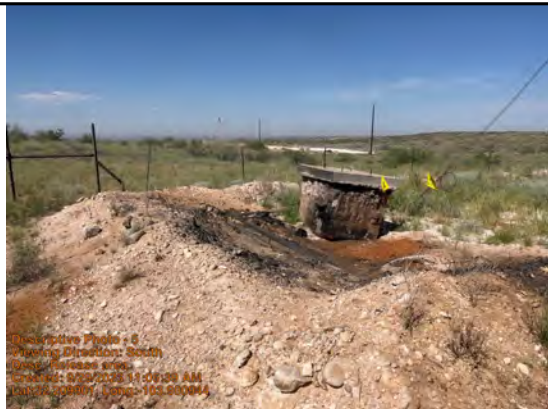
Release area.

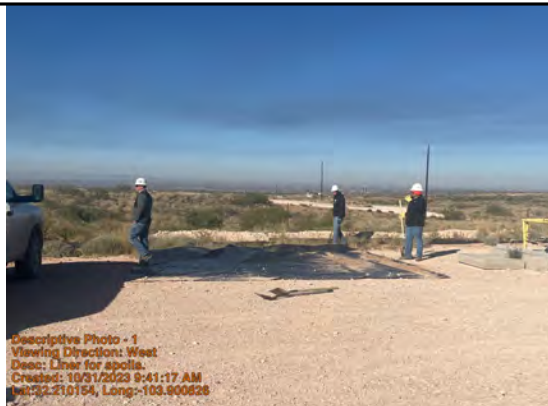
Liner for spoils.

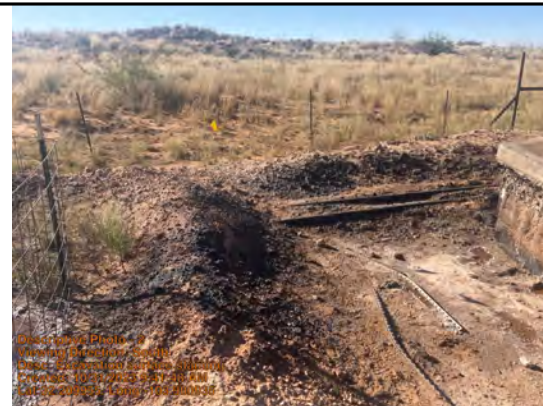
Excavation surface staining.

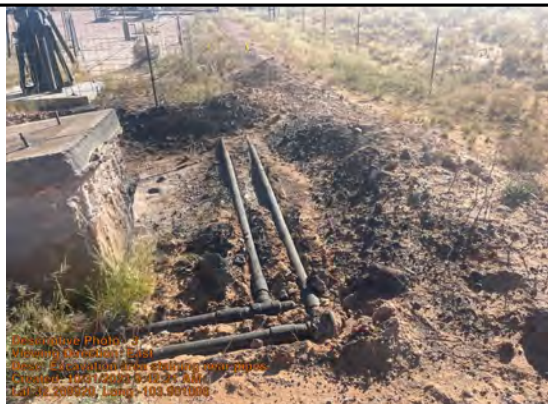
Excavation area staining near pipes.

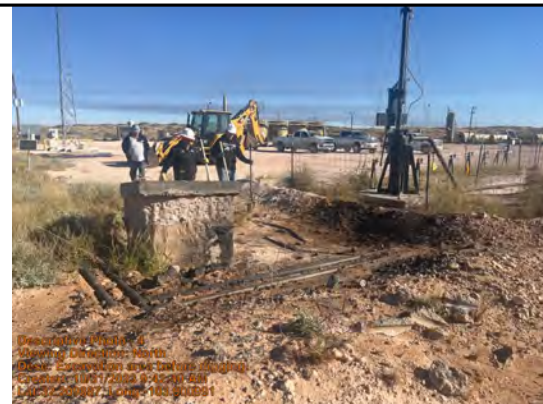
Excavation area before digging.

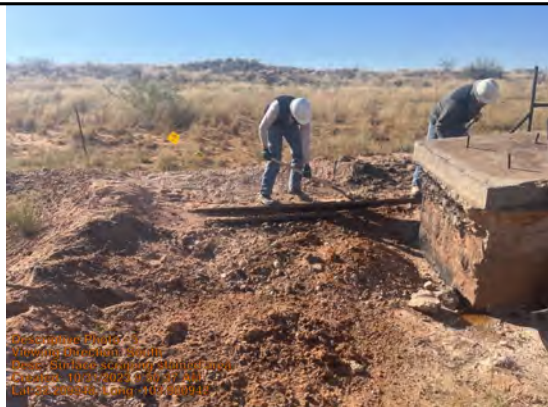
Surface scraping stained area.

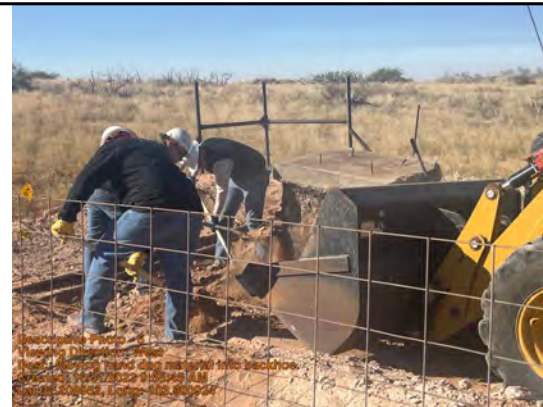
Moving hand dug material into backhoe.

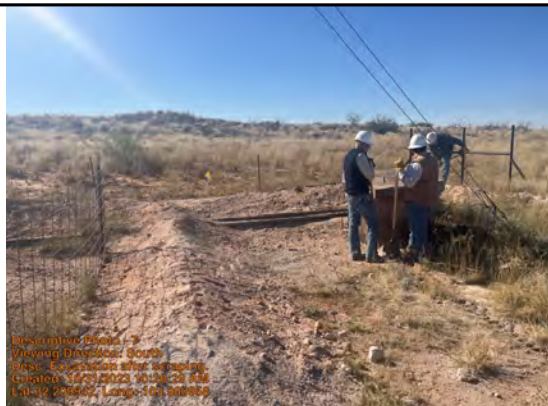
Excavation after scraping.

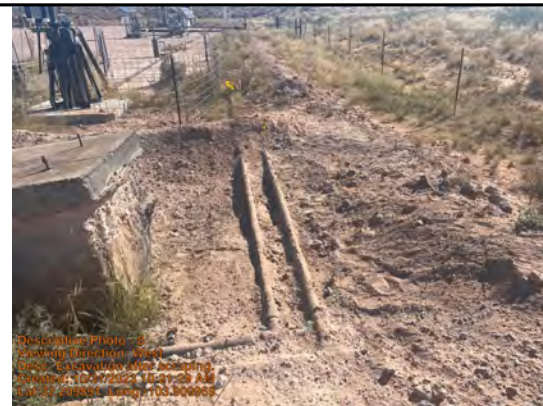
Excavation after scraping.

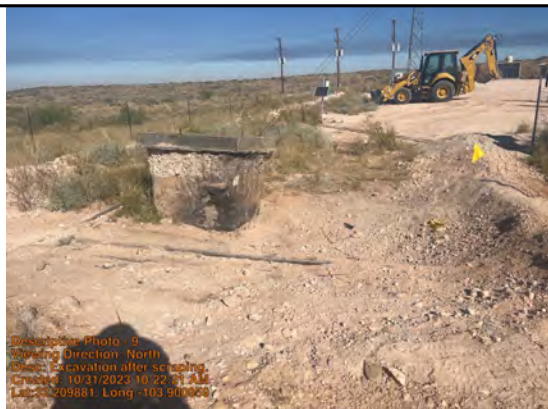
Excavation after scraping.

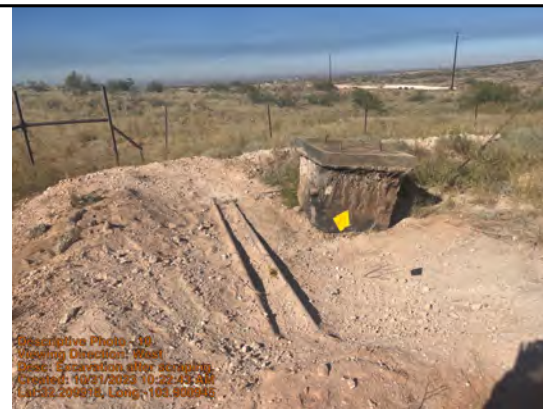
Excavation after scraping.
