**Re: Closure Request
Mesa 30 31 Tank Battery
Incident Number NAPP2106930621
Lea County, New Mexico**

Ensolum, LLC (Ensolum), on behalf of BTA Oil Producers, LLC (BTA), has prepared this *Closure Request* to document assessment, excavation, and soil sampling activities performed at the Mesa 30 31 Tank Battery (Site). The purpose of the Site assessment, excavation, and soil sampling activities was to address impacts to soil resulting from a historical crude oil release at the Site. Based on field observations, excavation activities, and soil sample laboratory analytical results, BTA is submitting this *Closure Request*, requesting no further action for Incident Number NAPP2106930621.

BTA Oil Producers, LLC
Closure Request
Mesa 30 31 Tank Battery

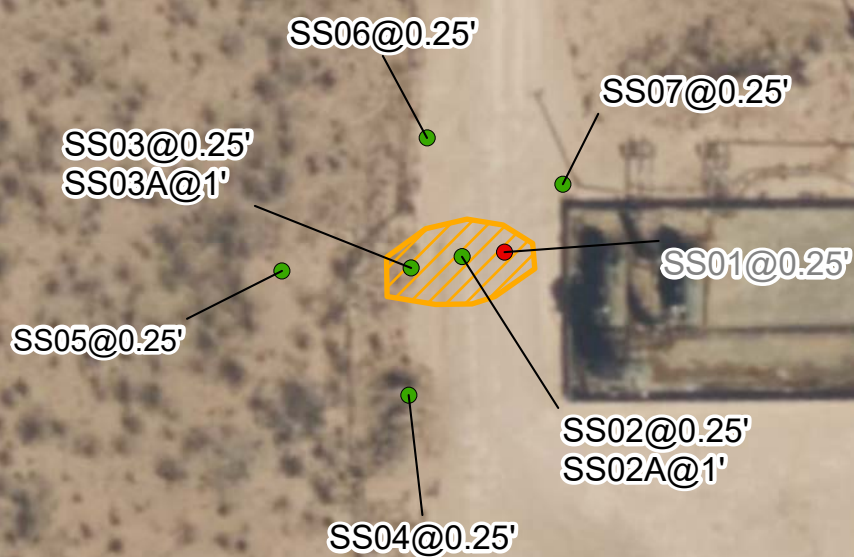
Assessment Soil Sample Locations

On May 3, 2023, Ensolum personnel were at the Site to evaluate the release extent based on information provided on the Form C-141, the documented release extent, and visual observations. Seven assessment soil samples (SS01 through SS07) were collected within and around the documented release extent at a depth of approximately 0.25 feet bgs, to assess for the presence or absence of impacted soil associated with the historical release. The soil samples were field screened for volatile organic compounds (VOCs) utilizing a calibrated photoionization detector (PID) and chloride using Hach® chloride QuanTab® test strips. The soil sample locations were mapped utilizing a handheld Global Positioning System (GPS) unit and are depicted on Figure 2. Photographic documentation was completed during the Site visit and a photographic log is included as Appendix B.

Laboratory analytical results for assessment soil samples SS02 and SS03, collected within the release extent, and SS04 through SS07, collected around the release extent, indicated all COC concentrations were compliant with the most stringent Table I Closure Criteria. Laboratory analytical results for assessment soil sample SS01, collected within the release extent, indicated chloride concentrations exceeded the reclamation requirement. Laboratory analytical results are summarized on Table 1 and the complete laboratory analytical reports are included as Appendix C. Based on the laboratory analytical results, additional assessment activities were warranted.

Notes:
 Sample ID @ Depth Below Ground Surface.
 Grey text indicate soil sample was removed during excavation activities.

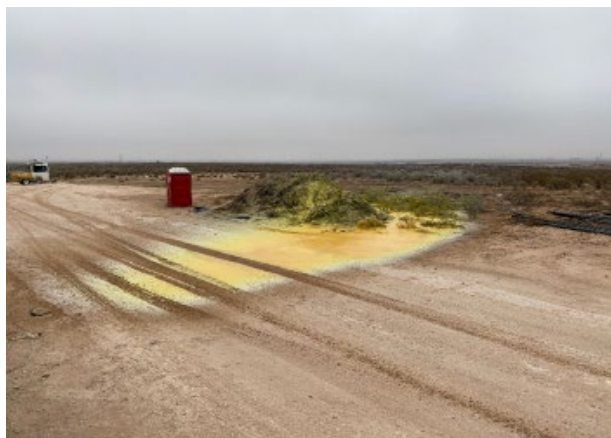
Photograph: 1 Date: 2/11/2021
Description: Soil staining in release footprint
View: Northeast

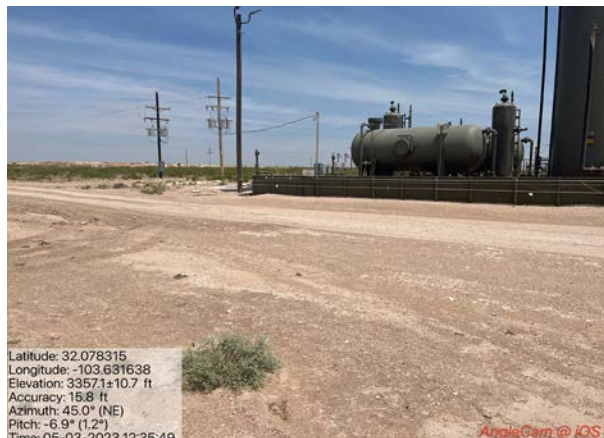
Photograph: 2 Date: 5/3/2023
Description: Release footprint
View: Northeast

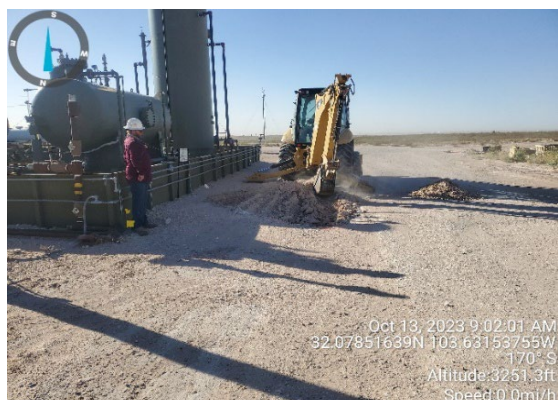
Photograph: 3 Date: 10/13/2023
Description: Excavation activities
View: South

On October 13, 2023, Ensolum personnel oversaw excavation of impacted soil from the release area as indicated by laboratory analytical results for assessment sample SS01. Excavation activities were performed via backhoe to a depth of 1-foot bgs. To direct excavation activities, soil was field screened for VOCs and chloride as previously described. Photographic documentation is included in Appendix B.

The aerial footprint of the excavation measured approximately 174 square feet. A total of approximately 7 cubic yards of soil were removed during excavation activities. The impacted soil was transported and properly disposed of at the Northern Delaware Basin Landfill in Jal, New Mexico.

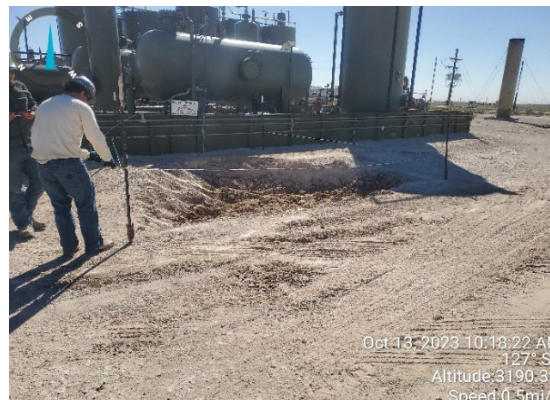
Photograph: 4 Date: 10/13/2023
Description: Post-excavation
View: Southeast

Following removal of impacted soil, one 5-point composite soil sample was collected from the floor of the 174 square foot excavation. The 5-point composite soil sample was collected by placing five equivalent aliquots of soil into a 1-gallon, resealable plastic bag and homogenizing the samples by thoroughly mixing. Composite soil sample FS01 was collected from the floor of the excavation at a depth of 1-foot bgs. Due to the shallow depth of the excavation, soil from the excavation sidewalls was included in the floor sample. The excavation soil sample was handled and analyzed as previously described. The excavation extent and excavation soil sample location were mapped utilizing a handheld GPS unit and are depicted on Figure 3.

Laboratory analytical results for excavation floor sample FS01 indicated all COC concentrations were compliant with the most stringent Table 1 Closure Criteria. Laboratory analytical results are summarized in Table 1 and the complete laboratory analytical reports are included as Appendix C.

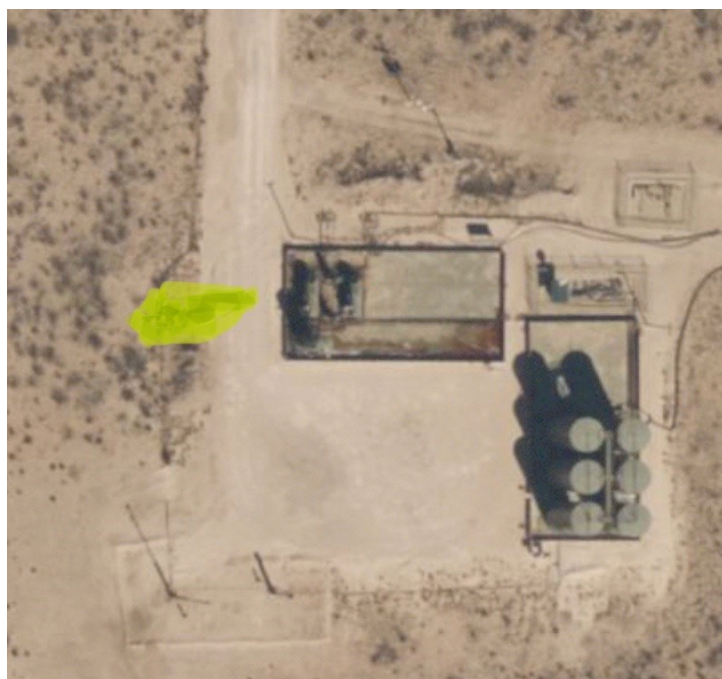
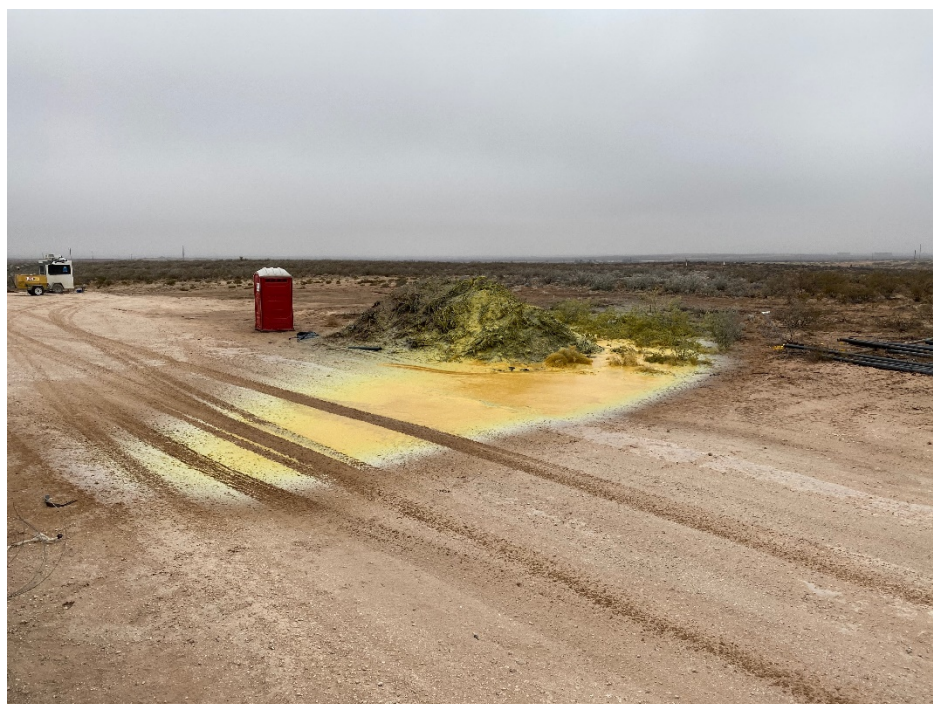
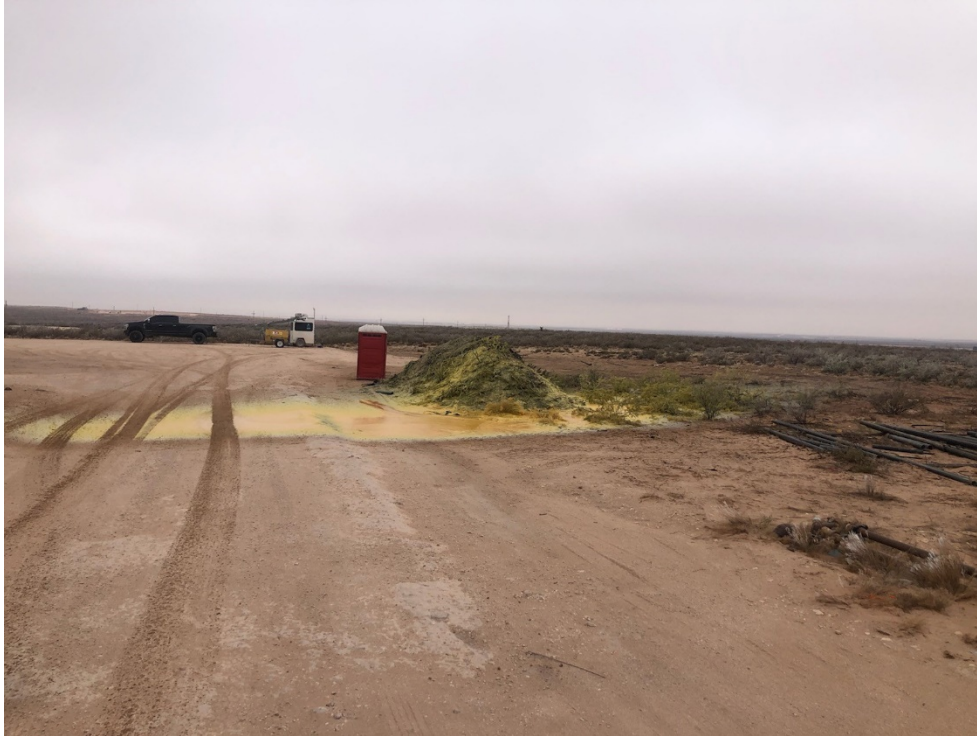
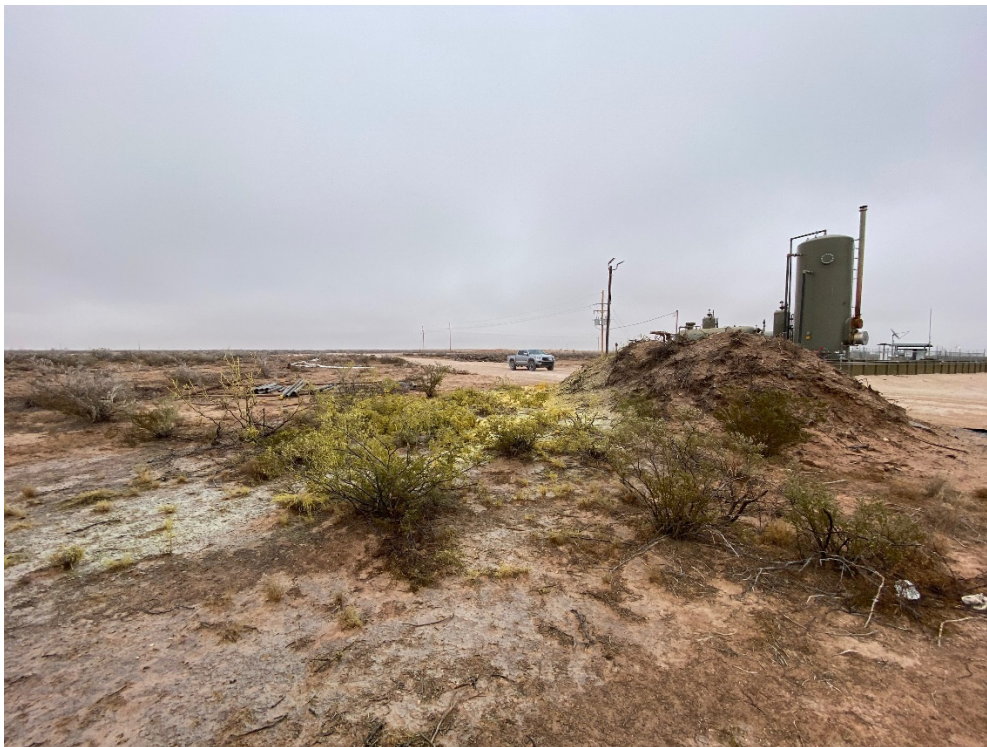
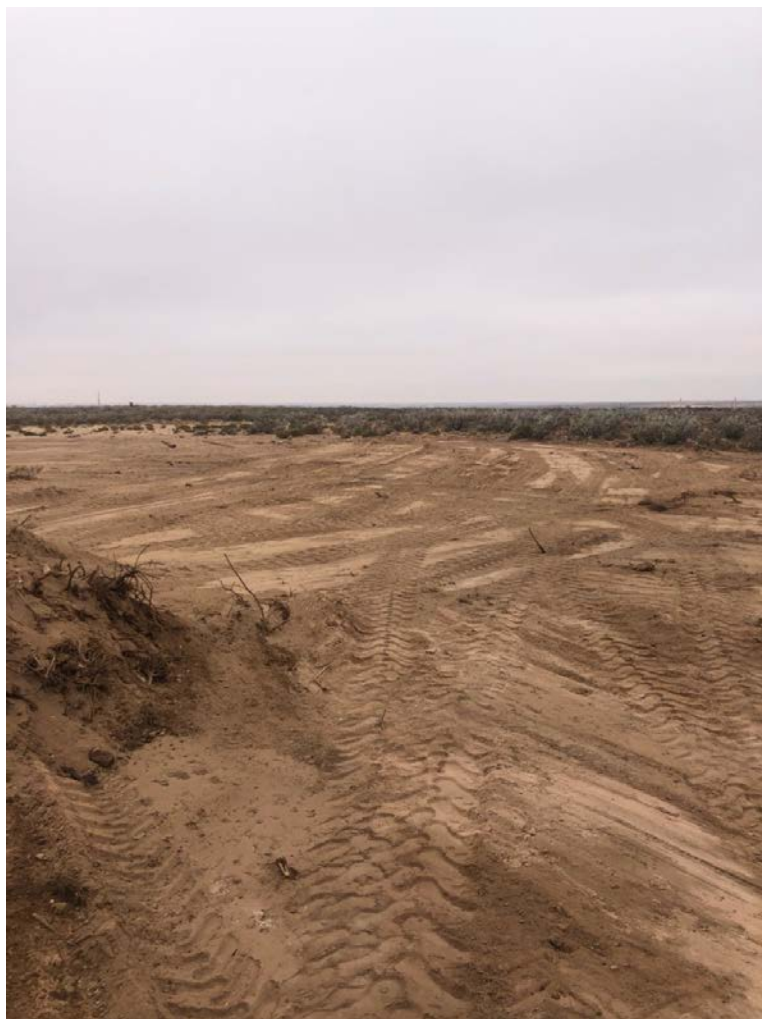
Mesa 30 31 Tank Battery
February 11, 2021

The supply gas regulator froze, causing failure of the dump valve operation which allowed pressure to build up in the separator vessel. The relief valve popped off and sprayed crude oil from the separator and across the pad as shown. A backhoe was nearby and scraped up 48 yards of crude oil impacted soil that will be sent to proper disposal. Due to the low ambient temperature, the crude oil had solidified on top of the soil and soaking was minimal. Closure sampling will be conducted in the area of the release.
