August 29, 2023

**RE: Closure Report
ConocoPhillips/COG Operating LLC
Super Cobra State Com #001H Flowline Release
Unit Letter P, Section 13, Township 19 South, Range 34 East
Lea County, New Mexico
Incident ID: nAPP2310336759**

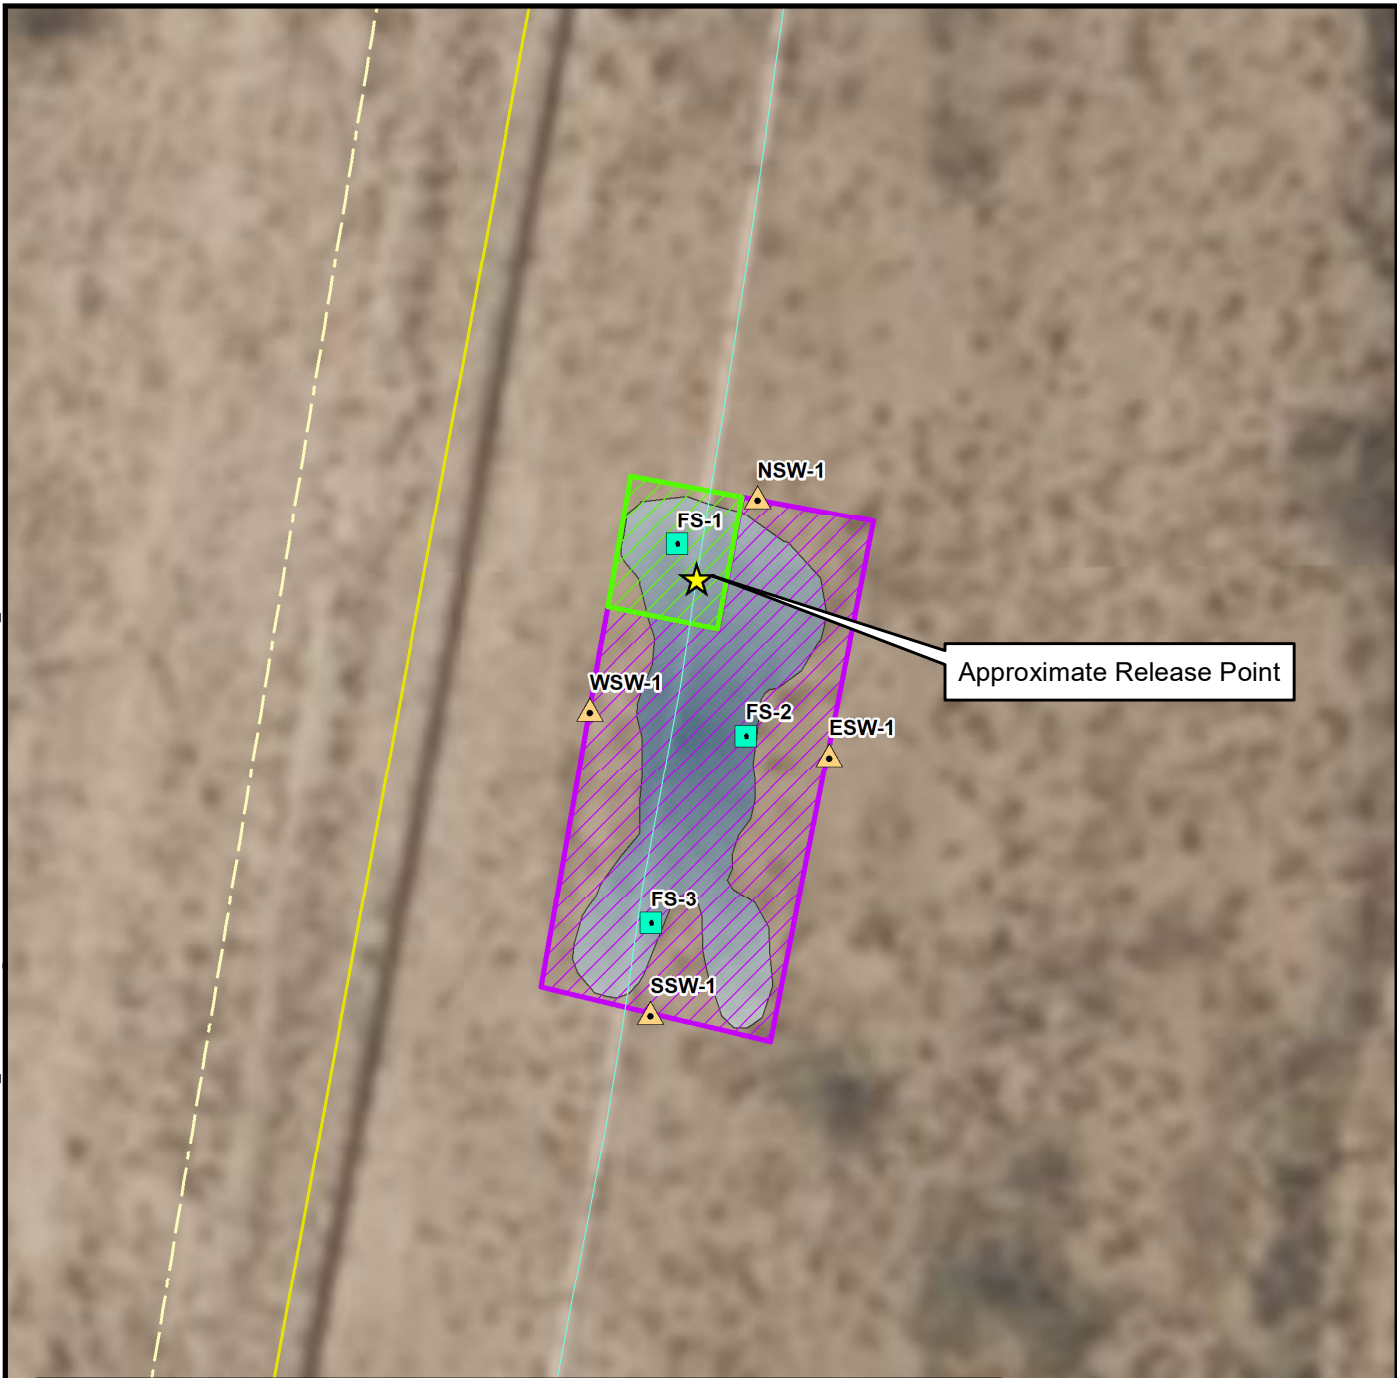
remedial activities. Confirmation sidewall sample locations were labeled with "SW"-#, and confirmation floor sample locations were labeled with "FS"-#. Analytical results for all confirmation soil samples (floor and sidewall) were below the RRALs for chloride, BTEX, and TPH. The results of the July 2023 confirmation sampling events are summarized in Table 2. Laboratory analytical data is included in Appendix D. Remediated areas, depths and confirmation sample locations are shown in Figure 5. Photographs from the area after backfilling are provided in Appendix E.

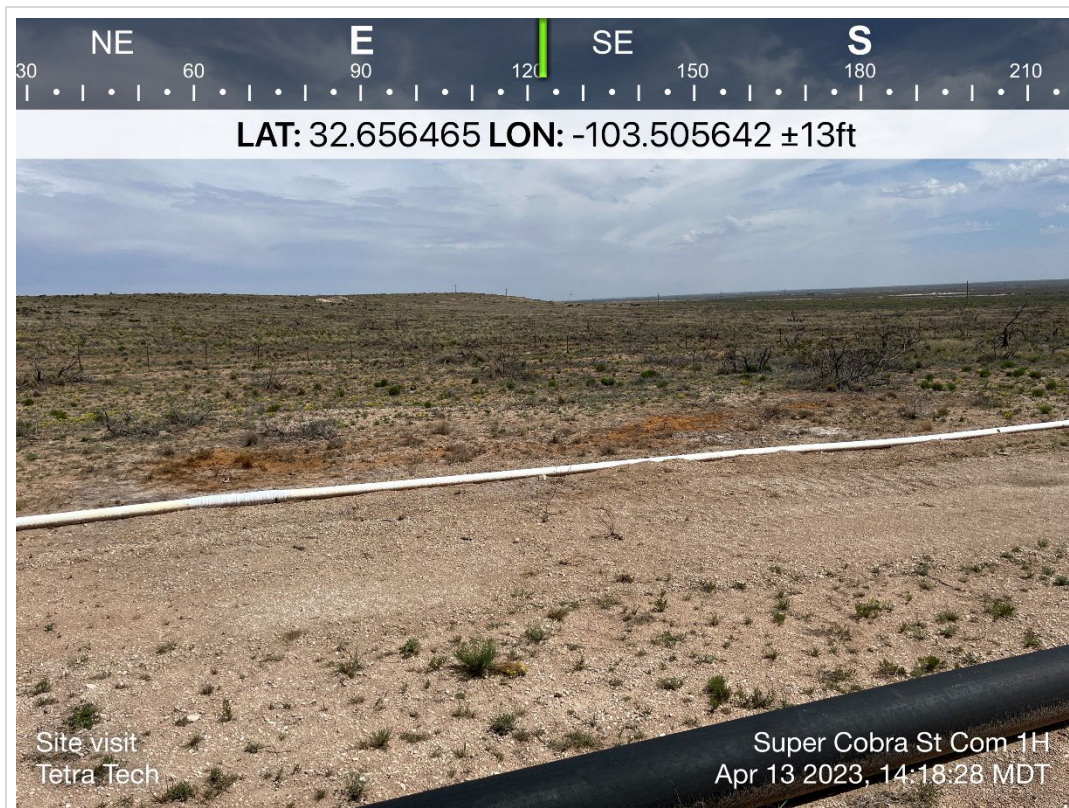
TETRA TECH, INC. PROJECT NO. 212C-MD-03092	DESCRIPTION	View southeast of release extent.	1
	SITE NAME	SUPER COBRA STATE COM #001H RELEASE	4/13/2023

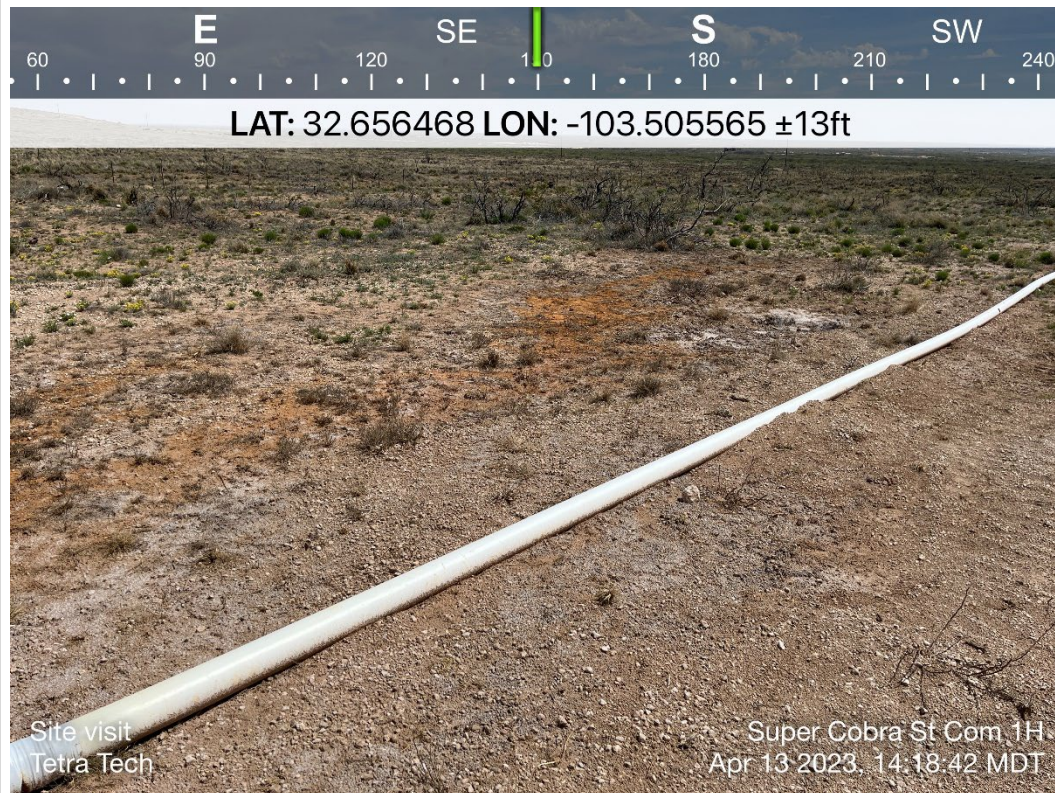
TETRA TECH, INC. PROJECT NO. 212C-MD-03092	DESCRIPTION	View southeast of release extent.	2
	SITE NAME	SUPER COBRA STATE COM #001H RELEASE	4/13/2023

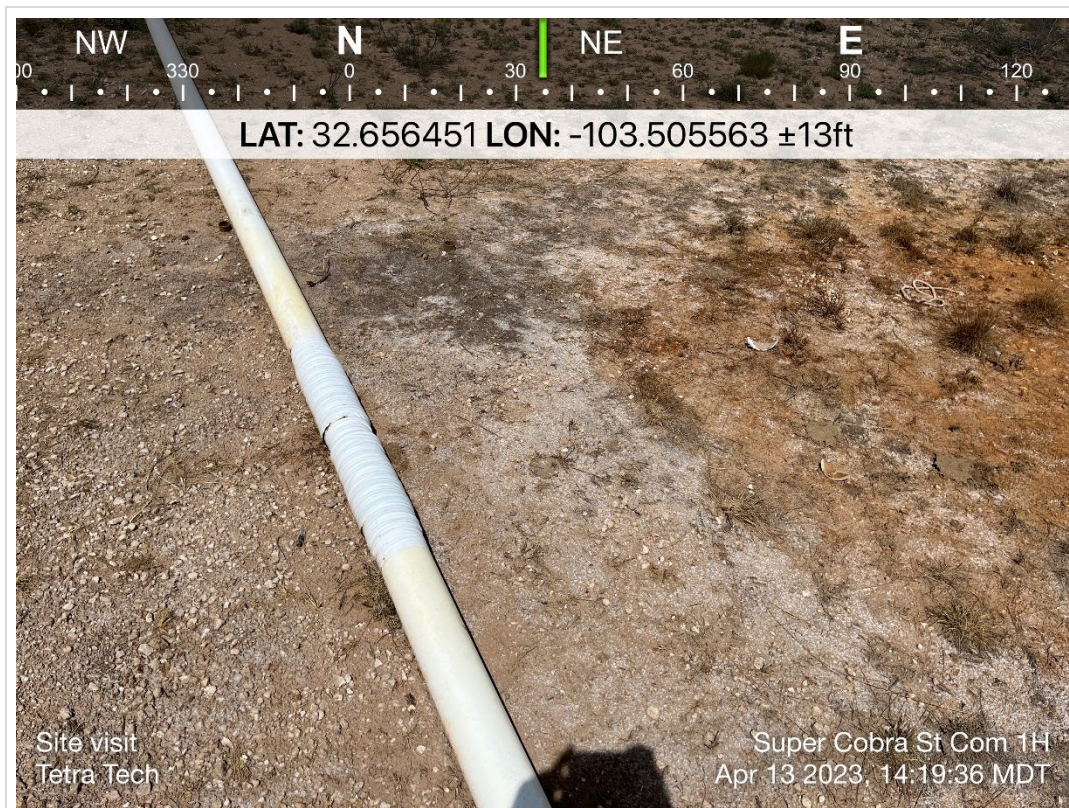
TETRA TECH, INC. PROJECT NO. 212C-MD-03092	DESCRIPTION	View of repaired flowline.	3
	SITE NAME	SUPER COBRA STATE COM #001H RELEASE	4/13/2023

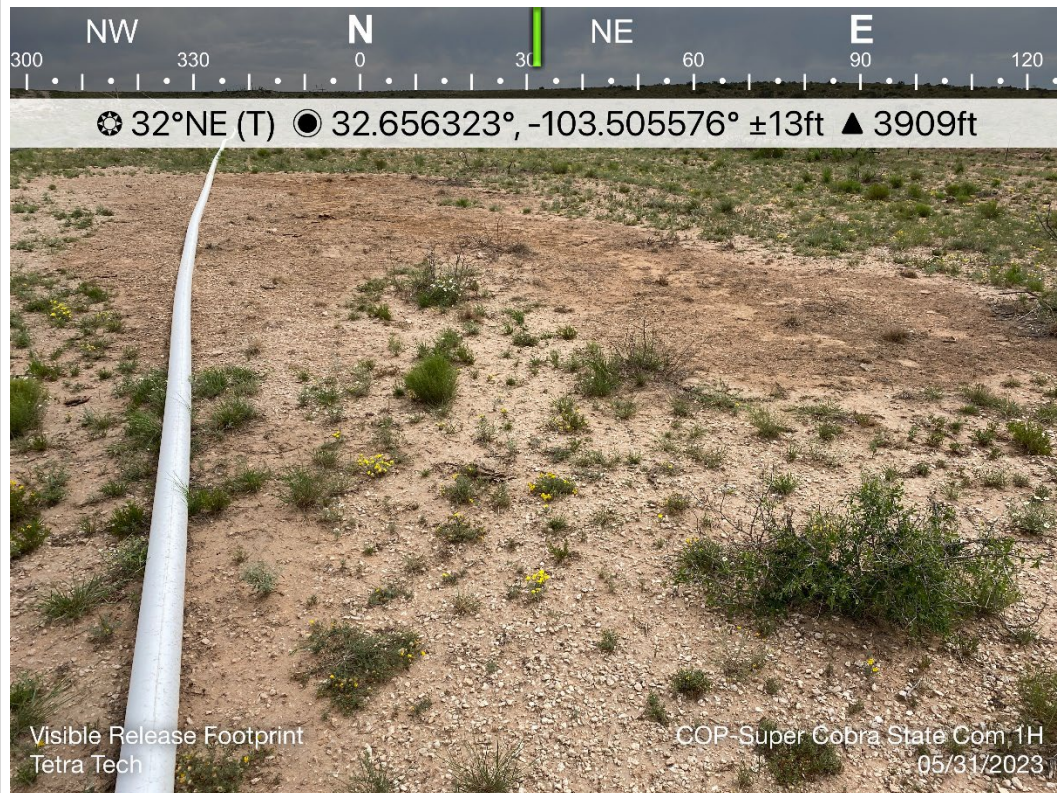
TETRA TECH, INC. PROJECT NO. 212C-MD-03092	DESCRIPTION	View north of release extent and flowline.	4
	SITE NAME	SUPER COBRA STATE COM #001H RELEASE	5/31/2023

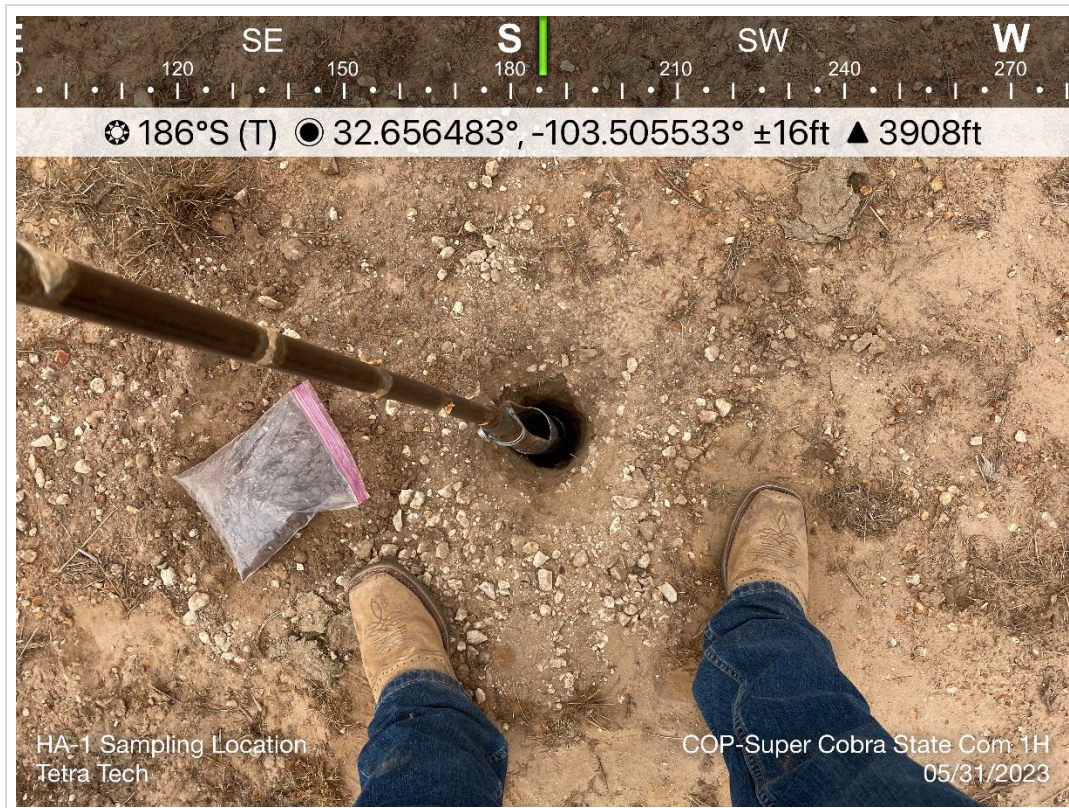
TETRA TECH, INC. PROJECT NO. 212C-MD-03092	DESCRIPTION	Hand auger location HA-1	5
	SITE NAME	SUPER COBRA STATE COM #001H RELEASE	5/31/2023

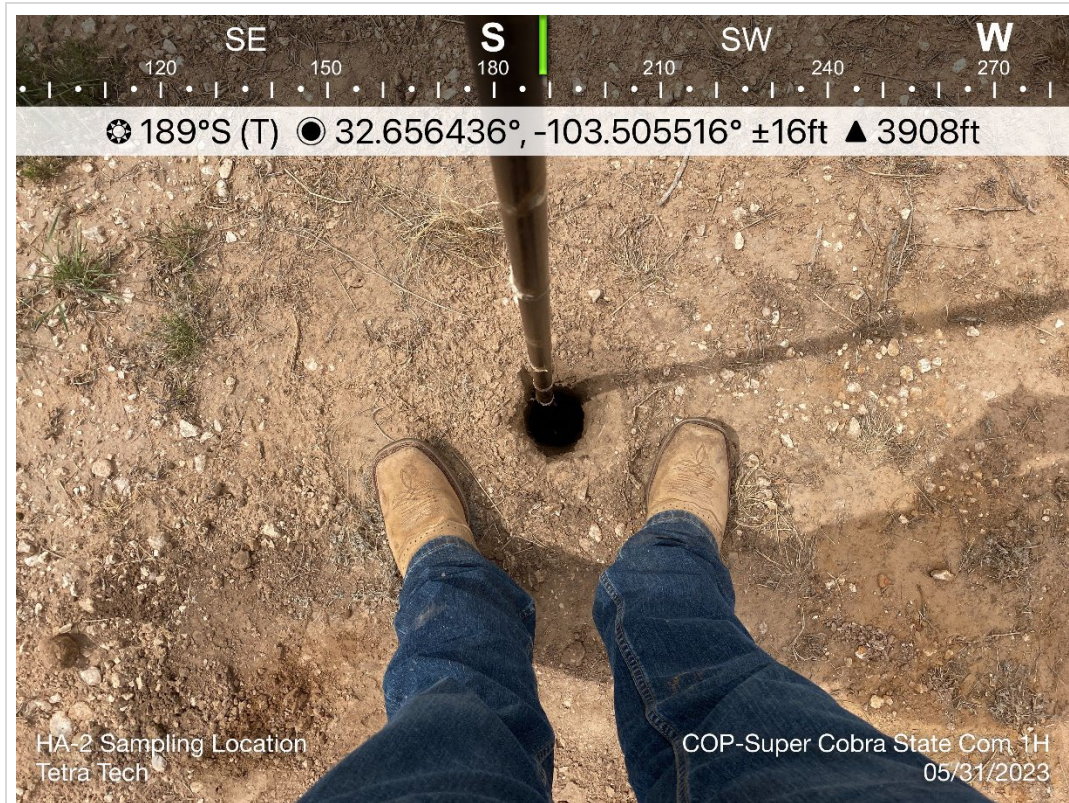
TETRA TECH, INC. PROJECT NO. 212C-MD-03092	DESCRIPTION	Hand auger location HA-2	6
	SITE NAME	SUPER COBRA STATE COM #001H RELEASE	5/31/2023

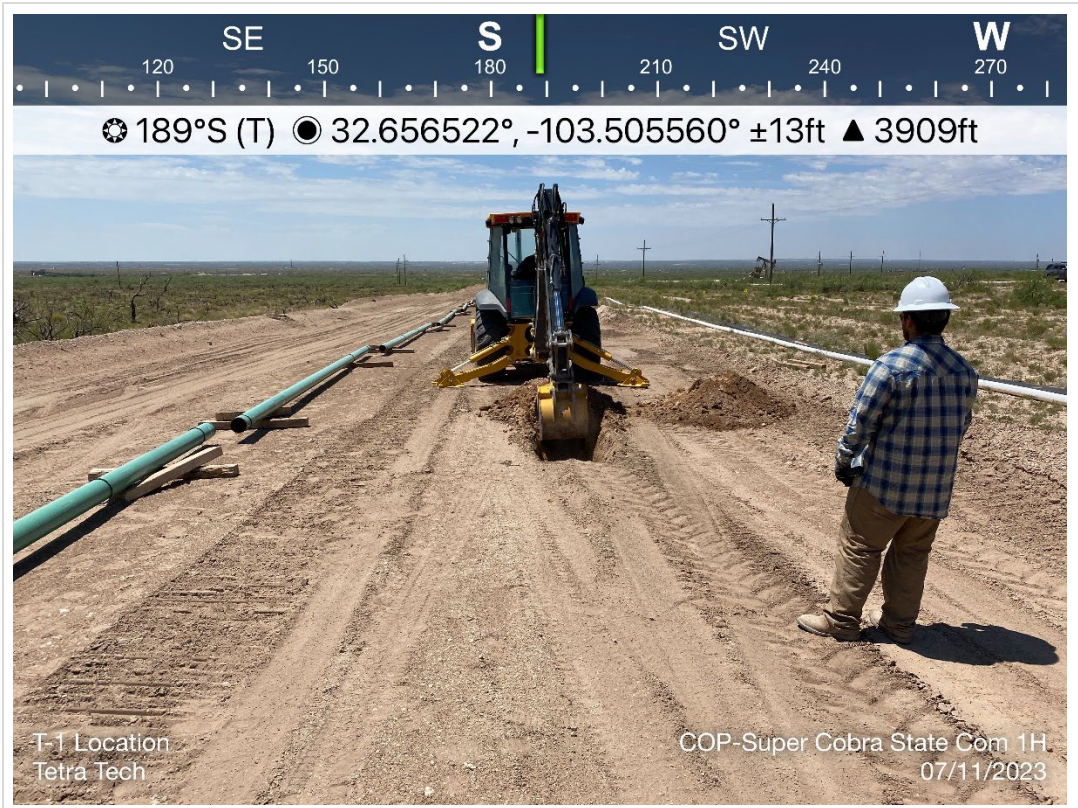
TETRA TECH, INC. PROJECT NO. 212C-MD-03092	DESCRIPTION	View south. Trench location T-1 and Plains pipeline installation.	7
	SITE NAME	SUPER COBRA STATE COM #001H RELEASE	7/11/2023

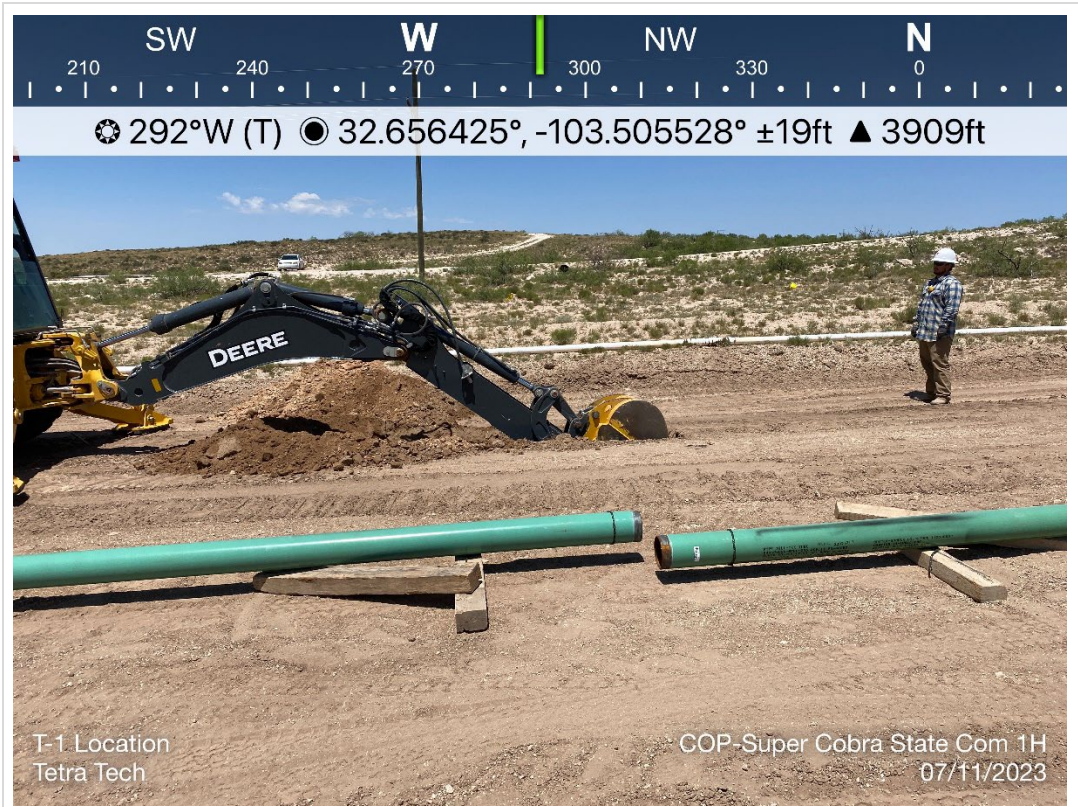
TETRA TECH, INC. PROJECT NO. 212C-MD-03092	DESCRIPTION	View west. Trench location T-1 and Plains pipeline installation.	8
	SITE NAME	SUPER COBRA STATE COM #001H RELEASE	7/11/2023

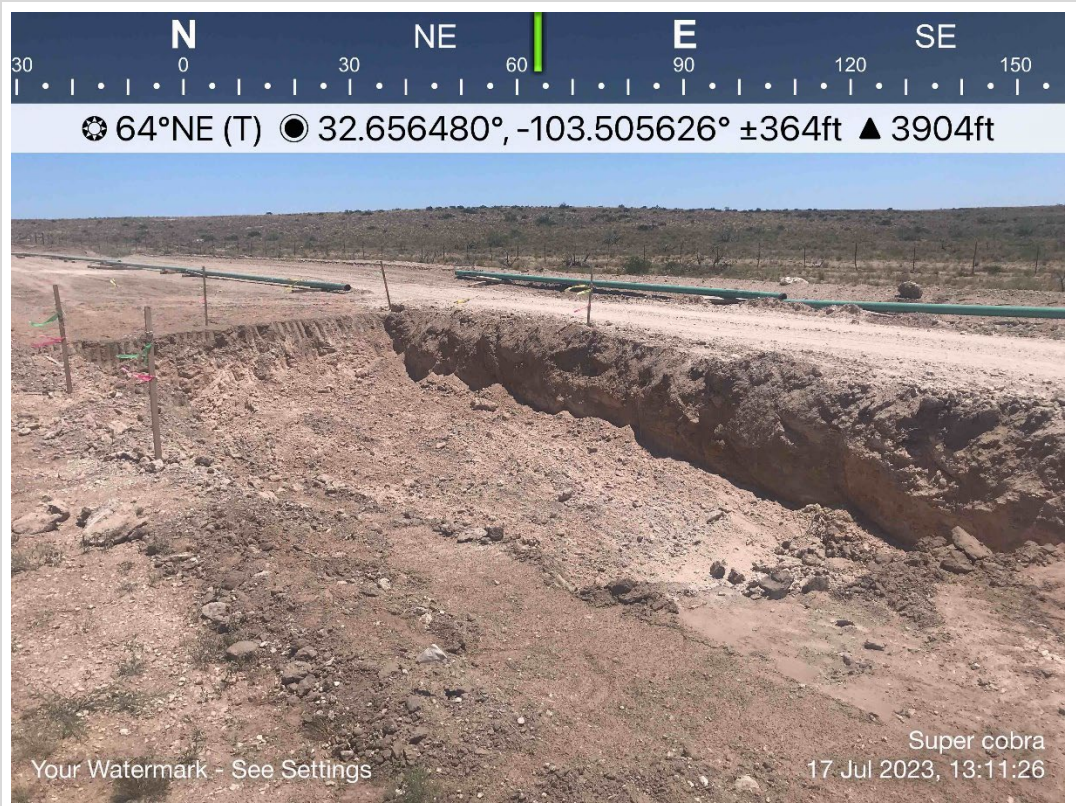
TETRA TECH, INC. PROJECT NO. 212C-MD-03092	DESCRIPTION	View northeast of excavated area.	9
	SITE NAME	SUPER COBRA STATE COM #001H RELEASE	7/17/2023

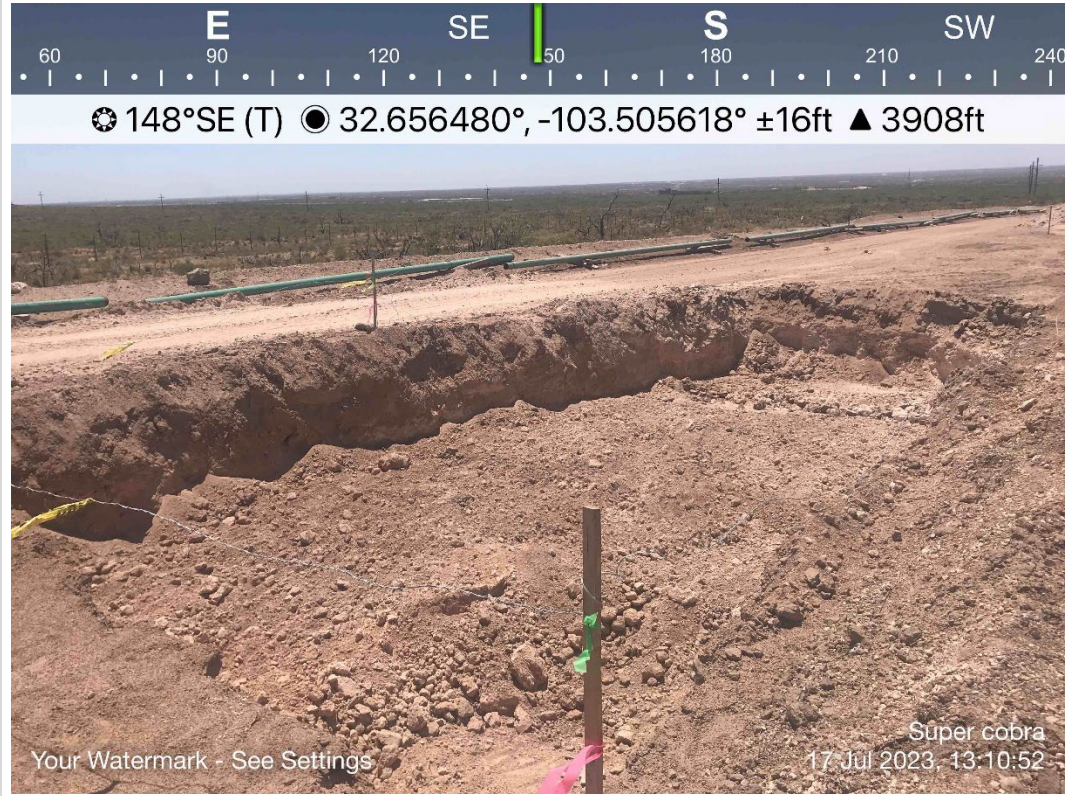
TETRA TECH, INC. PROJECT NO. 212C-MD-03092	DESCRIPTION	View southeast of excavated area.	10
	SITE NAME	SUPER COBRA STATE COM #001H RELEASE	7/17/2023

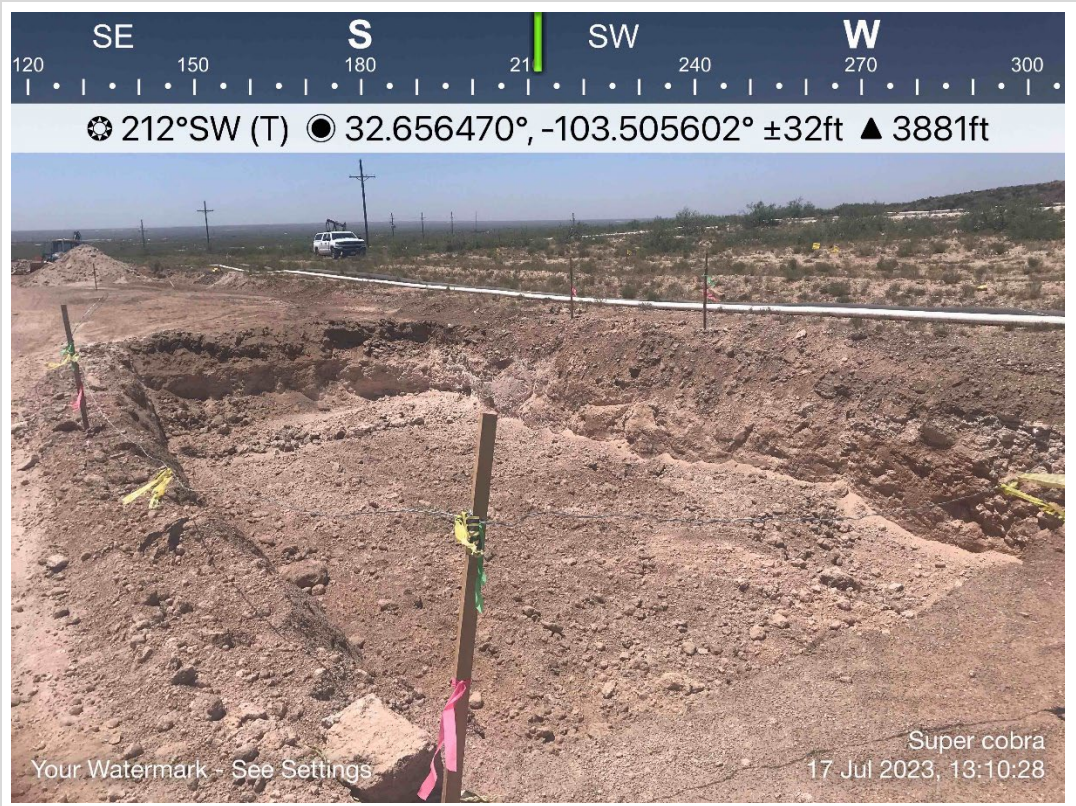
TETRA TECH, INC. PROJECT NO. 212C-MD-03092	DESCRIPTION	View south of excavated area.	11
	SITE NAME	SUPER COBRA STATE COM #001H RELEASE	7/17/2023

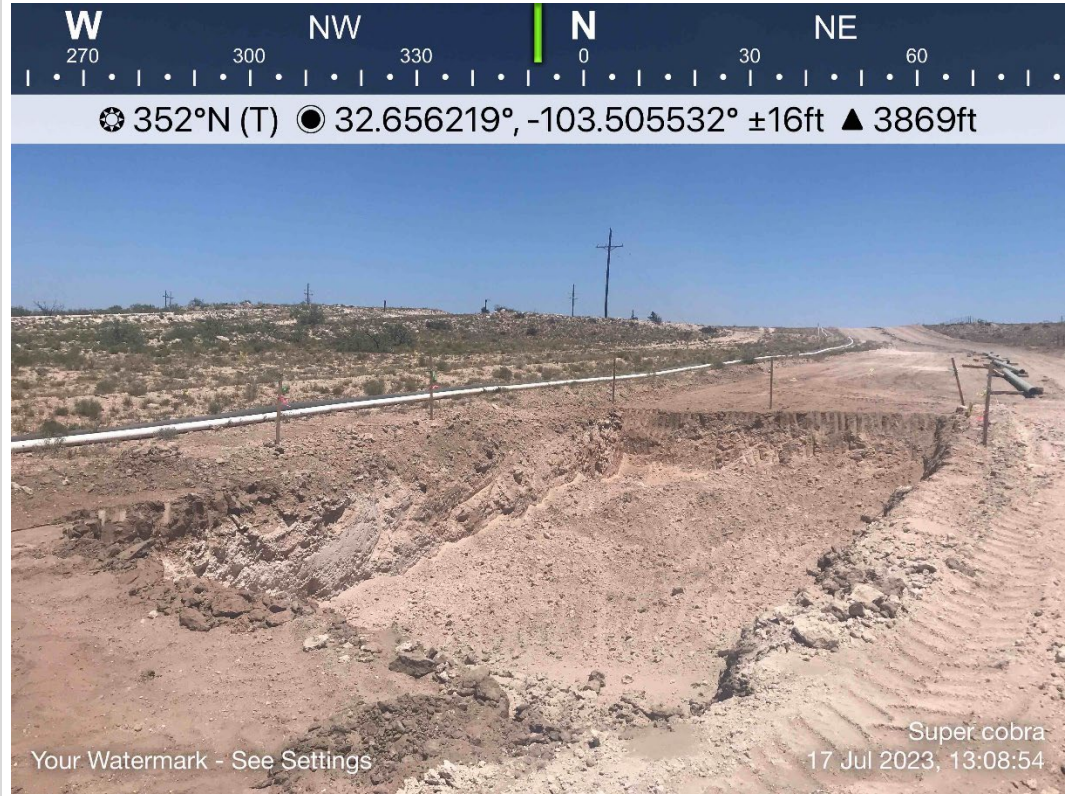
TETRA TECH, INC. PROJECT NO. 212C-MD-03092	DESCRIPTION	View north of excavated area	12
	SITE NAME	SUPER COBRA STATE COM #001H RELEASE	7/17/2023

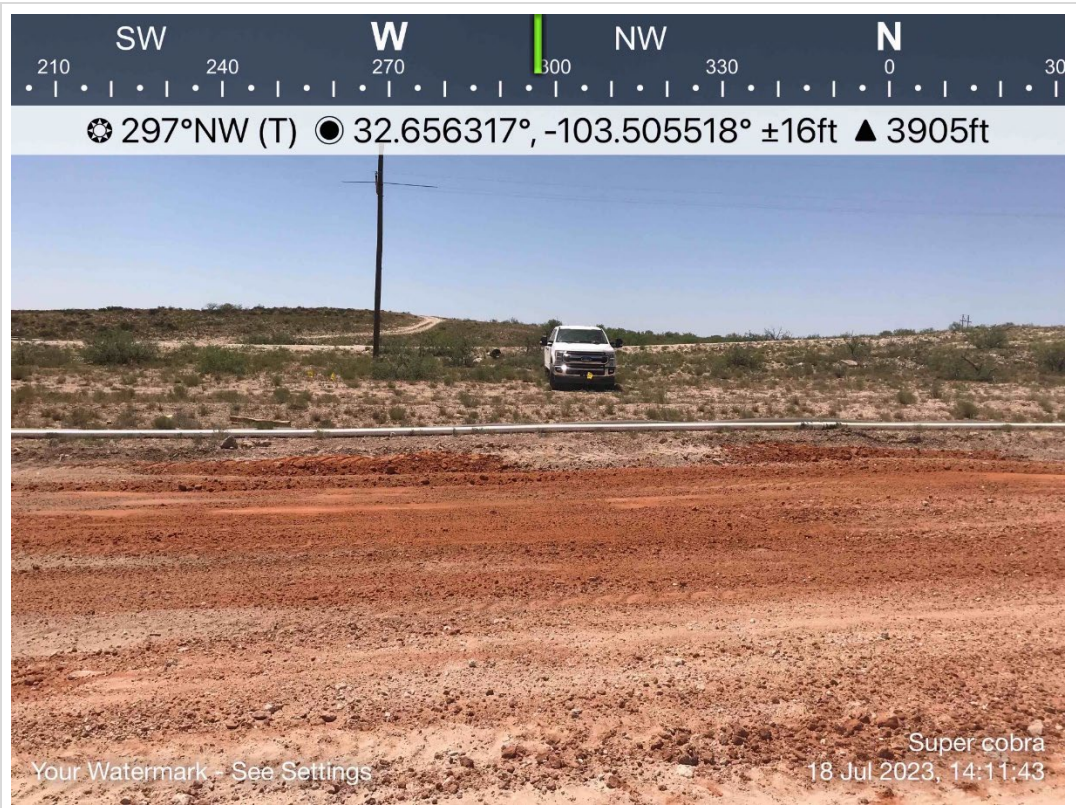
TETRA TECH, INC. PROJECT NO. 212C-MD-03092	DESCRIPTION	View west of backfilled area.	13
	SITE NAME	SUPER COBRA STATE COM #001H RELEASE	7/18/2023

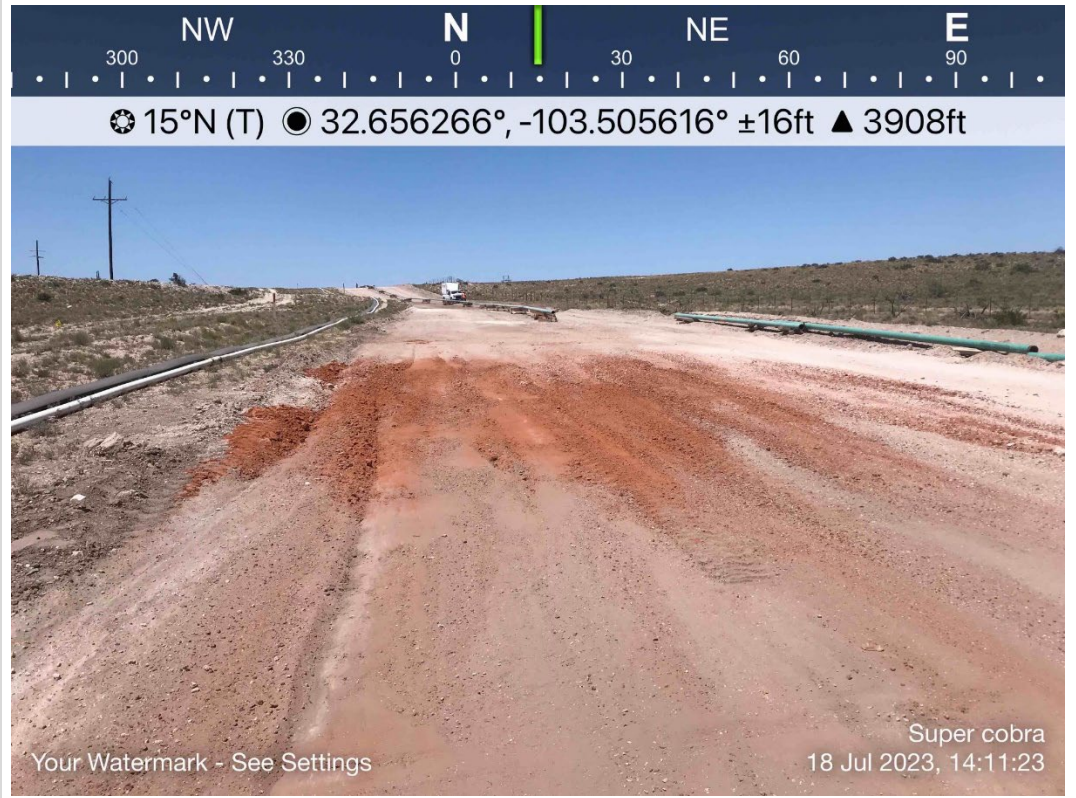
TETRA TECH, INC. PROJECT NO. 212C-MD-03092	DESCRIPTION	View north of backfilled area.	14
	SITE NAME	SUPER COBRA STATE COM #001H RELEASE	7/18/2023
