**Re: Closure Report
ConocoPhillips
Windward Federal 005H Release
Unit Letter D, Section 30, Township 24 South, Range 32 East
DOR: 7/01/2023
Lea County, New Mexico
Incident ID: NAPP2319143291**

**WINDWARD FEDERAL COM 005H FLOWLINE RELEASE
OVERVIEW MAP**

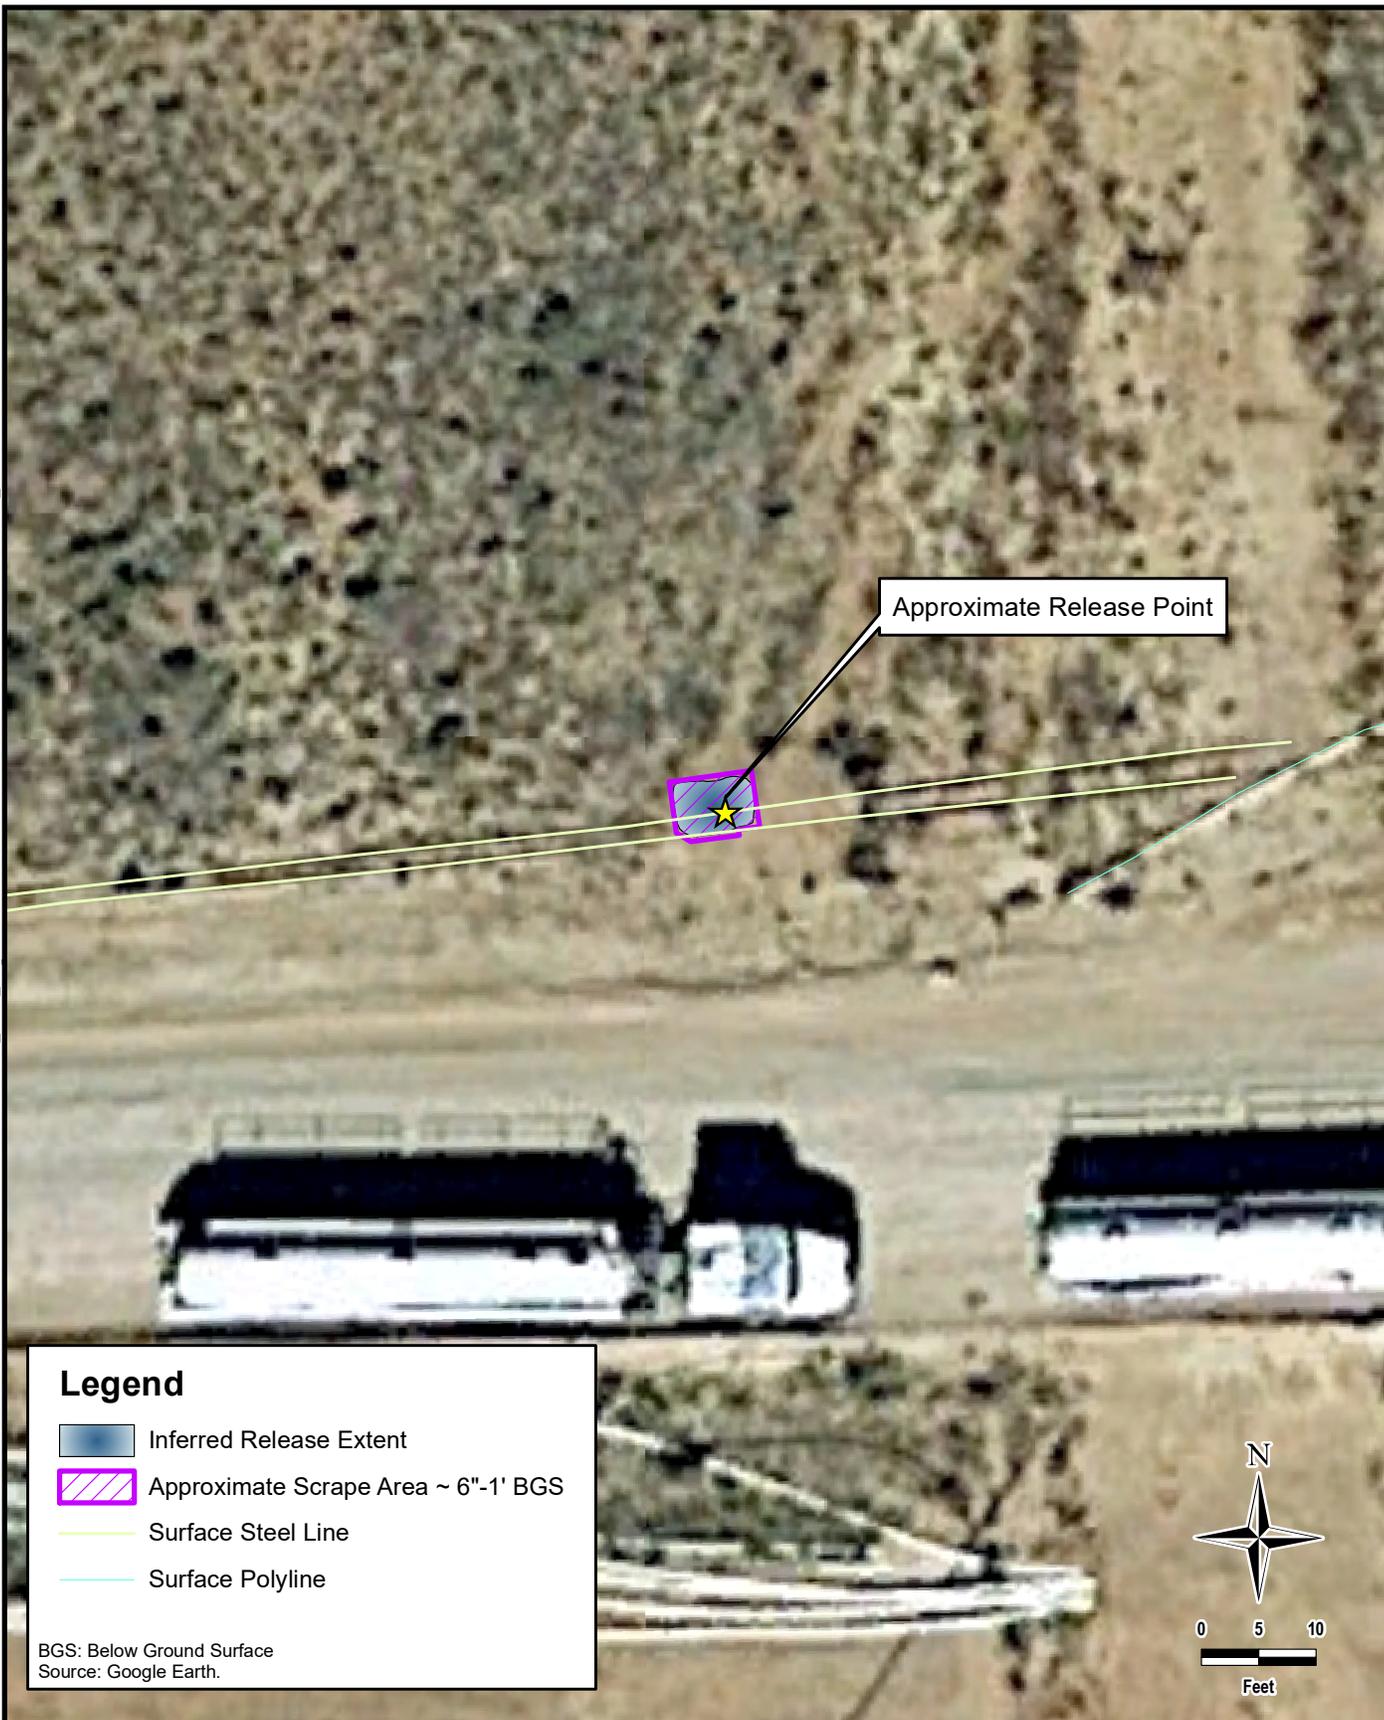
In accordance with 19.15.29.8. B. (4) NMAC that states “the responsible party may commence remediation immediately after discovery of a release,” ConocoPhillips elected to begin remediation of the impacted area on July 10, 2023. The visibly impacted material was initially excavated by scraping the surface to a depth of 1 foot bgs. Photographic documentation of the release extent scrape is presented in Appendix D. The initial response area is indicated in Figure 3.

- Inferred Release Extent
- Approximate Scrape Area ~ 6"-1' BGS
- Surface Steel Line
- Surface Polyline

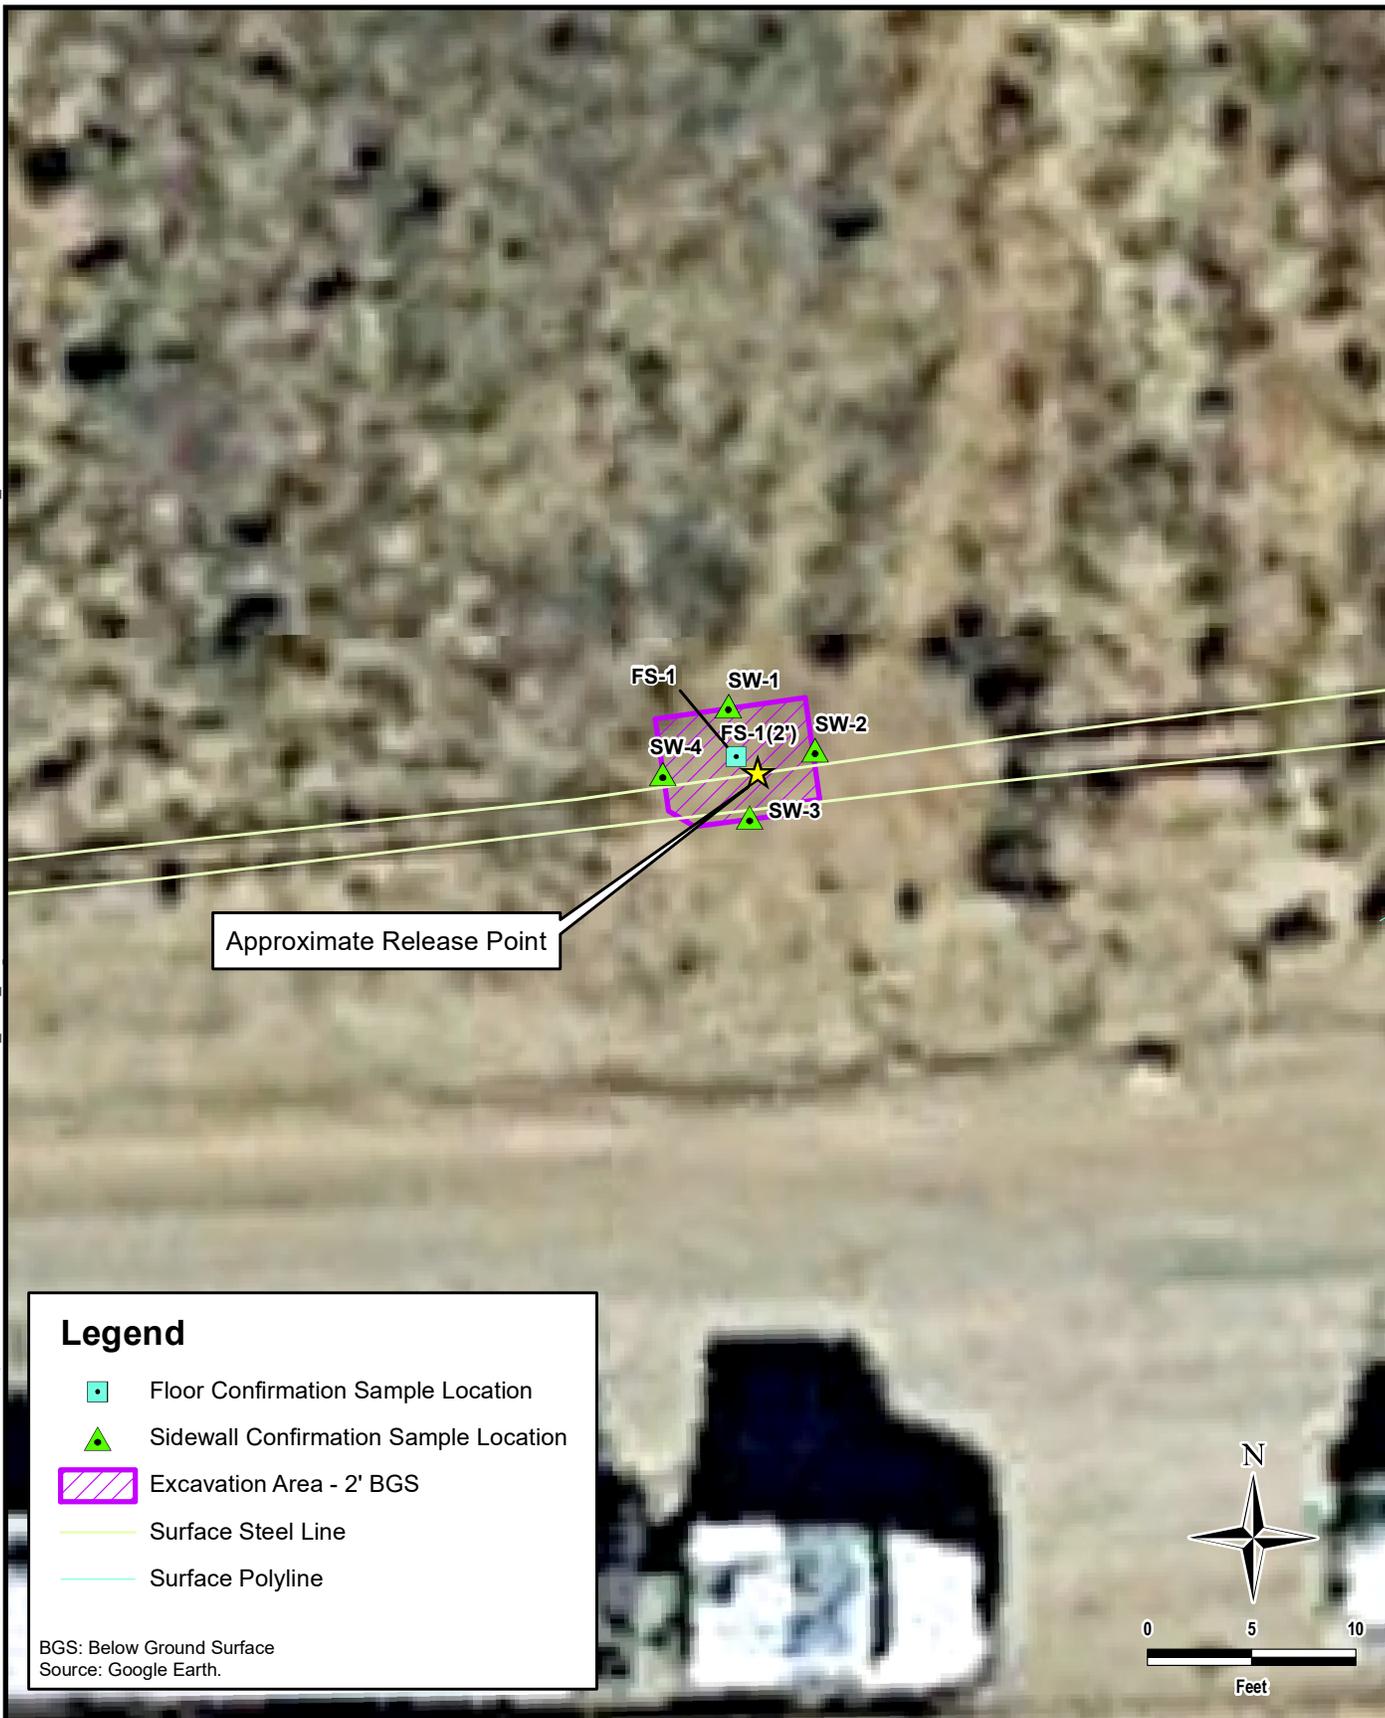
**WINDWARD FEDERAL COM 005H FLOWLINE RELEASE
REMEDATION EXTENT AND CONFIRMATION SAMPLING LOCATIONS**

Once confirmation sampling activities were completed, the excavated areas were backfilled with clean material to surface grade. Photographs from the excavated areas prior to backfill are provided in Appendix D. The backfilled areas were seeded with the BLM seed mixture for LPC Sand/Shinnery Sites to aid in revegetation. Remediated areas, depths and confirmation sample locations are shown in Figure 4.

- Floor Confirmation Sample Location
- ▲ Sidewall Confirmation Sample Location
- Excavation Area - 2' BGS
- Surface Steel Line
- Surface Polyline

On August 31 and September 1, 2023, Tetra Tech personnel remobilized to the site to conduct additional remedial activities and confirmation sampling. Based on the results of the initial sampling, Tetra Tech excavated the release extent an additional 1-foot to a total depth of 2 feet bgs.

One (1) floor sample (FS-1 (2')) was collected from the base of the excavation and submitted to Cardinal Laboratories (Cardinal) in Hobbs, New Mexico to be analyzed for chlorides via EPA Method 4500.0, TPH via EPA Method 8015M, and BTEX via EPA Method 8021B. The results of the confirmation sampling activities are summarized in Table 1. The analytical results were below the Site RRALs for all constituents. A copy of the laboratory analytical report and chain-of-custody documentation are included in Appendix E.

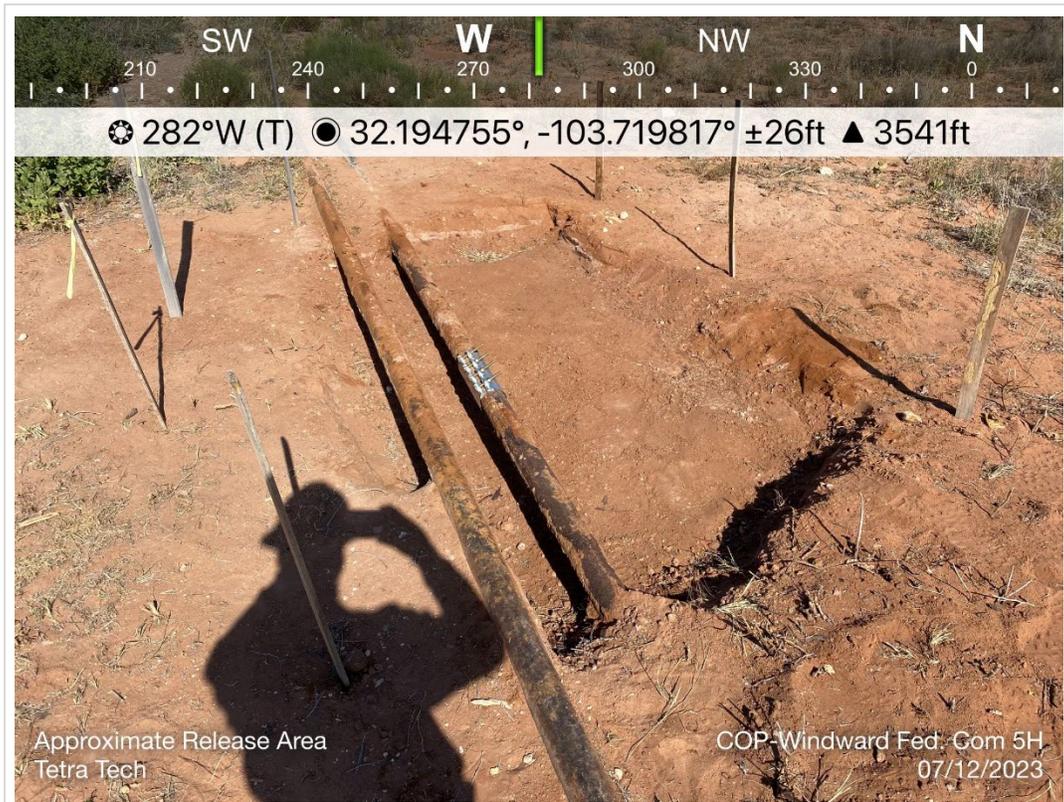
TETRA TECH, INC. PROJECT NO. 212C-MD-03168	DESCRIPTION	View west of release extent. Initial response area and subsurface steel lines.	1
	SITE NAME	Windward Federal Com #005H Release	7/12/2023

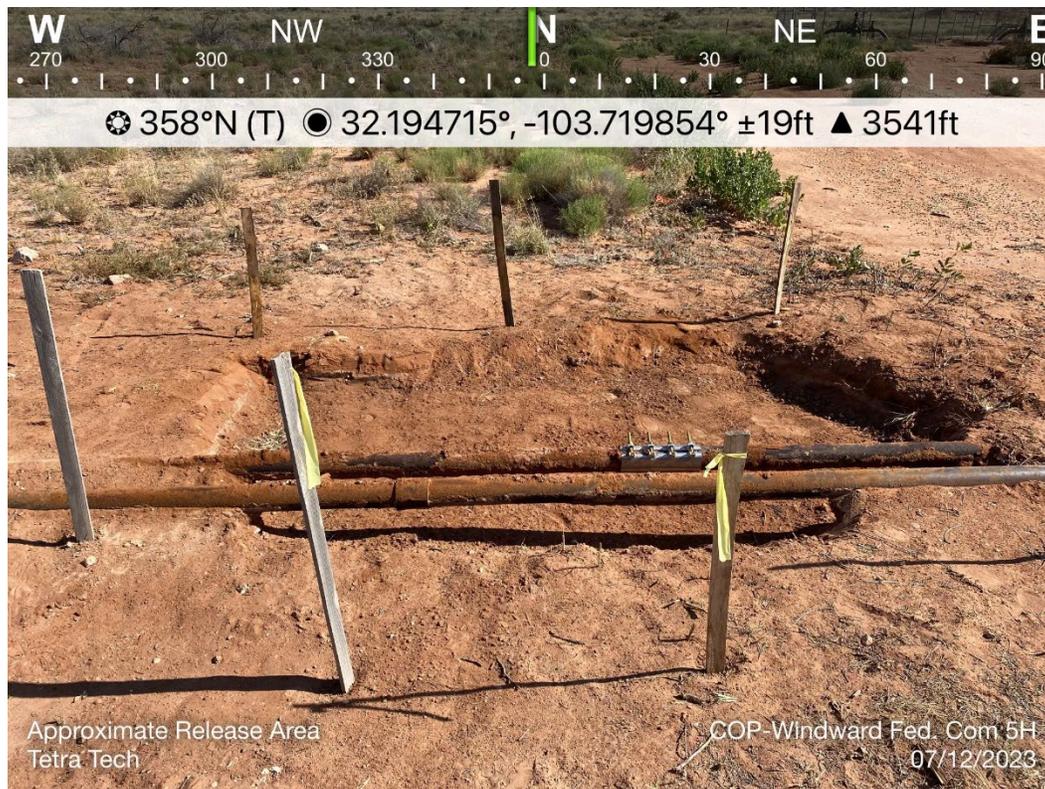
TETRA TECH, INC. PROJECT NO. 212C-MD-03168	DESCRIPTION	View north of release extent. Initial response area and subsurface steel lines.	2
	SITE NAME	Windward Federal Com #005H Release	7/12/2023

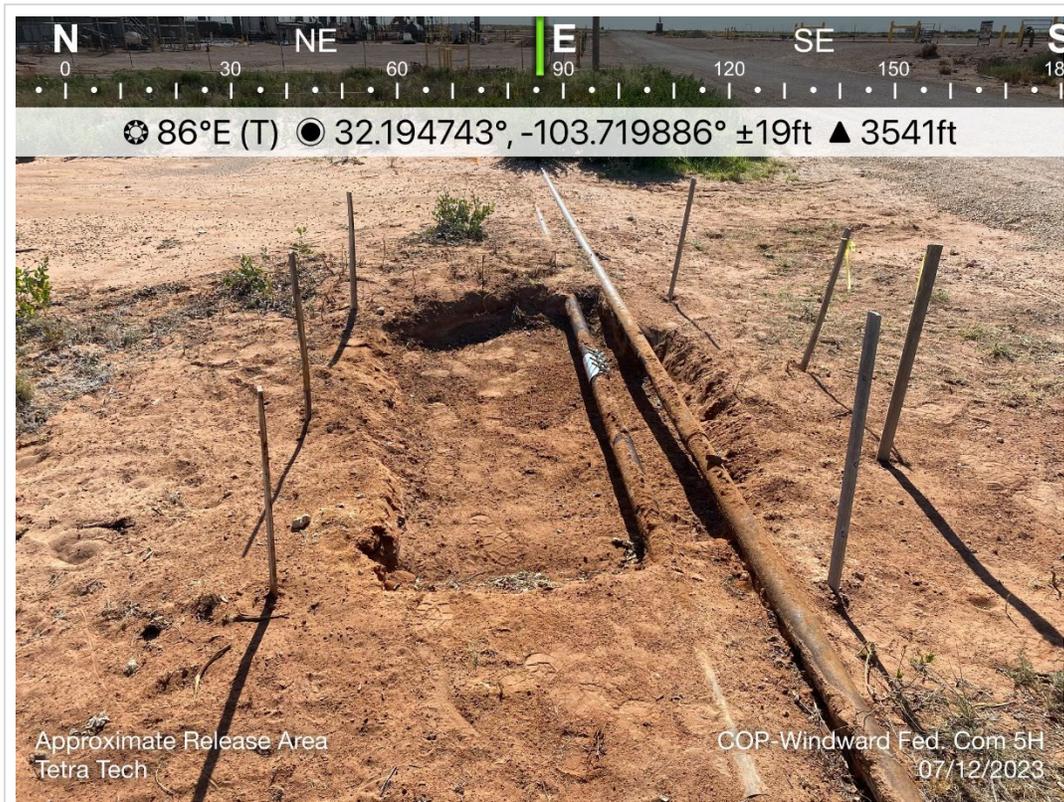
TETRA TECH, INC. PROJECT NO. 212C-MD-03168	DESCRIPTION	View east of release extent. Initial response area and subsurface steel lines.	3
	SITE NAME	Windward Federal Com #005H Release	7/12/2023

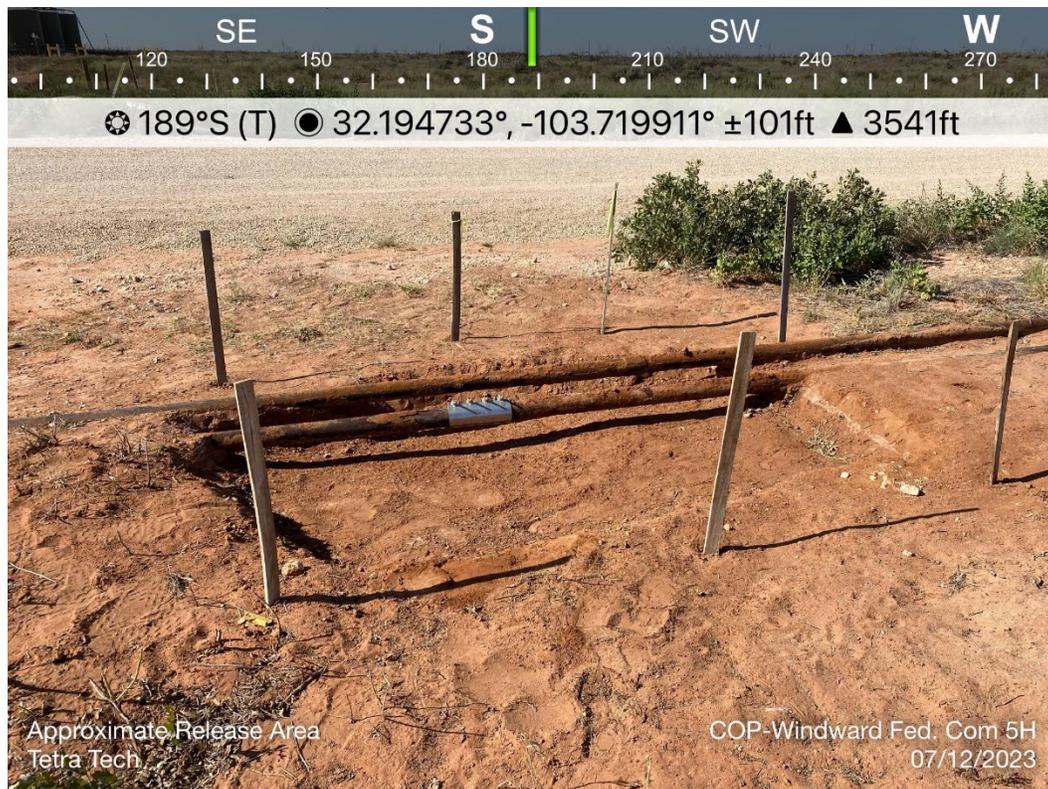
TETRA TECH, INC. PROJECT NO. 212C-MD-03168	DESCRIPTION	View south of release extent. Initial response area and subsurface steel lines.	4
	SITE NAME	Windward Federal Com #005H Release	7/12/2023

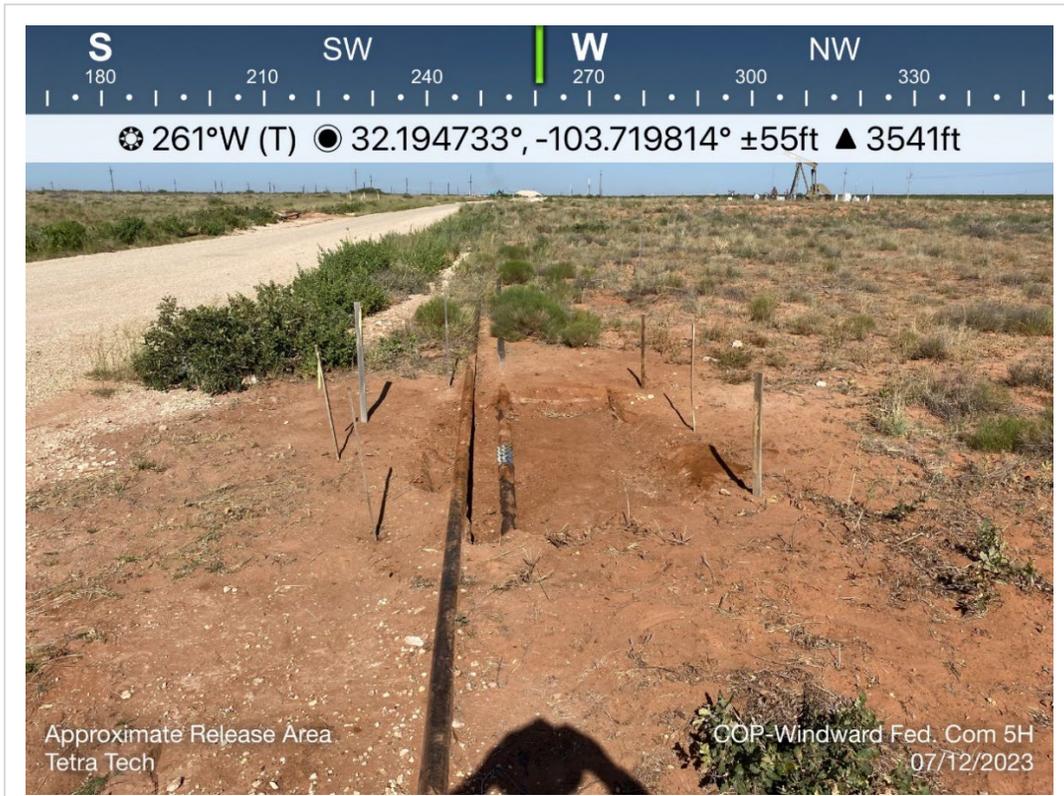
TETRA TECH, INC. PROJECT NO. 212C-MD-03168	DESCRIPTION	View west of release extent. Initial response area and subsurface steel lines.	5
	SITE NAME	Windward Federal Com #005H Release	7/12/2023

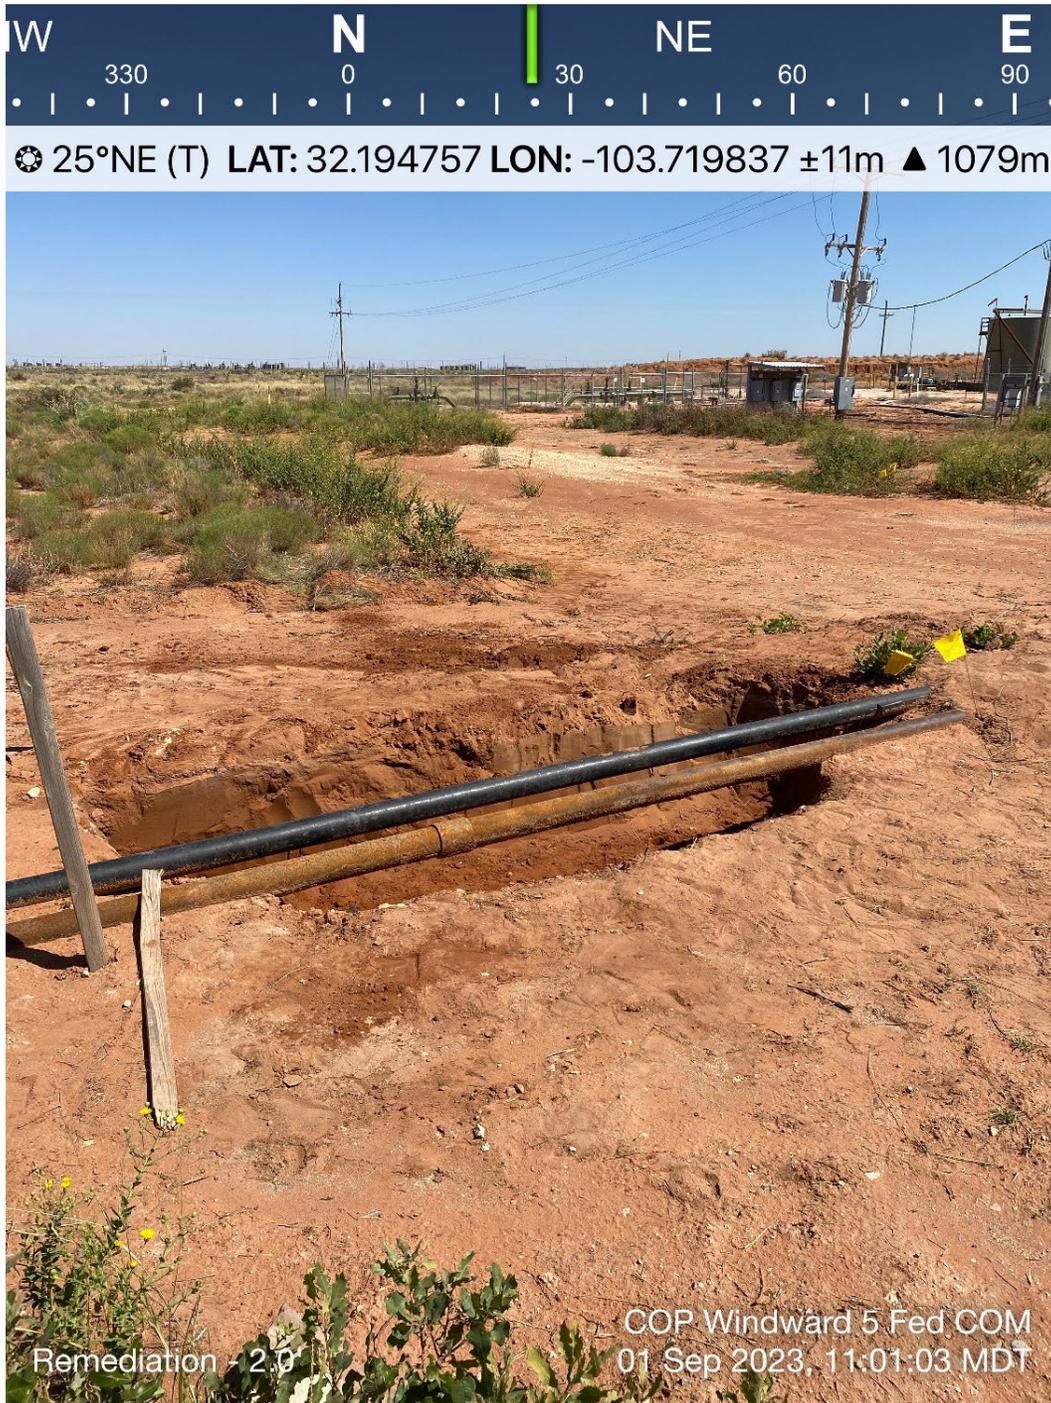
TETRA TECH, INC. PROJECT NO. 212C-MD-03168	DESCRIPTION	View north north-east. Excavated area and subsurface steel lines.	6
	SITE NAME	Windward Federal Com #005H Release	9/01/2023

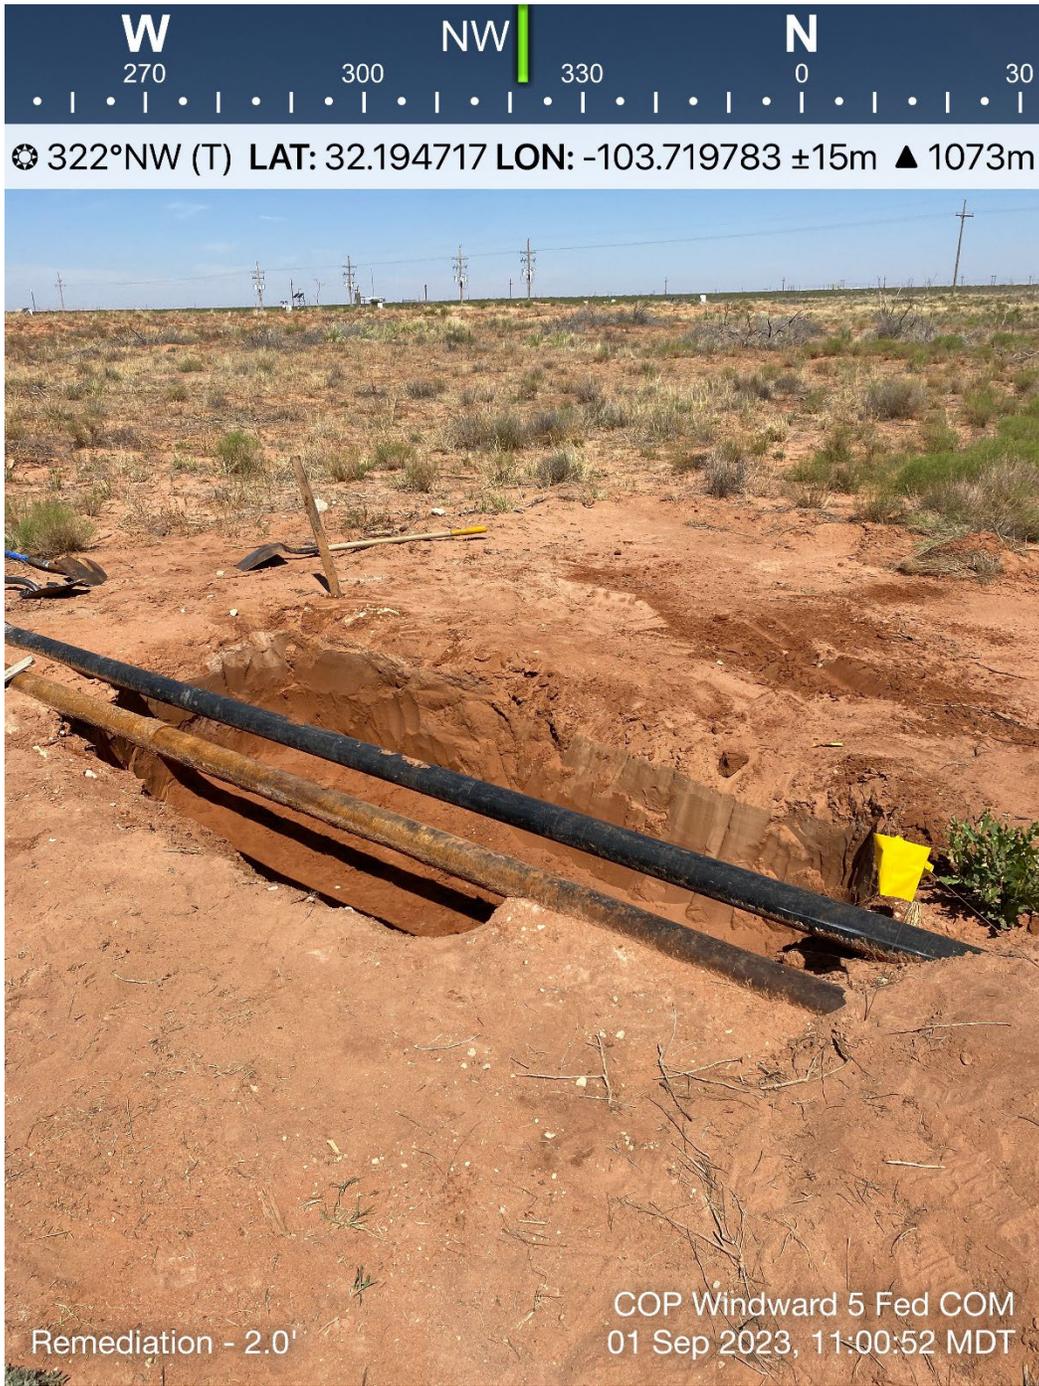
TETRA TECH, INC. PROJECT NO. 212C-MD-03168	DESCRIPTION	View north-west. Excavated area and subsurface steel lines.	7
	SITE NAME	Windward Federal Com #005H Release	9/01/2023

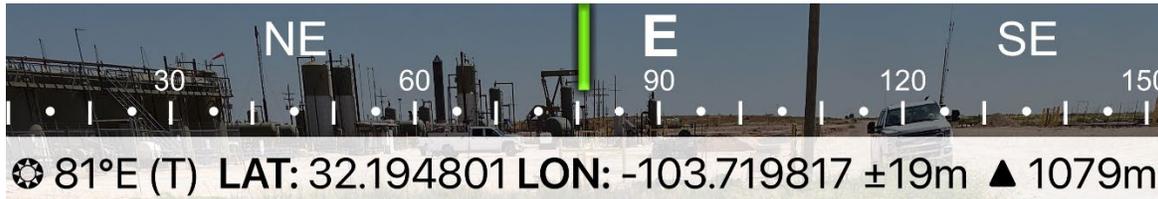
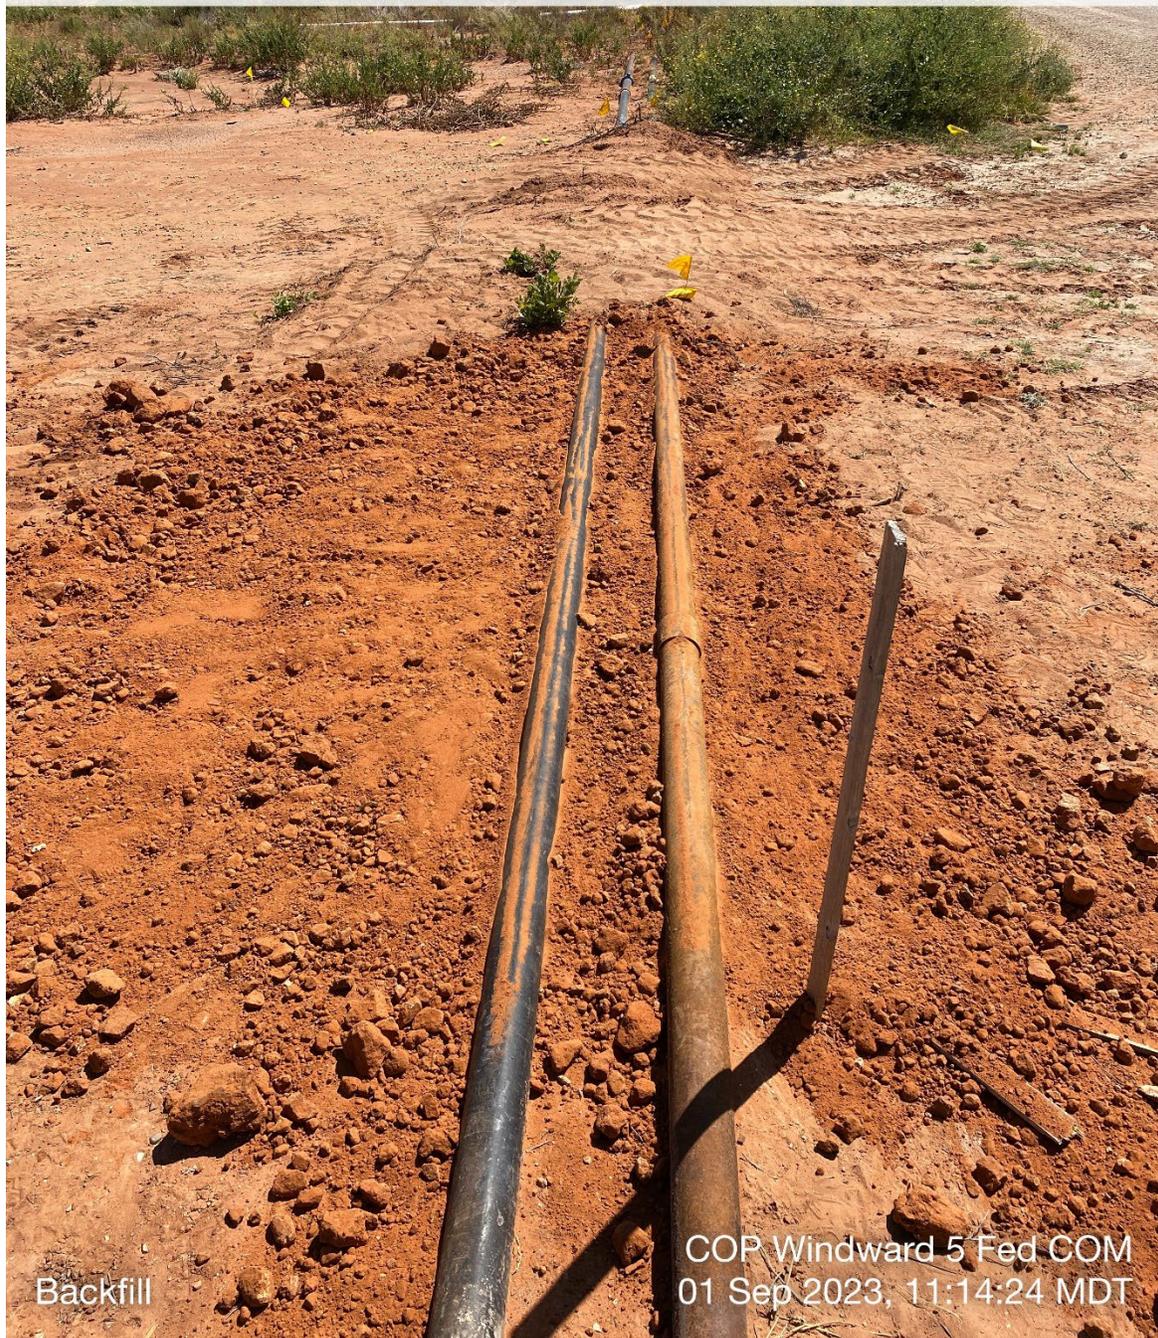
Backfill

COP Windward 5 Fed COM
01 Sep 2023, 11:14:24 MDT

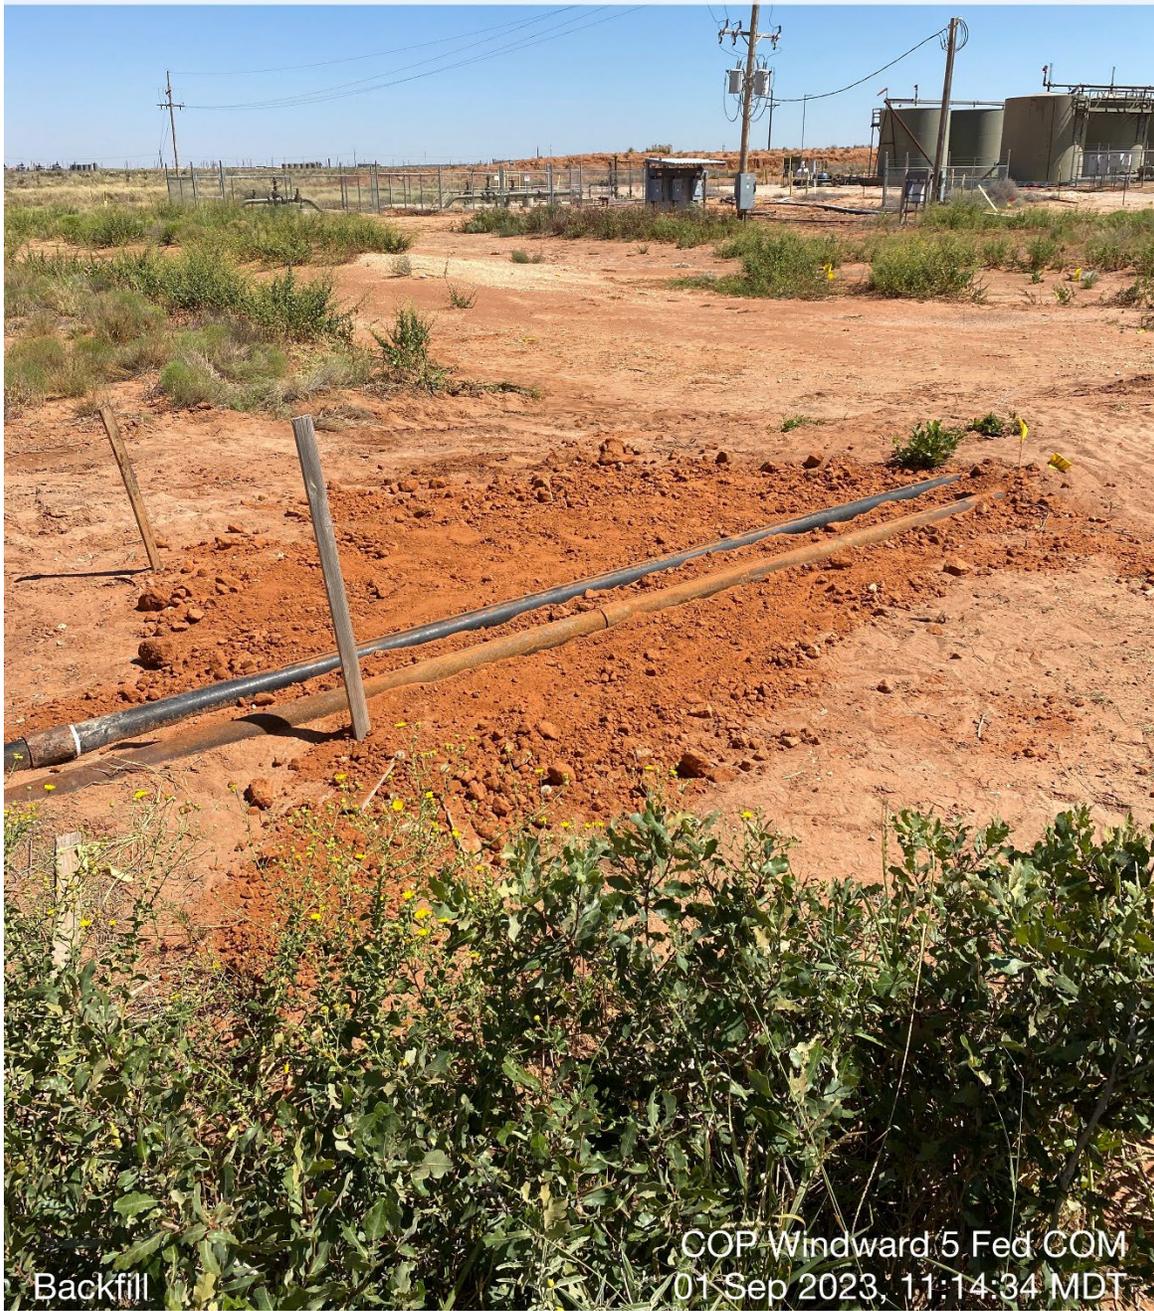
Backfill

COP Windward 5 Fed COM
01 Sep 2023, 11:14:34 MDT
