Site Assessment/Characterization

Closure

Re: Site Assessment and Closure Report
Todd 36 CTB 3
API No. N/A
GPS: Latitude 32.25676 Longitude -103.728575
UL -- O, Section 36, T23S, R31E
Eddy County, NM
NMOCD Ref. No. NAPP2112043668

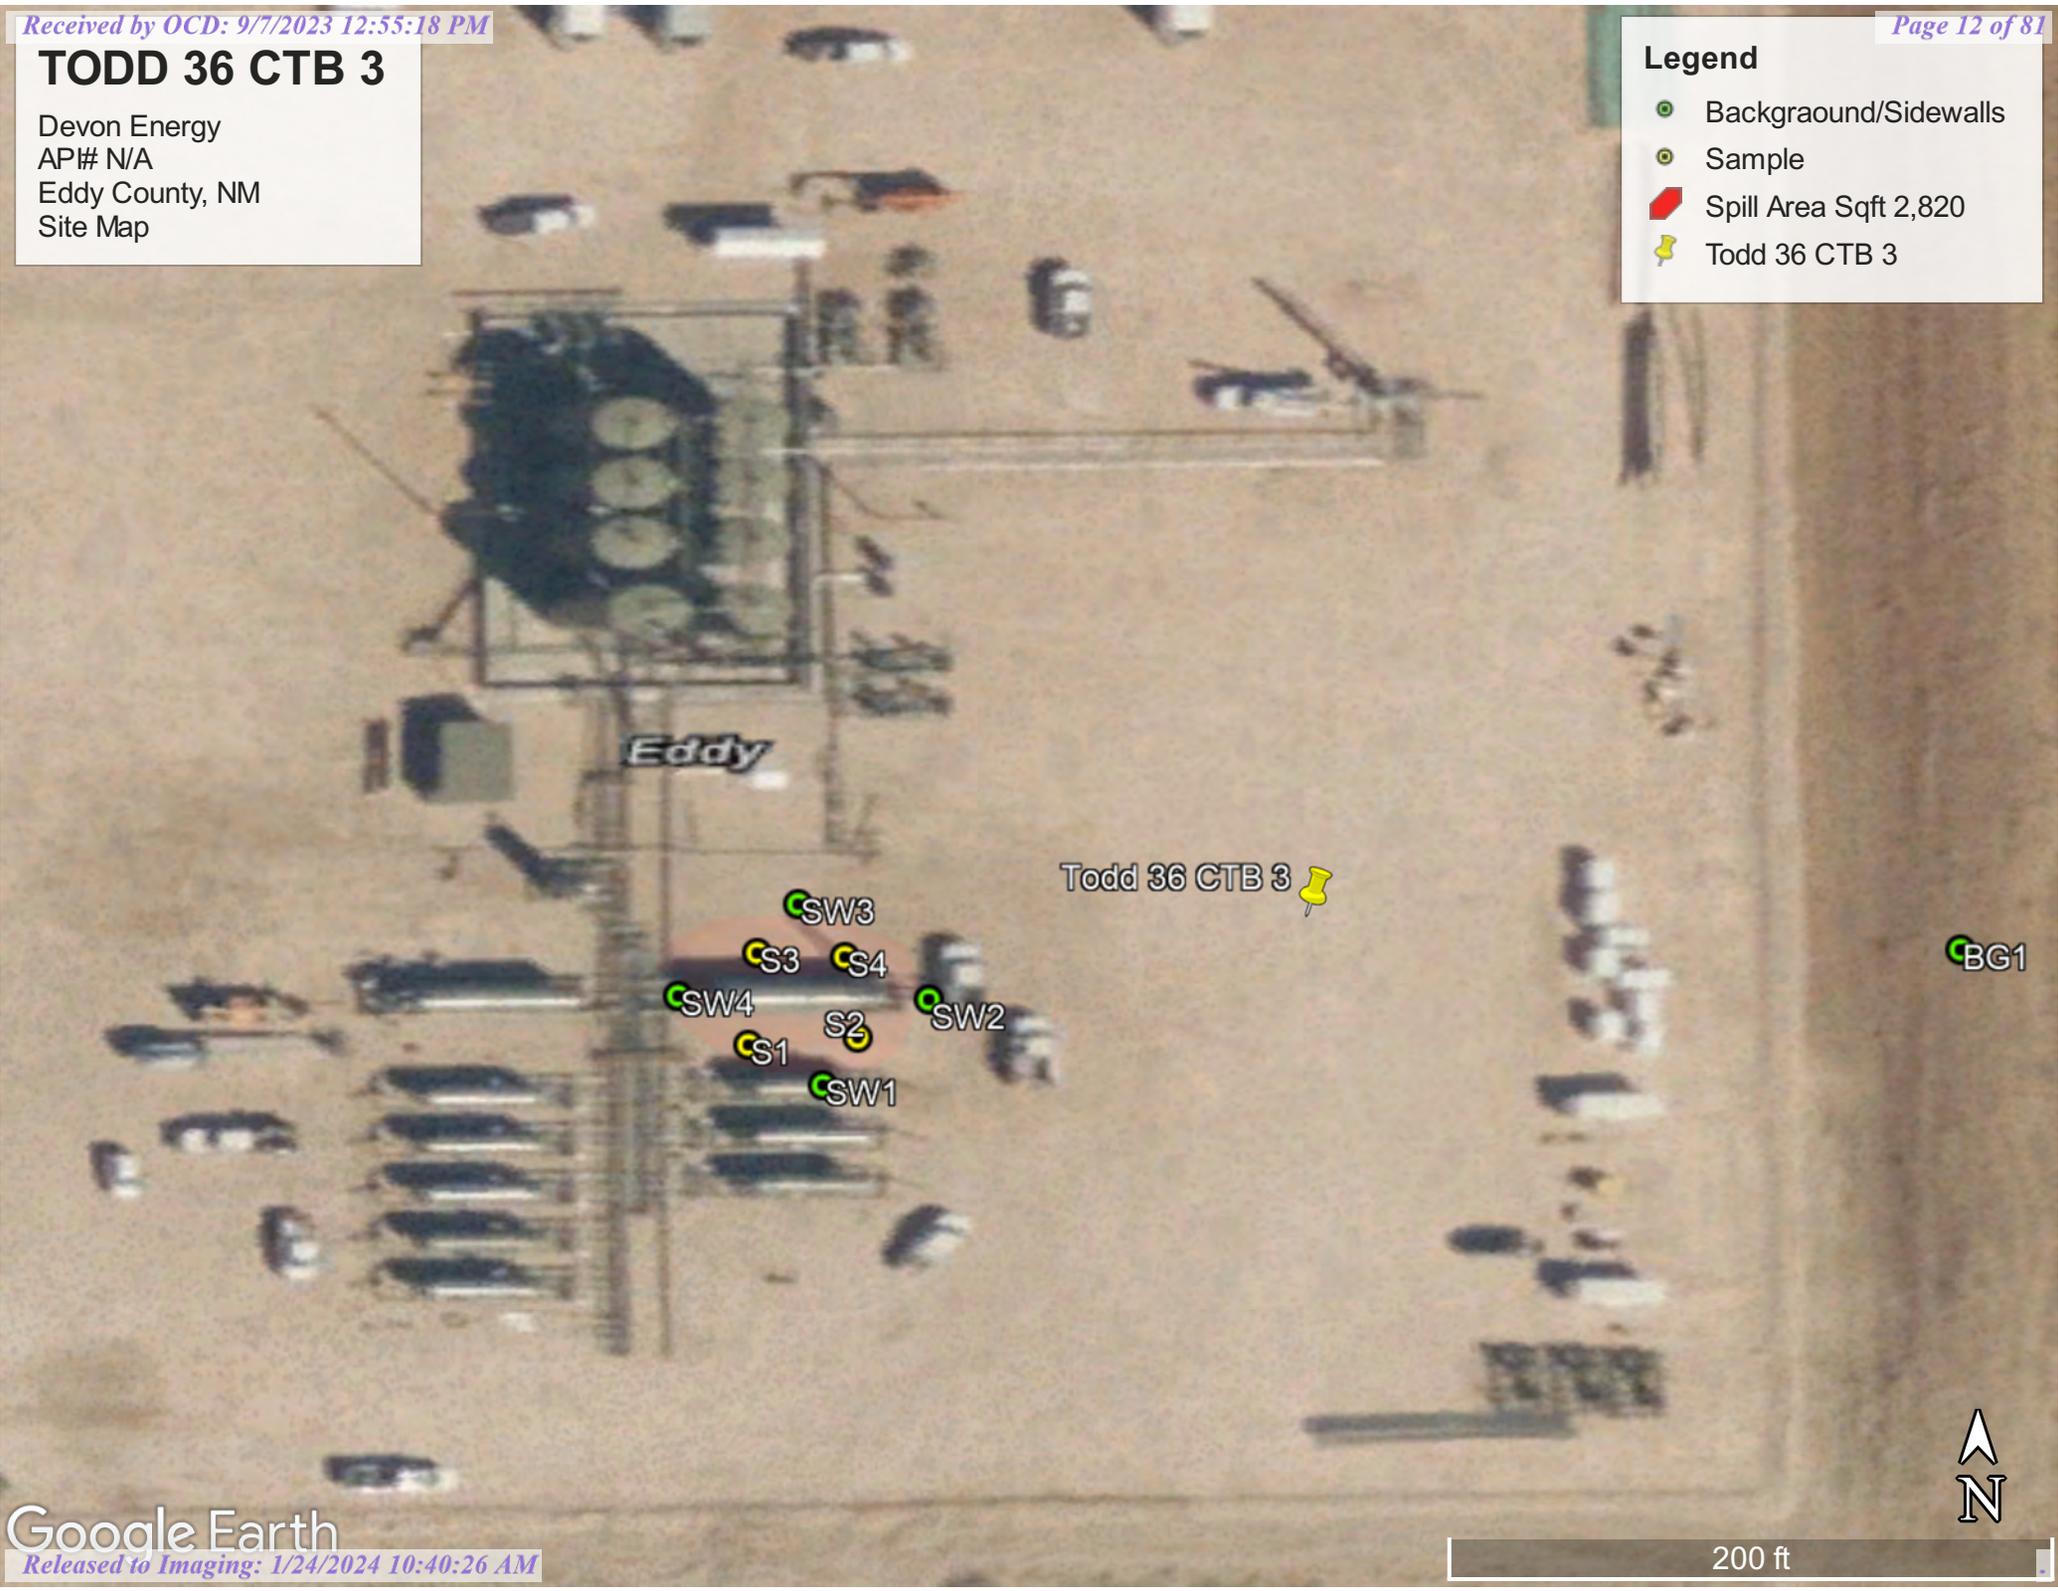
5-Site Map

Devon Energy
API# N/A
Eddy County, NM
Site Map

- Background/Sidewalls
- Sample
- Spill Area Sqft 2,820
- 📌 Todd 36 CTB 3

On March 1, 2023, Pima mobilized personnel to the site to begin collecting soil samples from the spill area. The laboratory results of this sampling event can be found in the following data table. A Site Map can be found in Figure 4.

Based on the sample results, the bottoms and sidewalls were below NMOCD Closure Criteria per Table 1 19.15.29 NMAC. Well Record & Log indicates C-04746 POD1 was installed on June 1, 2023, to a depth of 105' placing closure criteria for this incident in the >100' column of Table 1. See Figure 4.

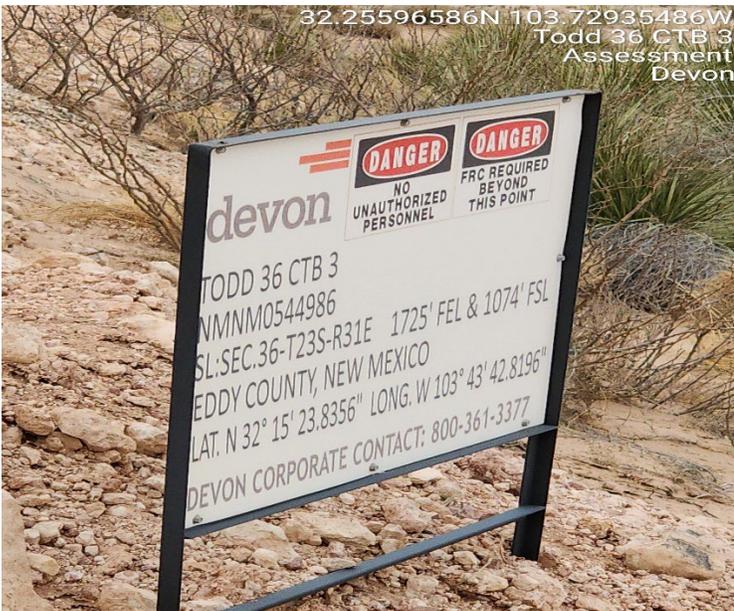
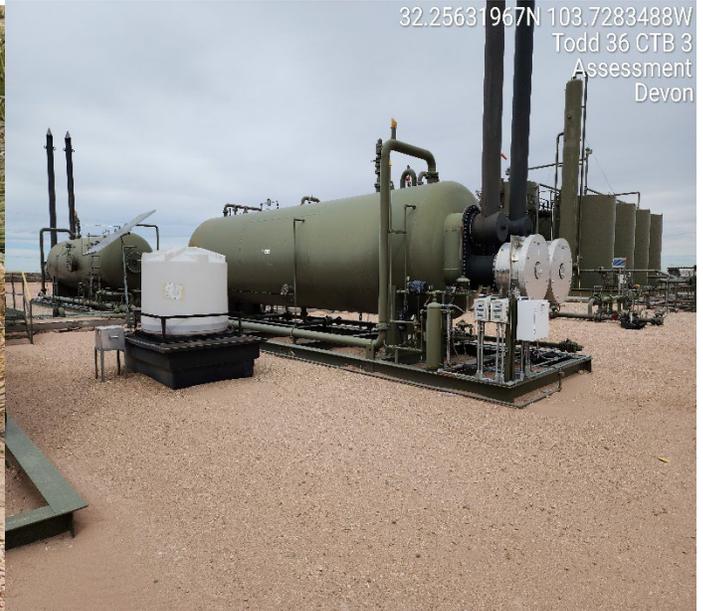
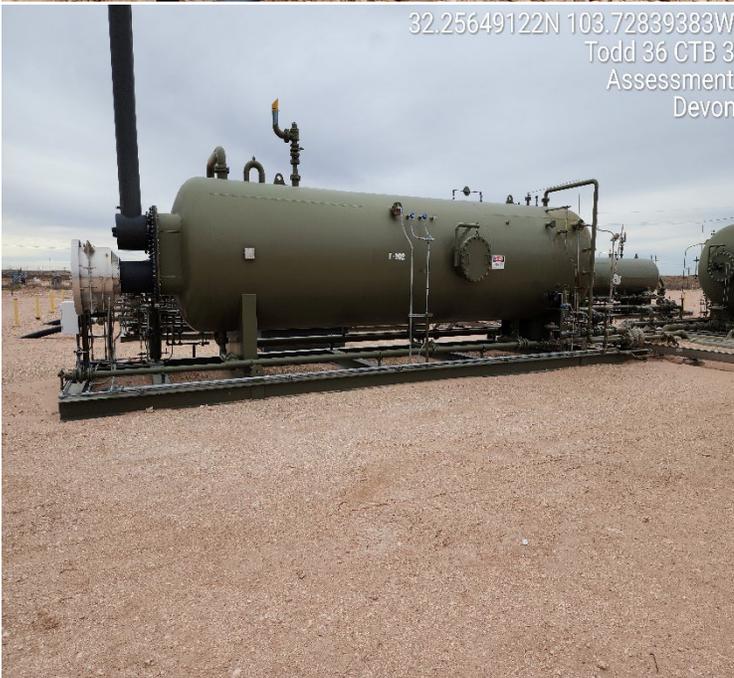
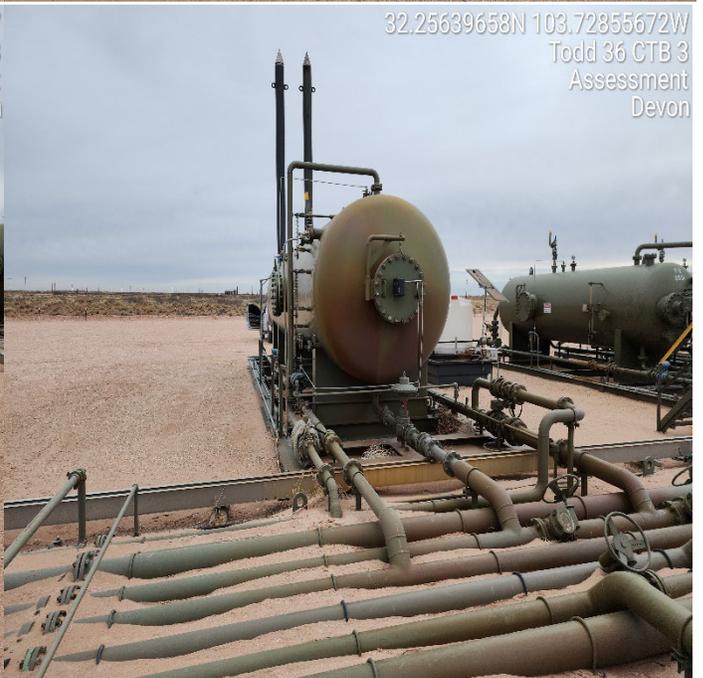
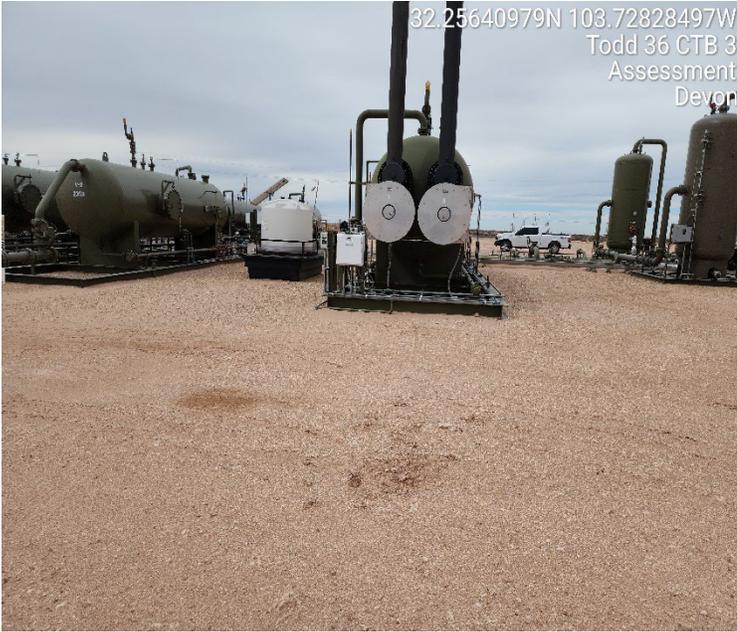
SITE PHOTOGRAPHS
DEVON ENERGY
TODD 36 CTB 3

Site Assessment

See Appendix D for Photographic Documentation.
