August 31, 2023

Re: Site Assessment and Closure Report
Todd 36 CTB 3
API No. N/A
GPS: Latitude 32.25676 Longitude -103.728575
UL -- O, Section 36, T23S, R31E
Eddy County, NM
NMOCD Ref. No. NAPP2112043668

Todd 36 CTB 3|Devon Energy

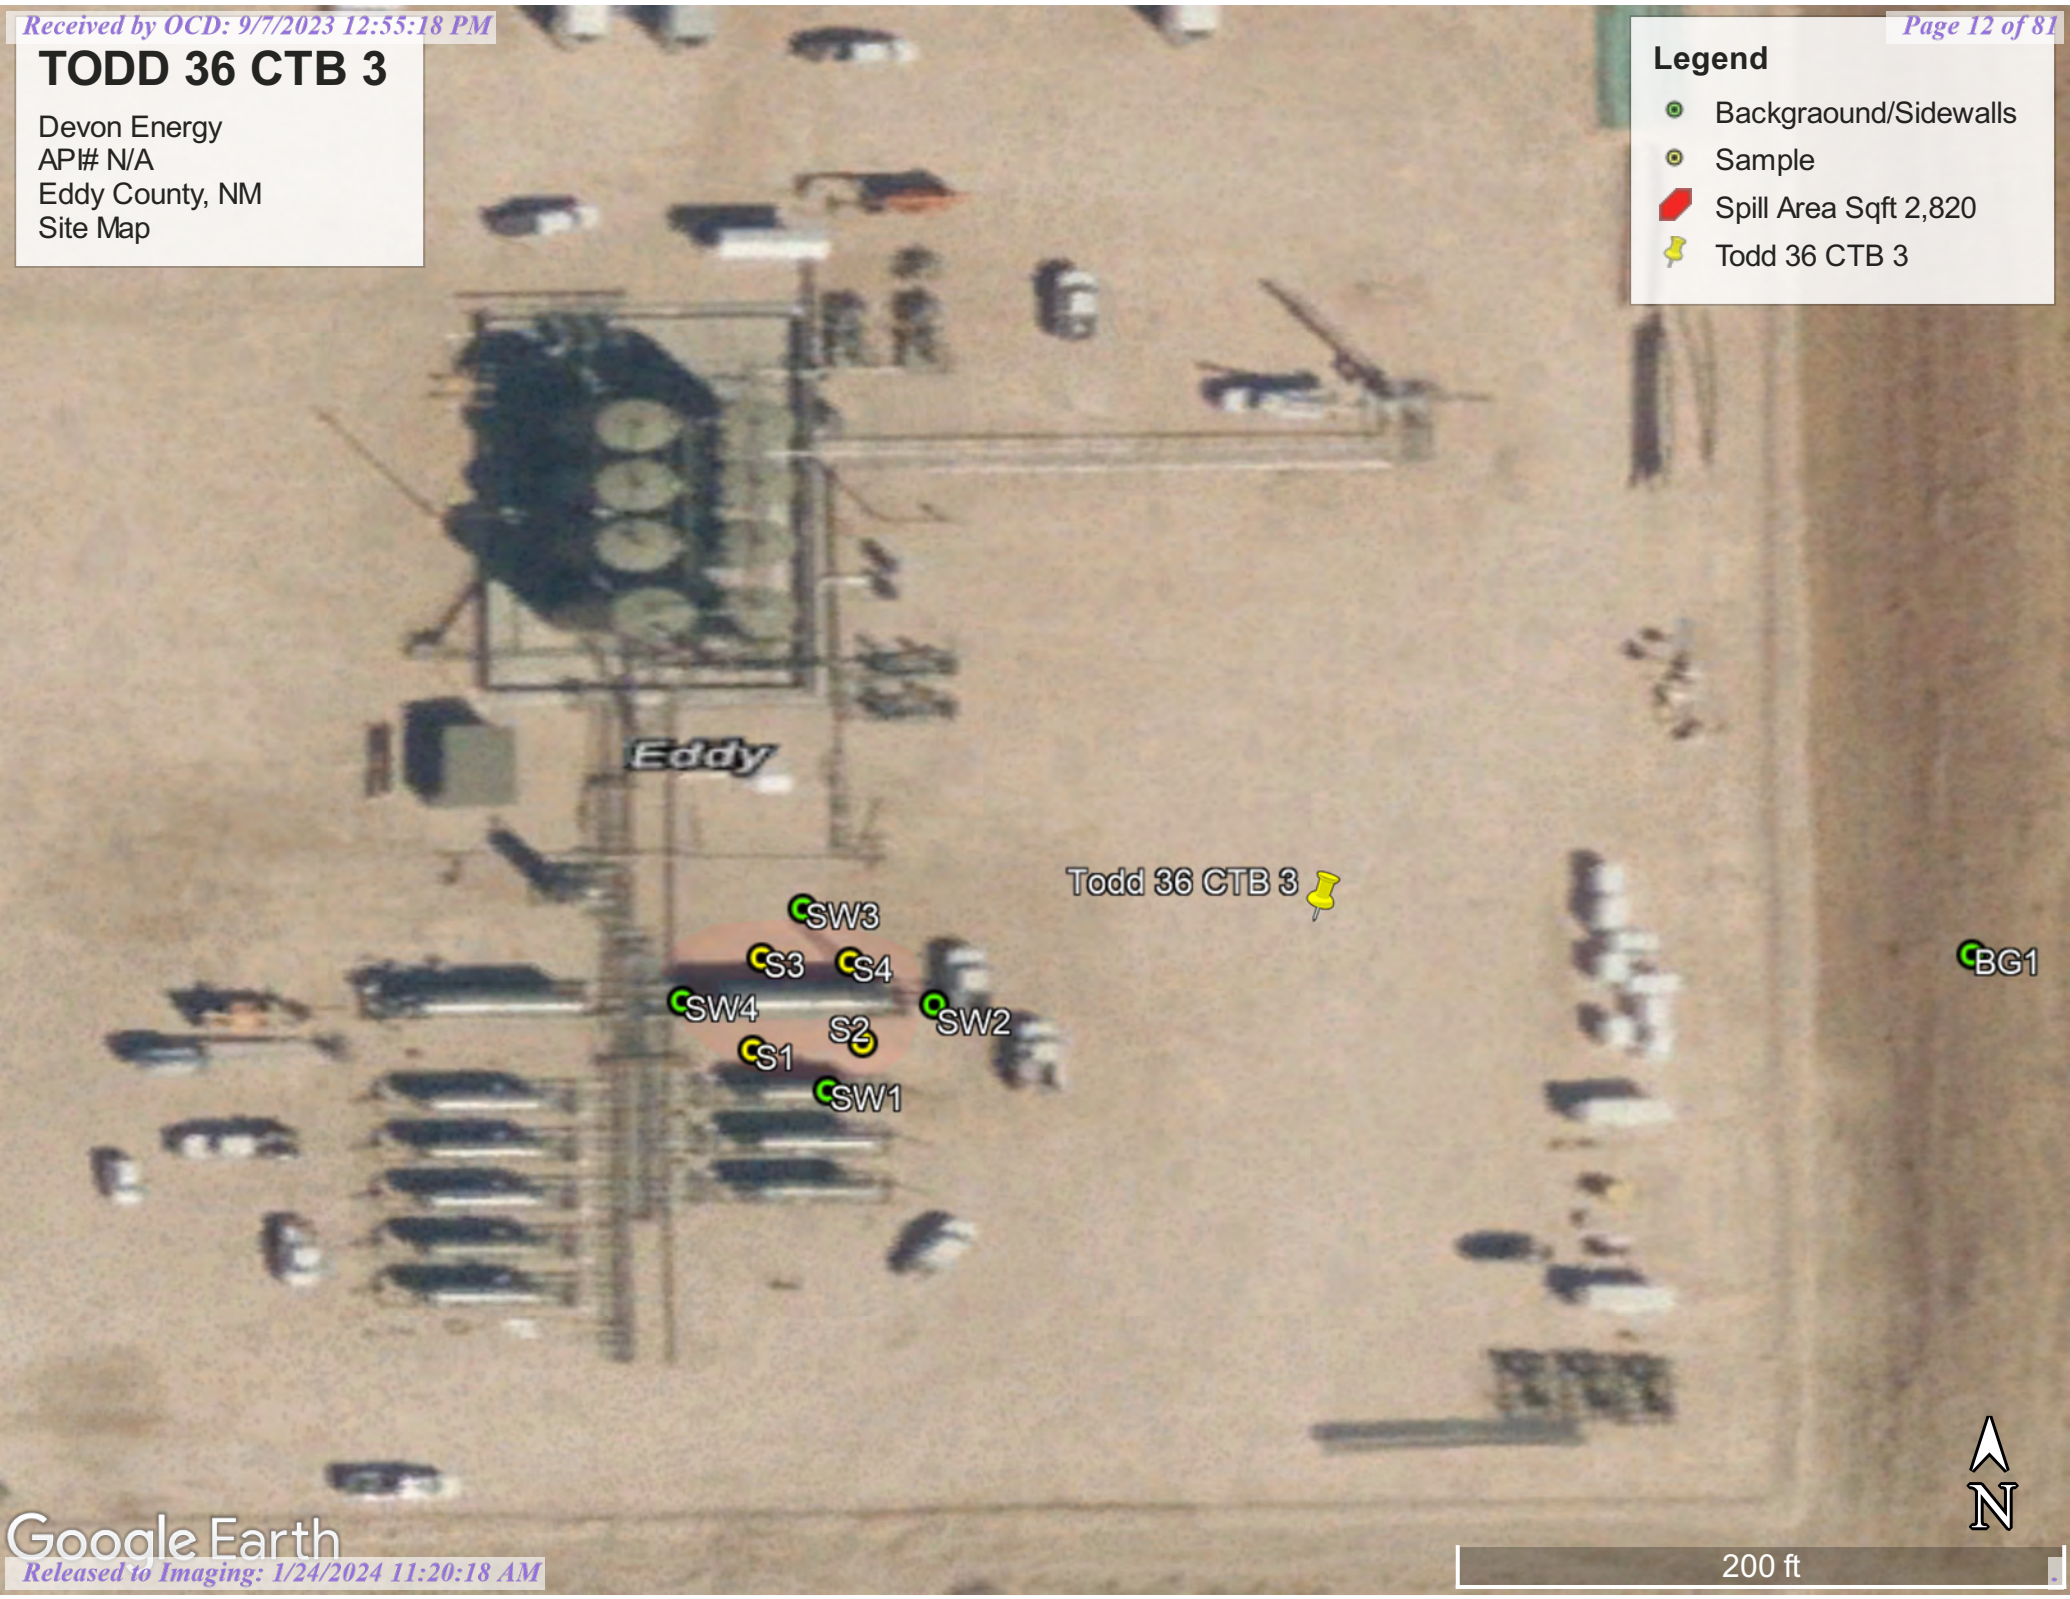
5-Site Map

On March 1, 2023, Pima mobilized personnel to the site to begin collecting soil samples from the spill area. The laboratory results of this sampling event can be found in the following data table. A Site Map can be found in Figure 4.

- Background/Sidewalls
- Sample
- Spill Area Sqft 2,820
- 📌 Todd 36 CTB 3

Based on the sample results, the bottoms and sidewalls were below NMOCD Closure Criteria per Table 1 19.15.29 NMAC. Well Record & Log indicates C-04746 POD1 was installed on June 1, 2023, to a depth of 105' placing closure criteria for this incident in the >100' column of Table 1. See Figure 4.

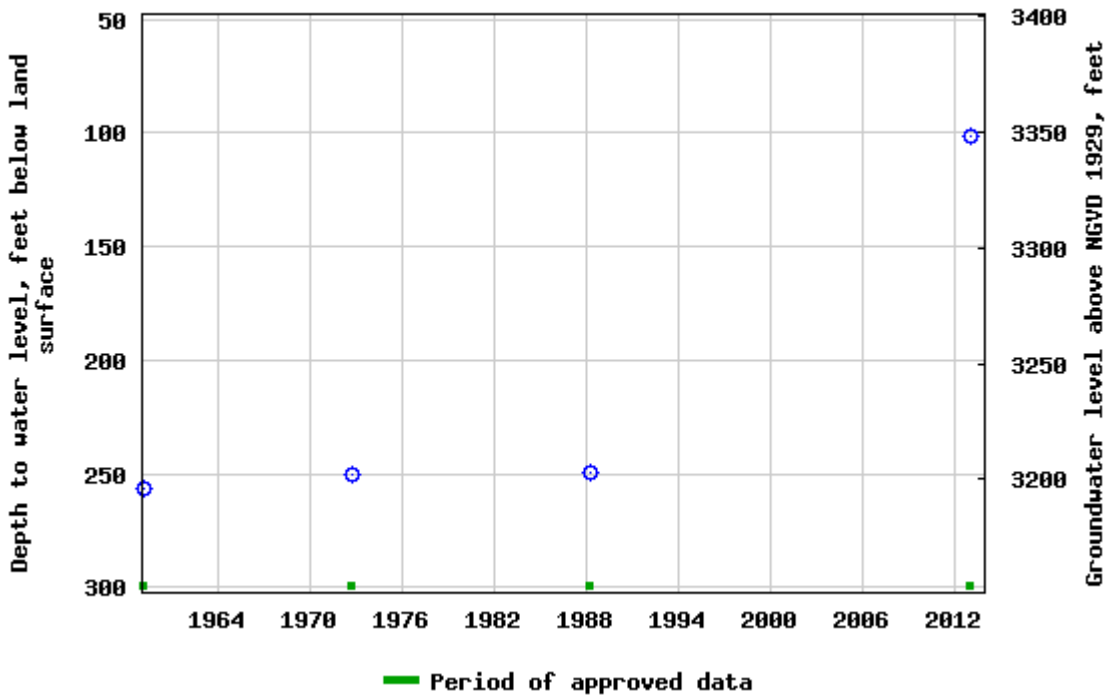
USGS 321609103445901 23S,31E,26,34411

The depth of the well is 365 feet below land surface.

This well is completed in the Dewey Lake Redbeds (312DYLK) local aquifer.

Breaks in the plot represent a gap of at least one year between field measurements. [Download a presentation-quality graph](#)

According to the New Mexico Office of the State Engineer, depth to the nearest groundwater in this area is 160 feet below grade surface (BGS). According to the United States Geological Survey (USGS), the nearest groundwater is 100 feet BGS. The closest waterway is the Salt Playa located approximately 12 miles to the northwest of this location. See Appendix A for referenced water surveys.

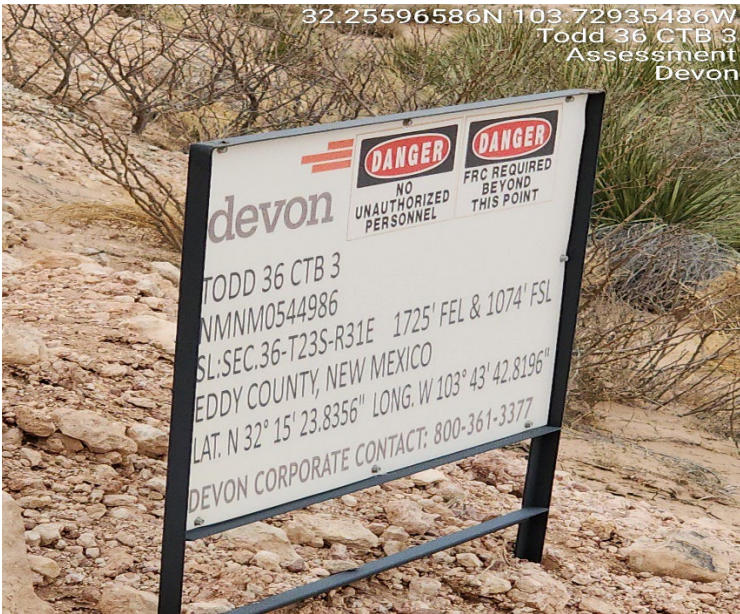
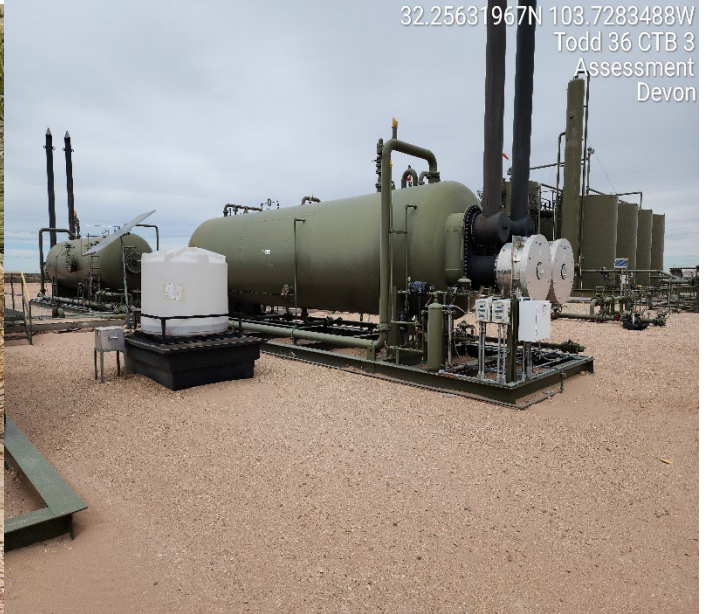
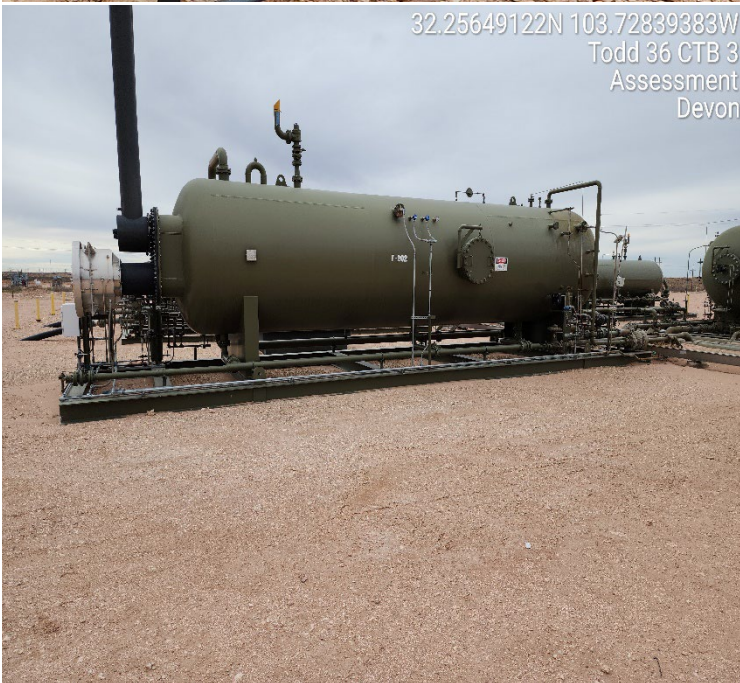
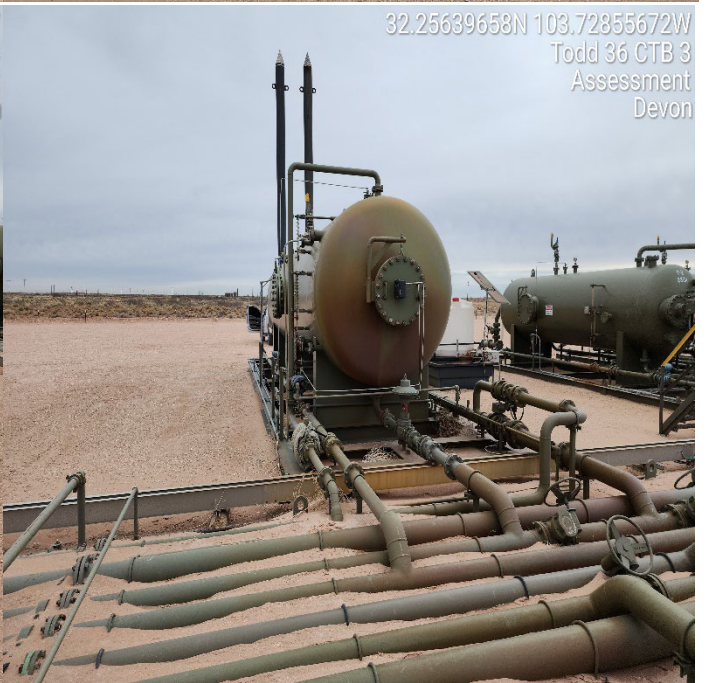
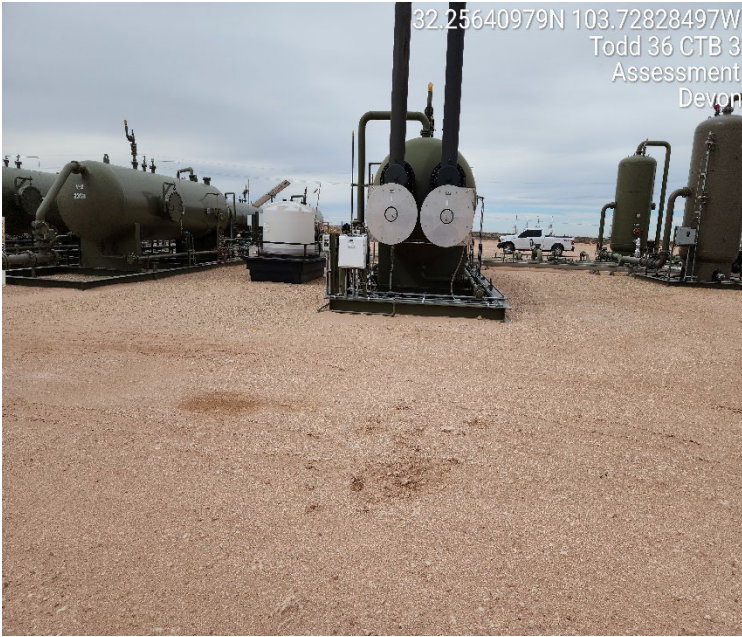
SITE PHOTOGRAPHS
DEVON ENERGY
TODD 36 CTB 3

Site Assessment

See Appendix D for Photographic Documentation.
