Release Notification

Site Name CHILI PARLOR 17 FED TB	Site Type Oil & Gas Facility
Date Release Discovered: 4/22/2023	API# (if applicable)

The bridal to LSHH was plugged, causing fluid in the flare line to not reach the tuning fork, which then sent it to the flare. As a result, a ~2200 square foot area around the flare and edge of the location were scorched. Characterization of impact is ongoing.

Vertex recommends no additional remediation action to address the release at the site. Laboratory analyses of confirmation samples collected at Chili Parlor show final confirmatory values below NMOCD closure criteria for areas where depth to groundwater is more than 100 feet bgs as presented in Table 1. There are no anticipated risks to human, ecological, or hydrological receptors at the release site.

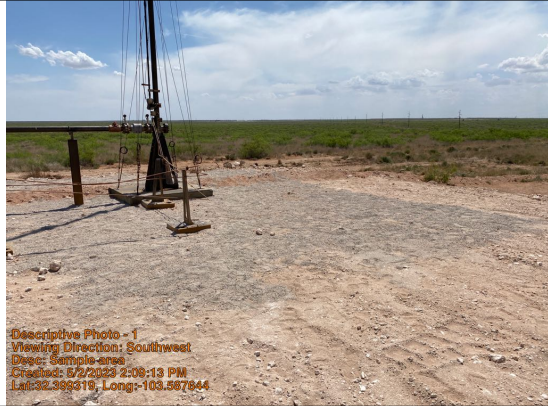
Viewing Direction: Southwest

Sample area

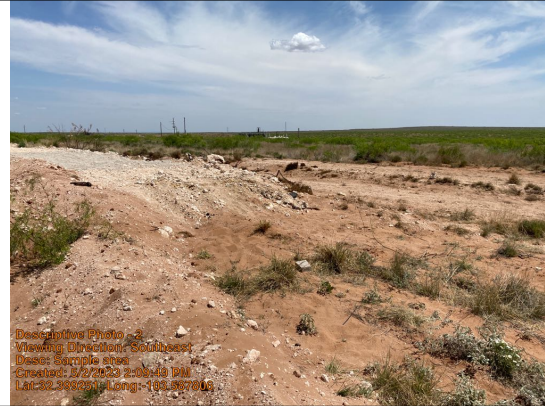
Viewing Direction: Southeast

Sample area

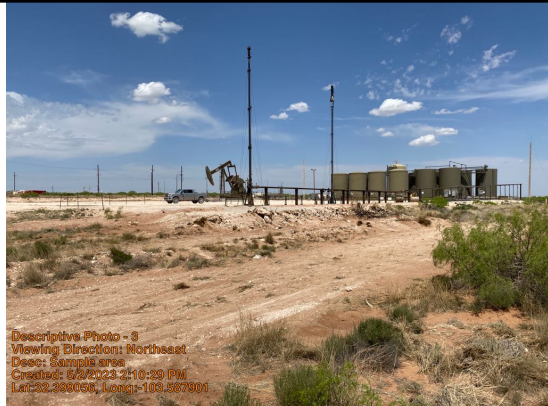
Viewing Direction: Northeast

Sample area

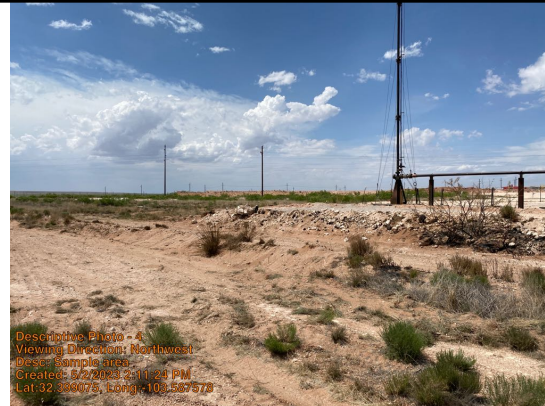
Viewing Direction: Northwest

Sample area
