Release Notification

## CLOSURE REPORT

**Trujillo Gas Com #1R (07/11/23)**  
Unit Letter K, S21 T29N R10W  
San Juan County, New Mexico

**New Mexico EMNRD OCD Incident ID No. NAPP2319227547**

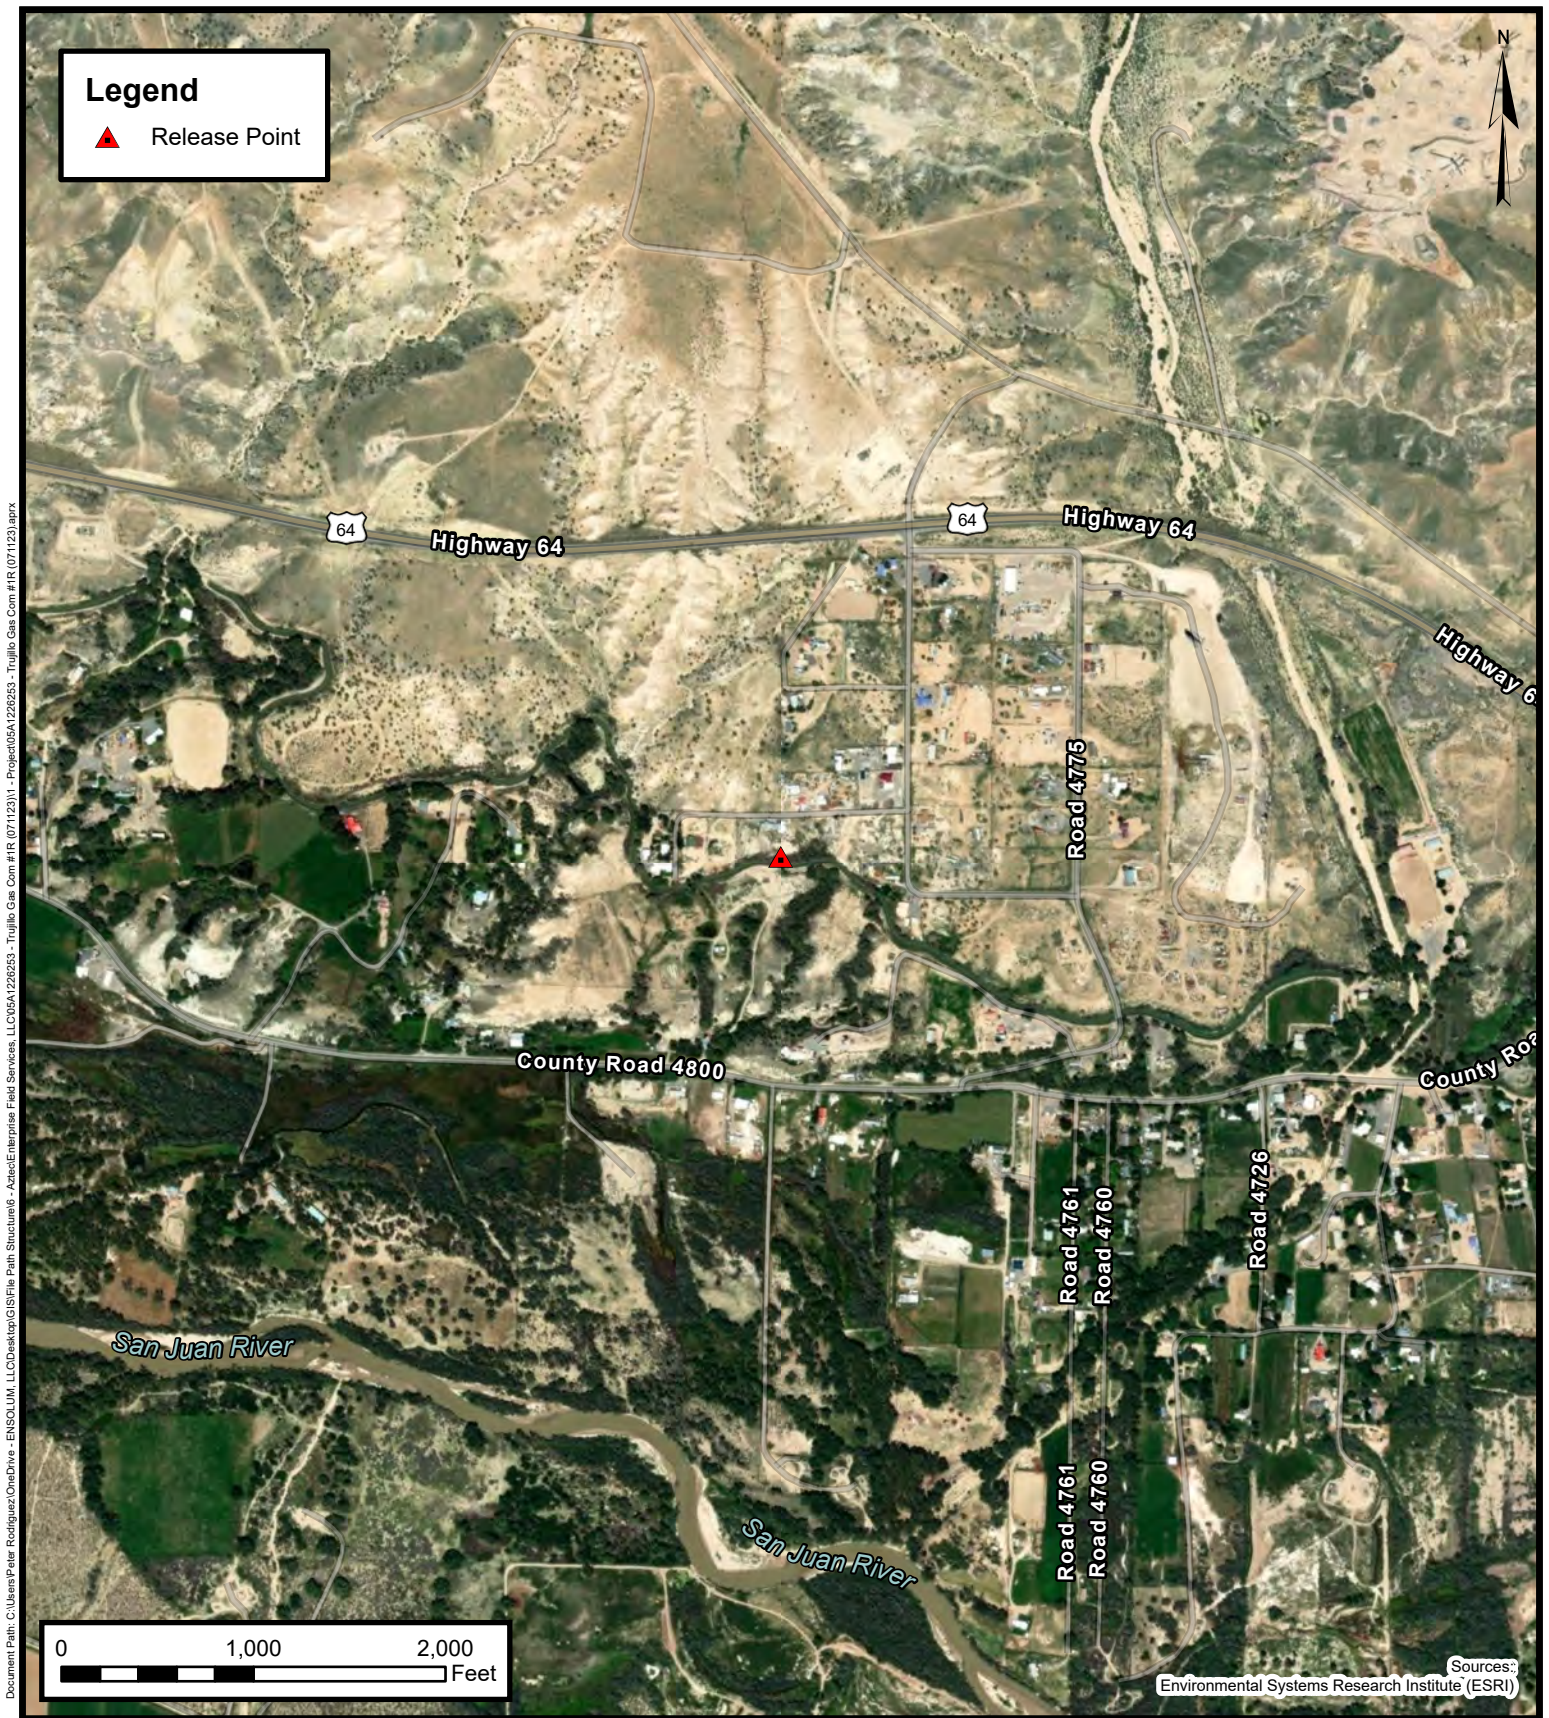
2

## Site Vicinity Map

A **Topographic Map** depicting the location of the Site is included as **Figure 1**, and a **Site Vicinity Map** is included as **Figure 2** in **Appendix A**.

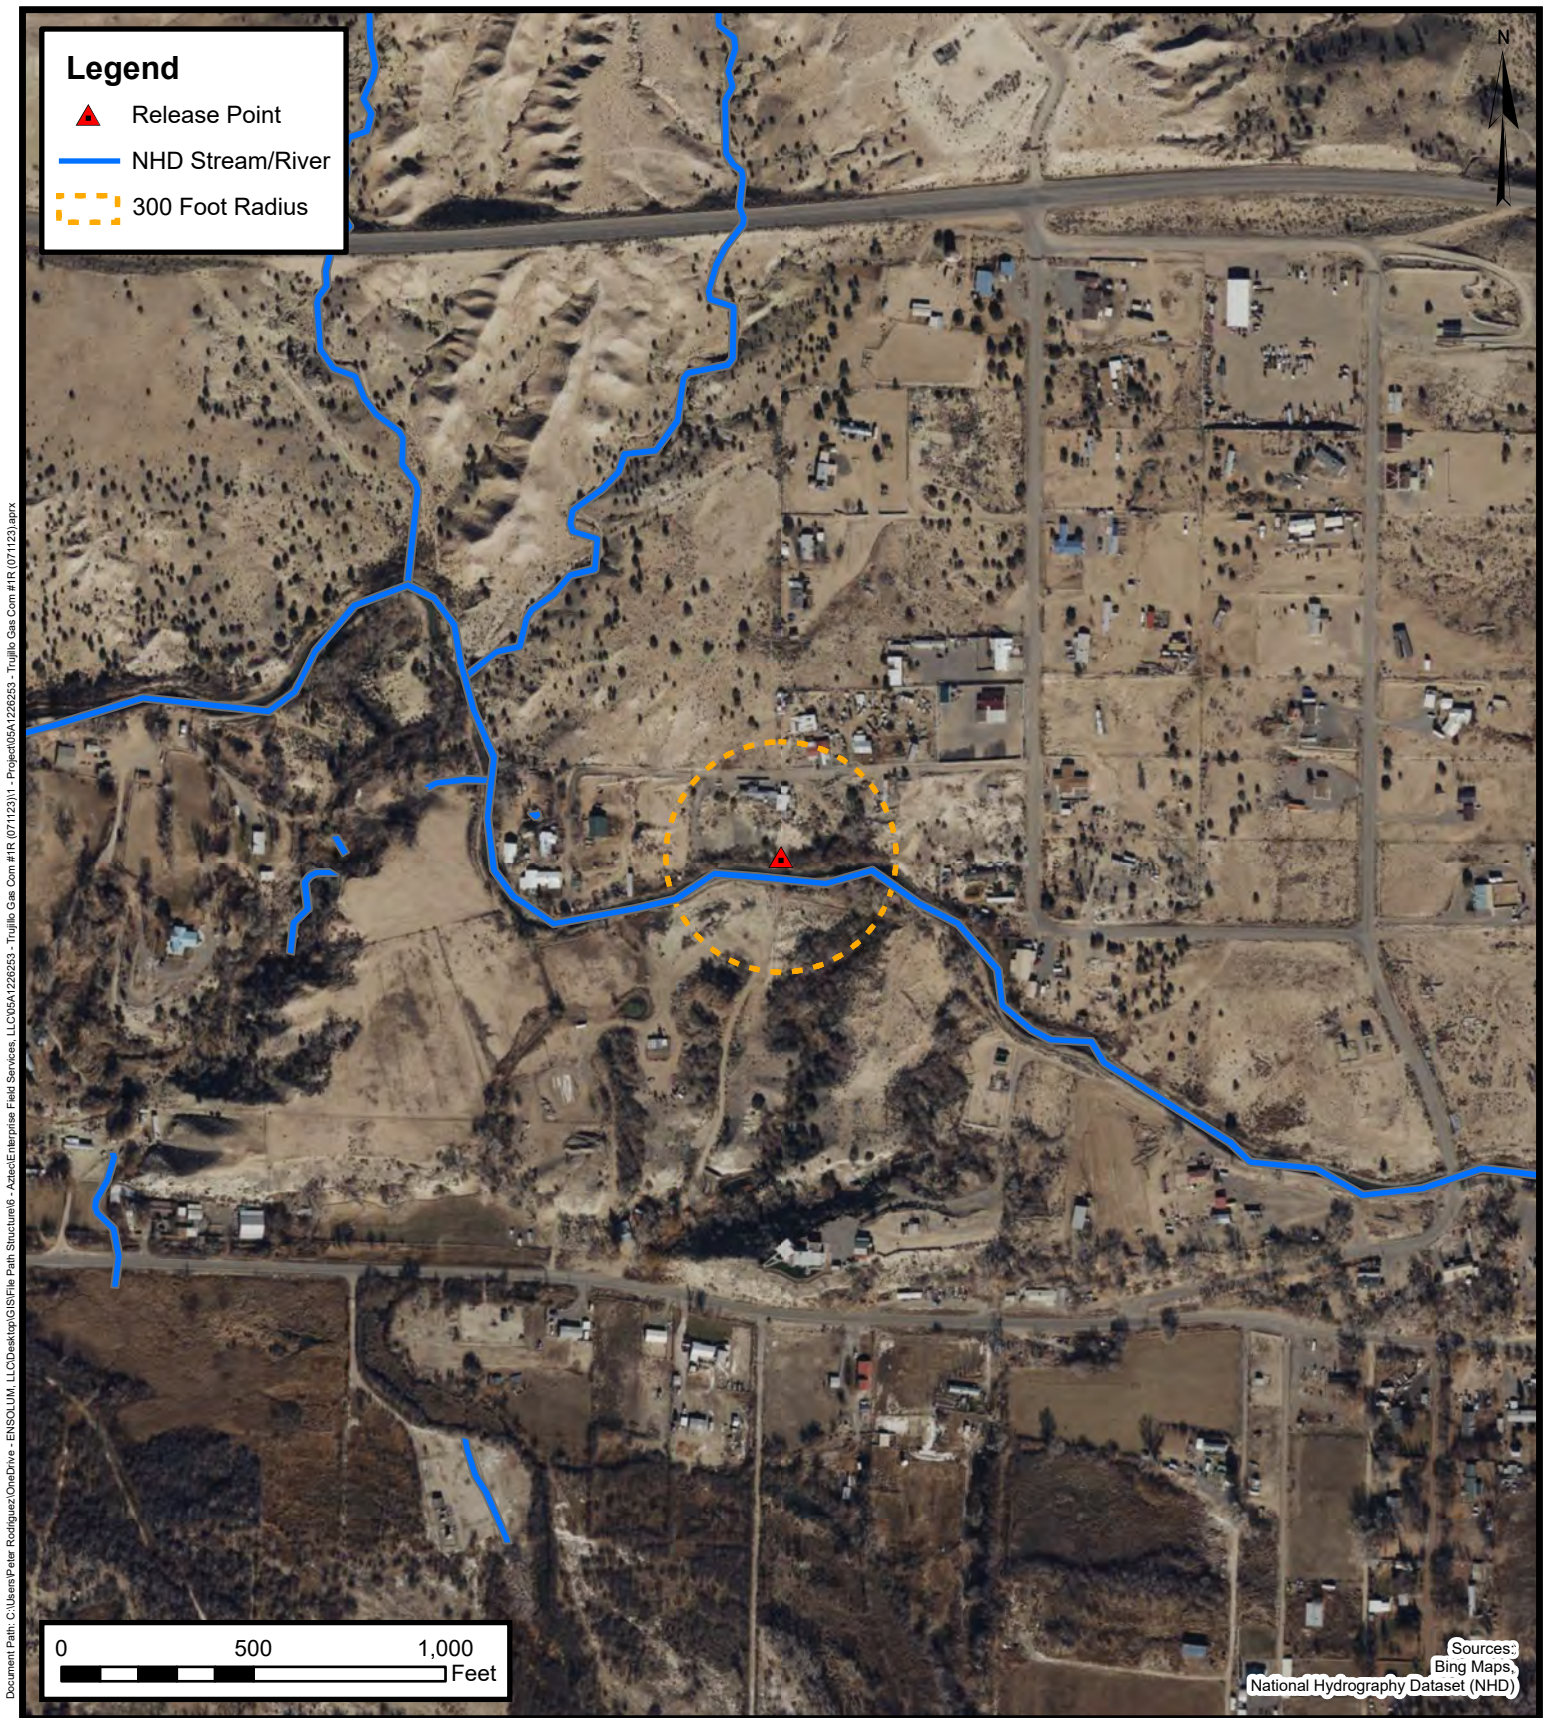
FIGURE  
**C**

### 300 Foot Radius Watercourse and Drainage Identification

- The Site is located within 300 feet of a NM EMNRD OCD-defined continuously flowing watercourse or significant watercourse (**Figure C, Appendix B**).

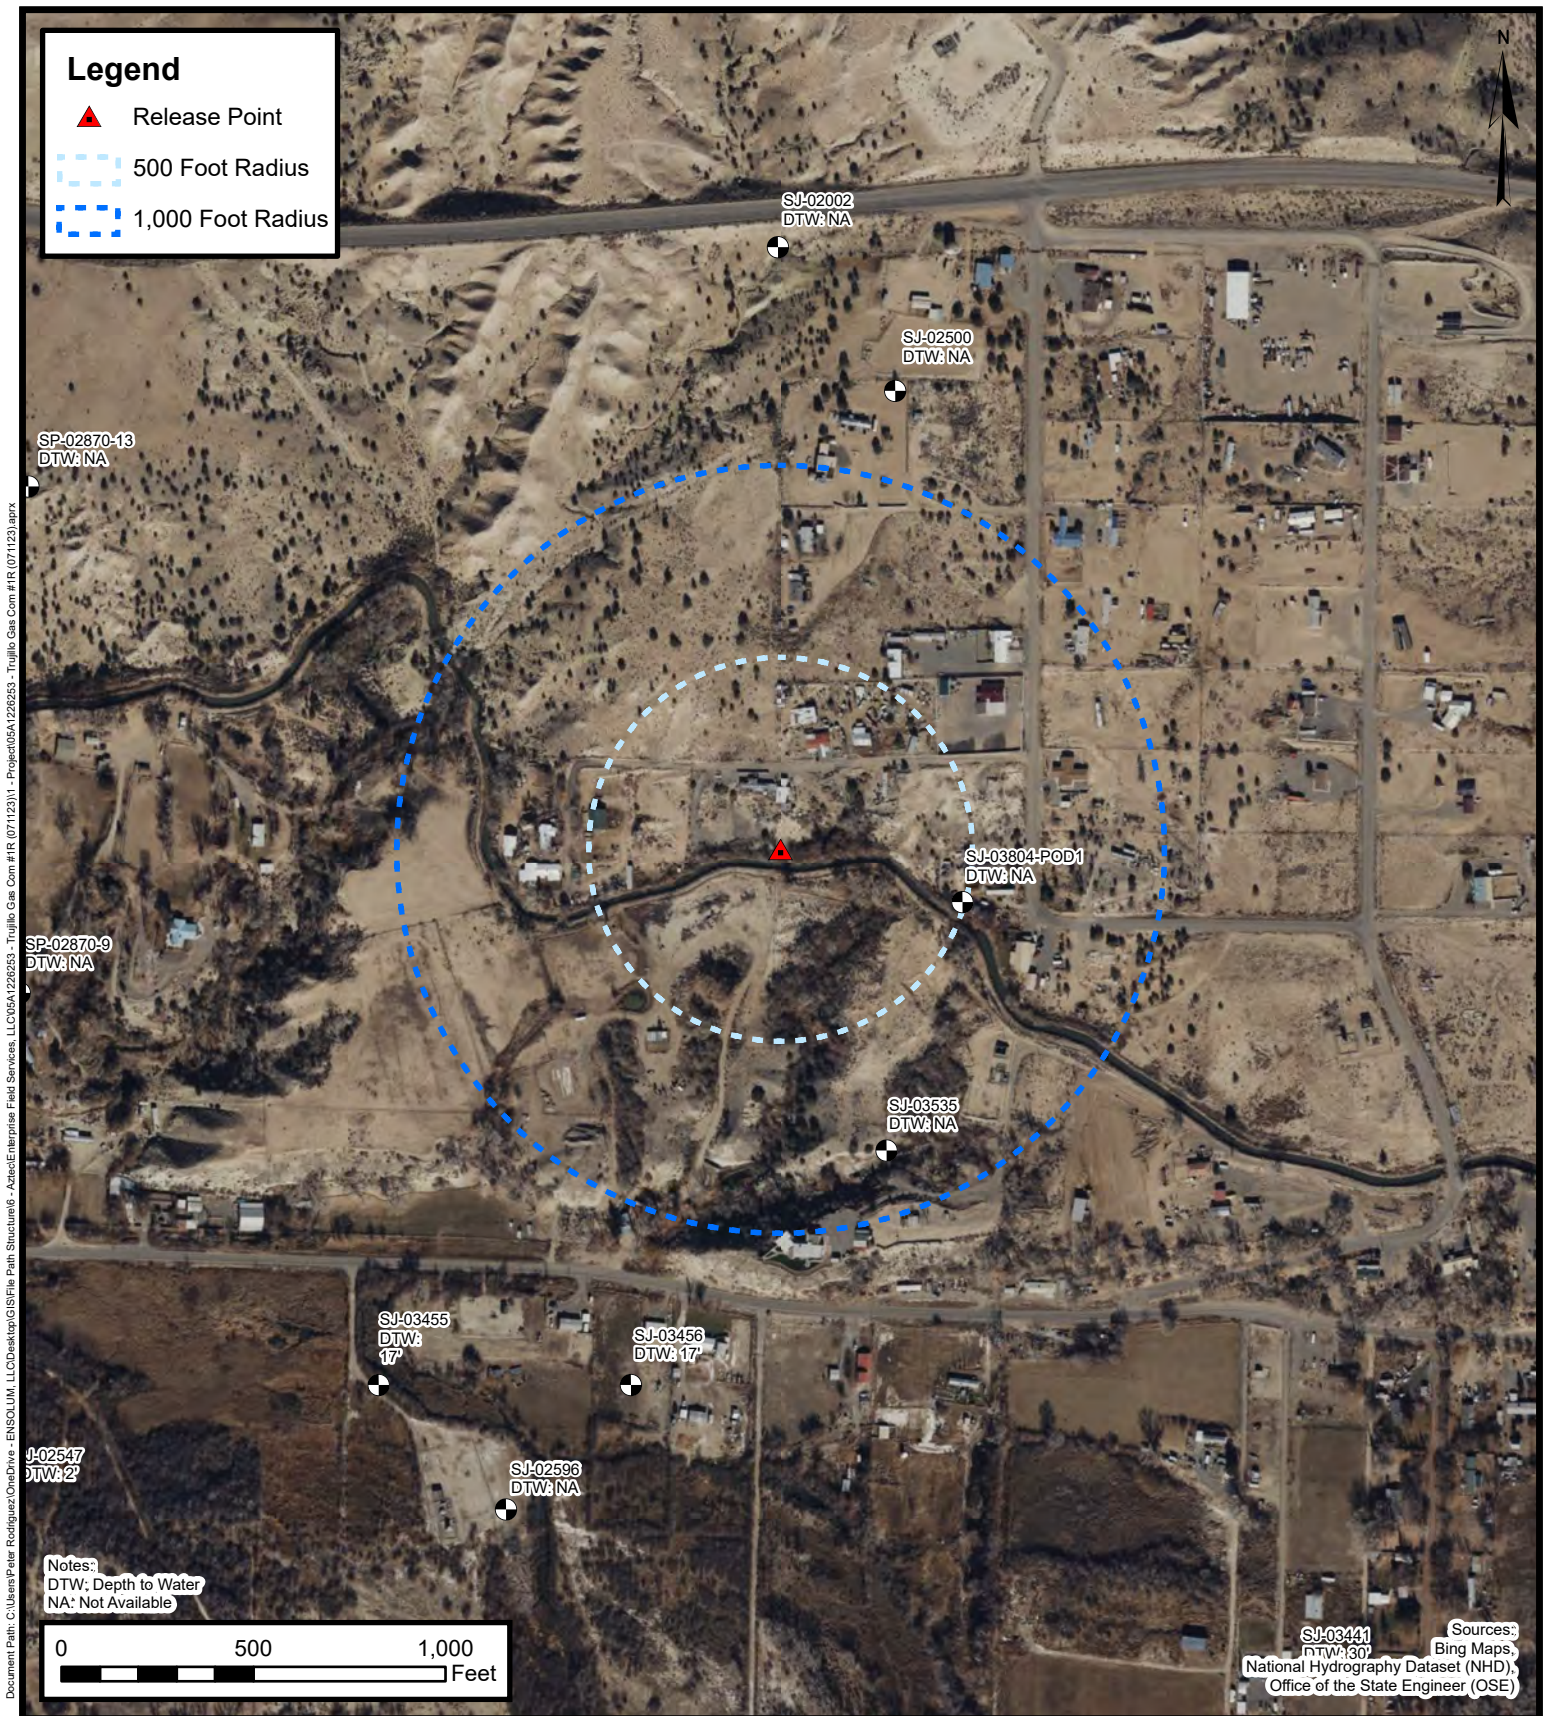
**FIGURE  
E**

**Water Well and  
Natural Spring Location**  
Enterprise Field Services, LLC  
Trujillo Gas Com #1R (07/11/23)  
Project Number: 05A1226253  
Unit Letter K, S21 T29N R10W, San Juan County, New Mexico  
36.711165, -107.894347

- No springs, or private domestic freshwater wells used by less than five households for domestic or stock watering purposes were identified within 500 feet of the Site (**Figure E, Appendix B**).

- No freshwater wells or springs were identified within 1,000 feet of the Site (**Figure E, Appendix B**).
- The Site is not located within incorporated municipal boundaries or within a defined municipal fresh water well field covered under a municipal ordinance adopted pursuant to New Mexico Statutes Annotated (NMSA) 1978, Section 3-27-3.

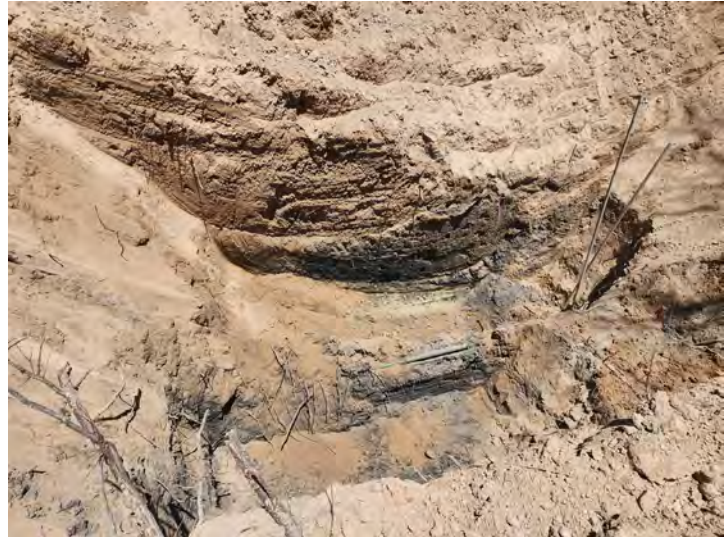
**Photograph 1**

Photograph Description: View of the in-process excavation activities.

On July 19, 2023, Enterprise initiated activities to repair the pipeline and remediate petroleum hydrocarbon impact identified by the vapor readings and field screening activities. During the remediation and corrective action activities, Sunland Construction Inc. provided heavy equipment and labor support, while Ensolum provided environmental consulting support. No leak was identified while remediating the hydrocarbon-affected soil.

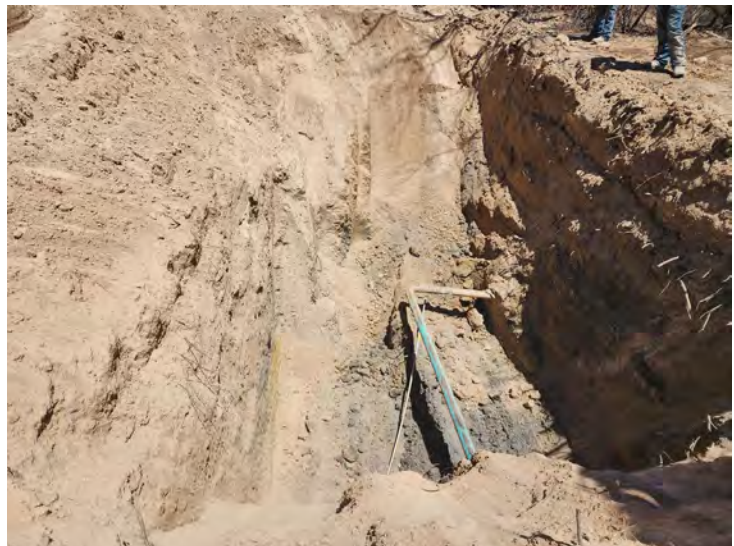
**Photograph 2**

Photograph Description: View of the final excavation.

The final excavation measured approximately 23 feet long and 14 feet wide at the maximum extents. The maximum depth of the excavation measured approximately 10 feet bgs. The lithology encountered during the completion of remediation activities consisted primarily of sandy silt.

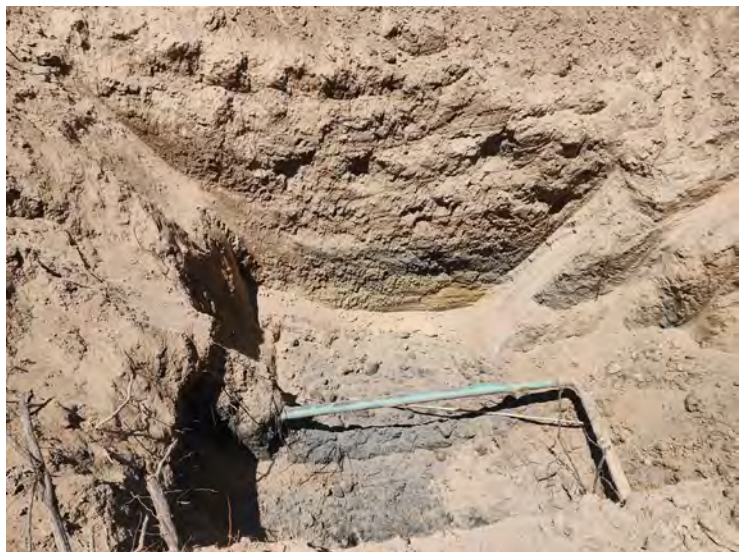
**Photograph 3**

Photograph Description: View of the final excavation.

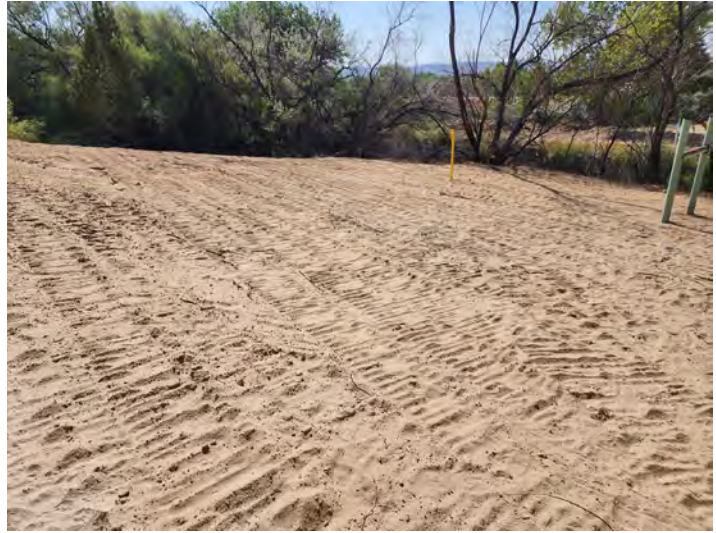
**Photograph 4**

Photograph Description: View of the site after initial restoration.

The excavation was backfilled with imported fill and then contoured to the surrounding topography.

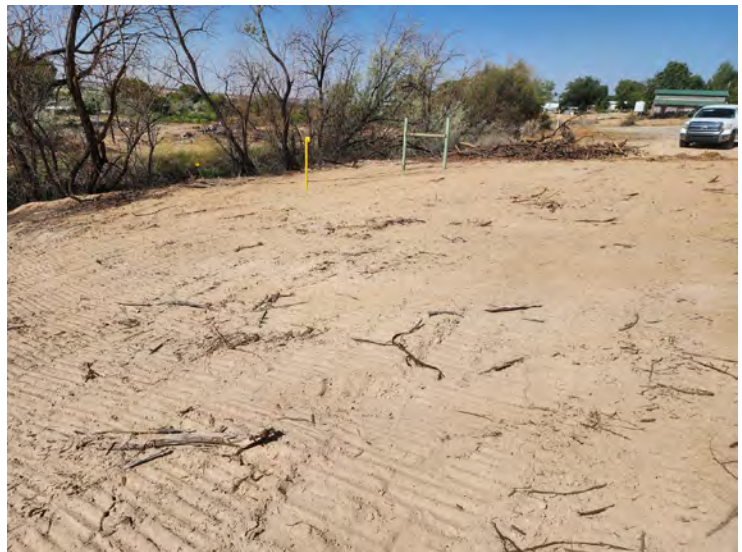
**Photograph 5**

Photograph Description: View of the site after initial restoration.
