Re: Deferral Request Update RDX 15 #001 Incident Number nAB1817138256 Eddy County, New Mexico

Ensolum, LLC (Ensolum), on behalf of WPX Energy Permian, LLC (WPX), has prepared this *Deferral Request Update* to document excavation and soil sampling activities at the RDX 15 #001 (Site). The purpose of the Site assessment and soil sampling activities was to address impacts to soil following a release of produced water into an earthen secondary containment. Based on field observations, field screening activities, and soil sample laboratory analytical results, WPX is submitting this *Deferral Request Update*, describing Site assessment and excavation activities that have occurred, addressing concerns of the New Mexico Oil Conservation Division (NMOCD), and requesting deferral of final remediation for Incident Number nAB1817138256 until the Site is reconstructed, and/or the well pad is plugged and abandoned and the deferral area is safely accessible.

WPX Energy Permian, LLC Deferral Request RDX 15 #001

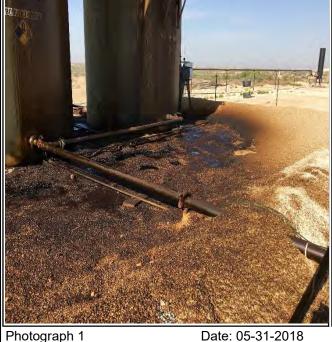
Photograph 1
Description: Spill Area
View: Southwest

On May 31, 2018, a water transfer pump malfunctioned and stopped transferring water to disposal. This resulted in the release of approximately 20 barrels (bbls) of produced water inside the earthen containment; 15 bbls were recovered with a vac truck. WPX submitted a Release Notification Form C-141 (Form C-141) on June 13, 2018. The release was assigned Incident Number nAB1817138256 (Appendix A).

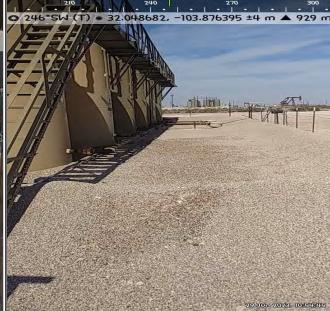
Photograph 6 Date: 06-29-2023

Beginning on June 29, 2023, Ensolum personnel visited the Site to evaluate the release extent based on information provided on the Form C-141 and visual observations. Three delineation soil samples (SS01, SS02 and SS04) were collected outside the earthen containment to assess the lateral extent of impacted soil at surface. Ensolum personnel returned to the Site on July 18, 2023, to collect lateral delineation soil sample SS03 and to complete two boreholes via hand auger inside the earthen containment. Ensolum personnel achieved a terminal depth of 6 feet bgs in borehole location BH01 before refusal and vertical delineation to a depth of 3 feet bgs was achieved in borehole location BH02.

Description: Site Assessment / Delineation

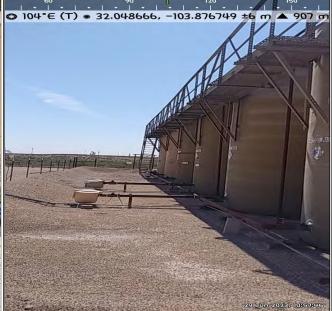
Photograph 8 Date: 06-29-2023

Description: Site Assesment / Delineation

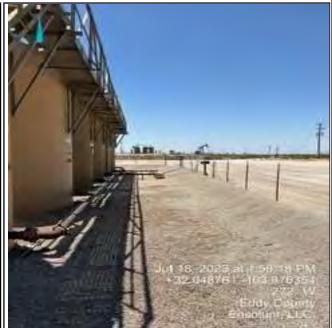
Photograph 10

On July 31, 2023, Ensolum personnel returned to the Site to collect a surface sample from borehole location BH02. Delineation soil samples were field screened for volatile aromatic hydrocarbons utilizing a calibrated photoionization detector (PID), chloride utilizing Hach® chloride QuanTab® test strips, and TPH utilizing PetroFLAG® soil reagents. The release extent and soil sample locations were mapped utilizing a handheld Global Positioning System (GPS) unit and are depicted on Figure 2. Photographic documentation was collected and a photographic log is included in Appendix C.

Description: Hand Augering

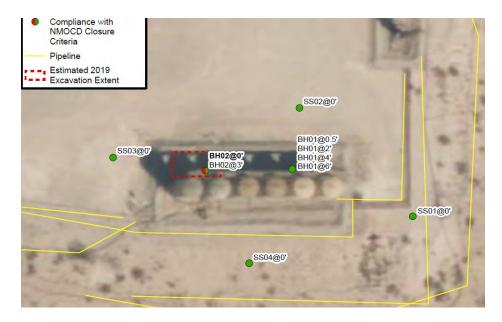
I am still confused at your assessment for this site and would like to further clarify that Borehole, BH01 is located on pad and within containment. The Closure Criteria is based on the absence of any nearby sensitive receptors and onsite drilling data indicating the depth to water is greater than 55 feet bgs. As such, the chloride concentration is in compliance with the appropriate Closure Criteria (10,000 mg/kg) and should not have to meet the reclamation requirement since it is on pad and in an active O&G production area (see image below for reference).

Laboratory analytical results for all soil samples collected from borehole BH01 are in compliance with the Closure Criteria (see image below for reference) and the reclamation requirement should not be applied for this location.
