CLOSURE REPORT

Blanco C-11 (07/19/23)
Unit Letter P, S10 T27N R9W
San Juan County, New Mexico

New Mexico EMNRD OCD Incident ID No. NAPP2320046214

Ensolum Project No. 05A1226259

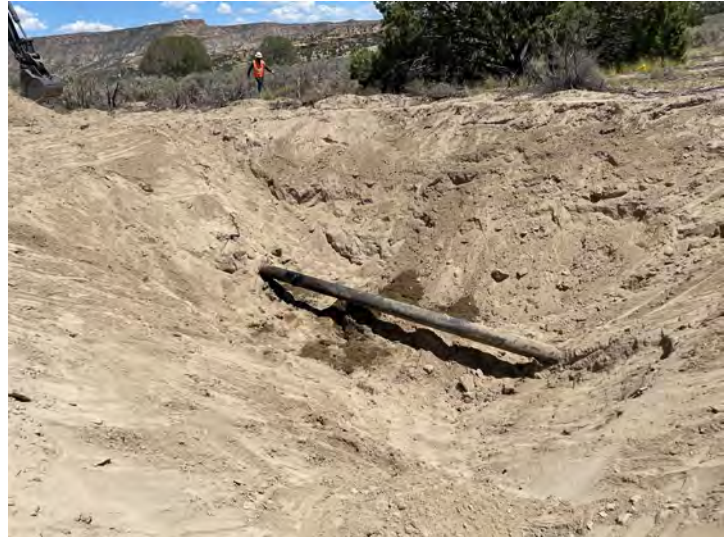
**Photograph 1**

Photograph Description: View of the in-process excavation activities.

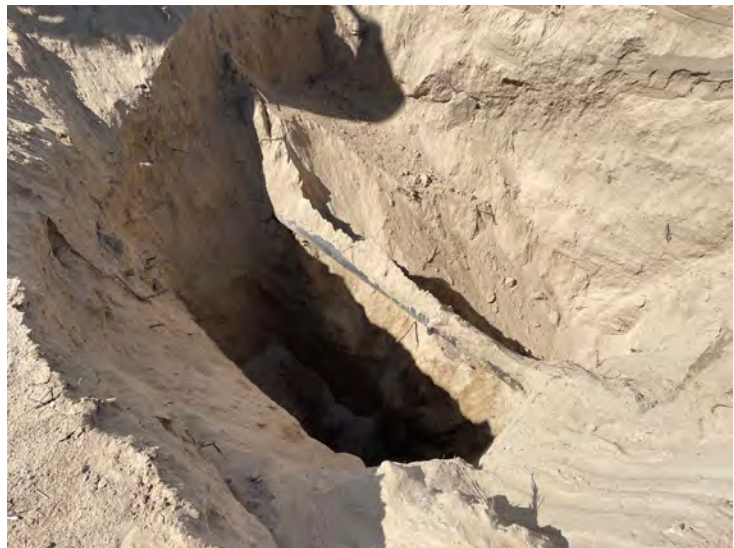
**Photograph 2**

Photograph Description: View of the in-process excavation activities.

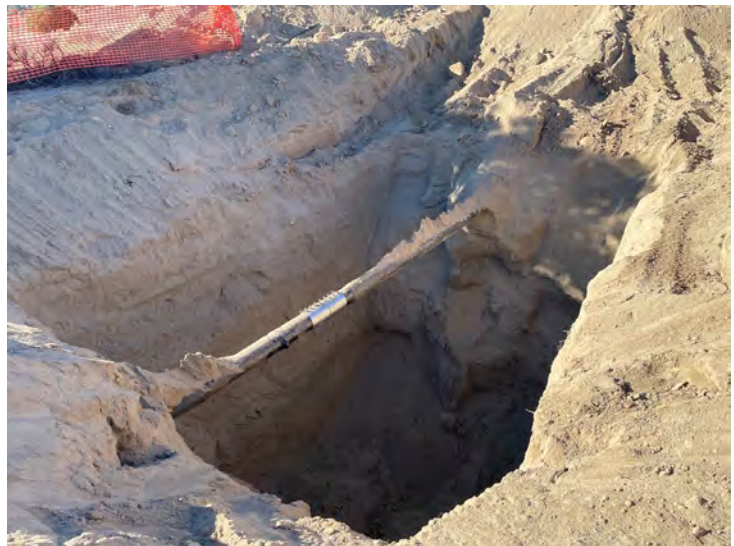
**Photograph 3**

Photograph Description: View of the final excavation (first sampling event).

The final excavation measured approximately 48 feet long and 21 feet wide at the maximum extents. The maximum depth of the excavation measured approximately 21 feet bgs. The lithology encountered during the completion of remediation activities consisted primarily of silty sand and sand.

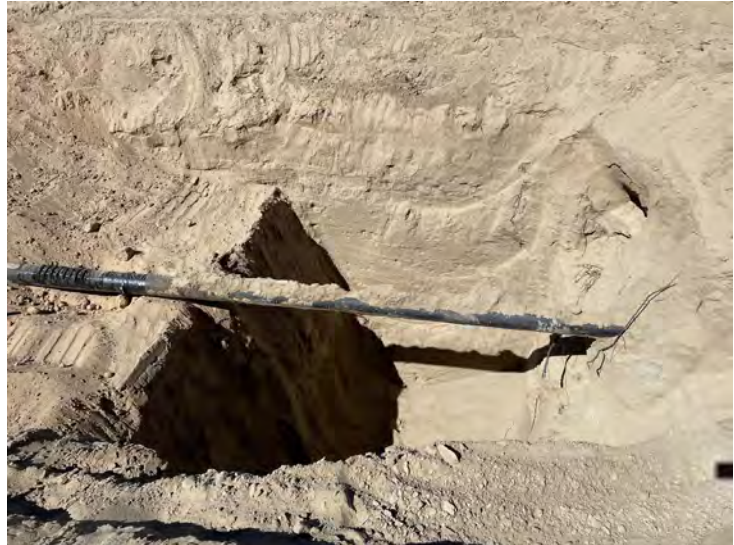
**Photograph 4**

Photograph Description: View of the final excavation (second sampling event).

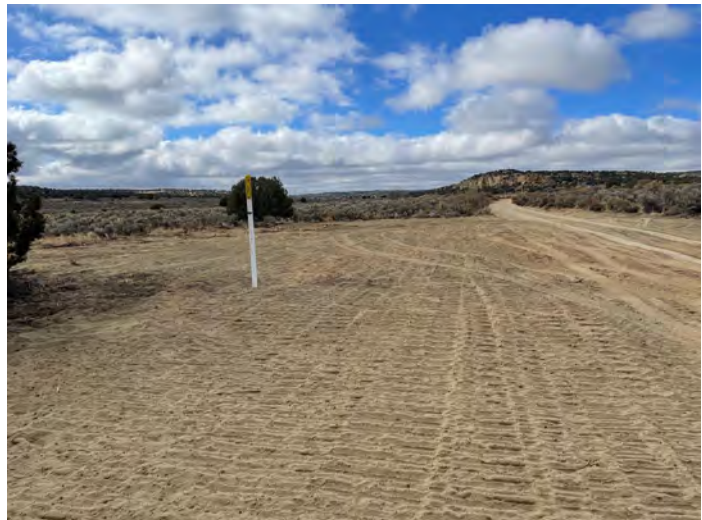
**Photograph 5**

Photograph Description: View of the site after initial restoration.

The excavation was backfilled with imported fill and laboratory-confirmed overburden soil and then contoured to the surrounding topography.

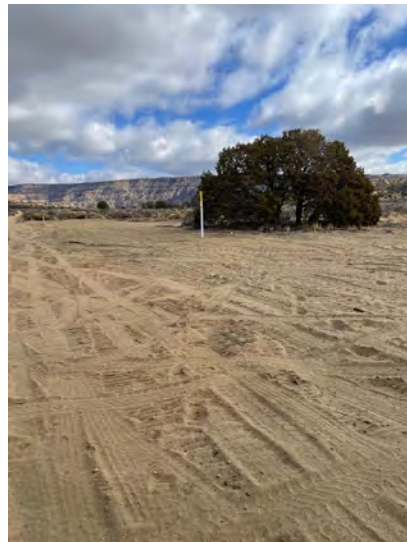
**Photograph 6**

Photograph Description: View of the site after initial restoration.
