Remediation Summary and Deferral Request

**BTA Oil Producers, LLC
South Ridge Production Facility
Lea County, New Mexico
Unit Letter "E", Section 2, Township 23 South, Range 34 East
Latitude 32.332680 North, Longitude 103.445730 West
NMOCD Incident # nAPP2125728285**

October 2023

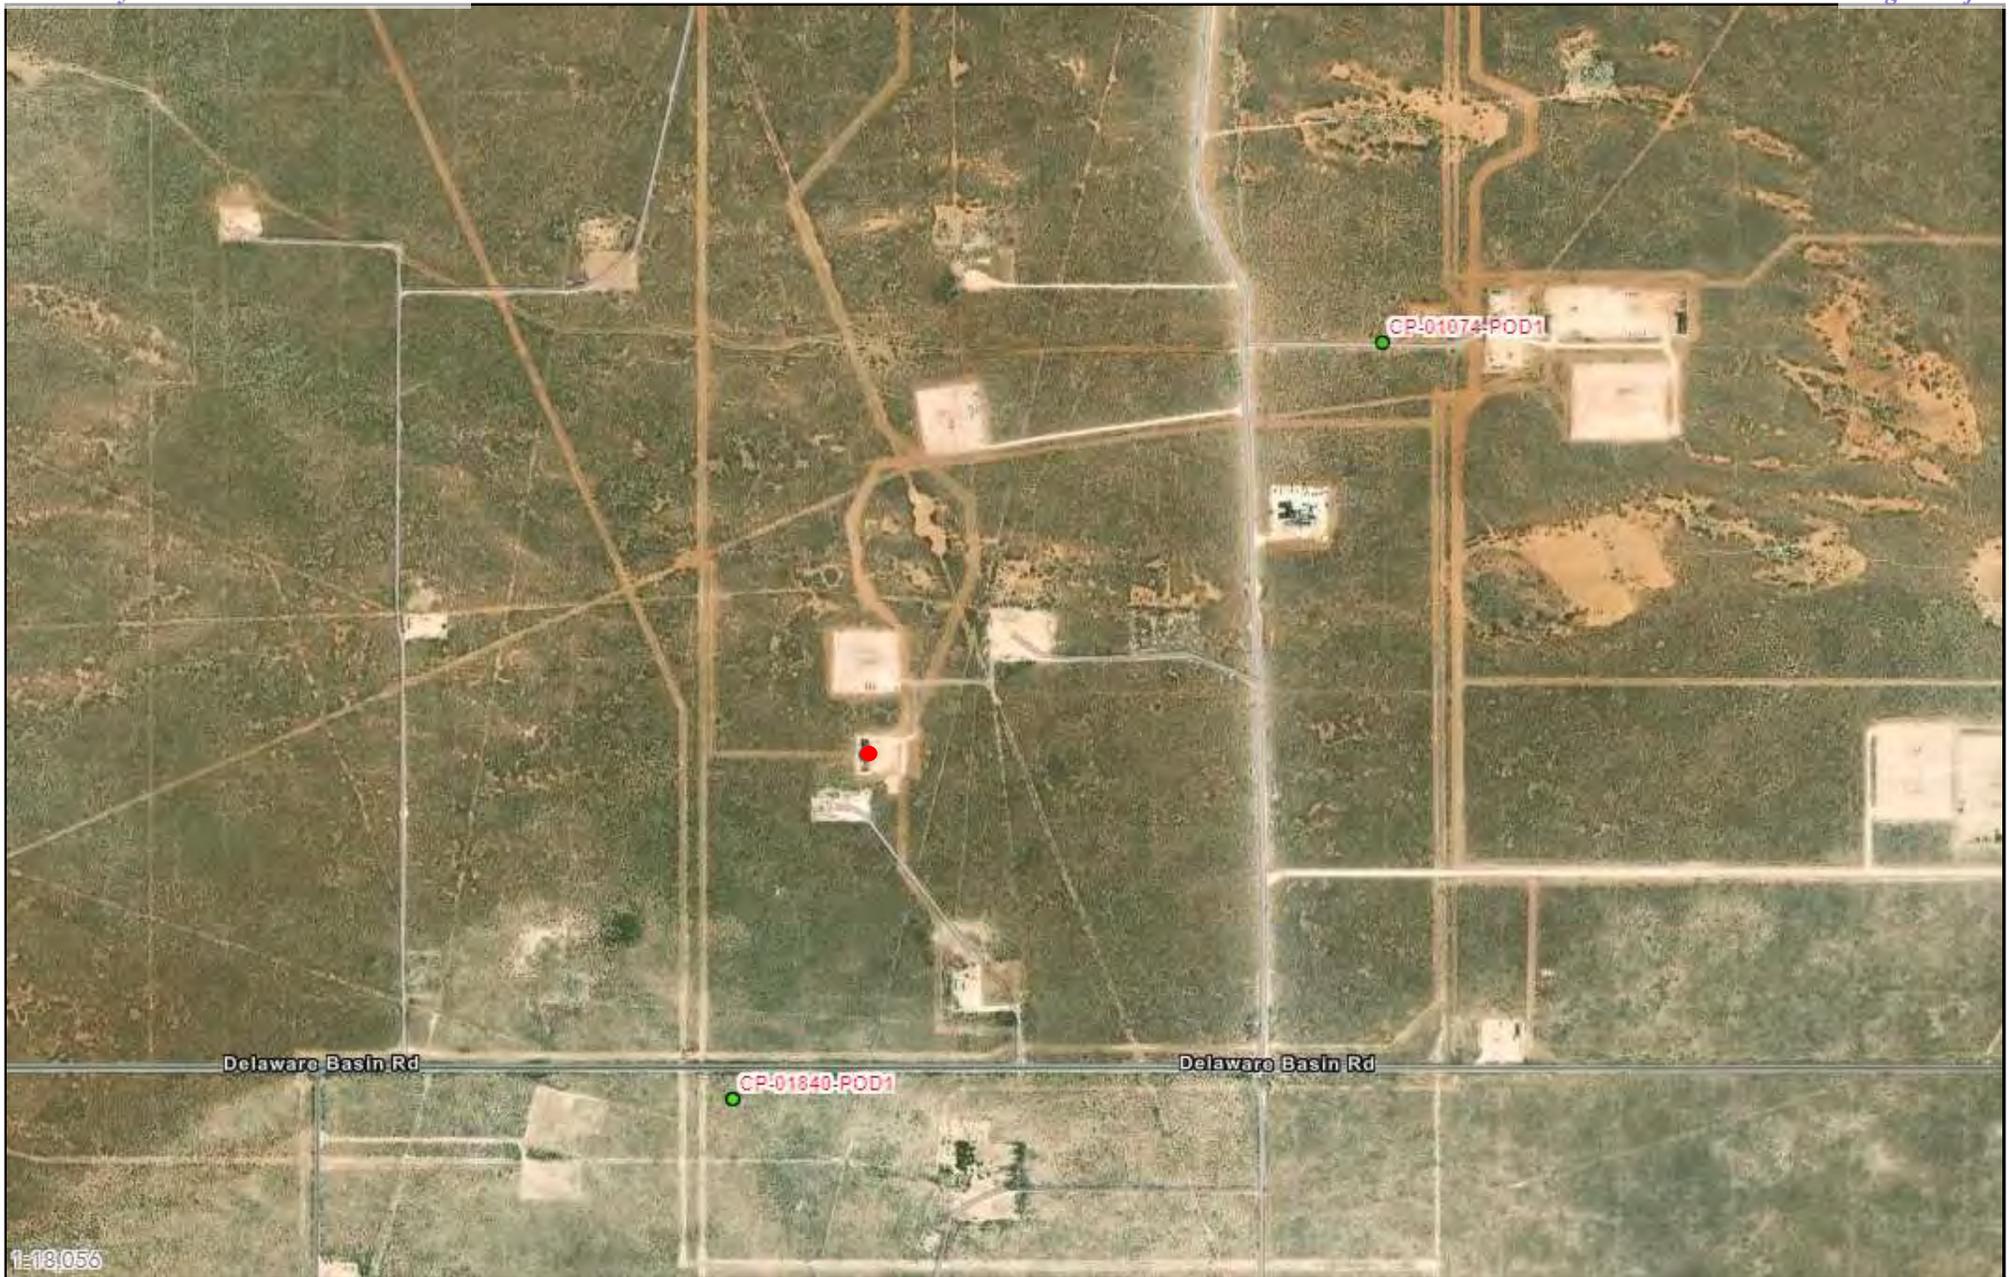
Figure 2

OSE POD Locations Map
 BTA Oil Producers, LLC
 South Ridge Production Facility
 GPS: 32.33268, -103.44573
 Lea County

A search of the New Mexico Office of the State Engineer (NMOSE) and United States Geological Survey (USGS) groundwater databases was completed in an effort to determine the horizontal distance to known water sources within a half mile radius of the Release Site. Approximate depth to groundwater was determined using maintained and published water well data. Karst mapping indicates the site is not located in a Karst designated area. Karst and Wetland Maps are provided as Attachment I. Depth to groundwater information is provided as Attachment IV and the results are depicted on Figures 2 & 3.

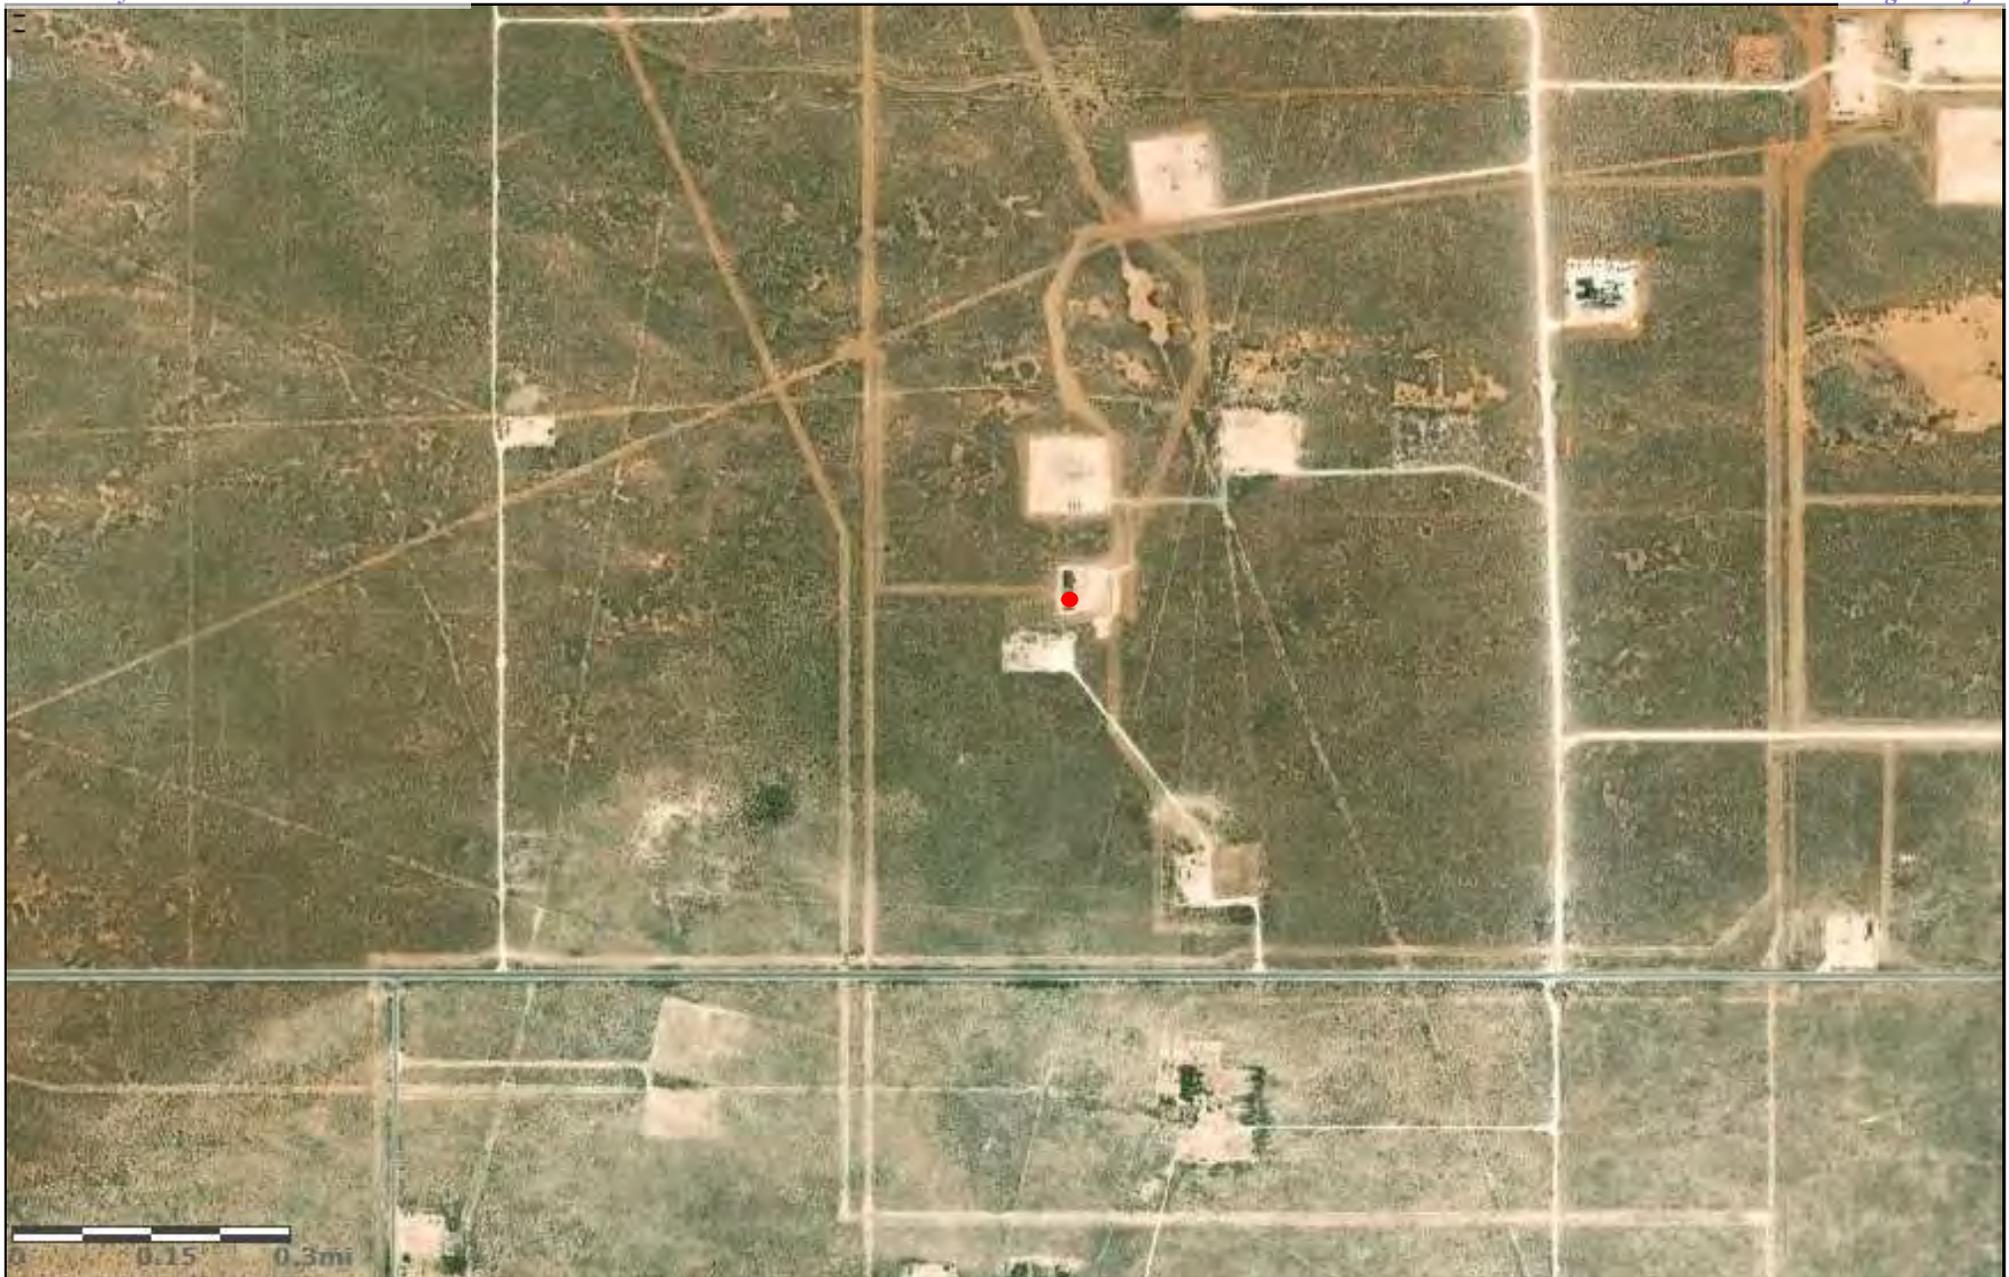
Figure 3

USGS Well Locations Map
BTA Oil Producers, LLC
South Ridge Production Facility
GPS: 32.33268, -103.44573
Lea County

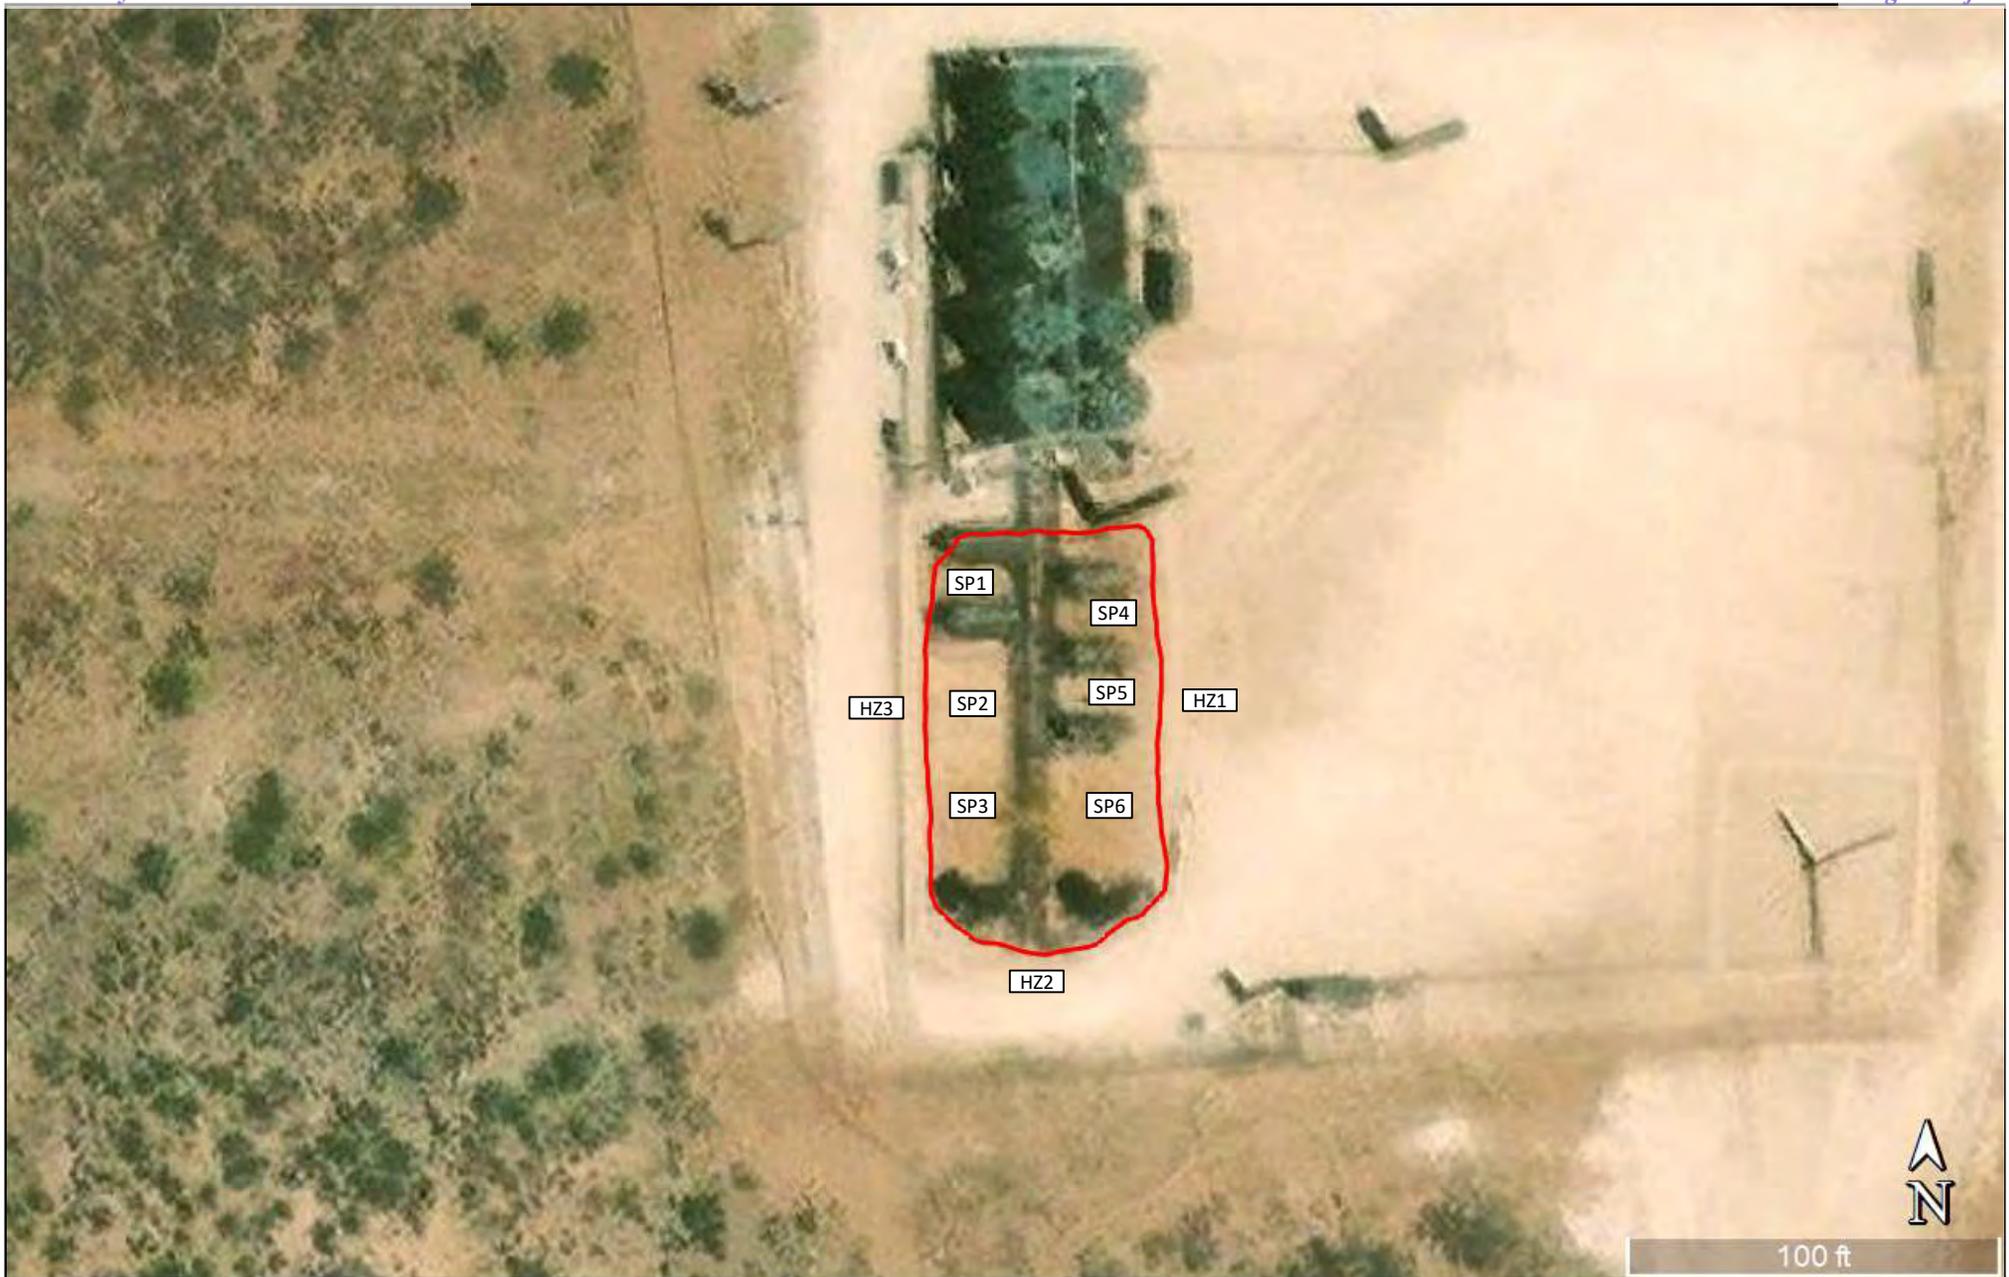
Figure 4

Based on field observations and field test data noted above and provided in Attachment V, thirty-six representative soil samples were selected for laboratory analysis. Delineation soil samples SP1 through SP6, HZ1 through HZ3, were submitted to the laboratory for analysis of BTEX, TPH, and chloride. Laboratory analytical results indicated contaminant concentrations were below the NMOCD Closure Criteria in each of the submitted samples, with the exception of SP1 Surface, SP2 Surface, SP3 Surface, SP4 Surface, SP5 Surface and one-foot bgs, and SP6 Surface, which exhibited TPH and/or chloride concentrations in excess of NMOCD Closure Criteria.

Delineation Sample Map
BTA Oil Producers, LLC
South Ridge Production Facility
GPS: 32.33268, -103.44573
Lea County

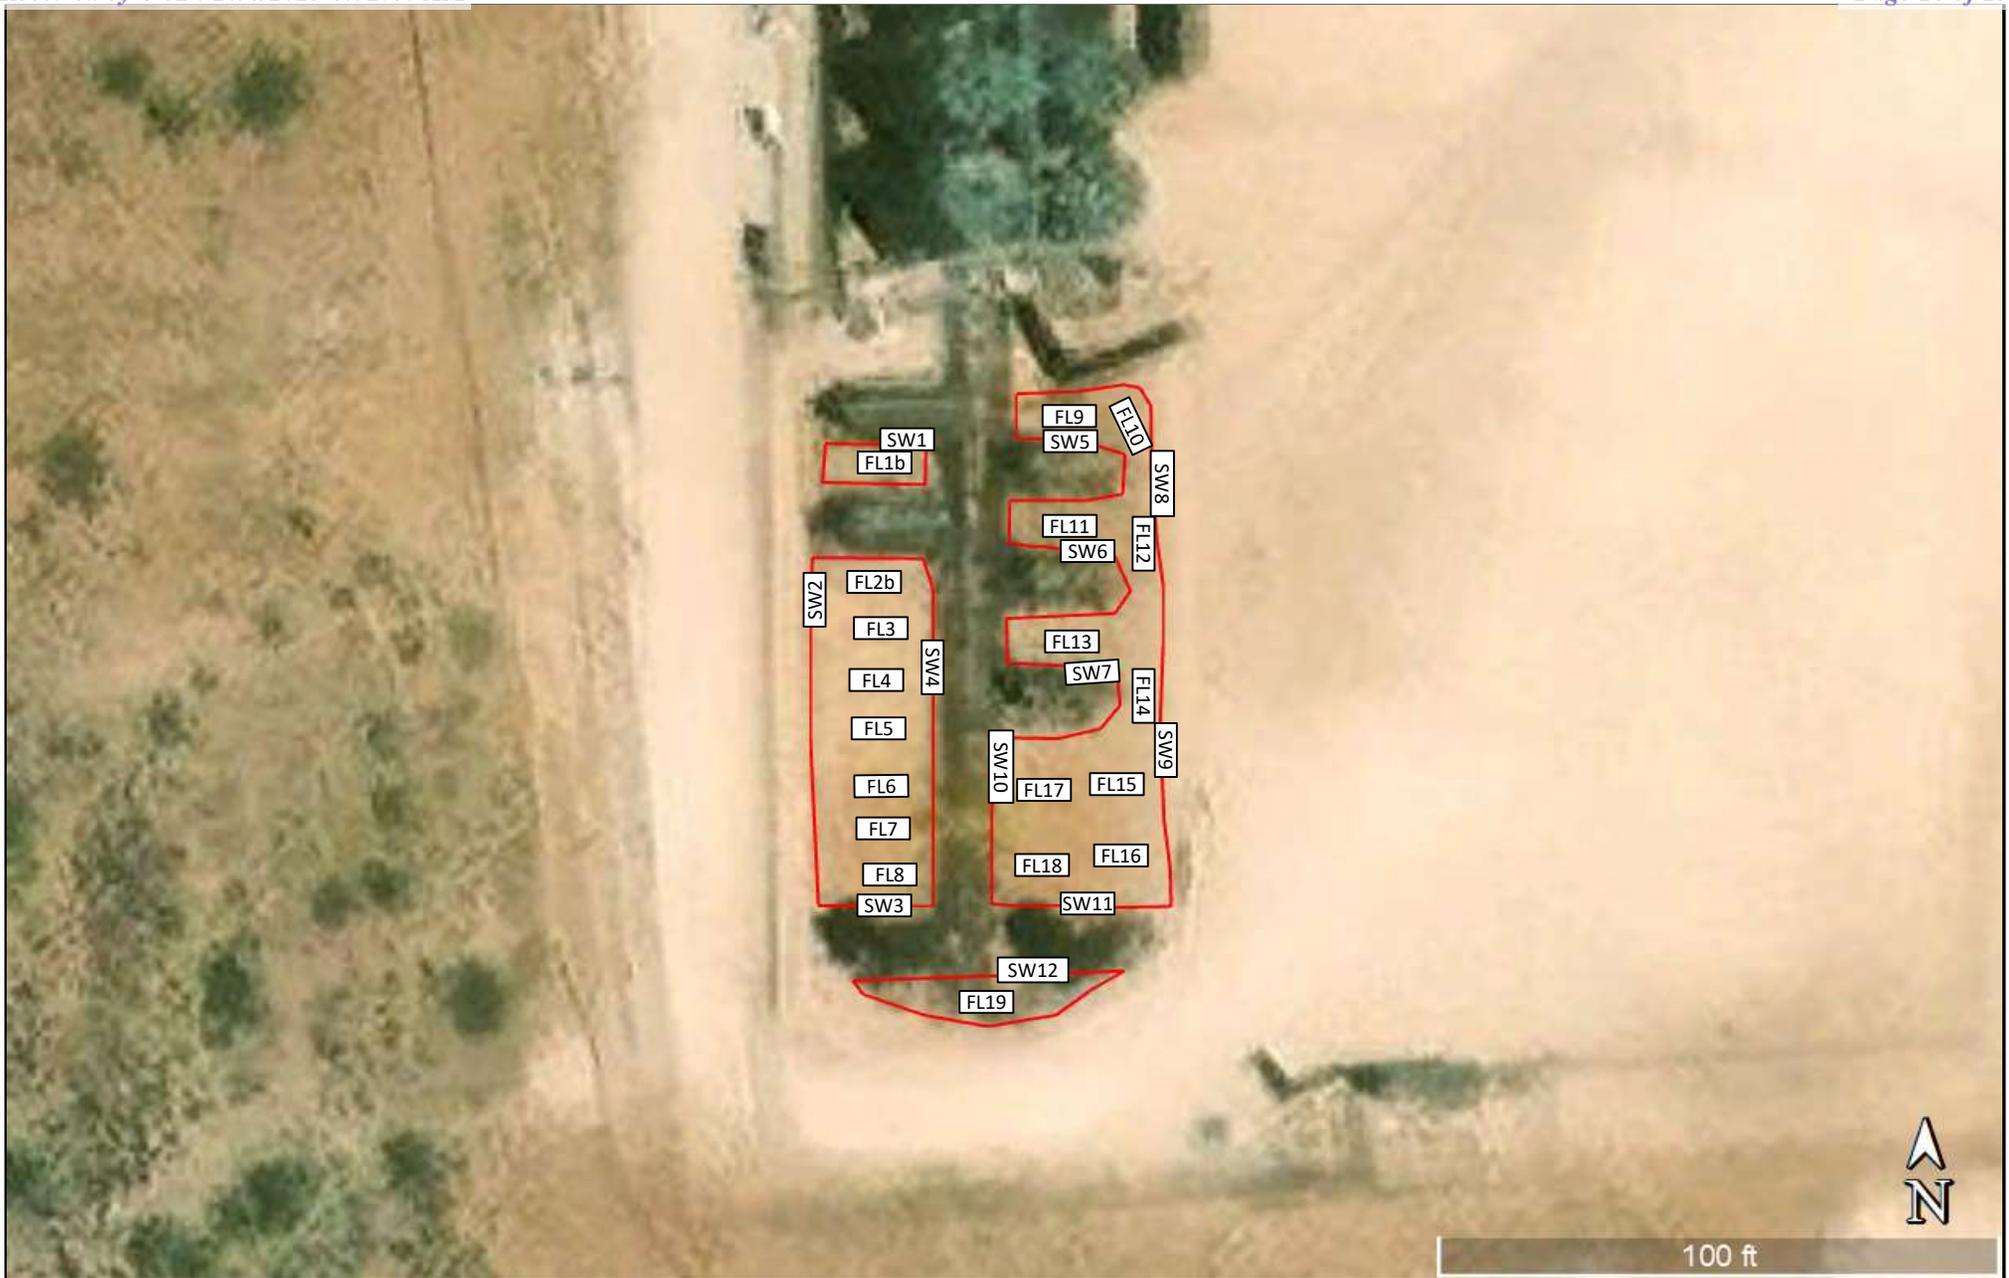
Figure 5

Excavation Sample Map
 BTA Oil Producers, LLC
 South Ridge Production Facility
 GPS: 32.33268, -103.44573
 Lea County
