## CLOSURE REQUEST REPORT

**Humidor Compressor Station  
Eddy County, New Mexico  
Incident Number  
NAPP2231158832**

February 9, 2024  
Ensolum Project No. 03A2013011

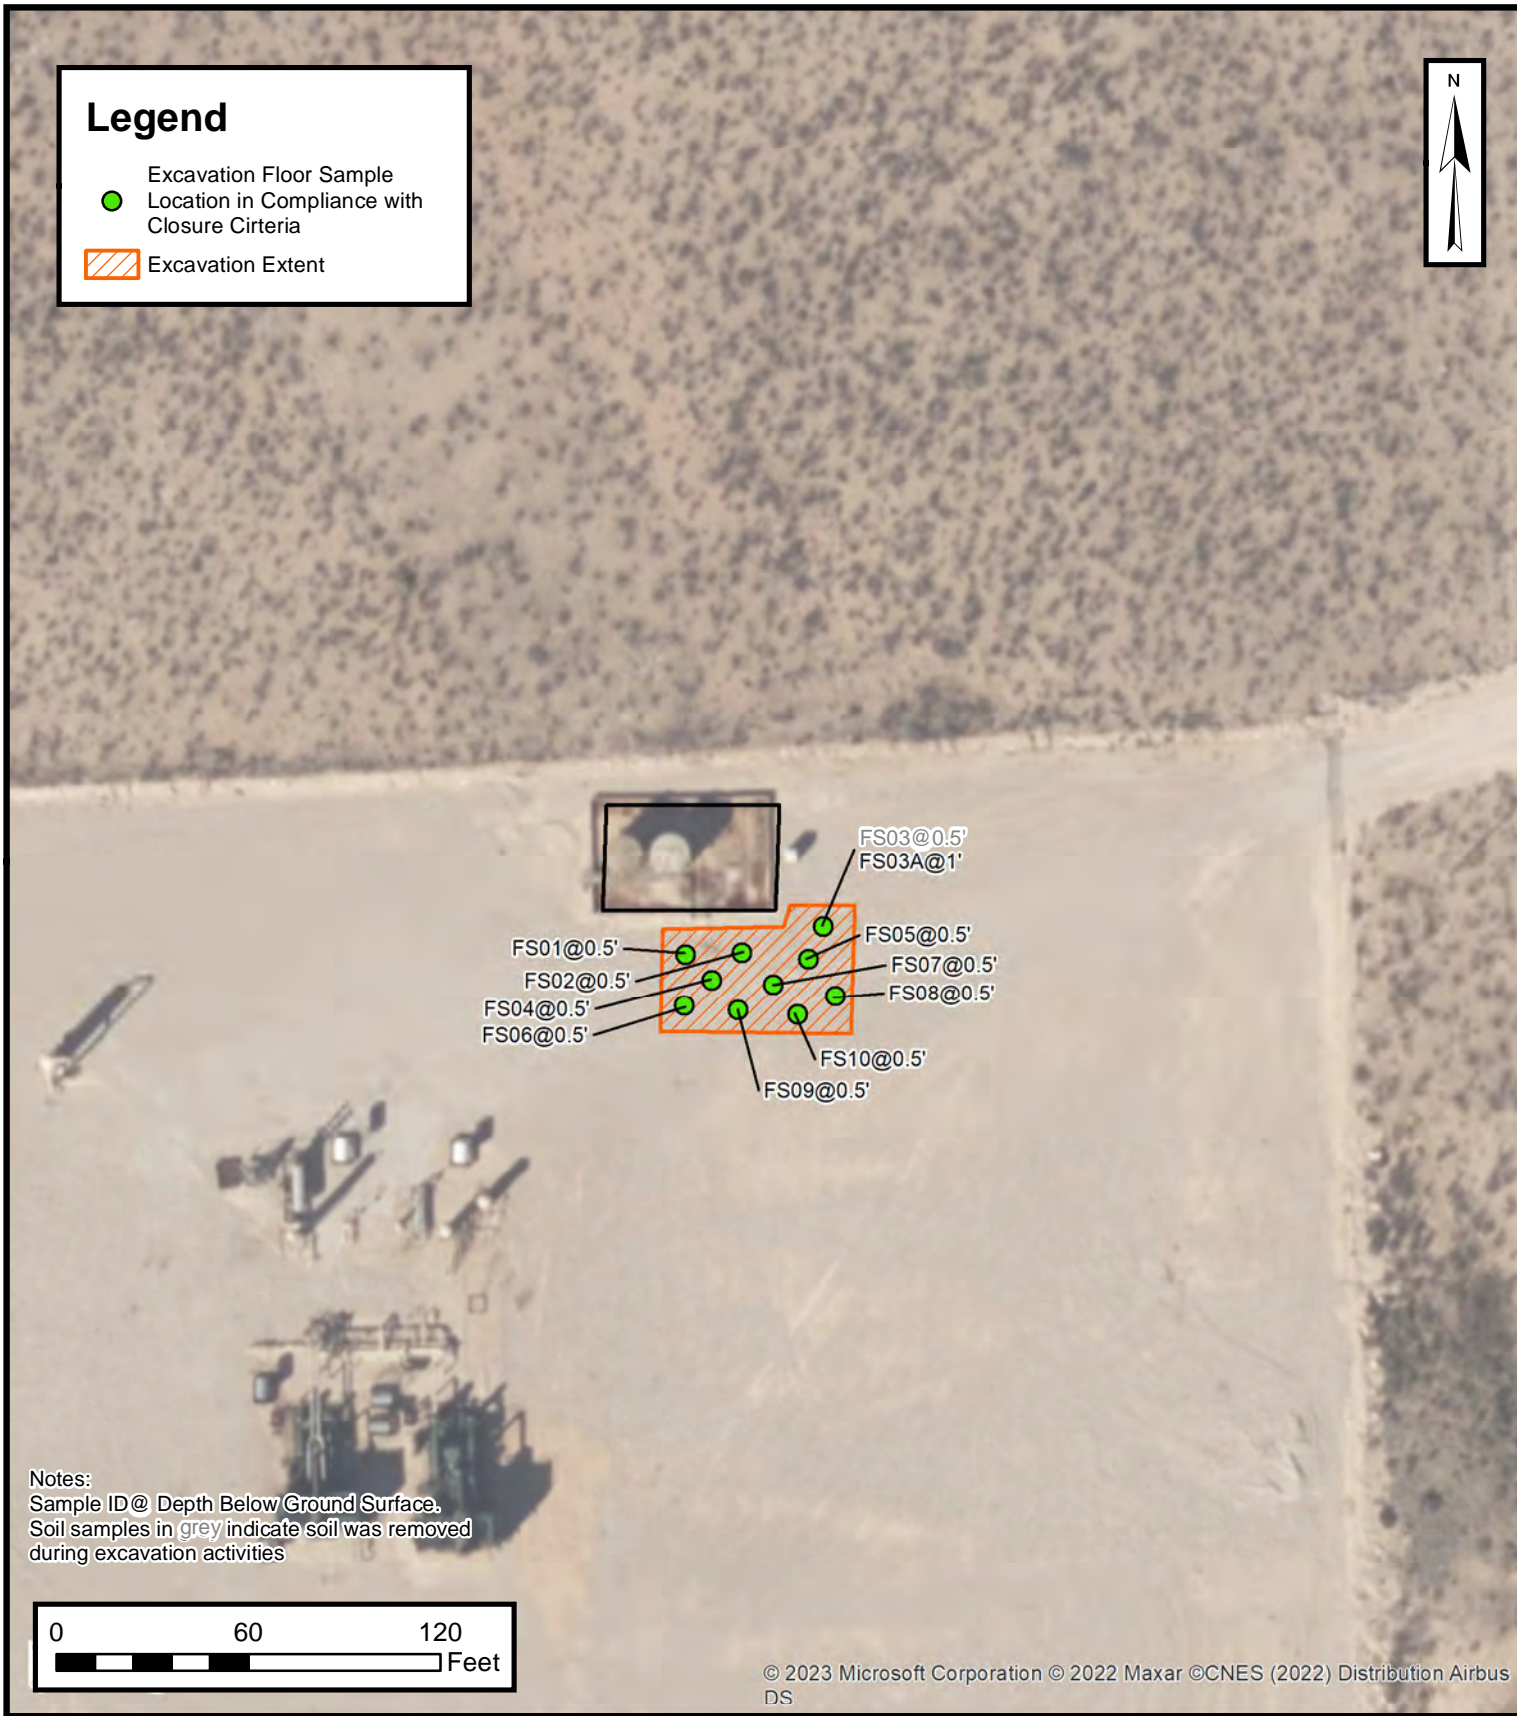
**FIGURE**  
**2**

A liner inspection was completed within the tank battery containment area associated with the subject release. The liner integrity was confirmed and no defects were identified. To assess the impacted area outside containment, 10 composite soil samples (FS01 through FS10) were collected at a depth of approximately 0.5-feet bgs within the scraped area. Confirmation soil samples were field screened for volatile organic compounds (VOCs) utilizing a calibrated photoionization detector (PID) and chloride using Hach® chloride QuanTab® test strips. Floor samples collected contained soil from the sidewall and floor due to the shallow nature of the excavation.

**Excavation Soil Sample Locations**

The area associated with FS03 at 0.5 feet bgs was excavated and disposed of based on elevated TPH concentrations. Final laboratory analytical results for FS01, FS02, FS03A, and FS04 through FS10 indicated all COCs met the applicable Closure Criteria. Laboratory analytical results are summarized in Table 1 included in **Appendix D**. The executed chain-of-custody forms and laboratory analytical reports are provided in **Appendix E**. **Appendix F** provides correspondence email notification receipts associated with the subject release.

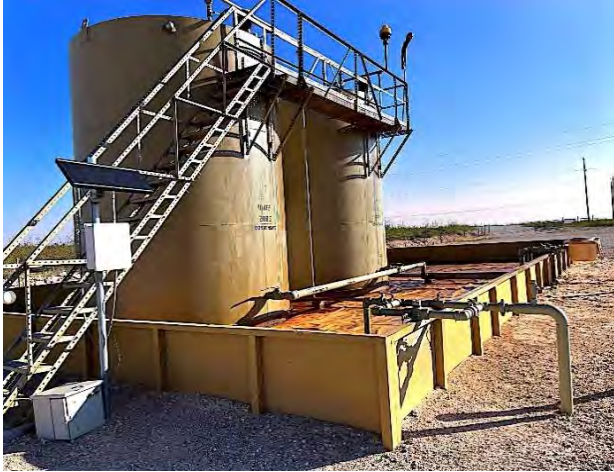
Photograph 1 Date: 11/09/2022  
 Description: Site assessment, containment area.  
 View: Northeast

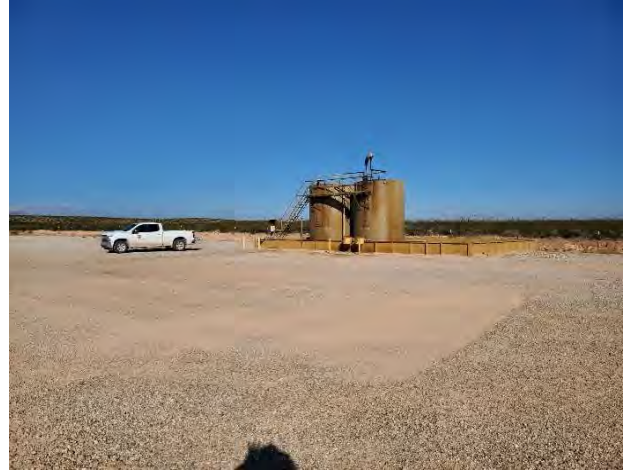
Photograph 2 Date: 11/09/2022  
 Description: Site assessment, surface scraping area.  
 View: Northwest

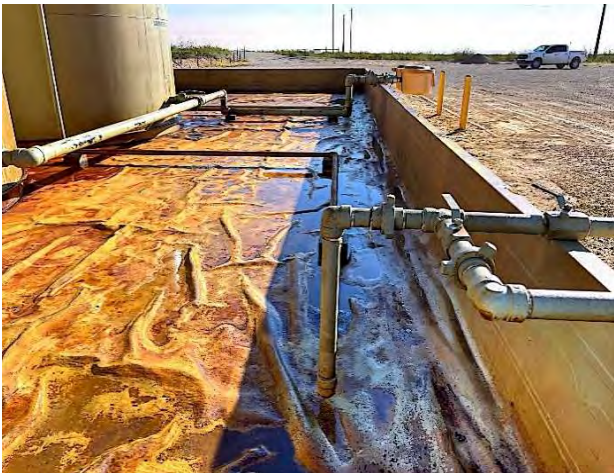
Photograph 3 Date: 11/09/2022  
 Description: Site assessment, liner condition.  
 View: East

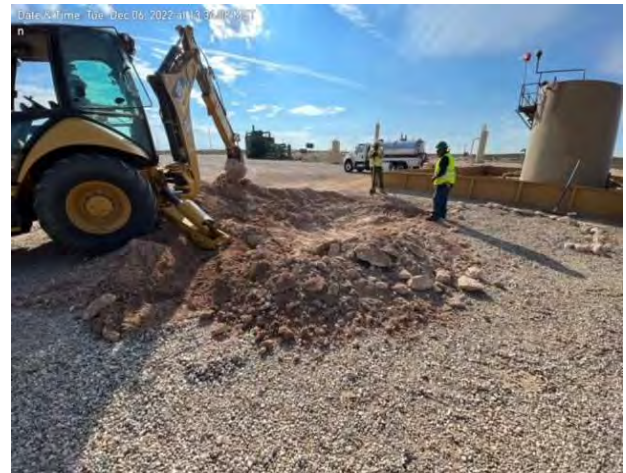
Photograph 4 Date: 12/06/2022  
 Description: Excavation activities, area of FS03.  
 View: Southwest

On December 6, 2022, Ensolum personnel returned to the Site to address elevated COCs, specifically TPH, associated with soil sample FS03. Excavation activities were performed utilizing heavy equipment and directed by field screening for VOCs. The existing area associated with FS03 was advanced to 1-foot bgs. Another confirmation sample (FS03A) was collected, handled, and analyzed as previously described. The location of the soil samples and final excavation extent is shown in **Figure 2** in **Appendix A**. Photographic documentation following remediation activities is included in **Appendix C**.

Approximately 40 cubic yards of waste-containing soil were excavated from the Site and was disposed of at an approved waste facility. The excavation was backfilled with locally sourced topsoil to match pre-existing Site conditions.
