**Re: Remediation Work Plan
Rojo 10H-13H, 34H-37H
Incident Number nAPP2313055442
Lea County, New Mexico**

Ensolum, LLC (Ensolum), on behalf of BTA Oil Producers, LLC (BTA), has prepared the following *Remediation Work Plan (Work Plan)* to document assessment, delineation, and soil sampling activities completed to date and propose remedial actions to address the impacted soil identified at the Rojo 10H-13H, 34H-37H (Site). The following *Work Plan* proposes additional delineation activities and excavation of impacted soil.

BTA Oil Producers, LLC
Remediation Work Plan
Rojo 10H-13H, 34H-37H

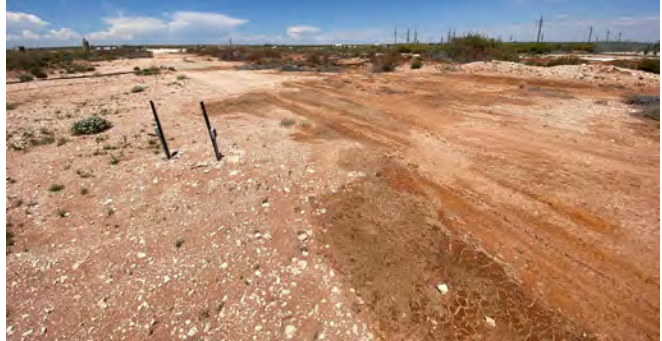
Photograph: 2

Description: Soil staining in release footprint

- The impacted soil will be transferred to a New Mexico approved landfill facility for disposal. The excavation will be backfilled and recontoured to match pre-existing conditions. The disturbed pasture area will be re-seeded with a landowner approved seed mixture.

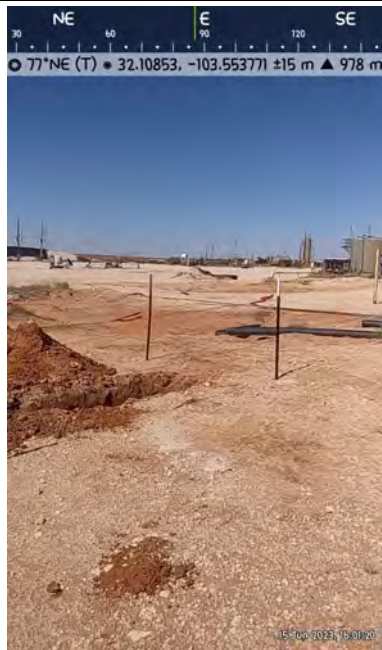
Photograph: 3

Description: Delineation activities
