## Remediation and Closure Report

Superior Federal #009  
Incident# nAPP2322634457  
Eddy County, New Mexico

Subject: **Remediation and Closure Report**  
Superior Federal #009  
Eddy County, NM

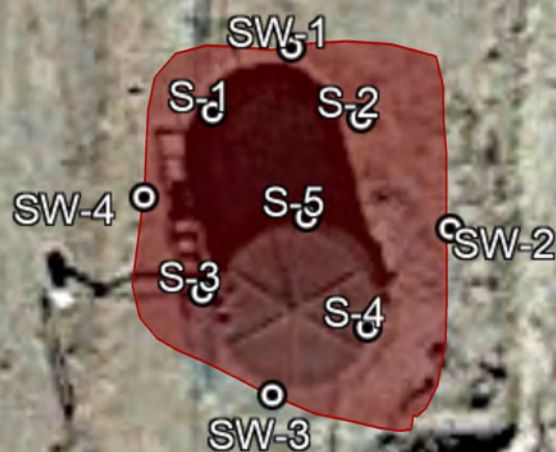
Cimarex Energy Co. of Colorado  
Incident# nAPP2322634457  
Eddy County, NM  
Confirmation Sample Map

- The impacted areas in the vicinity of sample points S-1 and S-2 were excavated to a total depth of 5-feet BGS.
- The impacted area in the vicinity of sample point S-3 was excavated to a total depth of 4.5-feet BGS.

- The impacted areas in the vicinity of sample points S-4 and S-5 were excavated to a total depth of 4-feet BGS.
- Composite confirmation samples were obtained from the bottom and sidewalls of the excavated areas to verify that all contaminants above closure criteria had been removed.

4-5ft. Excavation
-

Composite Confirmation Sample

- All the excavated material (86yds) was hauled to Lea Land, a NMOCD approved solid waste disposal facility.
- The excavated areas inside the earthen containment were backfilled with new caliche at depth and brought to grade, machine compacted and contoured to match the surrounding location. New berms were installed as well.

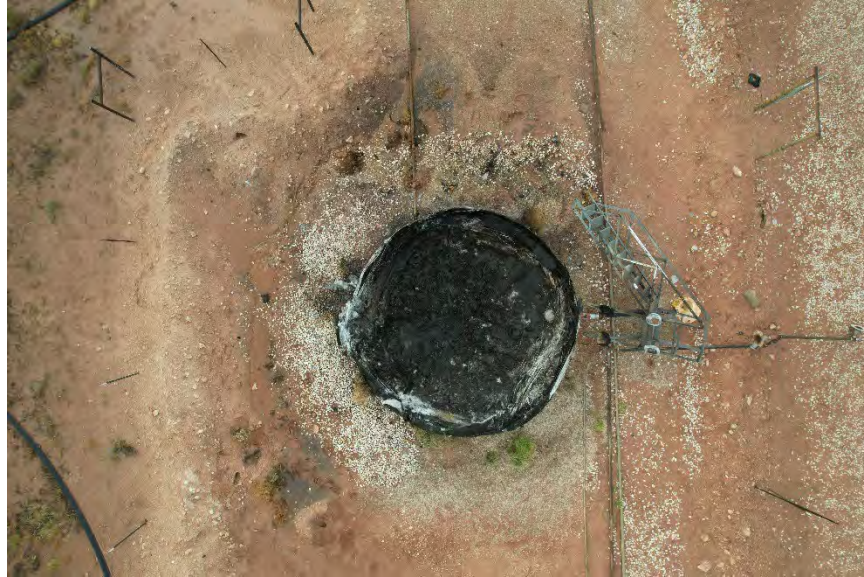
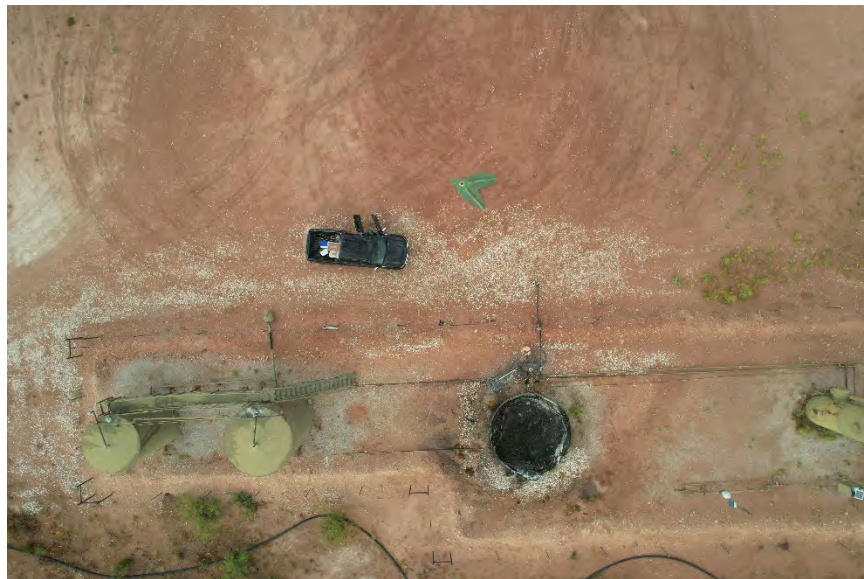
INITIAL PHOTOGRAPHS

On August 13, 2023, Cimarex Energy received a call from the Eddy County Emergency Department reporting the Superior Federal #009 location had a production tank of fire. It is believed that the tank was struck by lightning. This fire resulted in the release of 15 barrels (bbls) of produced water inside the earthen berm. A total of 20 bbls were recovered.
