### Re: Closure Report ConocoPhillips Company (Heritage COG Operating, LLC) Talco 9-26-35 Federal 003H Flowline Release Unit Letter J, Section 09, Township 26 South, Range 35 East Lea County, New Mexico Incident ID NAPP2308946629

Tetra Tech, Inc. (Tetra Tech) was contacted by ConocoPhillips (COP) to assess a release that occurred from a flowline associated with the Talco 9-26 35 Federal 003H (API 30-025-43458). The release footprint is located in Public Land Survey System (PLSS) Unit Letter J, Section 09, Township 26 South, Range 35 East, in Lea County, New Mexico (Site). The approximate release point occurred at coordinates 32.057784°, -103.371235°, as shown on Figures 1 and 2.

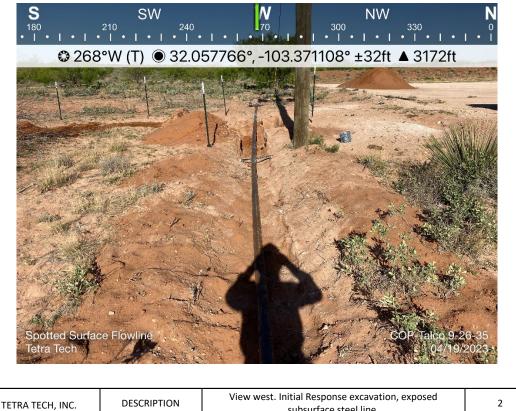
TETRA TECH, INC. PROJECT NO. 212C-MD-03073A	DESCRIPTION	subsurface steel line.	2
		SITE NAME	Talco 9-26-35 Federal #003H Flowline Release	4/19/2023
