**Re: Closure Request
Ogden Substation Tank Overflow
Incident Number nAPP2230983706
Eddy County, New Mexico**

Ensolum, LLC (Ensolum), on behalf of BTA Oil Producers, LLC (BTA), has prepared this *Closure Request* to document assessment, excavation, and soil sampling activities performed at the Ogden Substation Tank Overflow (Site). The purpose of the Site assessment, excavation, and soil sampling activities was to assess the integrity of the lined storage tank containment and address the impacted soil outside of containment, resulting from a produced water release at the Site. Based on field observations, excavation activities, and laboratory analytical results from the soil sampling events, BTA is submitting this Closure Request and requesting no further action for Incident Number nAPP2230983706.

BTA Oil Producers, LLC
Closure Request
Ogden Substation Tank Overflow

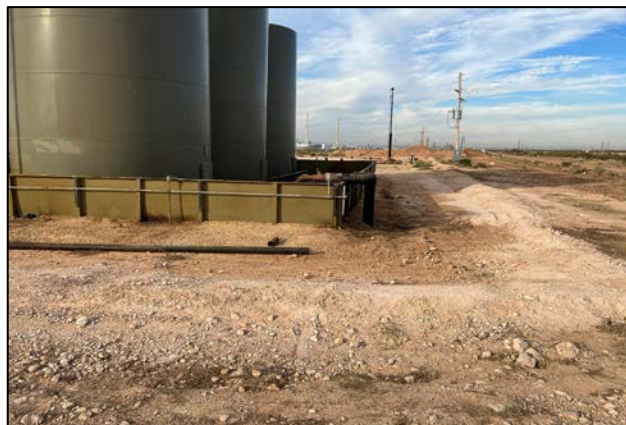
Photograph: 1 Date: 11/4/2022
Description: Soil staining in release footprint
View: West

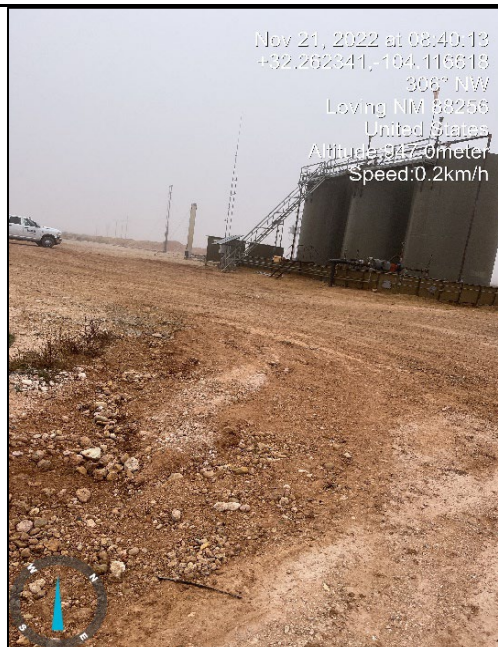
Photograph: 2 Date: 11/21/2022
Description: Soil staining in release footprint
View: Northwest

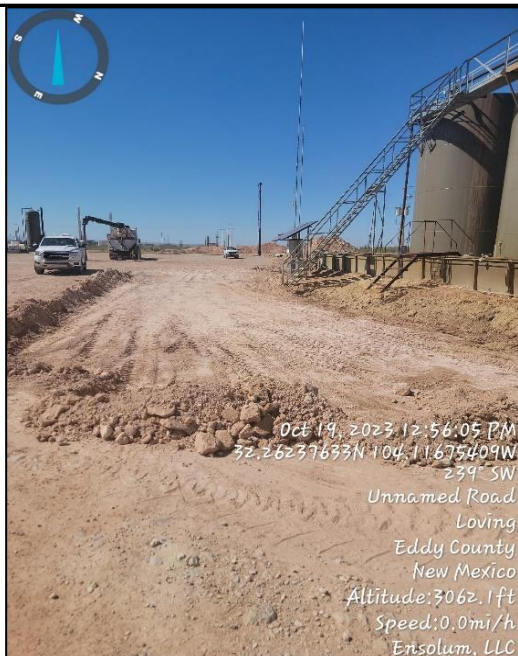
Photograph: 5 Date: 10/19/2023

Description: Excavation activities

Between October 18, 2022 and November 29, 2023, Ensolum personnel were at the Site to oversee excavation of the impacted soil outside of the lined containment. Impacted soil was excavated as indicated by visible staining, field screening activities, and laboratory analytical results for the delineation soil samples. Excavation activities were performed via hand shoveling and backhoe. To direct excavation activities, soil was screened for VOCs and chloride. The excavation was completed to depths ranging from 1-foot to 4 feet bgs.

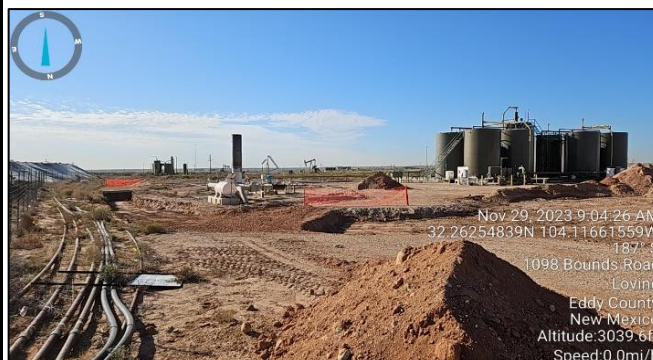
Photograph: 6 Date: 11/29/2023

Description: Excavation activities

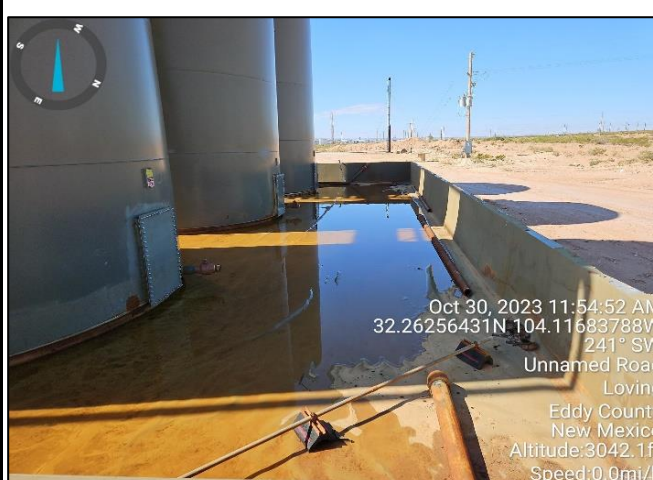
Photograph: 8 Date: 10/30/2023

A 48-hour advance notice of liner inspection was provided via email to the NMOCD on October 26, 2023. A liner integrity inspection was completed for the storage tank containment liner by Ensolum personnel on October 30, 2023. Upon inspection, no rips, tears, holes, or damage was observed. The liner was determined to be sufficient.

Description: View of lined containment with pooled rain water, deemed to be in good condition, facing east.
