## DEFERRAL REQUEST

**Mills 19 #001 CTB**

**Lea County, New Mexico  
32.37825 N, 103.72201 W  
NMOCD Incident ID: nAPP2302535216**

January 26, 2024  
Ensolum Project No. 03B1417072

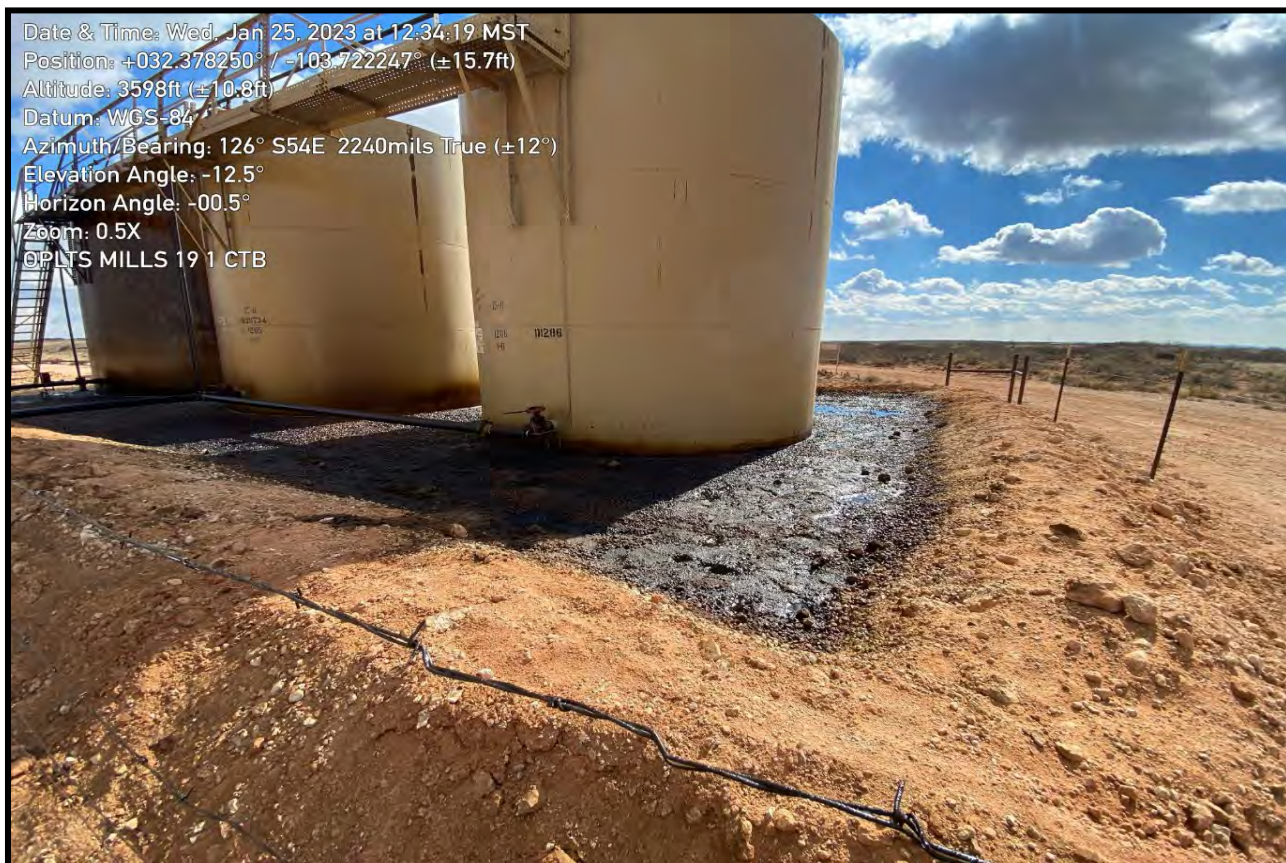
View of impact area subsequent to release, facing southeast.

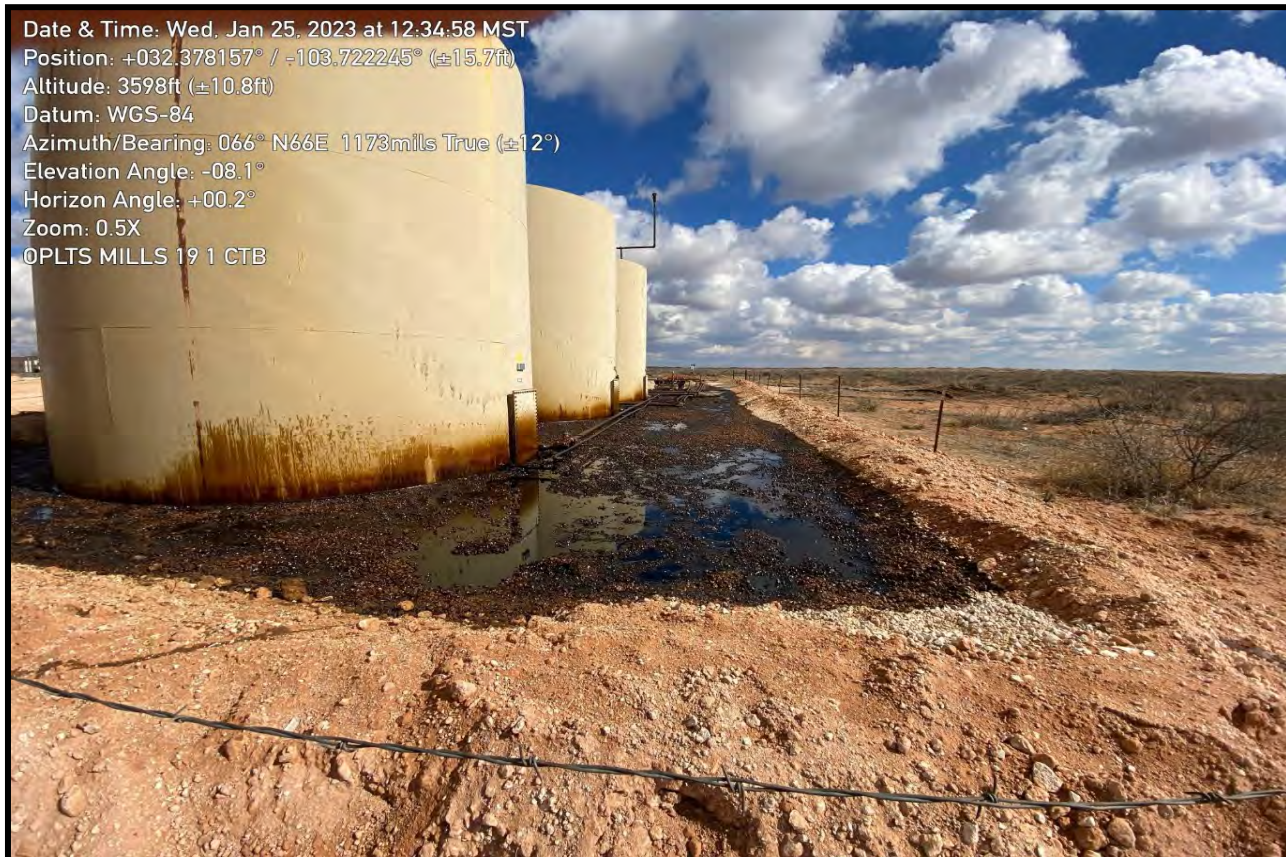
View of impact area subsequent to release, facing northeast.

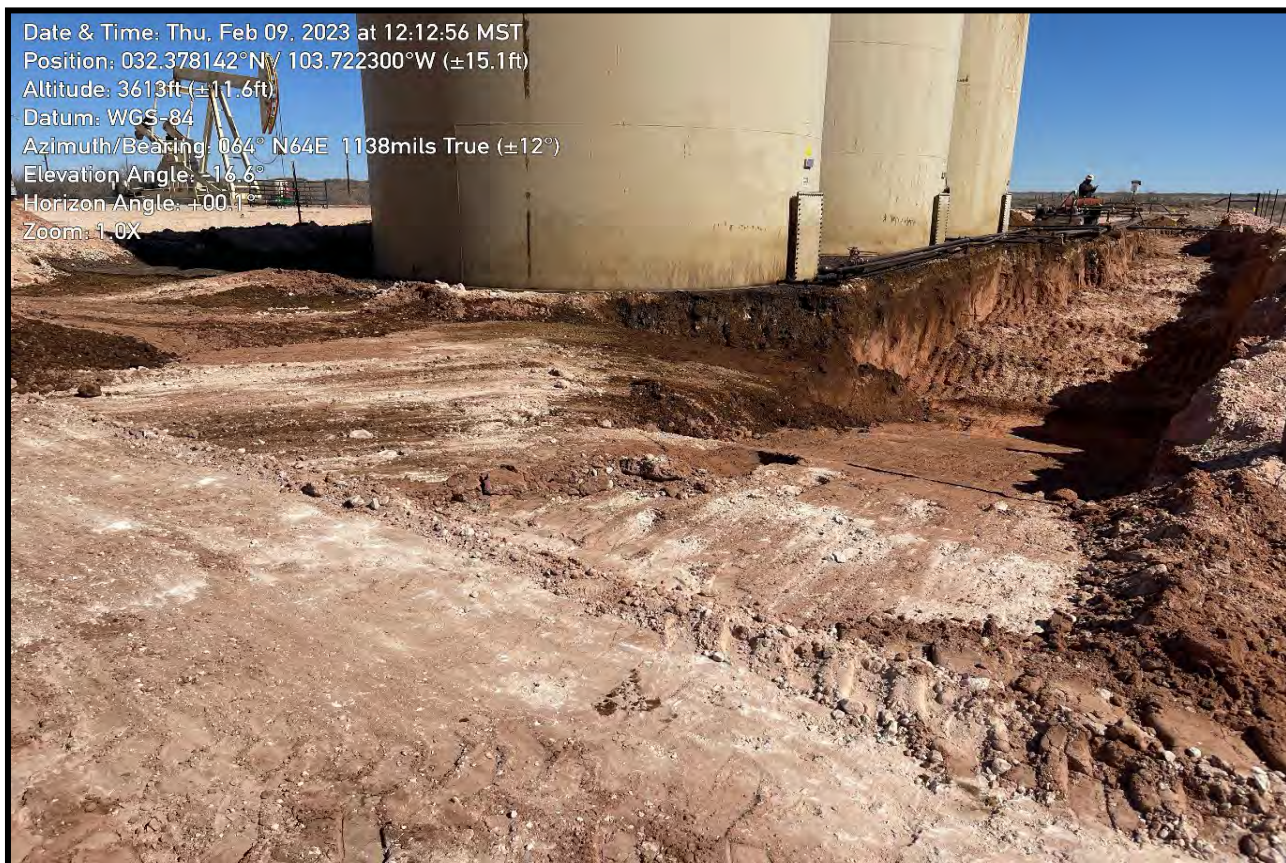
View of impact area during excavation activities, facing northeast.

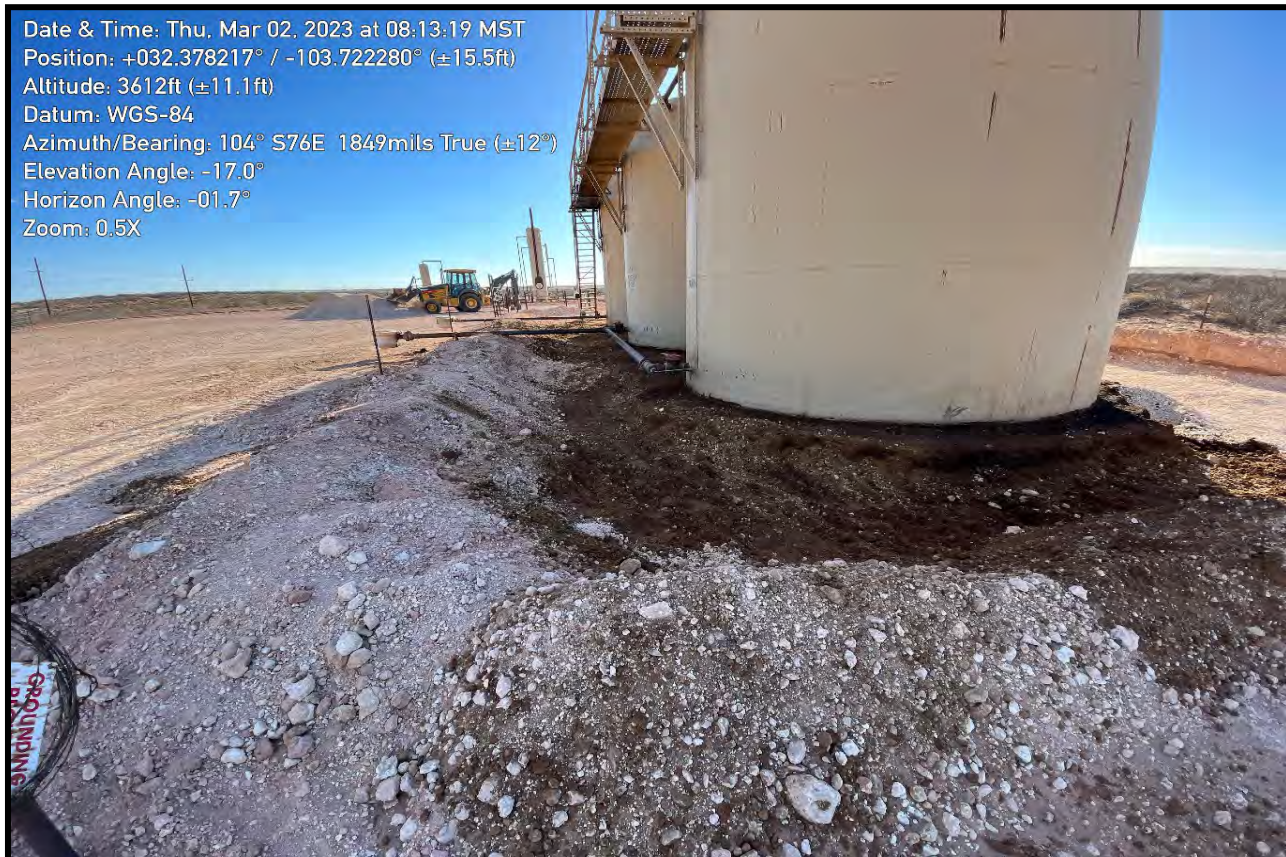
View of impact area during excavation activities, facing southeast.

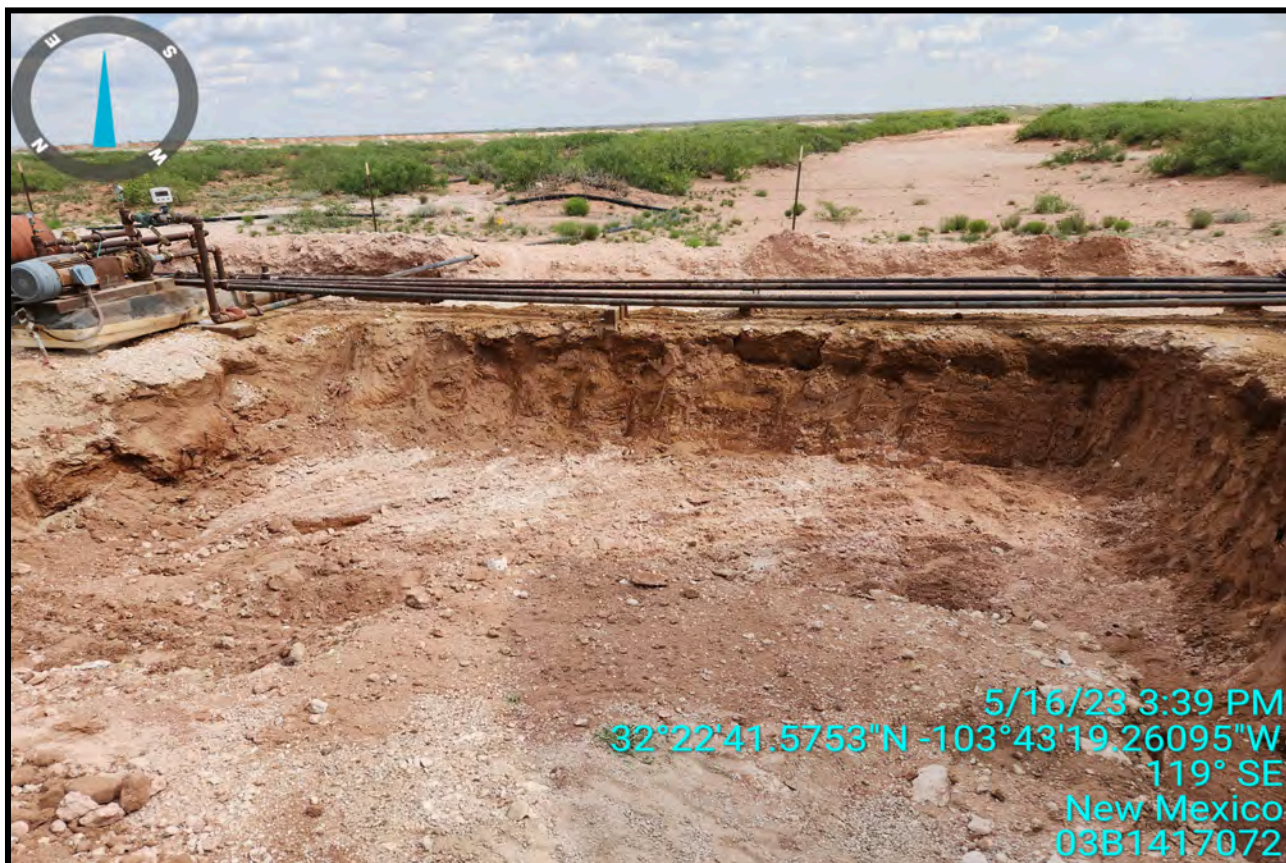
View of impact area during excavation activities, facing southeast.

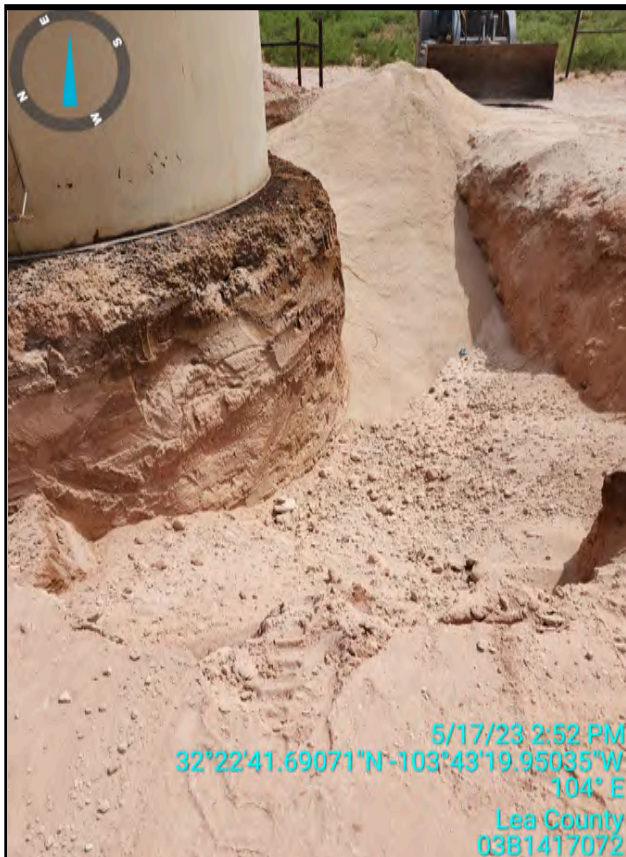
View of excavation activities, facing southeast.

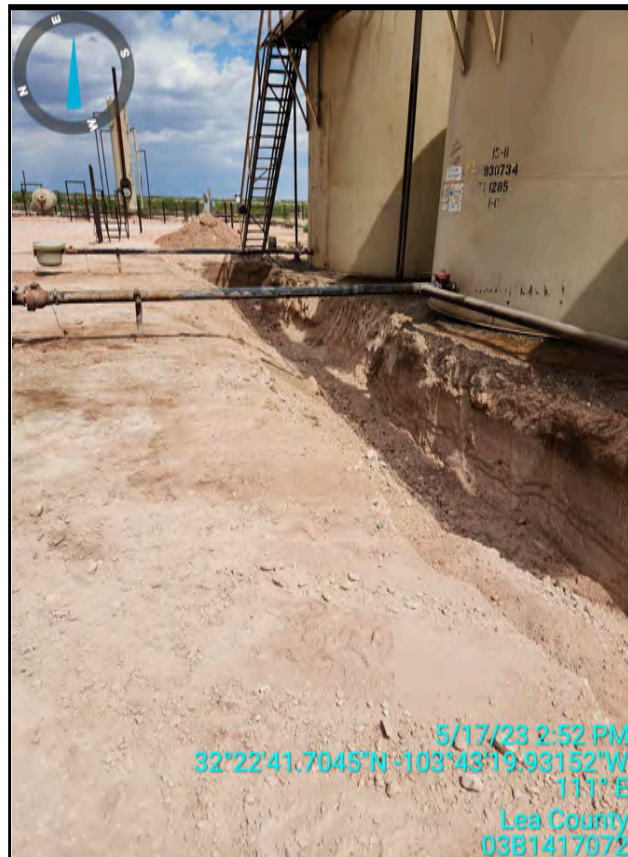
View of excavation activities, facing southeast.
