**Re: Closure Request  
Rojo 10-13 Tank Battery  
Incident Number NRM2022745673  
Lea County, New Mexico**

Ensolum, LLC (Ensolum), on behalf of BTA Oil Producers, LLC (BTA), has prepared this *Closure Request* to document delineation and soil sampling activities performed at the Rojo 10-13 Tank Battery (Site). The purpose of the Site assessment, delineation, and soil sampling activities was to assess for the presence or absence of impacts to soil following a release of produced water. Based on field observations, delineation activities, and soil sample laboratory analytical results, BTA is submitting this *Closure Request*, describing Site assessment and delineation activities that have occurred and requesting no further action and closure for Incident Number NRM2022745673.

BTA Oil Producers, LLC  
Closure Request  
Rojo 10-13 Tank Battery

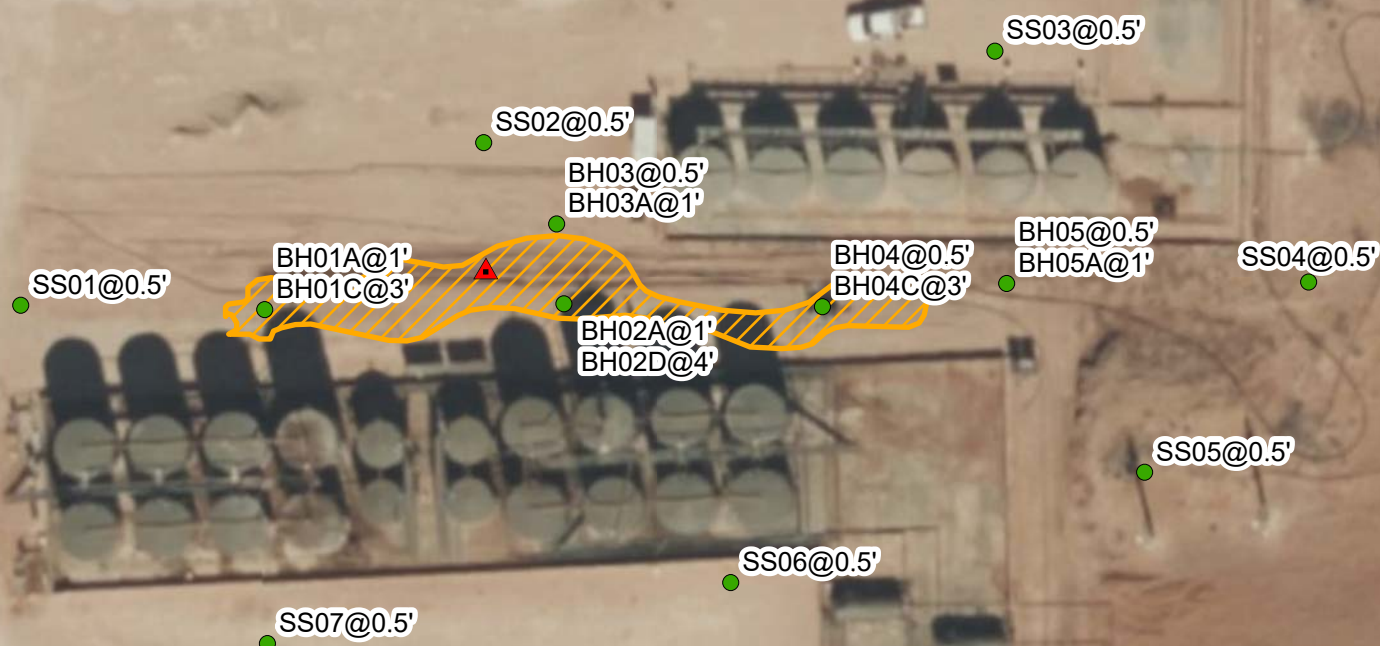
**Legend**

- Delineation Soil Sample in Compliance with NMOCD Closure Criteria
- ▲ Point of Release (POR)
- Release Extent

Notes:  
 Sample ID @ Depth Below Ground Surface.  
 NMOCD: New Mexico Oil Conservation Division

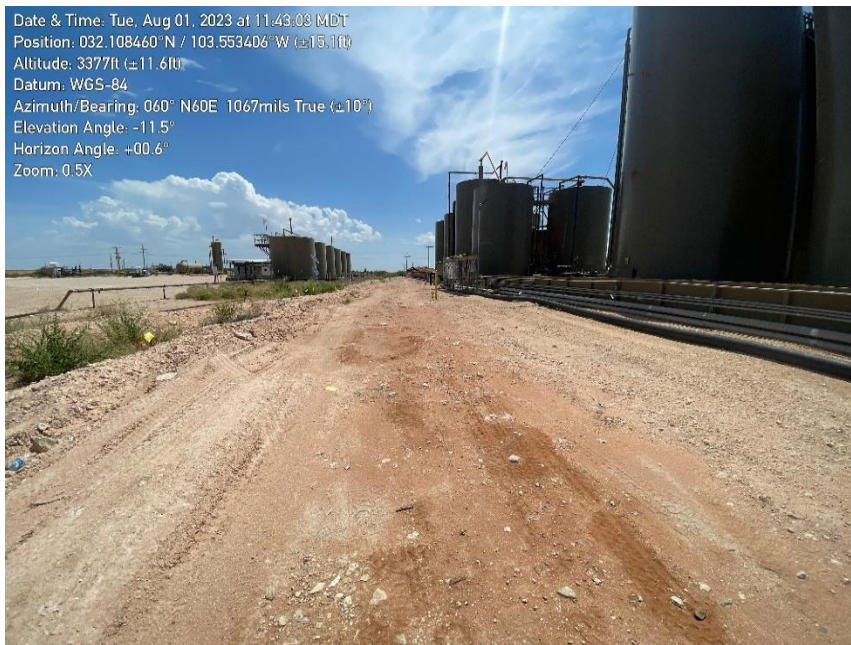
Photograph 1

Description: View of release extent during delineation activities, facing east.

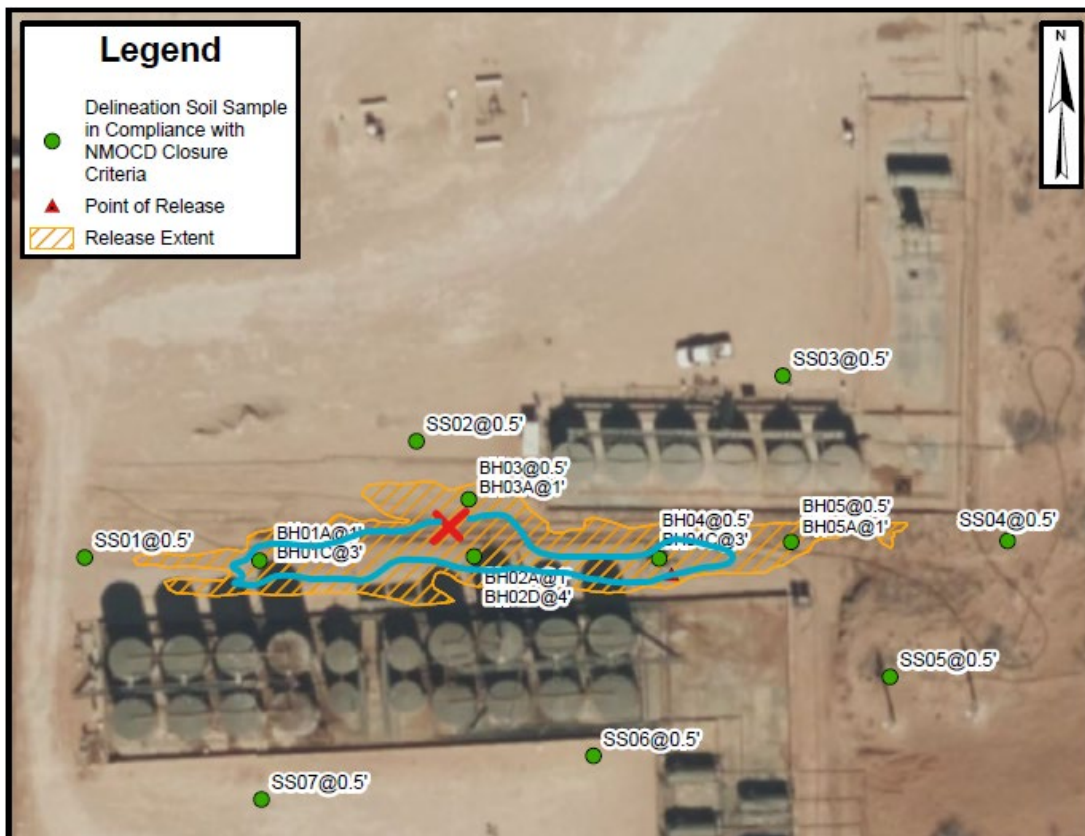
Upon further investigation of the Rojo 10-13 Tank Battery (Incident Number NRM2022745673; marked in blue in the below snippet) release, we determined that the release extent overlays the NCH1834763224 release extent previously approved and closed. I'd like to submit a Closure Request for the NRM2022745673 release using the same data collected for Incident NCH1834763224. The NMOCD notifications submitted were for the NCH1834763224 release and I would like to request a variance to use these same confirmation samples and notifications for the NRM2022745673 release.
