Site Assessment, Remediation, and Closure Report

DaVinci 7 18 Federal Com #009H Incident# nAB1906751888 Eddy County, New Mexico

March 21, 2024

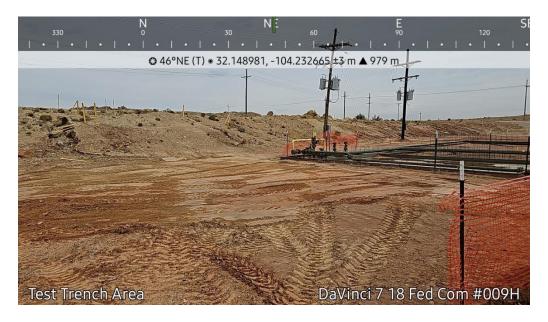
TEST TRENCH AREA

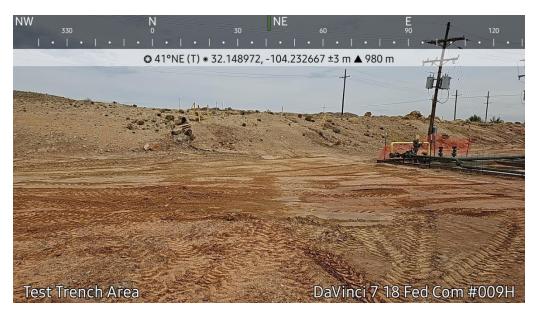
TEST TRENCH AREA

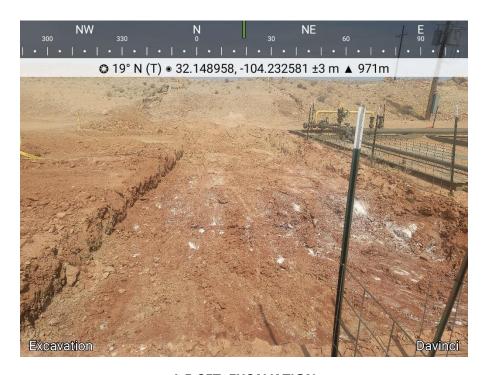
1.5-2FT. EXCAVATION

- The impacted area near sample point TT-1 was excavated to a total depth of 1.5 to 2feet BGS.
- Composite confirmation samples were obtained from the bottom and sidewalls of the excavated area every 200-square feet.
- All excavated material approximately (70yds) was hauled to Lea Land, a NMOCD approved solid waste disposal facility.
- The excavated area on the well pad were backfilled with new caliche at depth and brought to grade, machine compacted and contoured to match the surrounding location.

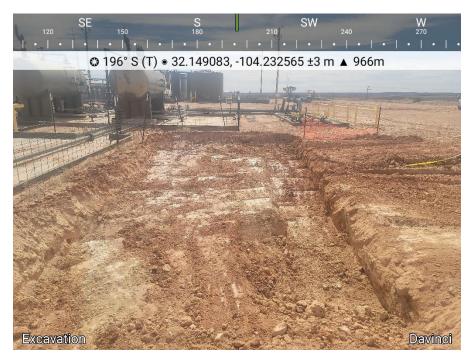
1.5-2FT. EXCAVATION
