**Re: Deferral Request**  
**RDX 15 East Production Pad**  
**Incident Number nAPP2323030159**  
**Eddy County, New Mexico**

WPX Energy Permian, LLC  
Deferral Request  
RDX 15 East Production Pad

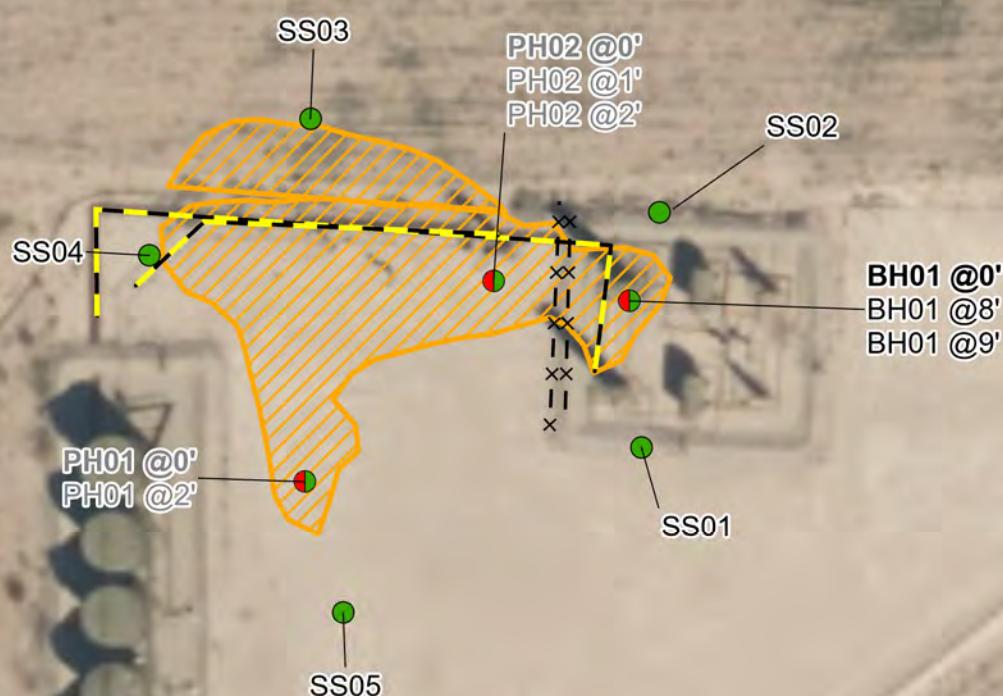
**2**

to soil. Delineation soil samples were collected from each pothole at depths ranging from ground surface to 2 feet bgs. A single borehole (BH01) was advanced via hand auger to a depth of 9 feet bgs to establish the vertical extent inside the earthen secondary containment. Delineation soil samples were collected from the borehole at depths ranging from ground surface to 9 feet bgs. Soil from the potholes PH01 and PH02 and borehole BH01 were field screened for TPH and chloride in the same manner previously described above. Field screening results and observations for the potholes were logged on lithologic soil sampling logs, which are included in Appendix D. The delineation soil sample locations are depicted on Figure 2.

## Delineation Soil Sample Locations

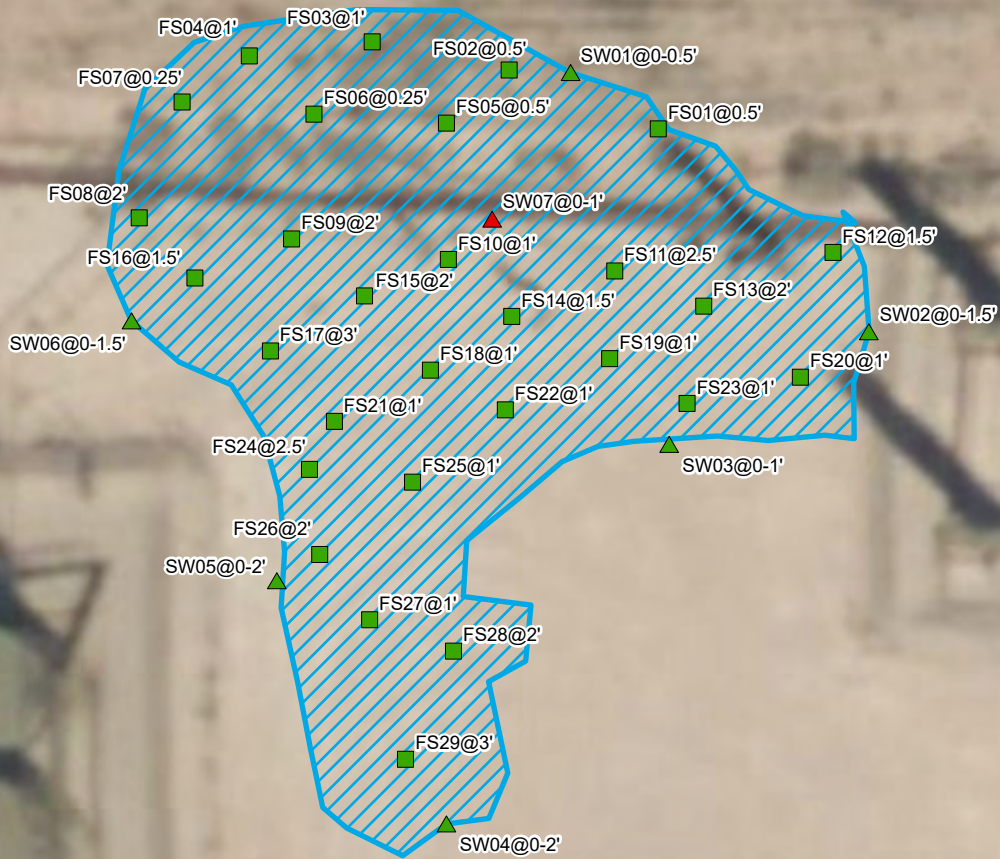
**3**

Ensolum personnel returned to the Site on November 21, 2023, to recollect excavation floor soil samples FS01, FS03, FS04, FS09, FS11, FS13, FS17 and FS29; all COC concentrations within the eight soil samples were in compliance the Site Closure Criteria and below the reclamation requirement. The excavation extent and excavation soil sample locations were mapped utilizing a handheld GPS unit and are depicted on Figure 3.

## Confirmation Soil Sample Locations

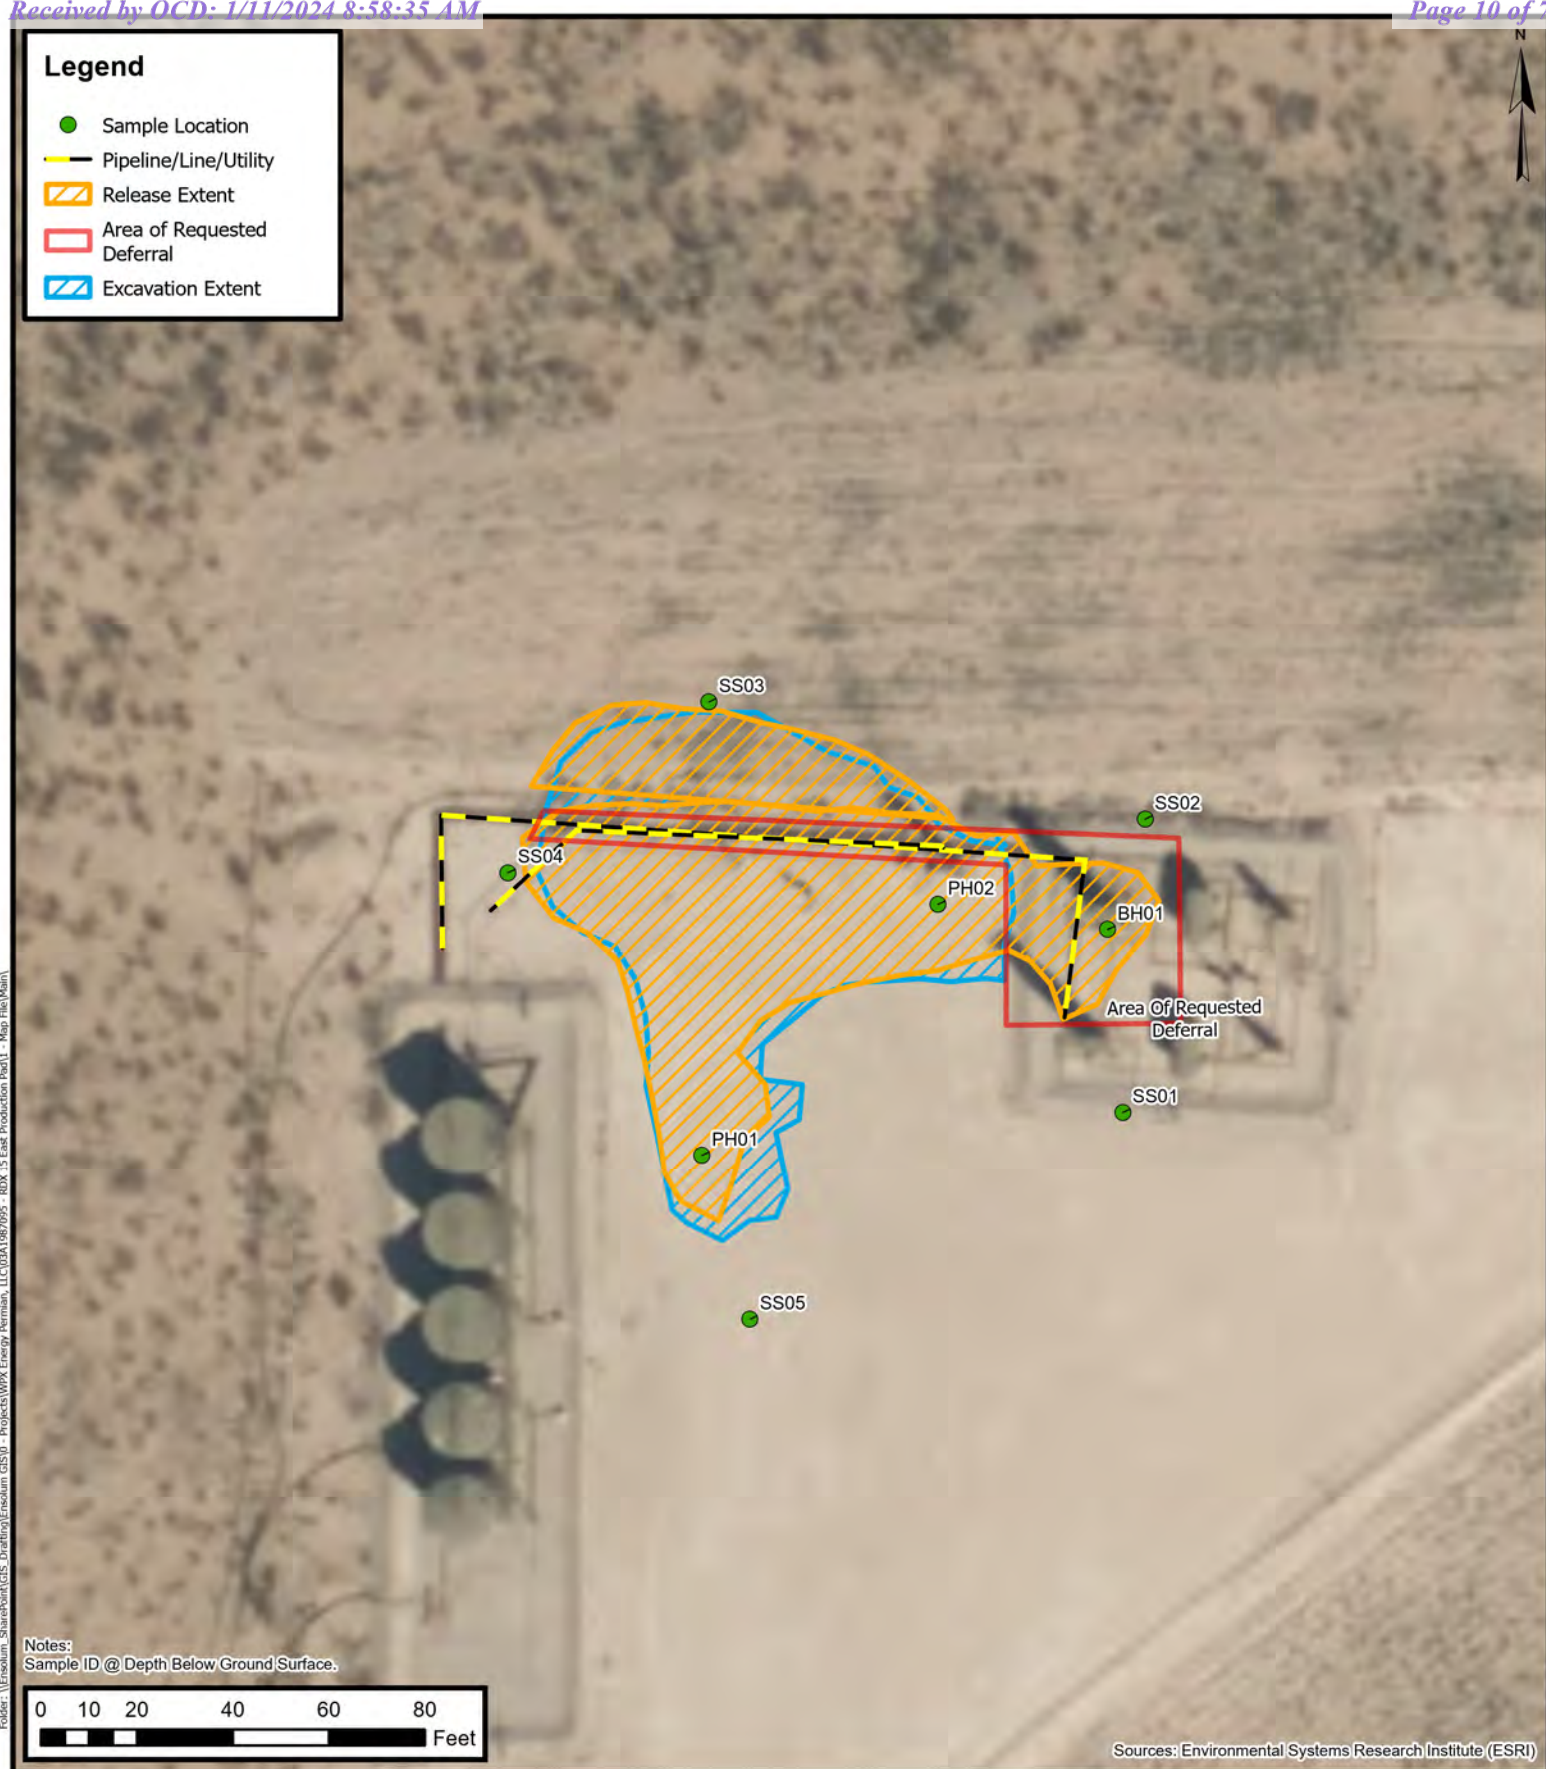
**FIGURE**  
**4**

WPX has remediated impacts at the Site to the maximum extent practicable (MEP) based on Site safety conditions relating to active production equipment and associated flow lines. WPX is requesting deferral of final remediation of residual impacts due to the presence of active production equipment and process piping preventing full excavation of impacted soil. The impacted soil is limited to the area beneath production equipment and surface piping, where remediation would require a major facility deconstruction. WPX was able to excavate approximately 580 cubic yards of accessible impacted soil outside of the earthen containment. The impacted soil remaining in place is laterally defined by delineation soil samples SS01 and SS02 at ground surface as well as the confirmation samples FS12 and FS20, along the west side of the earthen containment, and vertically defined by borehole samples BH01@8' and BH01@9'. The estimated area of remaining impacted soil measures an area of 1,850 square feet, and a total of approximately 548 cubic yards of impacted soil remains in place, assuming a depth of 8 feet bgs based on laboratory analytical results from delineation soil samples.

## Area of Requested Deferral

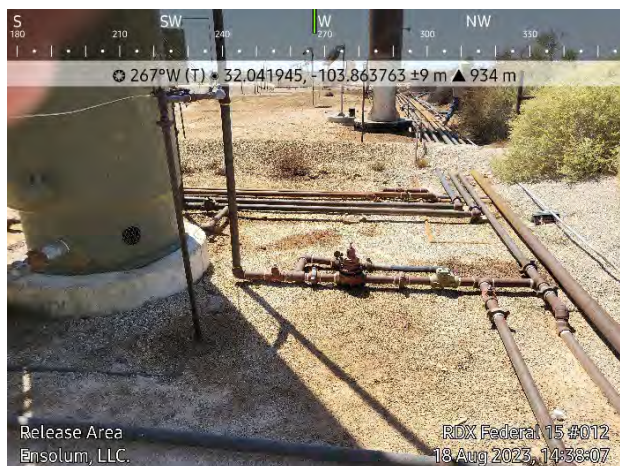
Photograph 1  
Description: Release Area  
View: West

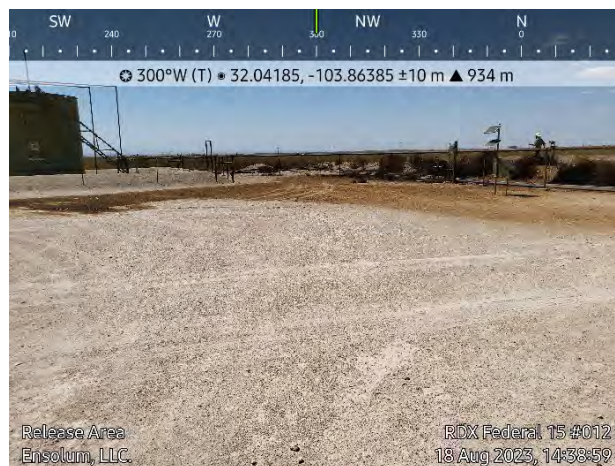
Photograph 2  
Description: Release Area  
View: West

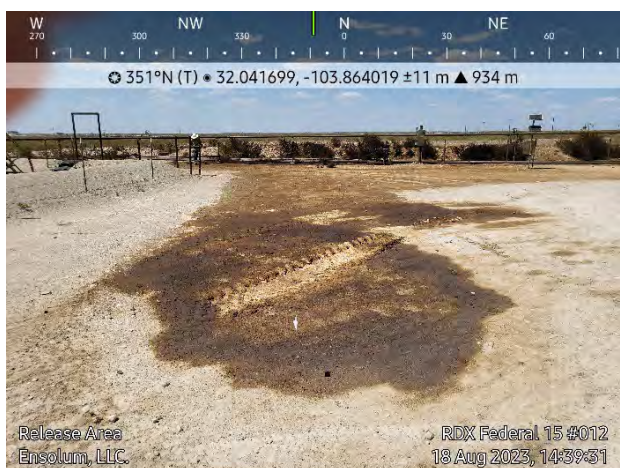
Photograph 3  
Description: Release Area  
View: North

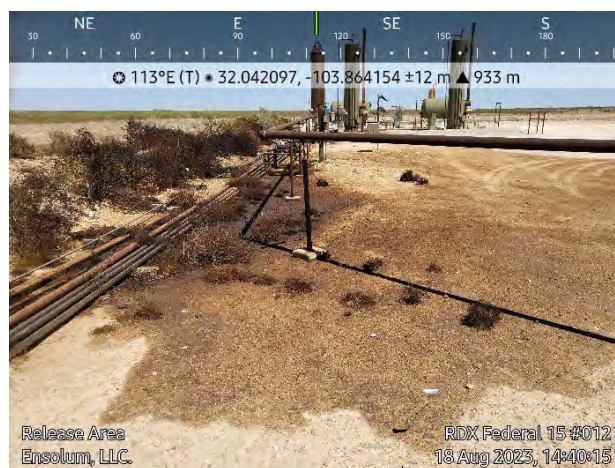
Photograph 4  
Description: Release Area  
View: East

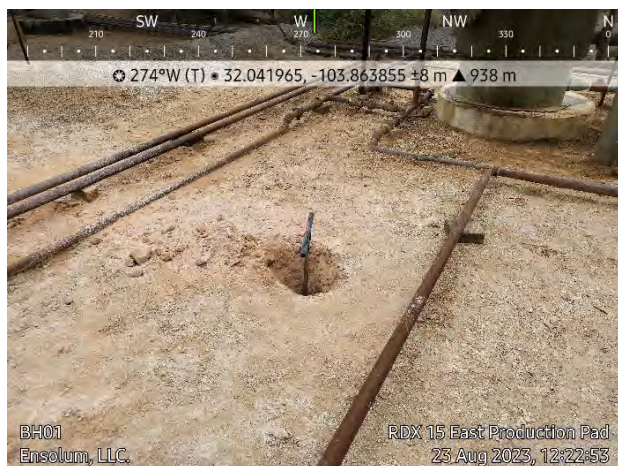
Photograph 5 Date: 8/23/23  
Description: BH01 Vertical Delineation  
View: North

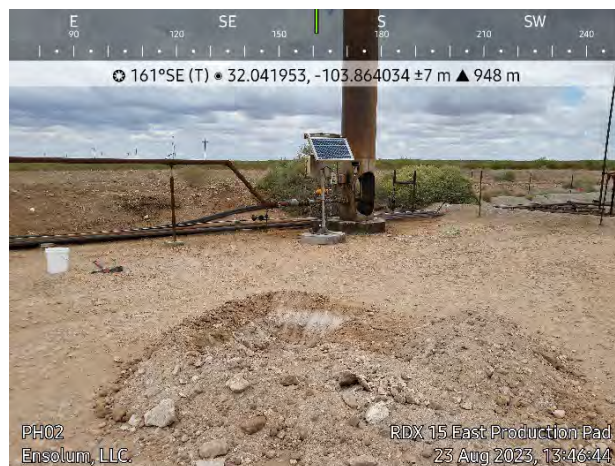
Photograph 6 Date: 08/23/2023  
Description: PH02 Vertical Delineation  
View: Northeast

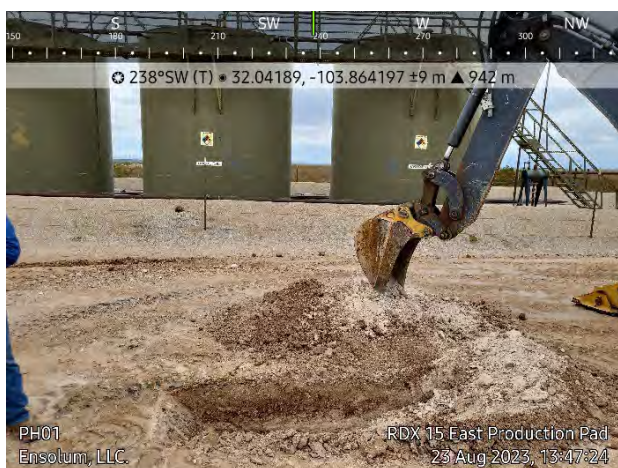
Photograph 7 Date: 08/23/2023  
Description: PH01 Vertical Delineation  
View: West

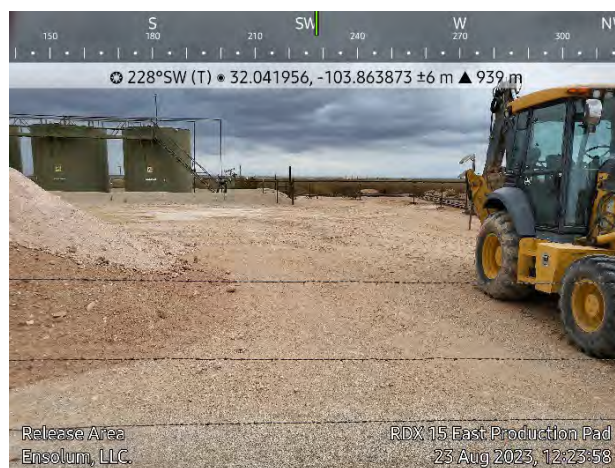
Photograph 8 Date: 08/23/2023  
Description: Release Area after scrape  
View: West

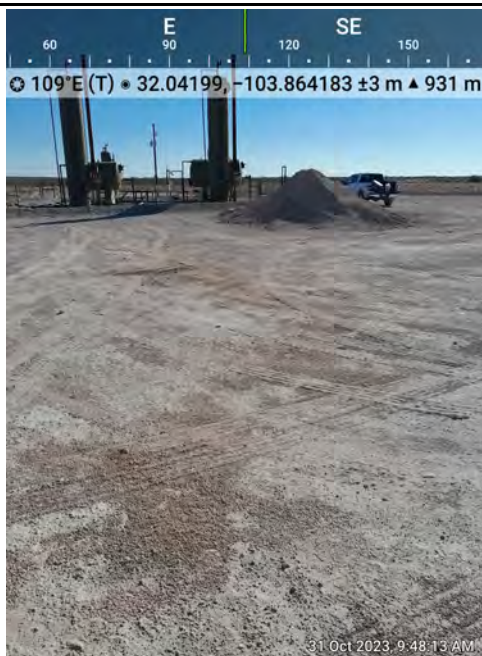
Photograph 9 Date: 10/31/23  
Description: Hand digging around equipment  
View: East

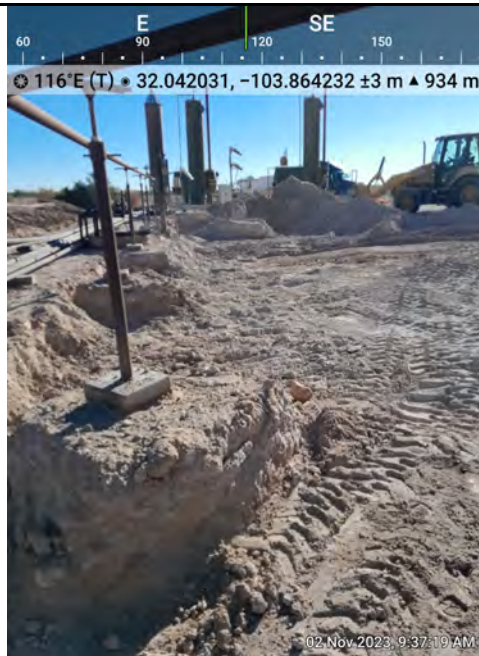
Photograph 10 Date: 11/2/23  
Description: Excavation  
View: East

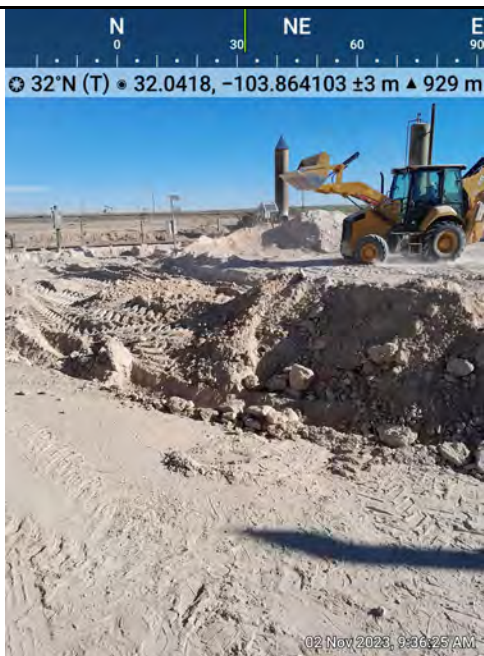
Photograph 11 Date: 11/2/23  
Description: Excavation  
View: Northeast

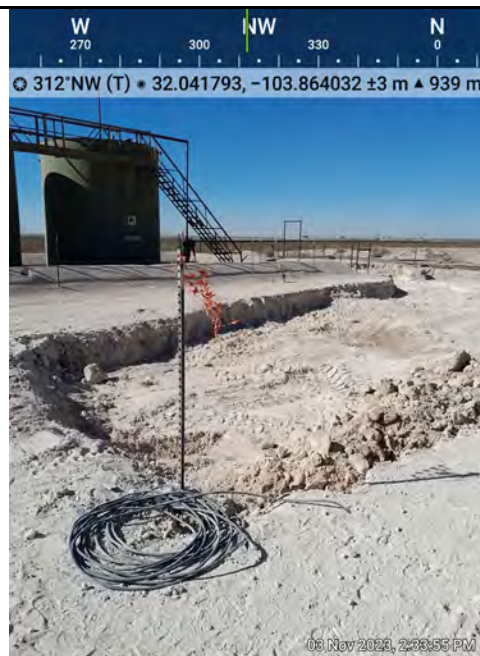
Photograph 12 Date: 11/3/23  
Description: Excavation  
View: Northwest

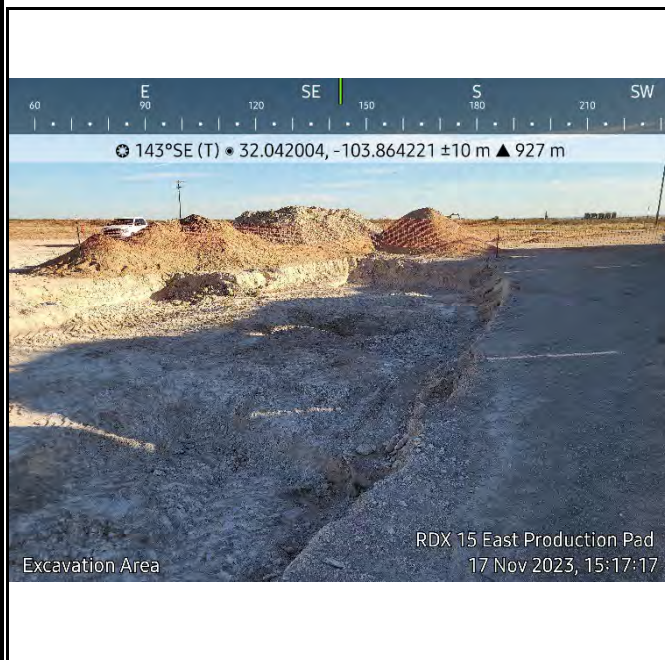
Photograph 13  
Description: Excavation  
View: Southeast

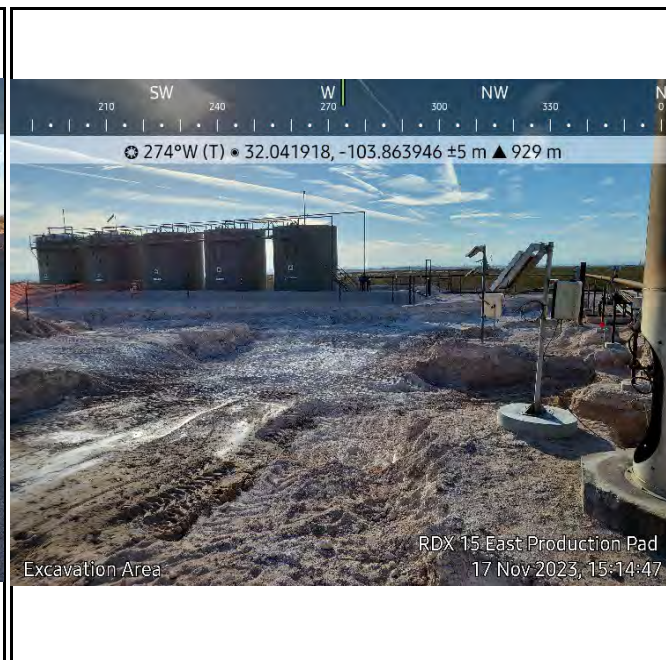
Photograph 14  
Description: Excavation  
View: West

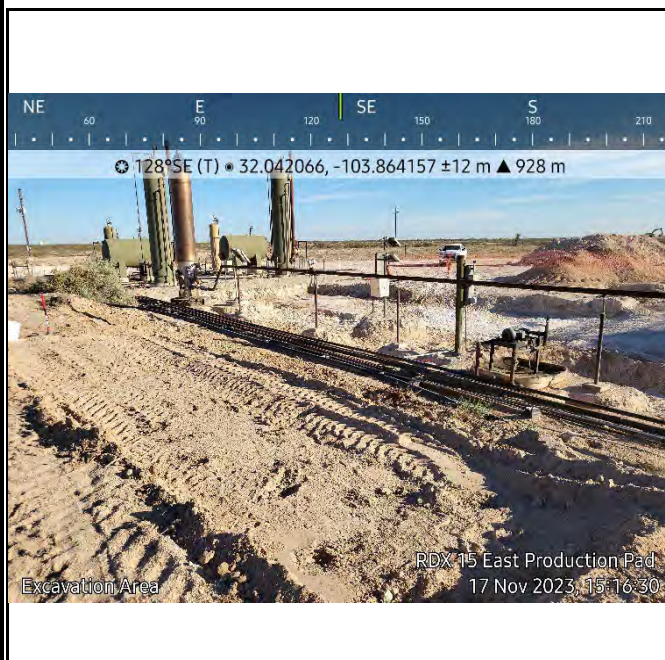
Photograph 15  
Description: Excavation  
View: Southeast

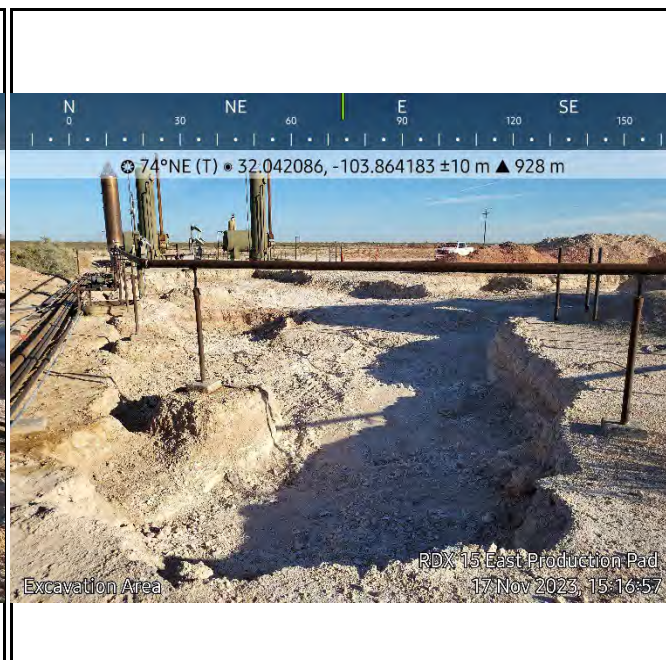
Photograph 16  
Description: Excavation  
View: East
