## CLOSURE REPORT

**Neil Gas Com B#1 (11/06/23)**  
Unit Letter L, S14 T31N R11W  
San Juan County, New Mexico

**New Mexico EMNRD OCD Incident ID No. NAPP2331047418**

**January 4, 2024**

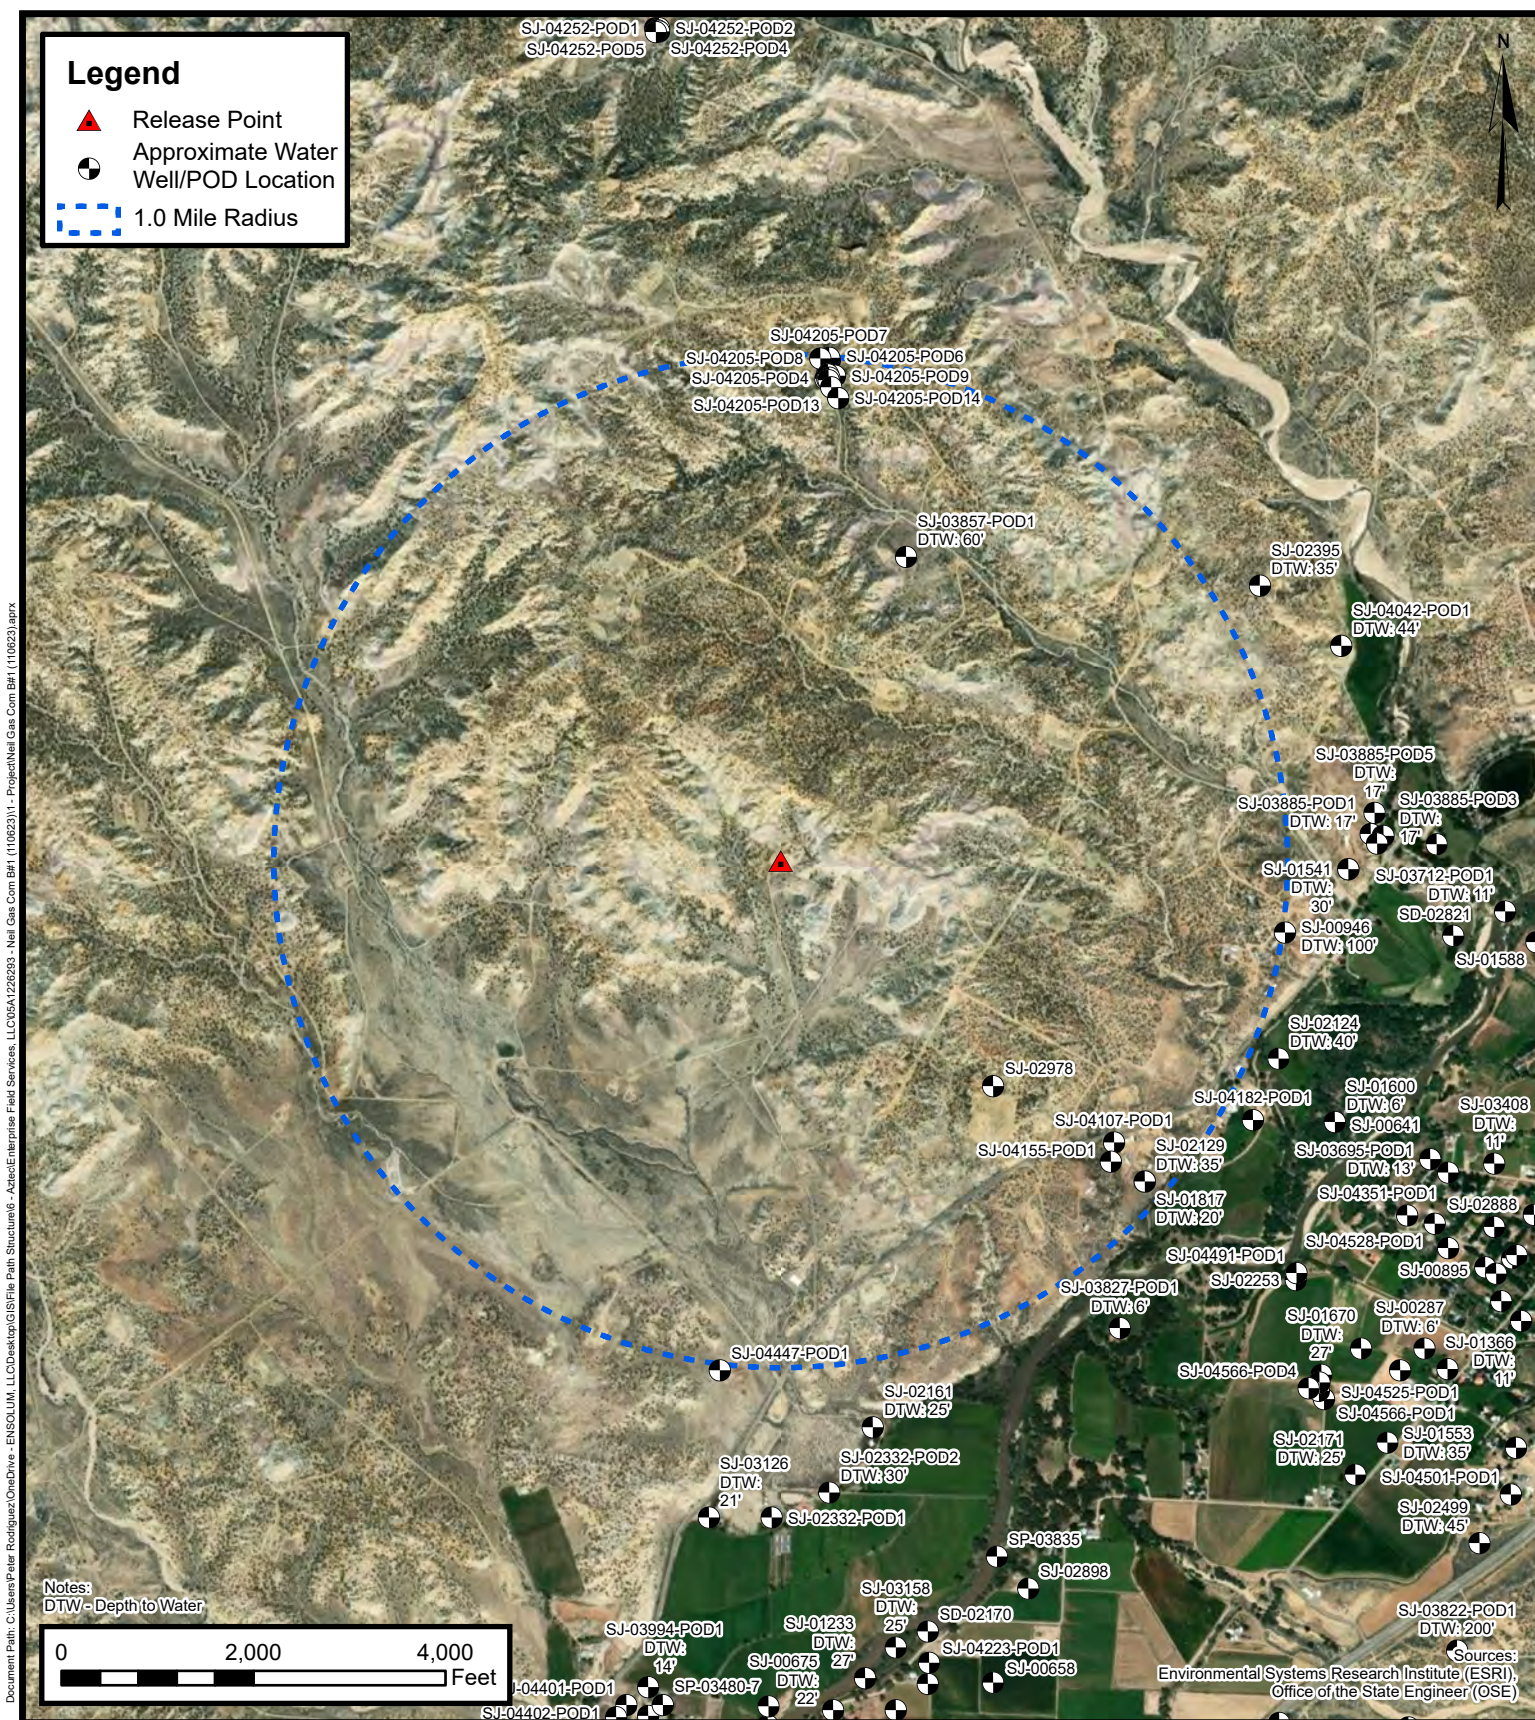
FIGURE  
**A**

elevation than the Site. The recorded depth to water for this POD is 60 feet bgs (**Figure A, Appendix B**).

## 1.0 Mile Radius Water Well / POD Location Map

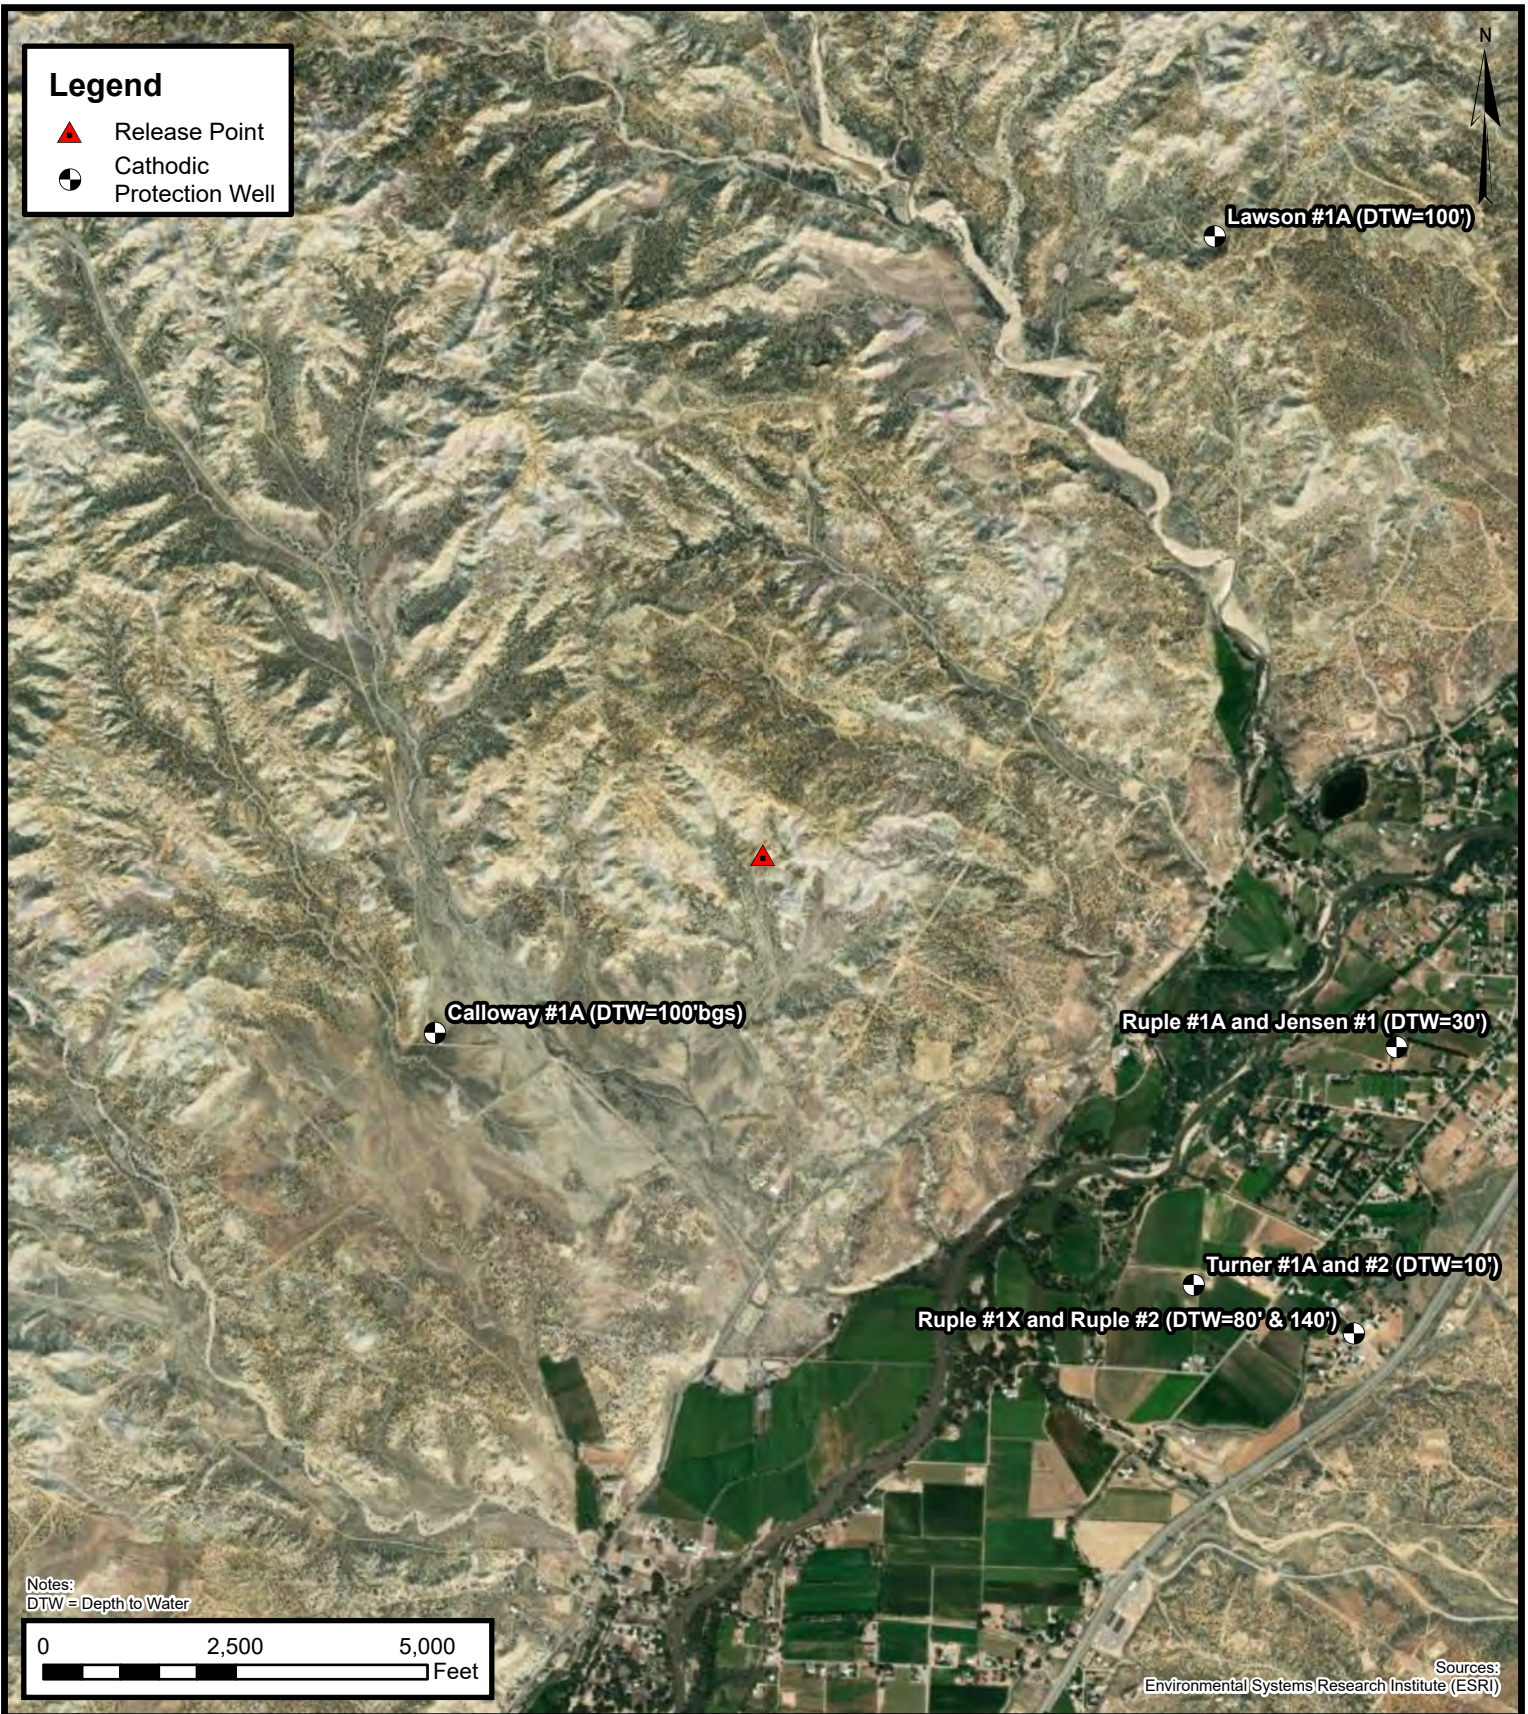
**FIGURE  
B**

- Five cathodic protection wells (CPWs) were identified in the NM EMNRD OCD imaging database in the adjacent PLSS sections. These CPWs are depicted on **Figure B (Appendix B)**. The closest CPW (Calloway #1A) is located less than one mile from the Site. Documentation for the cathodic protection well located near the Calloway #1A production pad indicates a depth to water of 100 feet bgs. This cathodic protection well is located approximately 0.92 miles southwest of the Site and is approximately 34 feet lower in elevation than the Site. The other four CPWs are located over 1.5 miles from the Site. The average depth to water for these CPWs is 72 feet bgs.

## Cathodic Protection Well Recorded Depth to Water

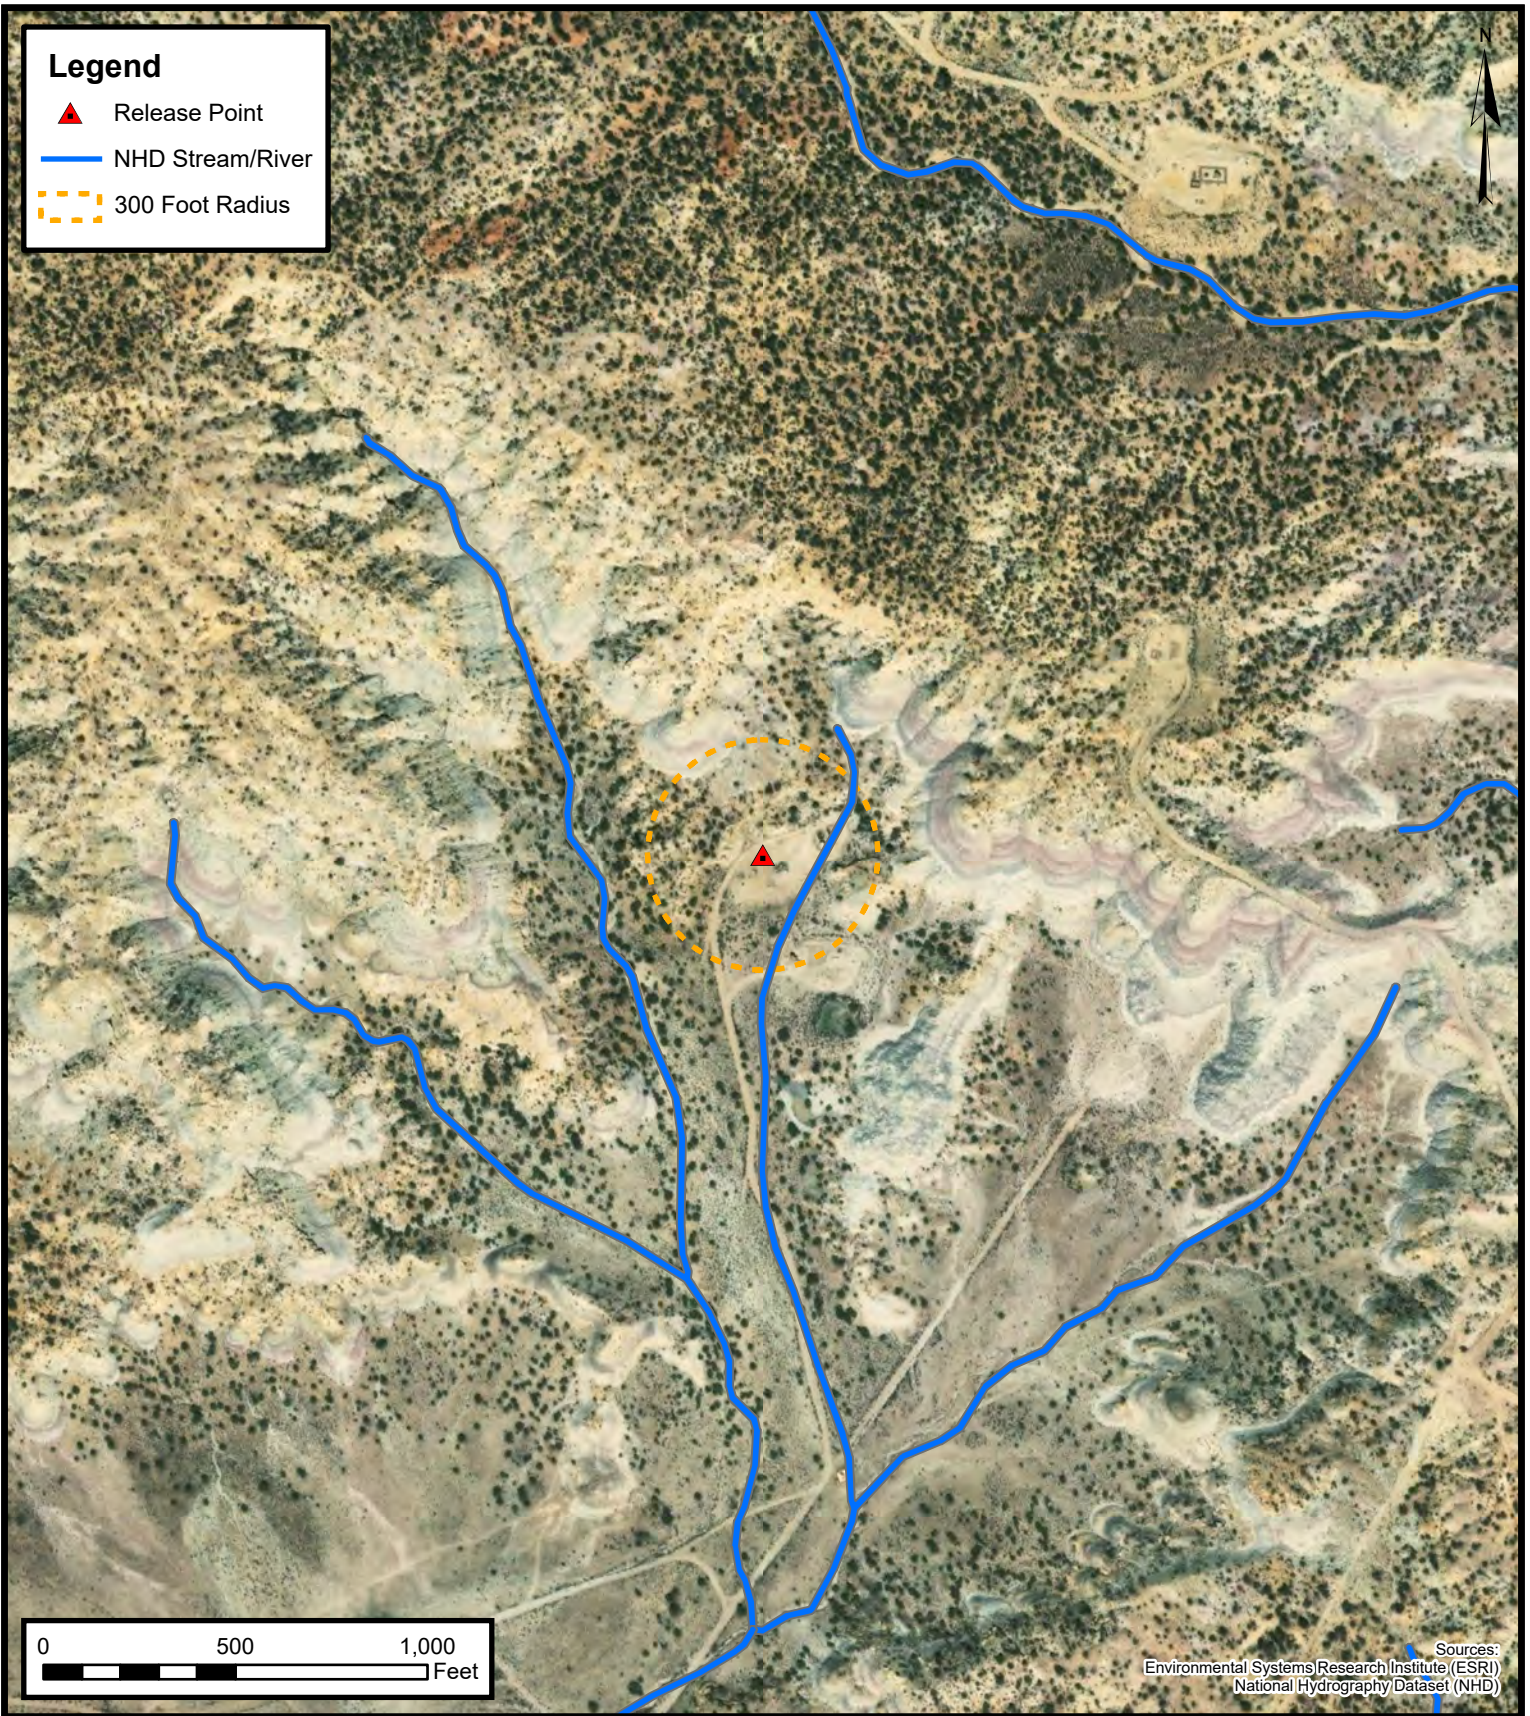
FIGURE  
C

- The Site is located within 300 feet of a NM EMNRD OCD-defined continuously flowing watercourse or significant watercourse (**Figure C, Appendix B**).

### 300 Foot Radius Watercourse and Drainage Identification

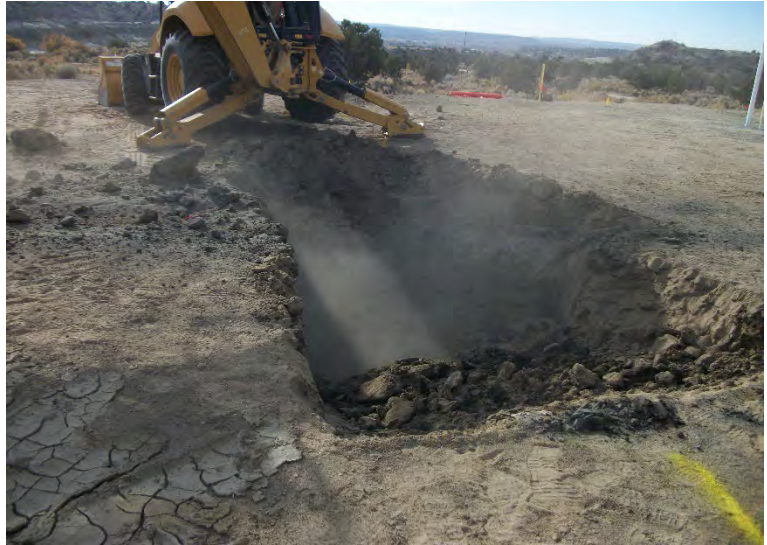
**Photograph 1**

Photograph Description: View of the in-process excavation activities (first excavation).

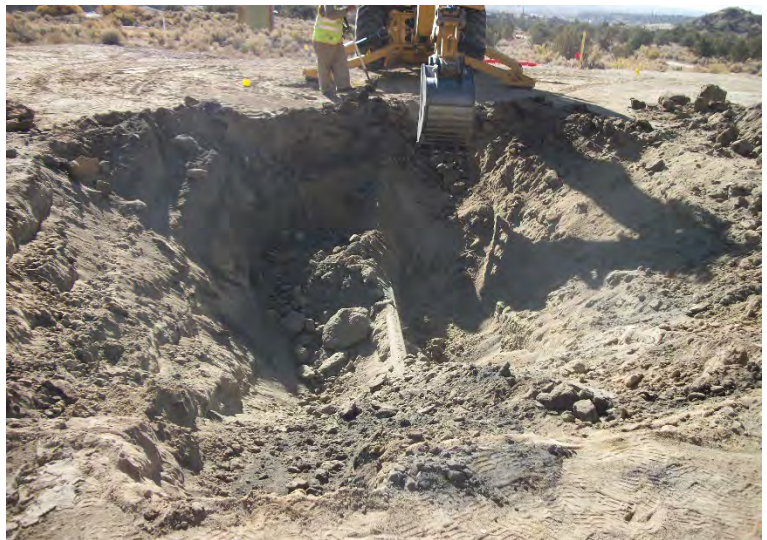
**Photograph 2**

Photograph Description: View of the in-process excavation activities (first excavation).

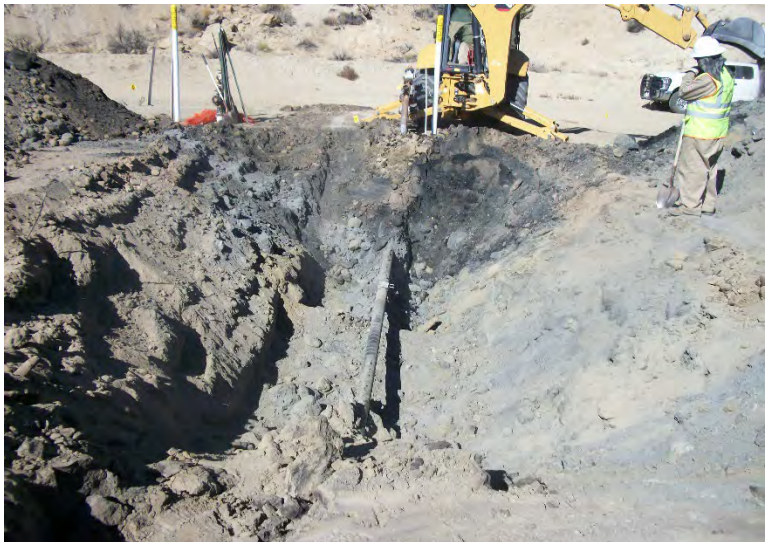
**Photograph 3**

Photograph Description: View of the in-process excavation activities (first excavation).

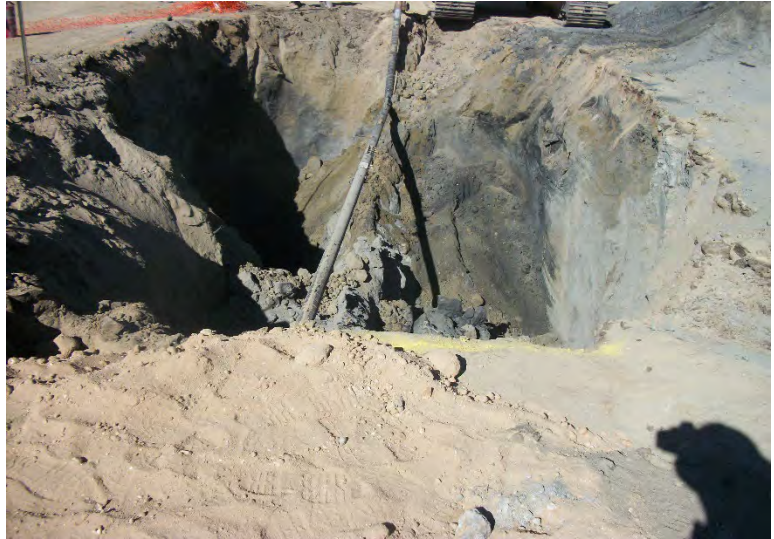
**Photograph 4**

Photograph Description: View of the in-process excavation activities (first excavation).

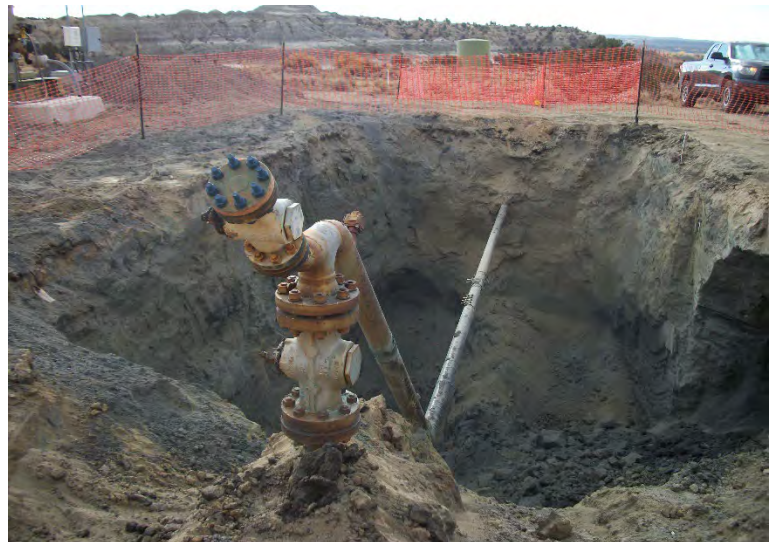
**Photograph 5**

Photograph Description: View of the final excavation (first excavation).

The first excavation measured approximately 26 feet long and 14 feet wide at the maximum extents. The maximum depth of the first excavation measured approximately 14 feet bgs. The second excavation measured approximately 10 feet long and 10 feet wide at the maximum extents. The maximum depth of the second excavation measured approximately five feet bgs. The lithology encountered during the completion of remediation activities consisted primarily of consolidate to unconsolidated silty sand and clay.

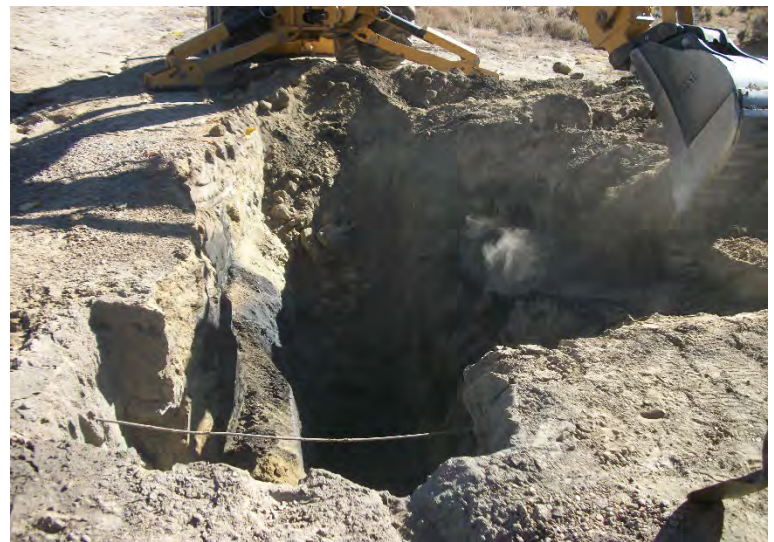
**Photograph 6**

Photograph Description: View of the in-process excavation activities (second excavation).

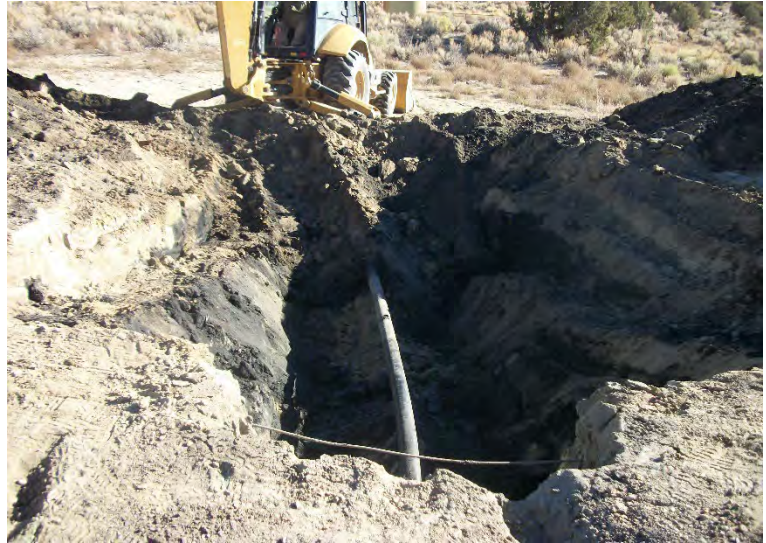
**Photograph 7**

Photograph Description: View of the final excavation (second excavation).

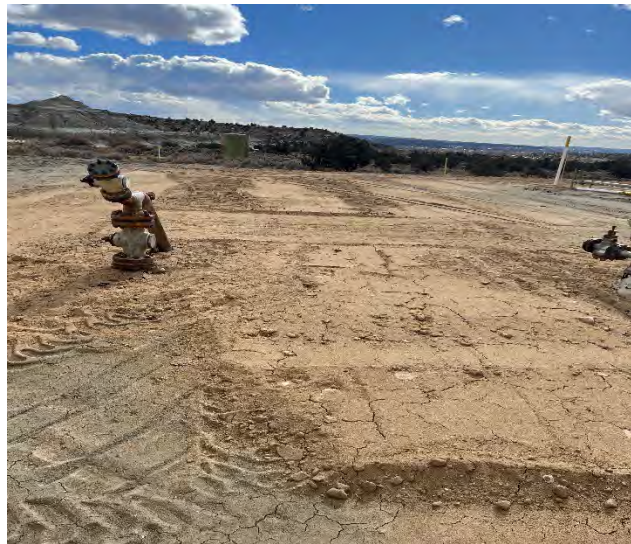
**Photograph 8**

Photograph Description: View of the site after initial restoration (first excavation).

The excavation was backfilled with imported fill and then contoured to the surrounding grade.

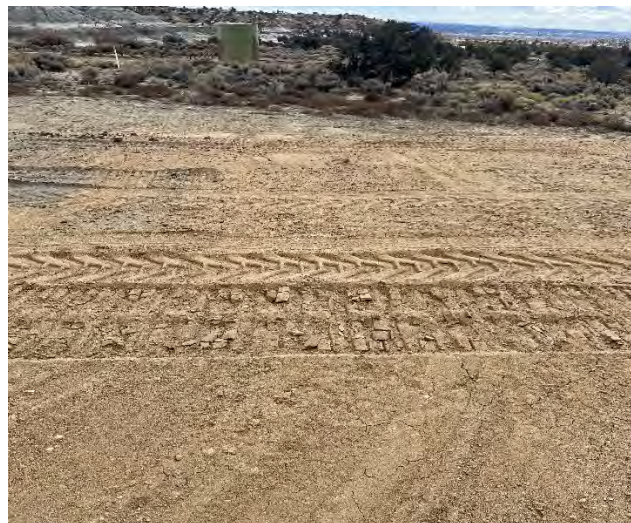
**Photograph 9**

Photograph Description: View of the site after initial restoration (second excavation).
