Release Assessment and Closure

Boyd Y Water Transfer Line

Vertex File Number: 23E-05378

Silverback Exploration

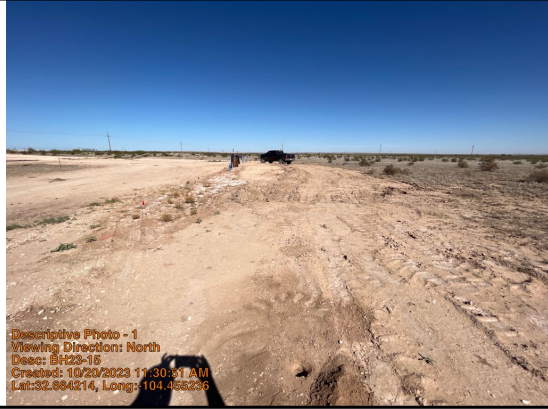
Viewing Direction: North

BH23-15 @ 0-2ft

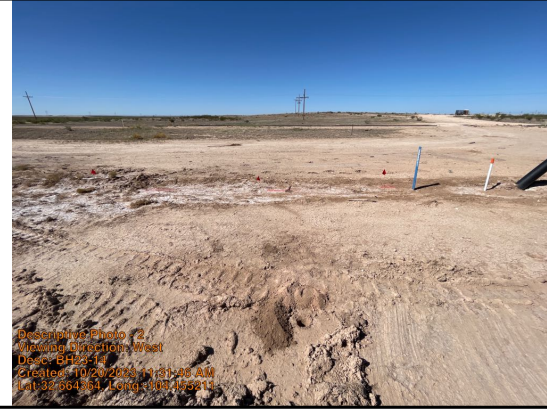
Viewing Direction: West

BH23-14 @ 0-2ft

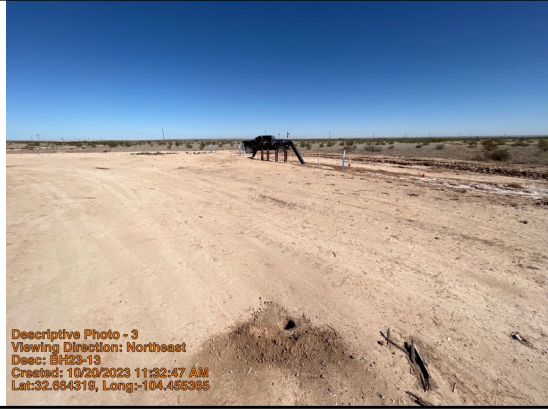
Viewing Direction: Northeast

BH23-13 @ 0-2ft

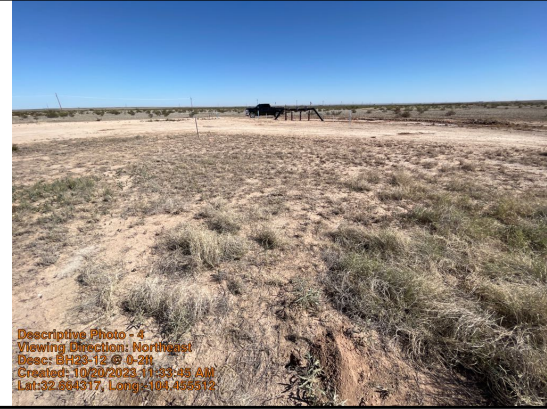
Viewing Direction: Northeast

BH23-12 @ 0-2ft

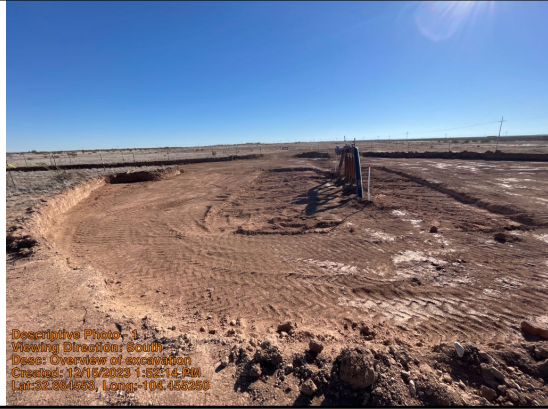
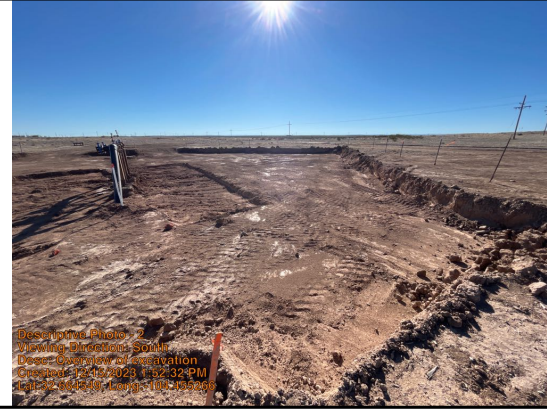
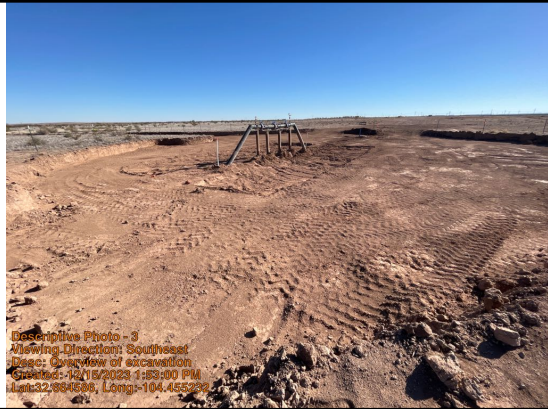
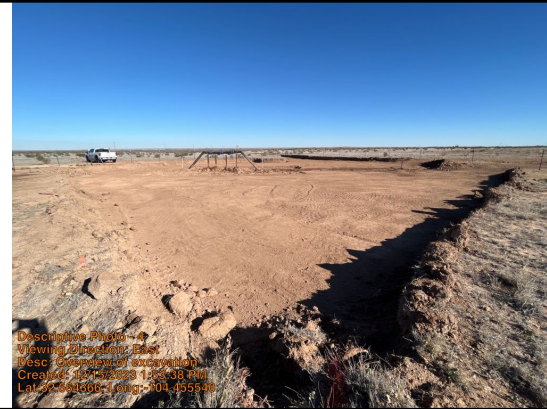
Overview of excavation

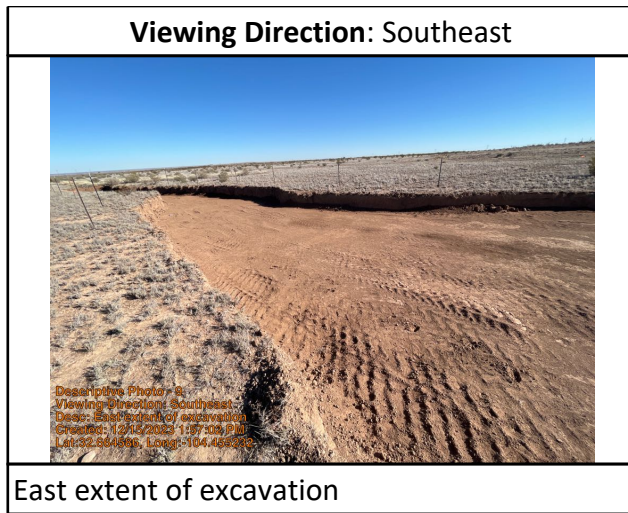
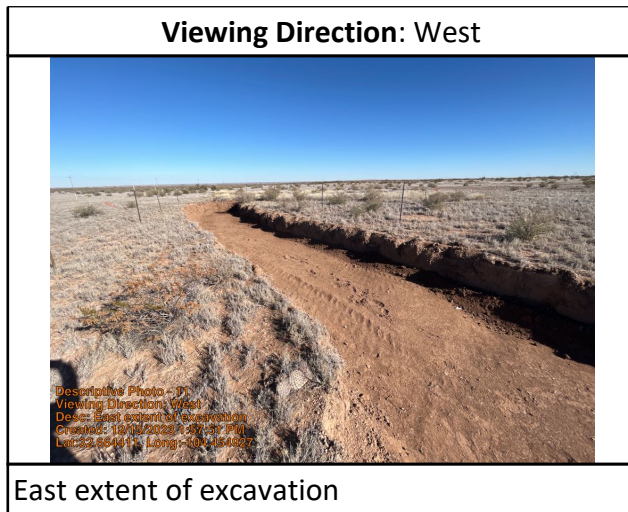
East extent of excavation

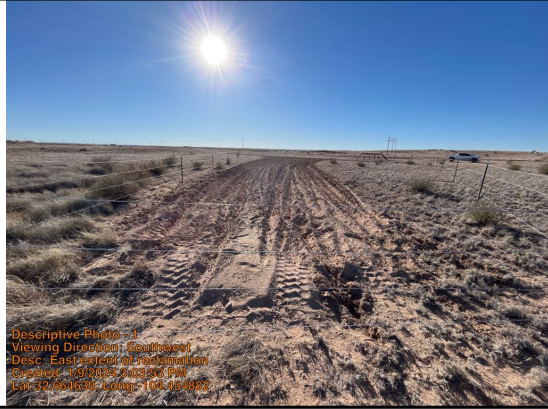
Description Photo - 1
Viewing Direction: Southwest
Desc: East extent of reclamation
Created: 1/9/2024 2:03:20 PM
Lat: 32.491653, Long: 104.483119

East extent of reclamation

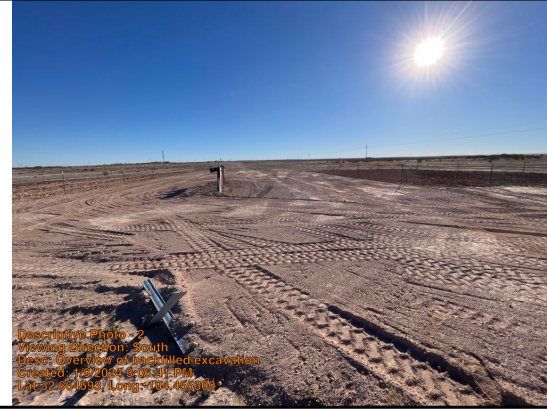
Description Photo - 2
Viewing Direction: South
Desc: Overview of backfilled excavation
Created: 1/9/2024 2:05:31 PM
Lat: 32.491653, Long: 104.483119

Overview of backfilled excavation

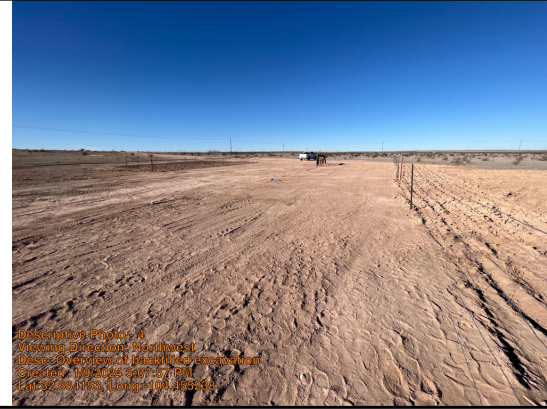
Description Photo - 4
Viewing Direction: Northwest
Desc: Overview of backfilled excavation
Created: 1/9/2024 2:07:57 PM
Lat: 32.491653, Long: 104.483119

Overview of backfilled excavation

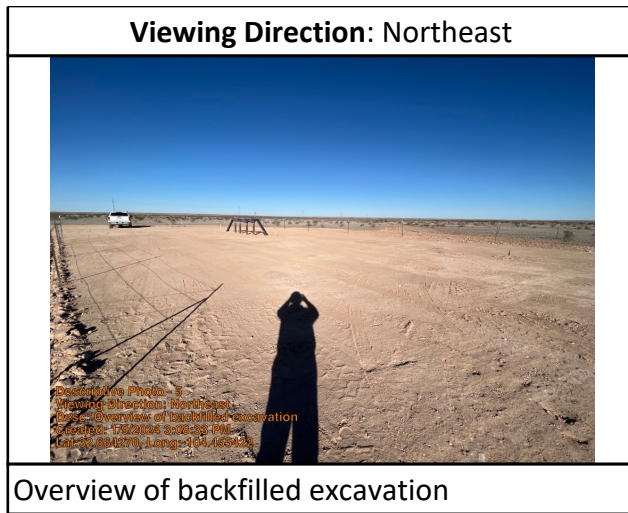
Overview of backfilled excavation

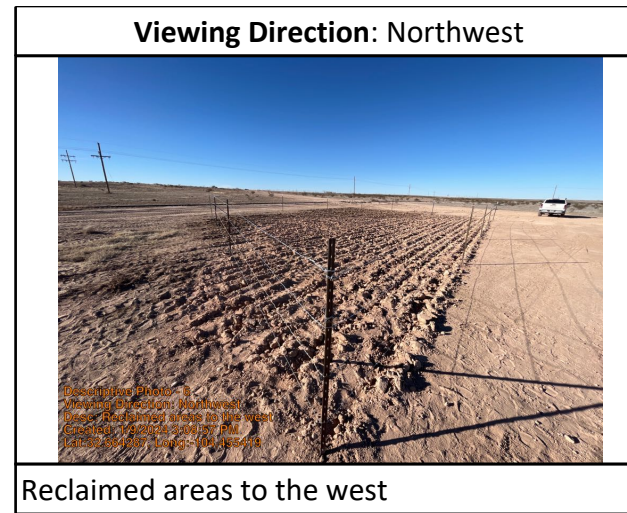
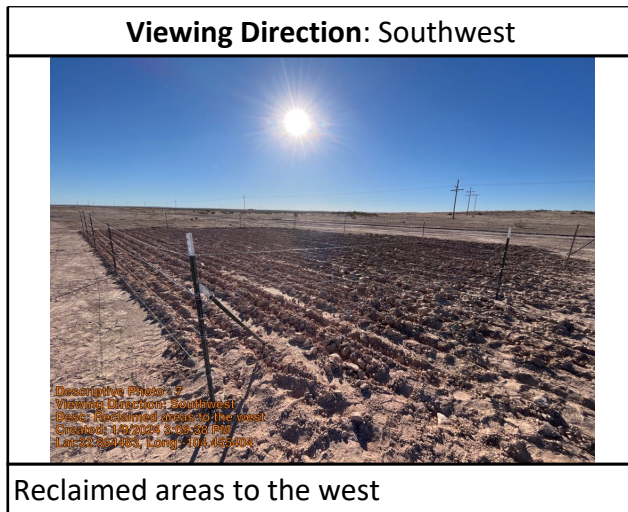
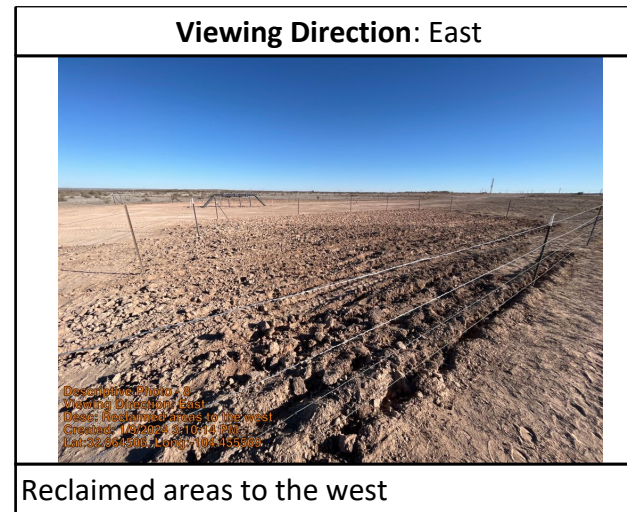
Reclaimed areas to the west
