Re: Site Characteristic and Remediation Plan Report
Sea Snake 35 State 1H
API No. 30-025-41625
GPS: Latitude 32.2544518 Longitude -103.5474319
UL –M, Section 35, T23S, R33E
Lea County, NM
NMOCD Ref. No. NT01431629657

Pima Environmental Services, LLC. (Pima) has been contracted by Devon Energy Production Company, LP (Devon) to prepare this Site Characteristic and Remediation Plan Report for a freshwater mud release that occurred at the Sea Snake 35 State 1H (Sea Snake). The initial C-141 was submitted on December 15, 2023 (Appendix C). This incident was assigned Incident ID NTO1431629657 by the New Mexico Oil Conservation Division (NMOCD).

Devon Energy
API: 30-025-41625
Lea County, NM
Site Map

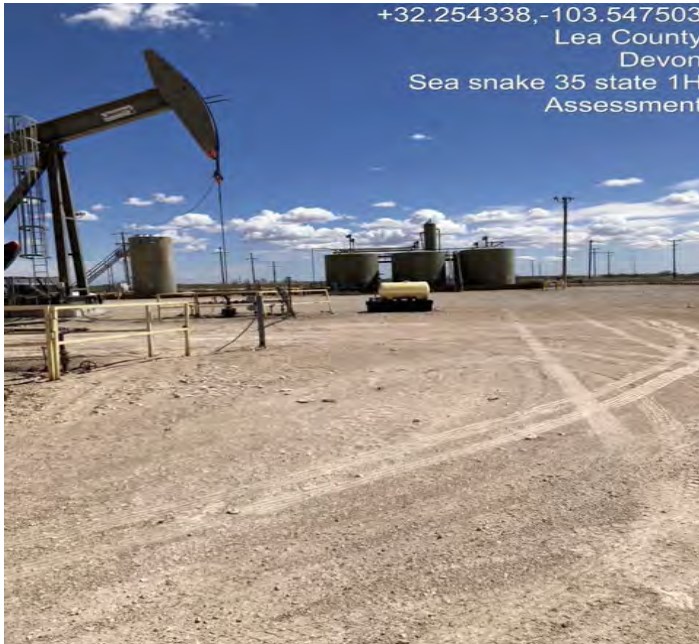
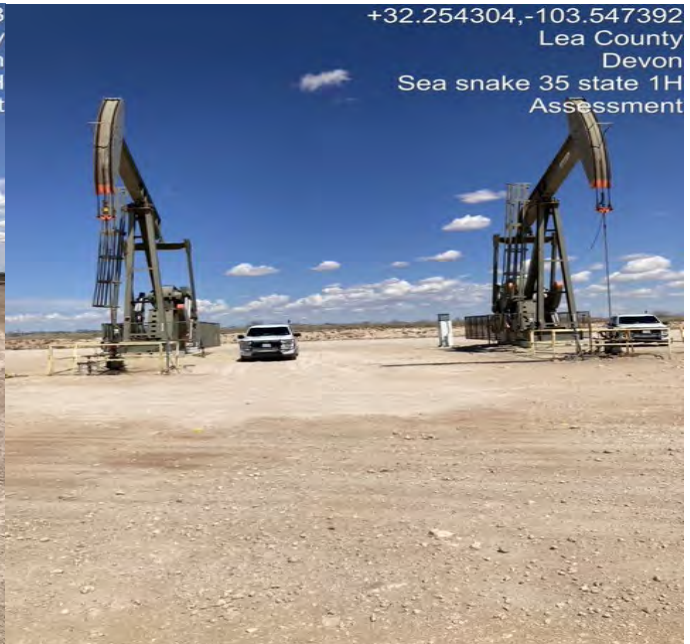
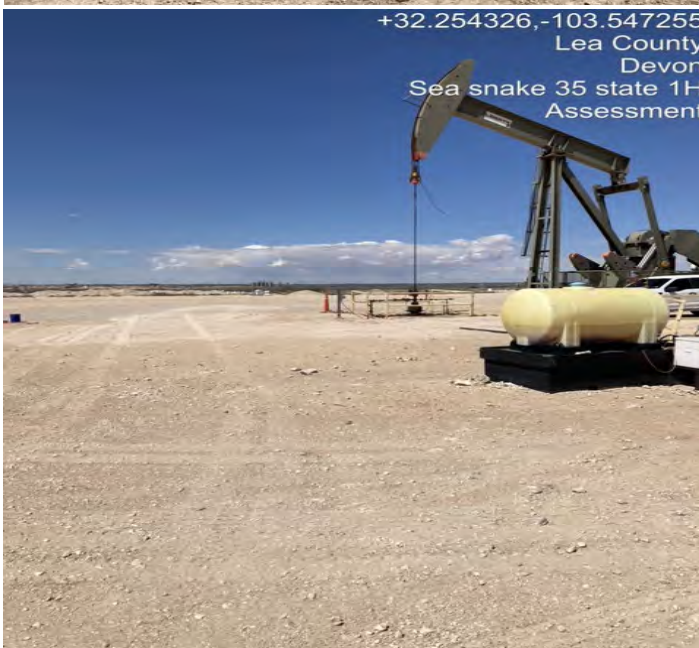
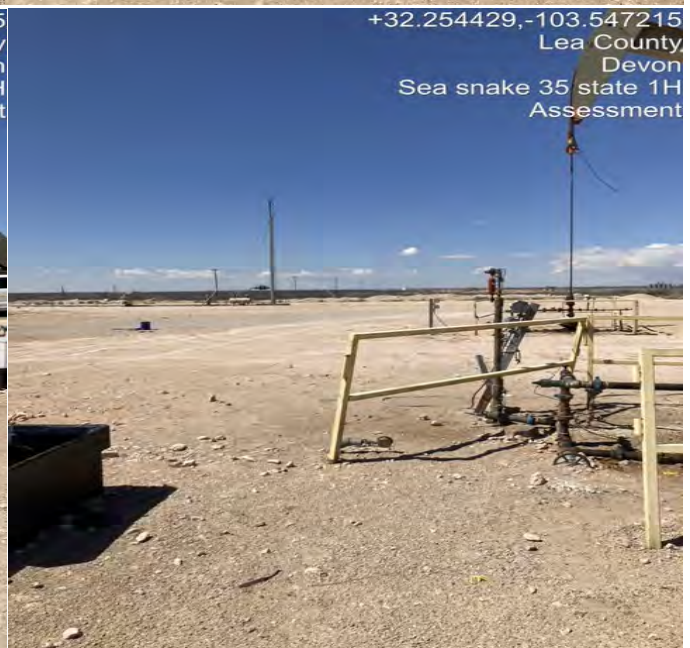
Assessment

**SITE PHOTOGRAPHS
DEVON ENERGY**

Sea Snake 35 State #001H
