**Re: Closure Report
ConocoPhillips Company (Heritage COG Operating, LLC)
King Tut Federal #001H Flowline Release
Unit Letter D, Section 30, Township 24 South, Range 32 East
Lea County, New Mexico
Incident ID# nAB1905046526**

Closure Report
April 19, 2024

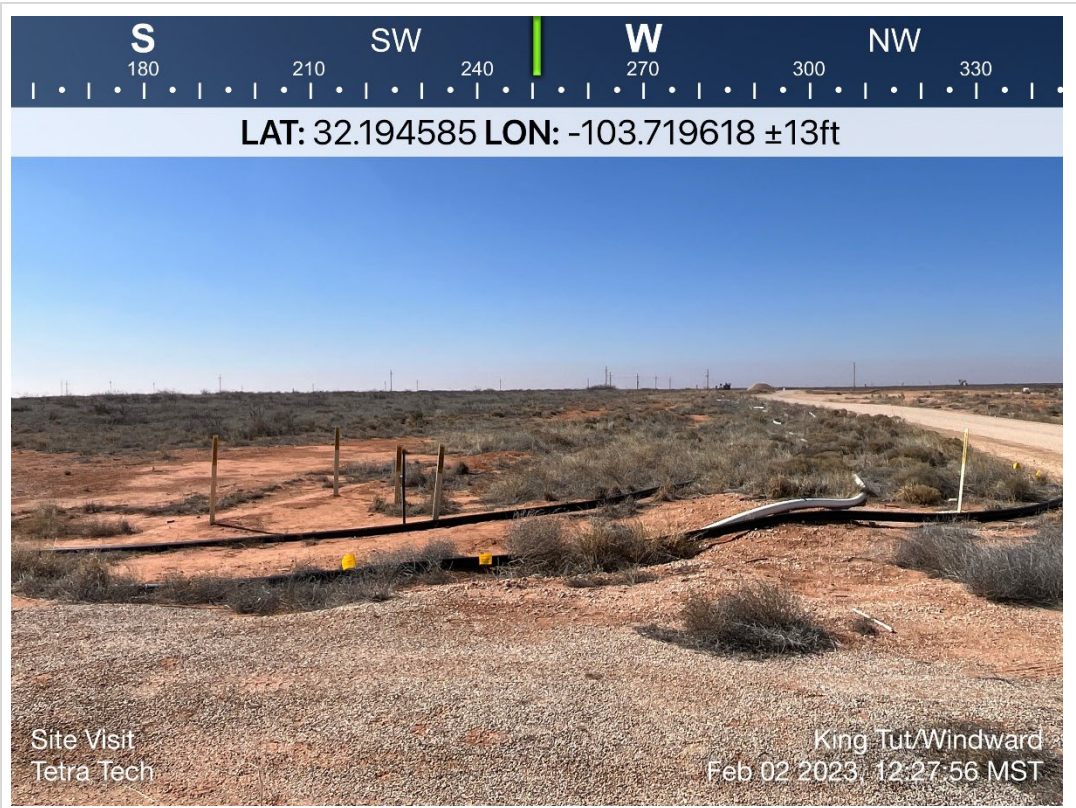
TETRA TECH, INC. PROJECT NO. 212C-MD-02999	DESCRIPTION	View SW-W of release extent at the NW corner of pad. Vegetated towards lease road Surface poly-lines present.	1
	SITE NAME	KING TUT FEDERAL #001H, KING TUT FEDERAL #003H, & WINDWARD FEDERAL #001H Releases	2/2/2023

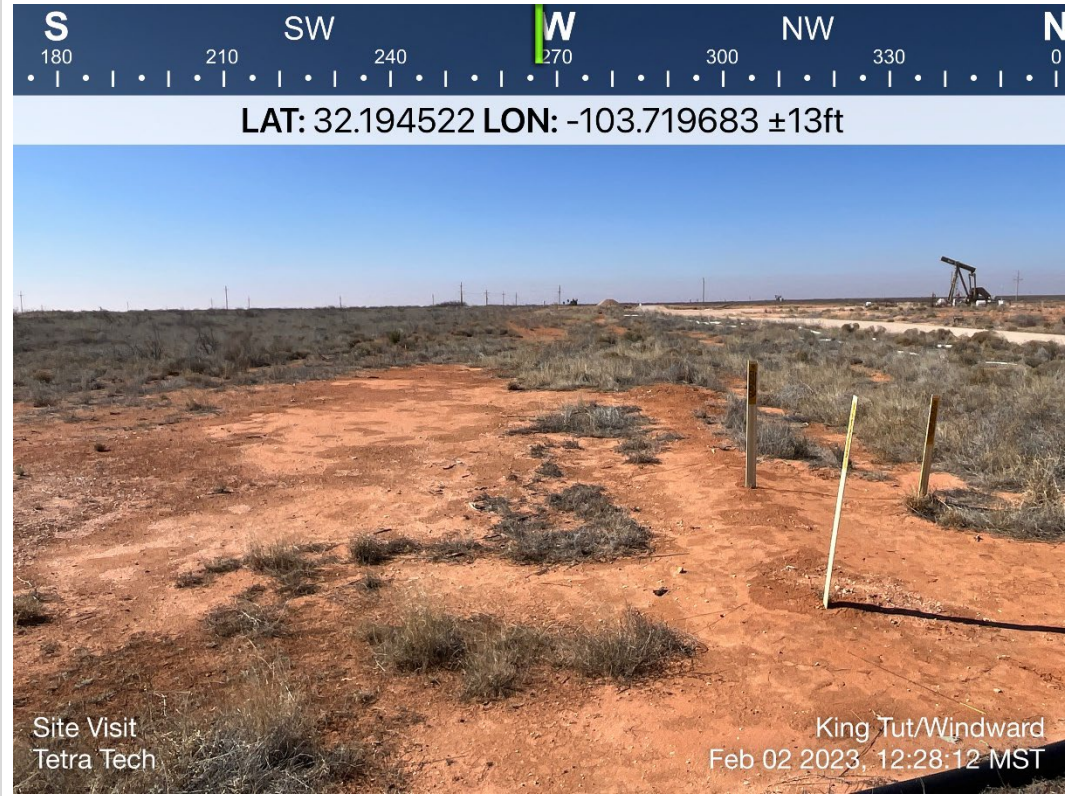
TETRA TECH, INC. PROJECT NO. 212C-MD-02999	DESCRIPTION	View W of release extent and pipeline right-of-way.	2
	SITE NAME	KING TUT FEDERAL #001H, KING TUT FEDERAL #003H, & WINDWARD FEDERAL #001H Releases	2/2/2023

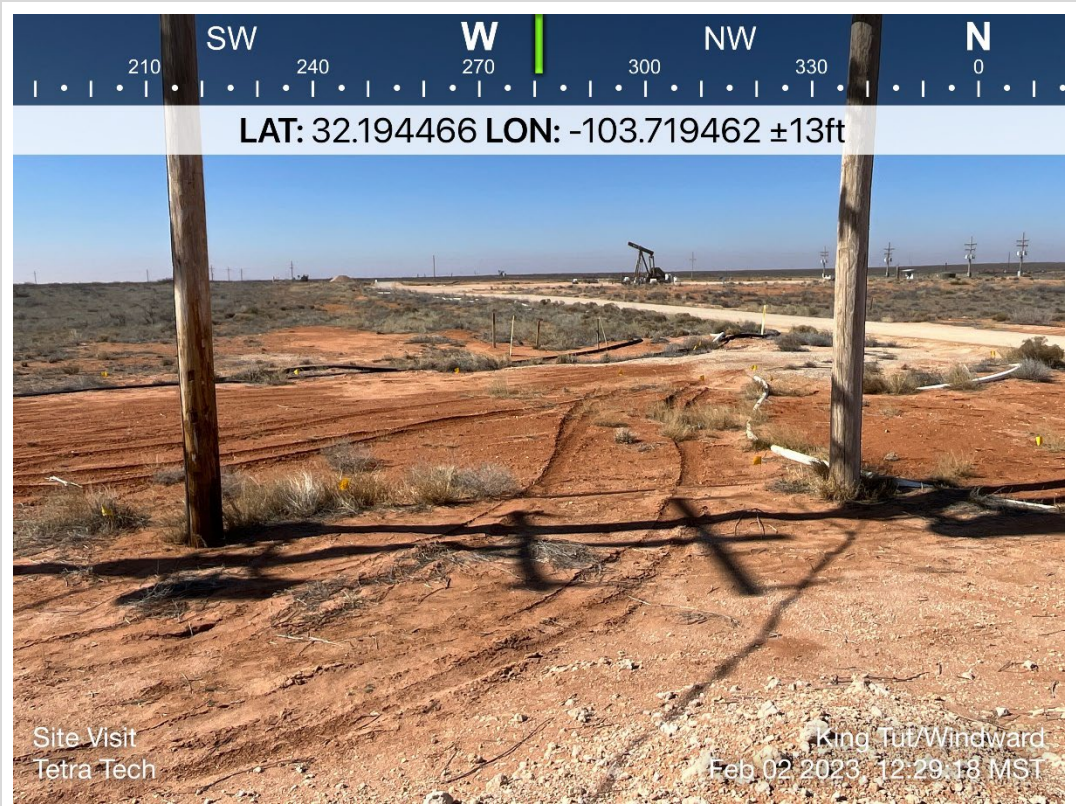
TETRA TECH, INC. PROJECT NO. 212C-MD-02999	DESCRIPTION	View W of lease road and release extent from beneath overhead electrical lines.	3
	SITE NAME	KING TUT FEDERAL #001H, KING TUT FEDERAL #003H, & WINDWARD FEDERAL #001H Releases	2/2/2023

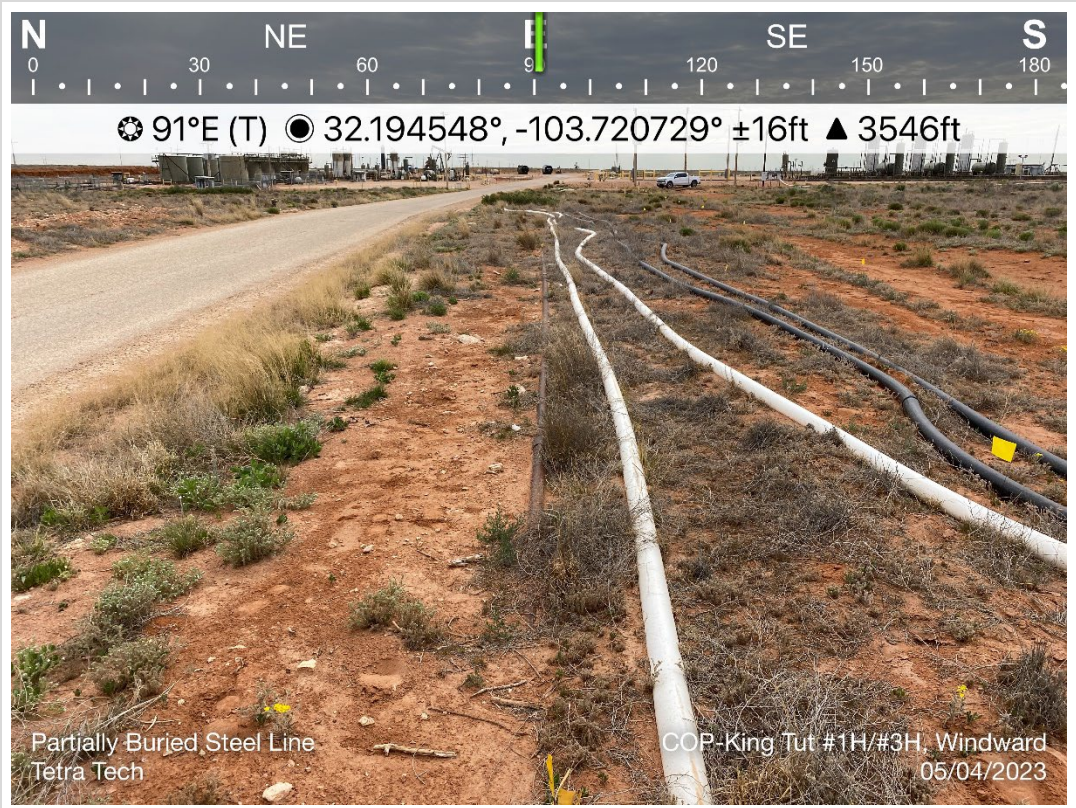
TETRA TECH, INC. PROJECT NO. 212C-MD-02999	DESCRIPTION	View west. View of historical release area. Surface poly lines and buried steel line.	5
	SITE NAME	KING TUT FEDERAL #001H, KING TUT FEDERAL #003H, & WINDWARD FEDERAL #001H Releases	5/4/2023

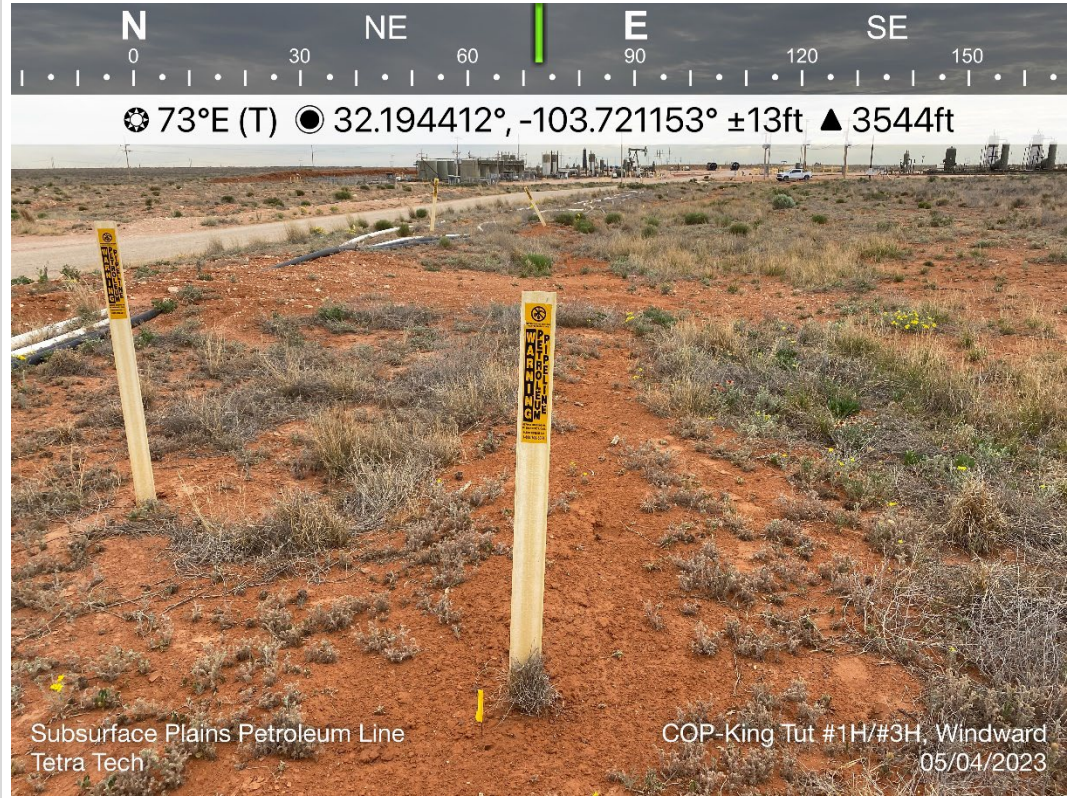
TETRA TECH, INC. PROJECT NO. 212C-MD-02999	DESCRIPTION	View northeast. View of surface lines. Vegetation present.	6
	SITE NAME	KING TUT FEDERAL #001H, KING TUT FEDERAL #003H, & WINDWARD FEDERAL #001H Releases	5/4/2023

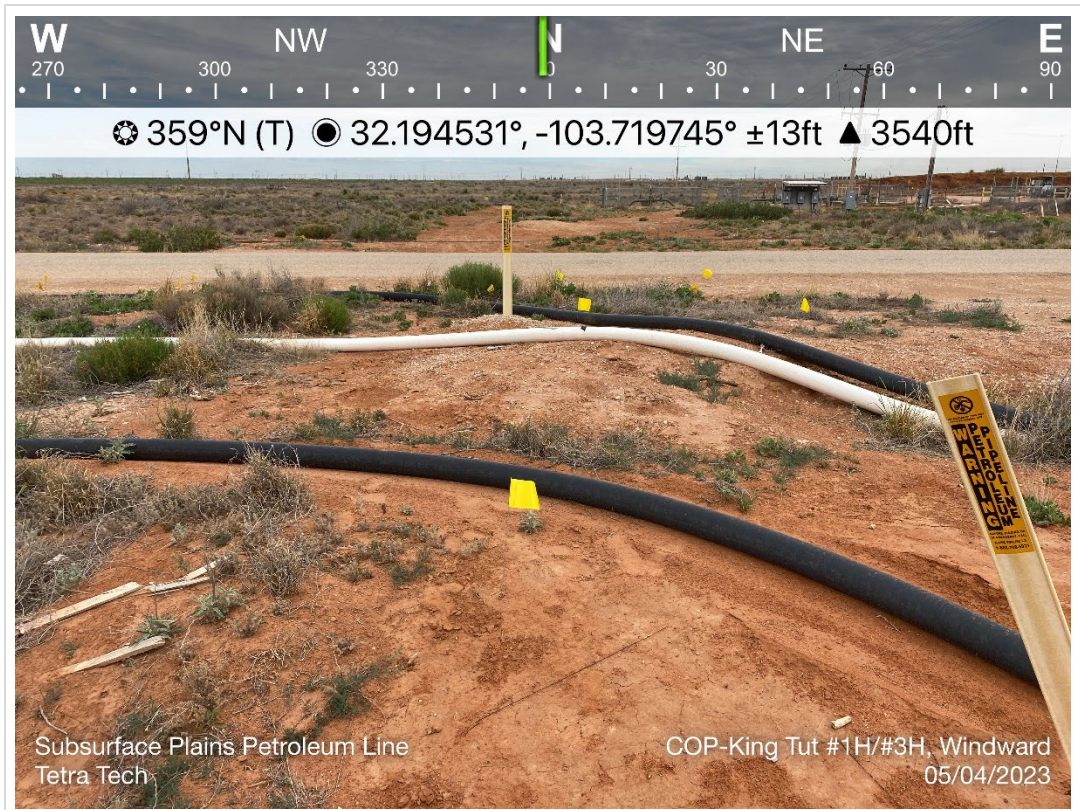
TETRA TECH, INC. PROJECT NO. 212C-MD-02999	DESCRIPTION	View north. View of surface poly lines.	7
	SITE NAME	KING TUT FEDERAL #001H, KING TUT FEDERAL #003H, & WINDWARD FEDERAL #001H Releases	5/4/2023

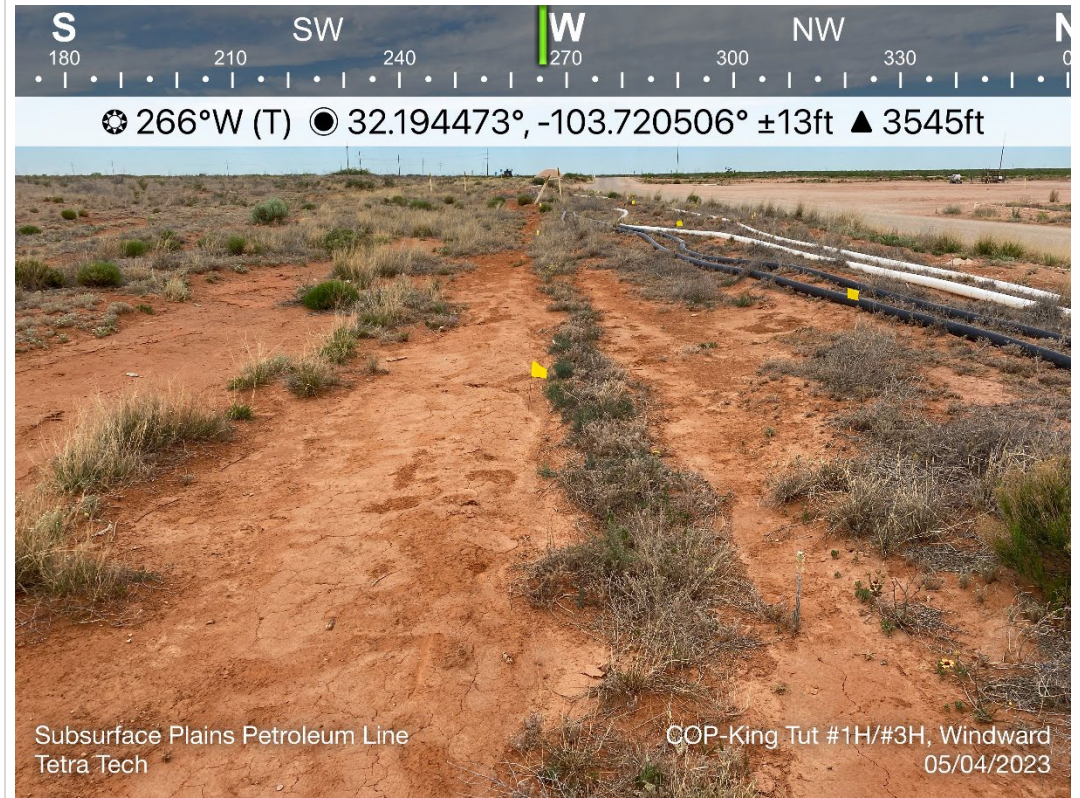
TETRA TECH, INC. PROJECT NO. 212C-MD-02999	DESCRIPTION	View west. View of historical release area. View of surface poly lines and vegetation present.	8
	SITE NAME	KING TUT FEDERAL #001H, KING TUT FEDERAL #003H, & WINDWARD FEDERAL #001H Releases	5/4/2023

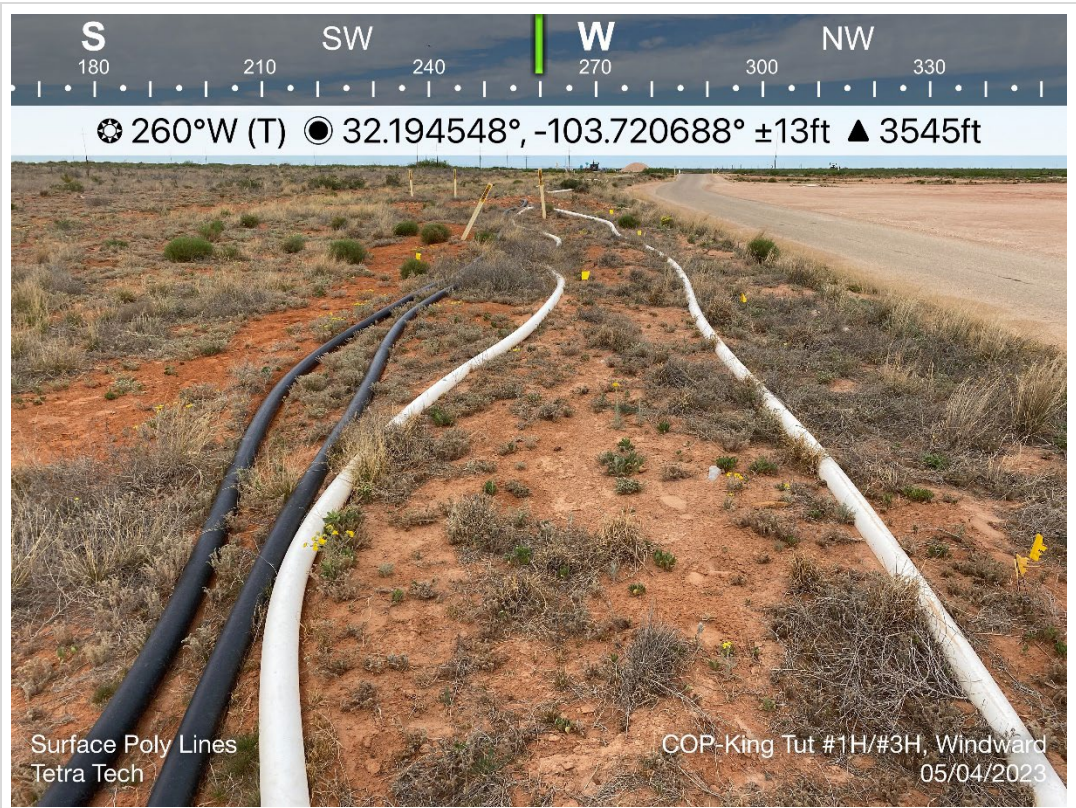
TETRA TECH, INC. PROJECT NO. 212C-MD-02999	DESCRIPTION	View west. View of surface poly lines and area of historical release.	9
	SITE NAME	KING TUT FEDERAL #001H, KING TUT FEDERAL #003H, & WINDWARD FEDERAL #001H Releases	5/4/2023

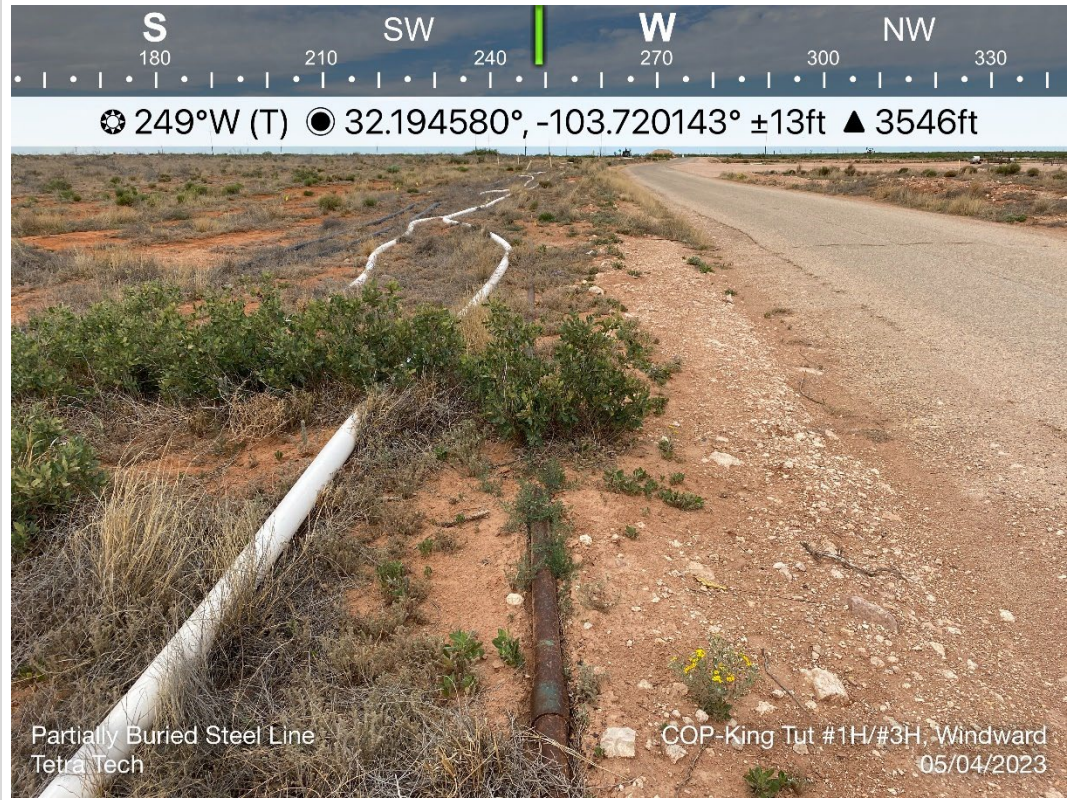
TETRA TECH, INC. PROJECT NO. 212C-MD-02999	DESCRIPTION	View southwest west. View surface poly lines and buried steel line.	10
	SITE NAME	KING TUT FEDERAL #001H, KING TUT FEDERAL #003H, & WINDWARD FEDERAL #001H Releases	5/4/2023

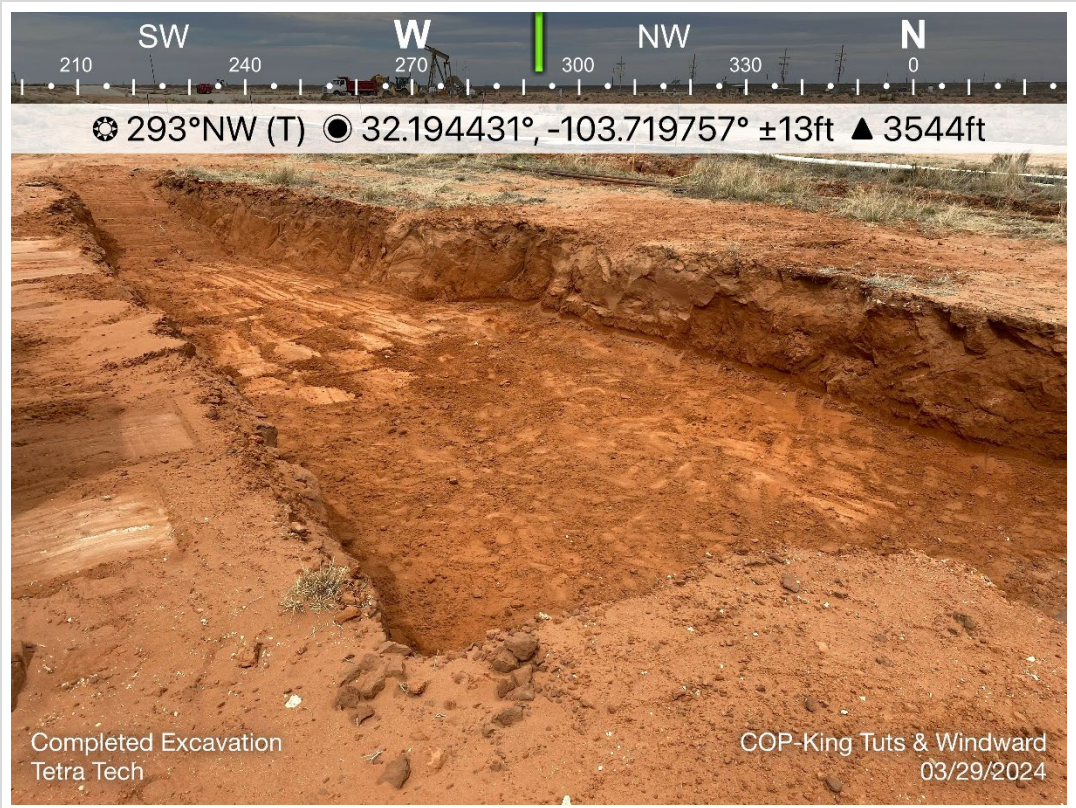
TETRA TECH, INC. PROJECT NO. 212C-MD-02999	DESCRIPTION	View west. View of excavated areas.	11
	SITE NAME	KING TUT FEDERAL #001H, KING TUT FEDERAL #003H, & WINDWARD FEDERAL #001H Releases	3/29/2024

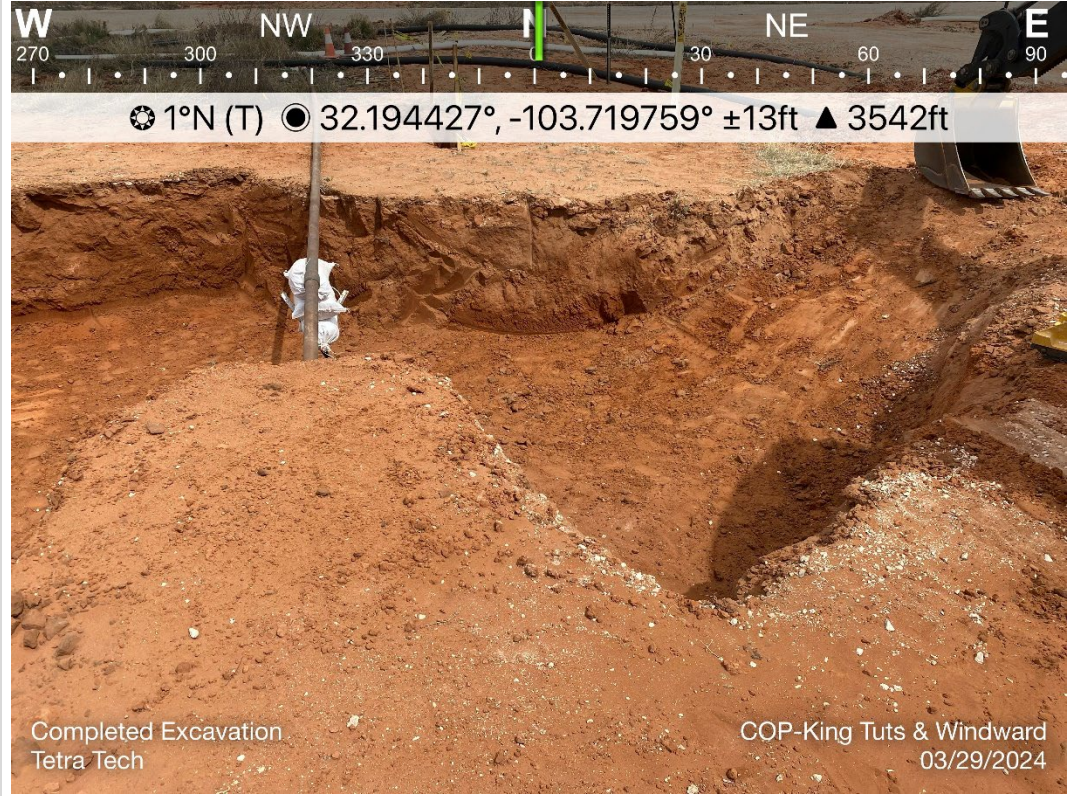
TETRA TECH, INC. PROJECT NO. 212C-MD-02999	DESCRIPTION	View north. View of excavation activities.	12
	SITE NAME	KING TUT FEDERAL #001H, KING TUT FEDERAL #003H, & WINDWARD FEDERAL #001H Releases	3/29/2024

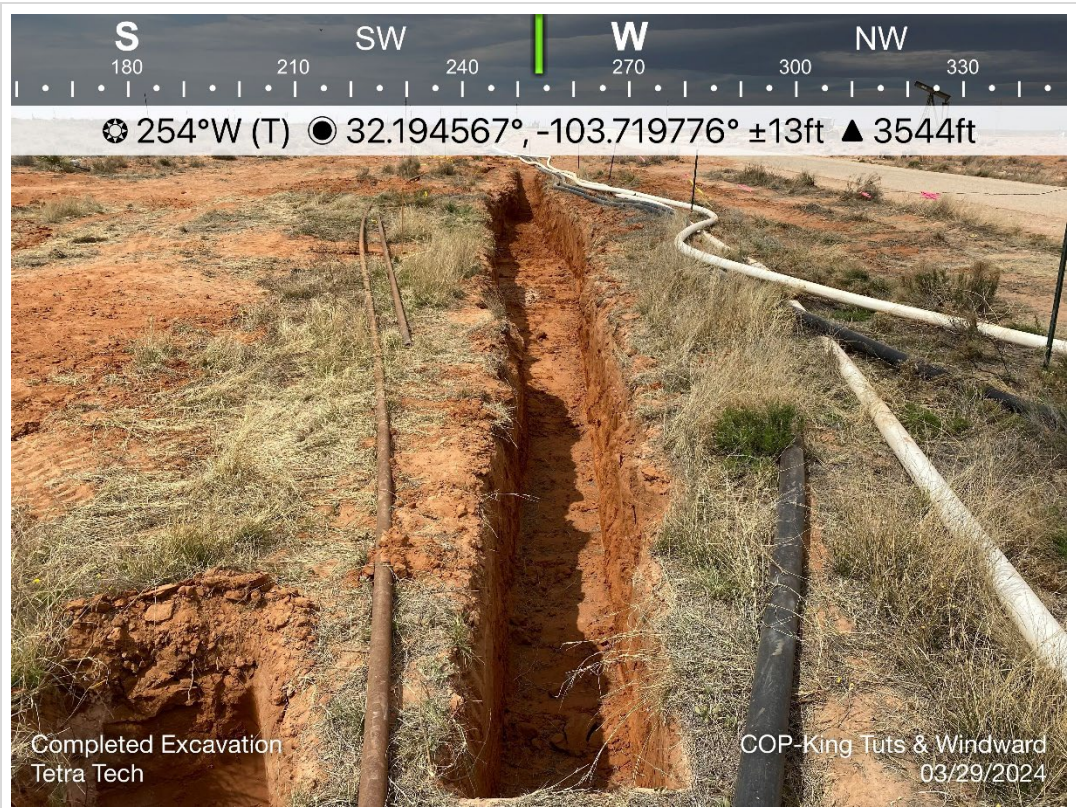
TETRA TECH, INC. PROJECT NO. 212C-MD-02999	DESCRIPTION	View west. View of excavation activities.	13
	SITE NAME	KING TUT FEDERAL #001H, KING TUT FEDERAL #003H, & WINDWARD FEDERAL #001H Releases	3/29/2024

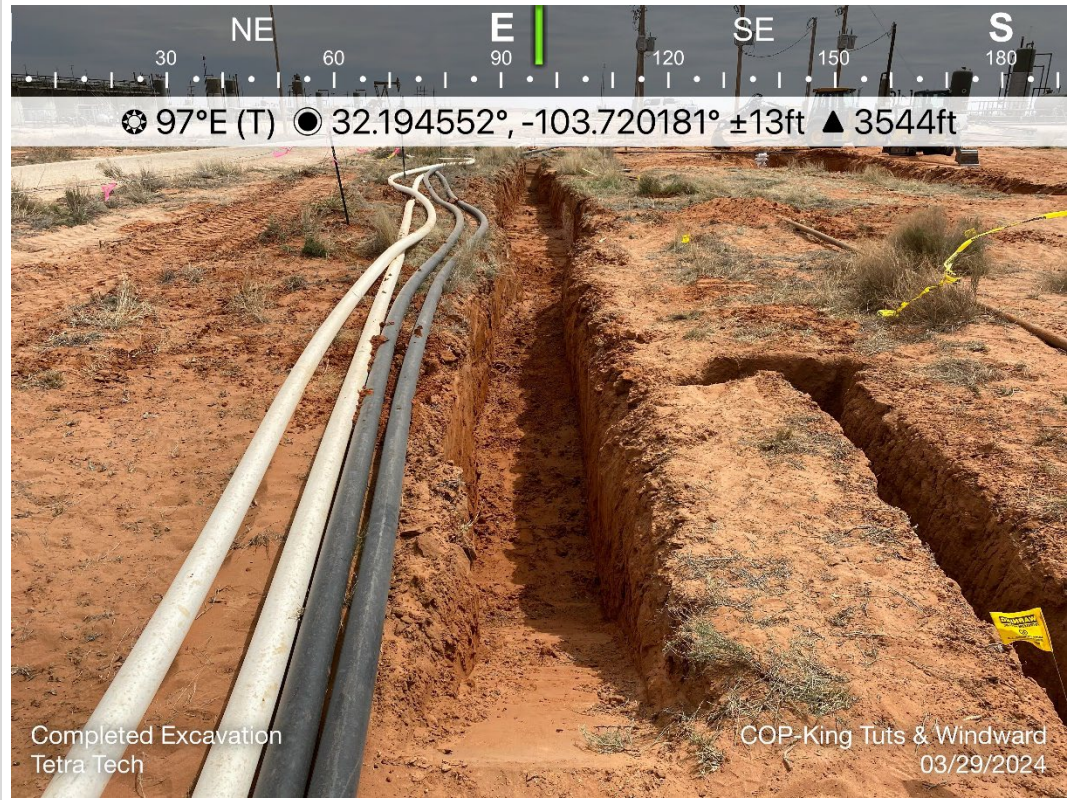
TETRA TECH, INC. PROJECT NO. 212C-MD-02999	DESCRIPTION	View east. View of excavation activities.	14
	SITE NAME	KING TUT FEDERAL #001H, KING TUT FEDERAL #003H, & WINDWARD FEDERAL #001H Releases	3/29/2024

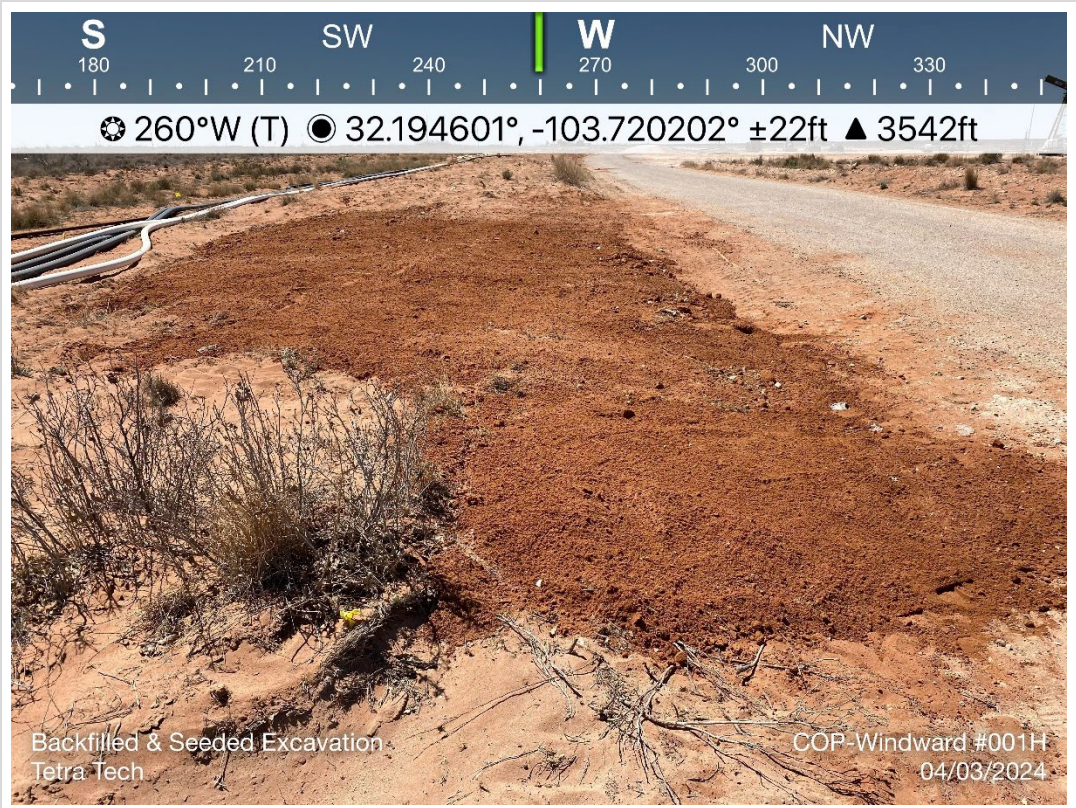
TETRA TECH, INC. PROJECT NO. 212C-MD-02999	DESCRIPTION	View west. View of backfilled and seeded excavation areas.	15
	SITE NAME	KING TUT FEDERAL #001H, KING TUT FEDERAL #003H, & WINDWARD FEDERAL #001H Releases	4/3/2024

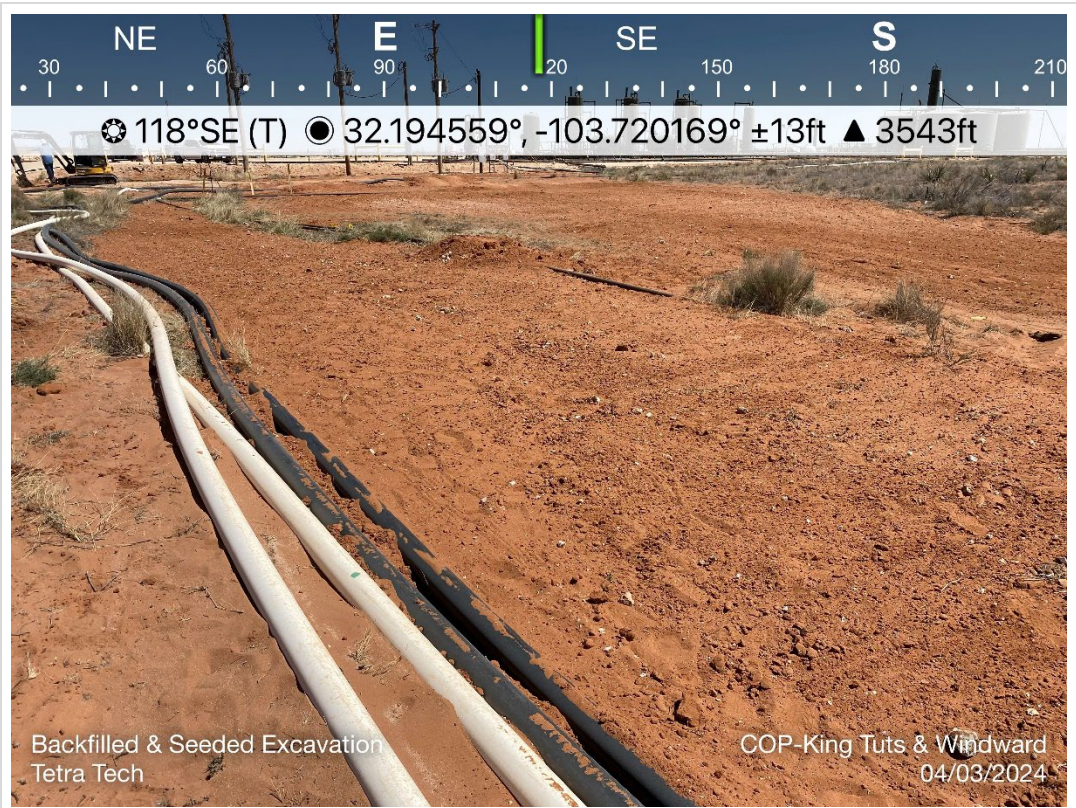
TETRA TECH, INC. PROJECT NO. 212C-MD-02999	DESCRIPTION	View east southeast. View of backfilled and seeded excavated areas.	17
	SITE NAME	KING TUT FEDERAL #001H, KING TUT FEDERAL #003H, & WINDWARD FEDERAL #001H Releases	4/3/2024

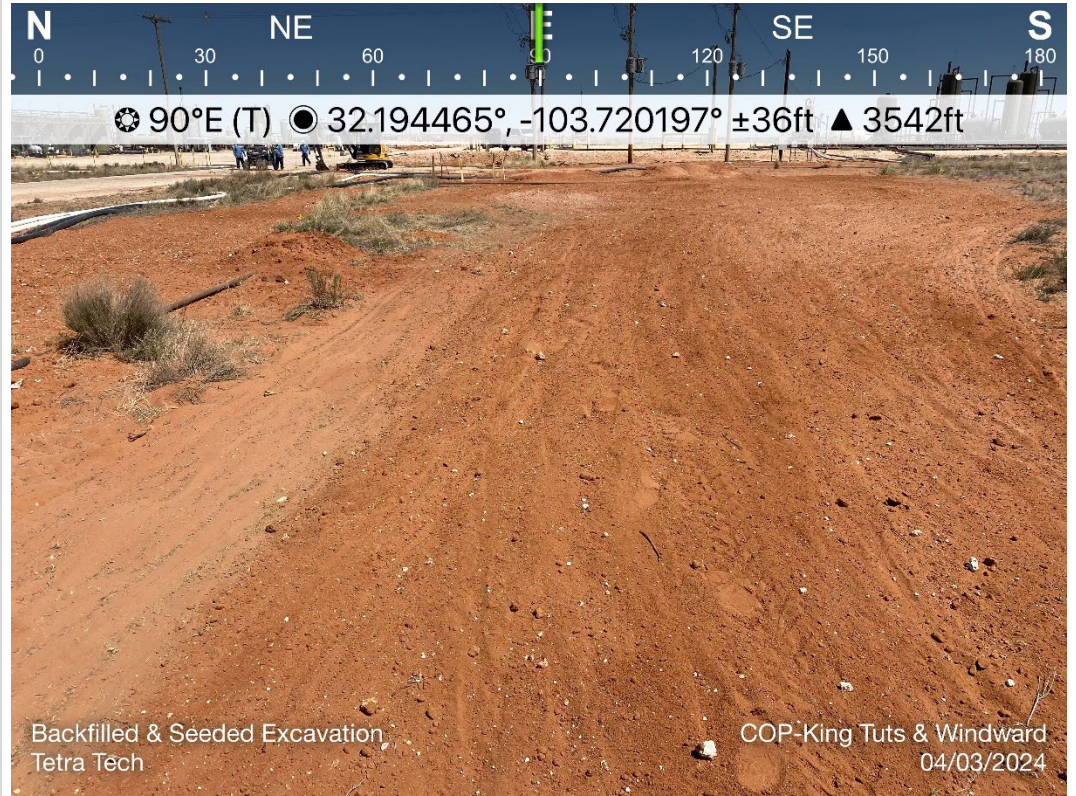
TETRA TECH, INC. PROJECT NO. 212C-MD-02999	DESCRIPTION	View east. View of backfilled and seeded excavated areas.	18
	SITE NAME	KING TUT FEDERAL #001H, KING TUT FEDERAL #003H, & WINDWARD FEDERAL #001H Releases	4/3/2024
