Closure Report

Chevron 12 Federal # 3
Lea County, New Mexico
API ID # 30-025-30601

Incident #s NSAP0233641771 and NSAP0230537626

Subject: **Closure Report**
Chevron 12 Federal # 3
Lea County, New Mexico
API # 30-025-30601
Incident # NSAP0233641771 / NSAP0230537626

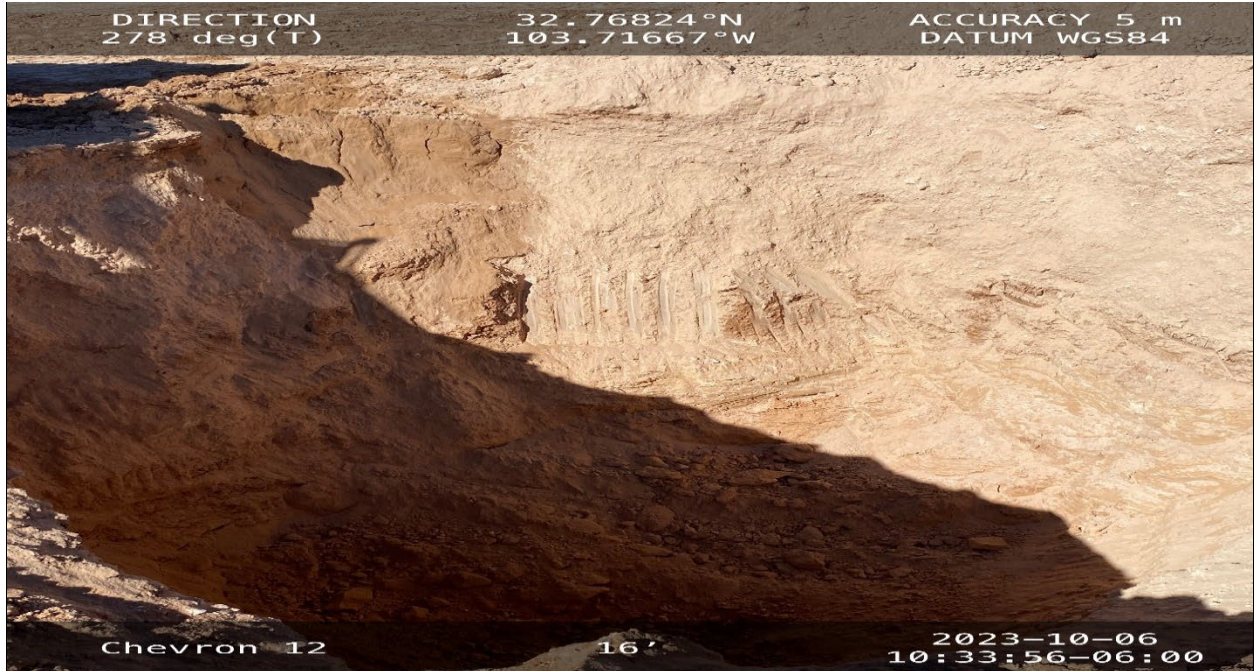
Photograph No.3
Description:

View of final excavation.
