Re: Site Assessment, Remediation, and Closure Report

Redlake 32 State Tank Battery

NMOCD Ref. No. <u>NAPP2317136107</u>

Pima Environmental Services, LLC (Pima) has been contracted by Spur Energy to perform a spill assessment, remediation activities, and submit this closure report for a produced water and crude oil release that occurred at the Redlake 32 State Tank Battery (Redlake). The initial C-141 was submitted on June 20th, 2023 (Appendix C). This incident was assigned Incident ID NAPP2317136107, by the New Mexico Oil Conservation Division (NMOCD).

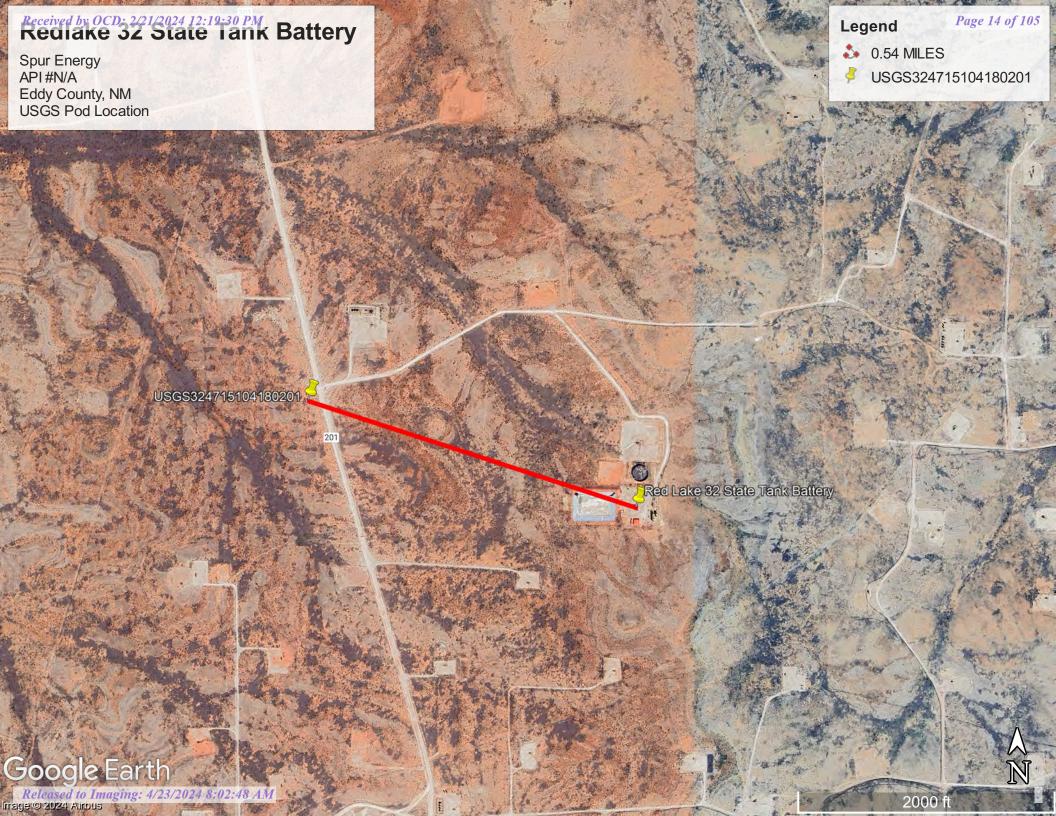
Spur Energy API#N/A Eddy County, NM Site Map

NAPP2317136107: On June 20th, 2023, a check valve malfunction resulted in a breach in the flowline, leading to the release of a blend of produced water and crude oil into an unlined containment. Approximately 30 barrels of crude oil and 30 barrels of produced water were discharged, with subsequent recovery efforts accounting for 28 barrels of crude oil and 28 barrels of produced water. The remaining 4 barrels were successfully recovered during subsequent remediation activities. Importantly, all fluids were contained on-site within the unlined containment. The overall extent of the release covered an approximate area of 590 square feet.

Release Area

Sample Location

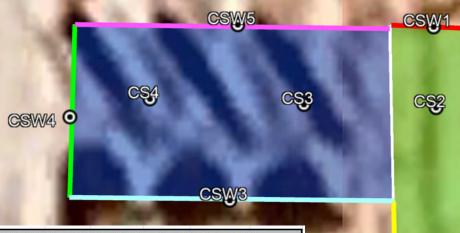
Spur Energy API#N/A Eddy County, NM Confirmation Site Map

Each soil sample was a 5-point composite derived from the excavated area, specifically representing an area not exceeding 200 square feet of the open excavation. A total of nine (9) samples were collected for laboratory analysis for total chloride using EPA Method 300.0; benzene, toluene, ethylbenzene and total xylenes (BTEX) using EPA Method 8021B; and motor, diesel, and gasoline range organics (MRO, DRO, & GRO) by EPA Method 8015D. All samples were placed into laboratory supplied glassware, labeled, and maintained on ice until delivery to EnviroTech laboratories in Farmington, New Mexico (Appendix C).

2.5' Excavation

Confirmation Sample

Upon confirming that all soil samples met the closure standards set by the New Mexico Oil Conservation Division (NMOCD), clean backfill material was brought in and utilized to restore the excavated area, returning it to its original state.
