BD I-18 EOL Remediation Summary & Closure Report

NMOCD Incident No. nAPP2109856086
UL "I", Sec. 18, T21S, R37E
32.477379°, -103.197098°
Lea County, New Mexico

Re: Remediation Summary & Closure Report
BD I-18 EOL (1R426-13)
UL "I", Section 18, Township 21 South, Range 37 East
Lea County, New Mexico
NMOCD Incident No. nAPP2109856086
Tasman Project No. 4778

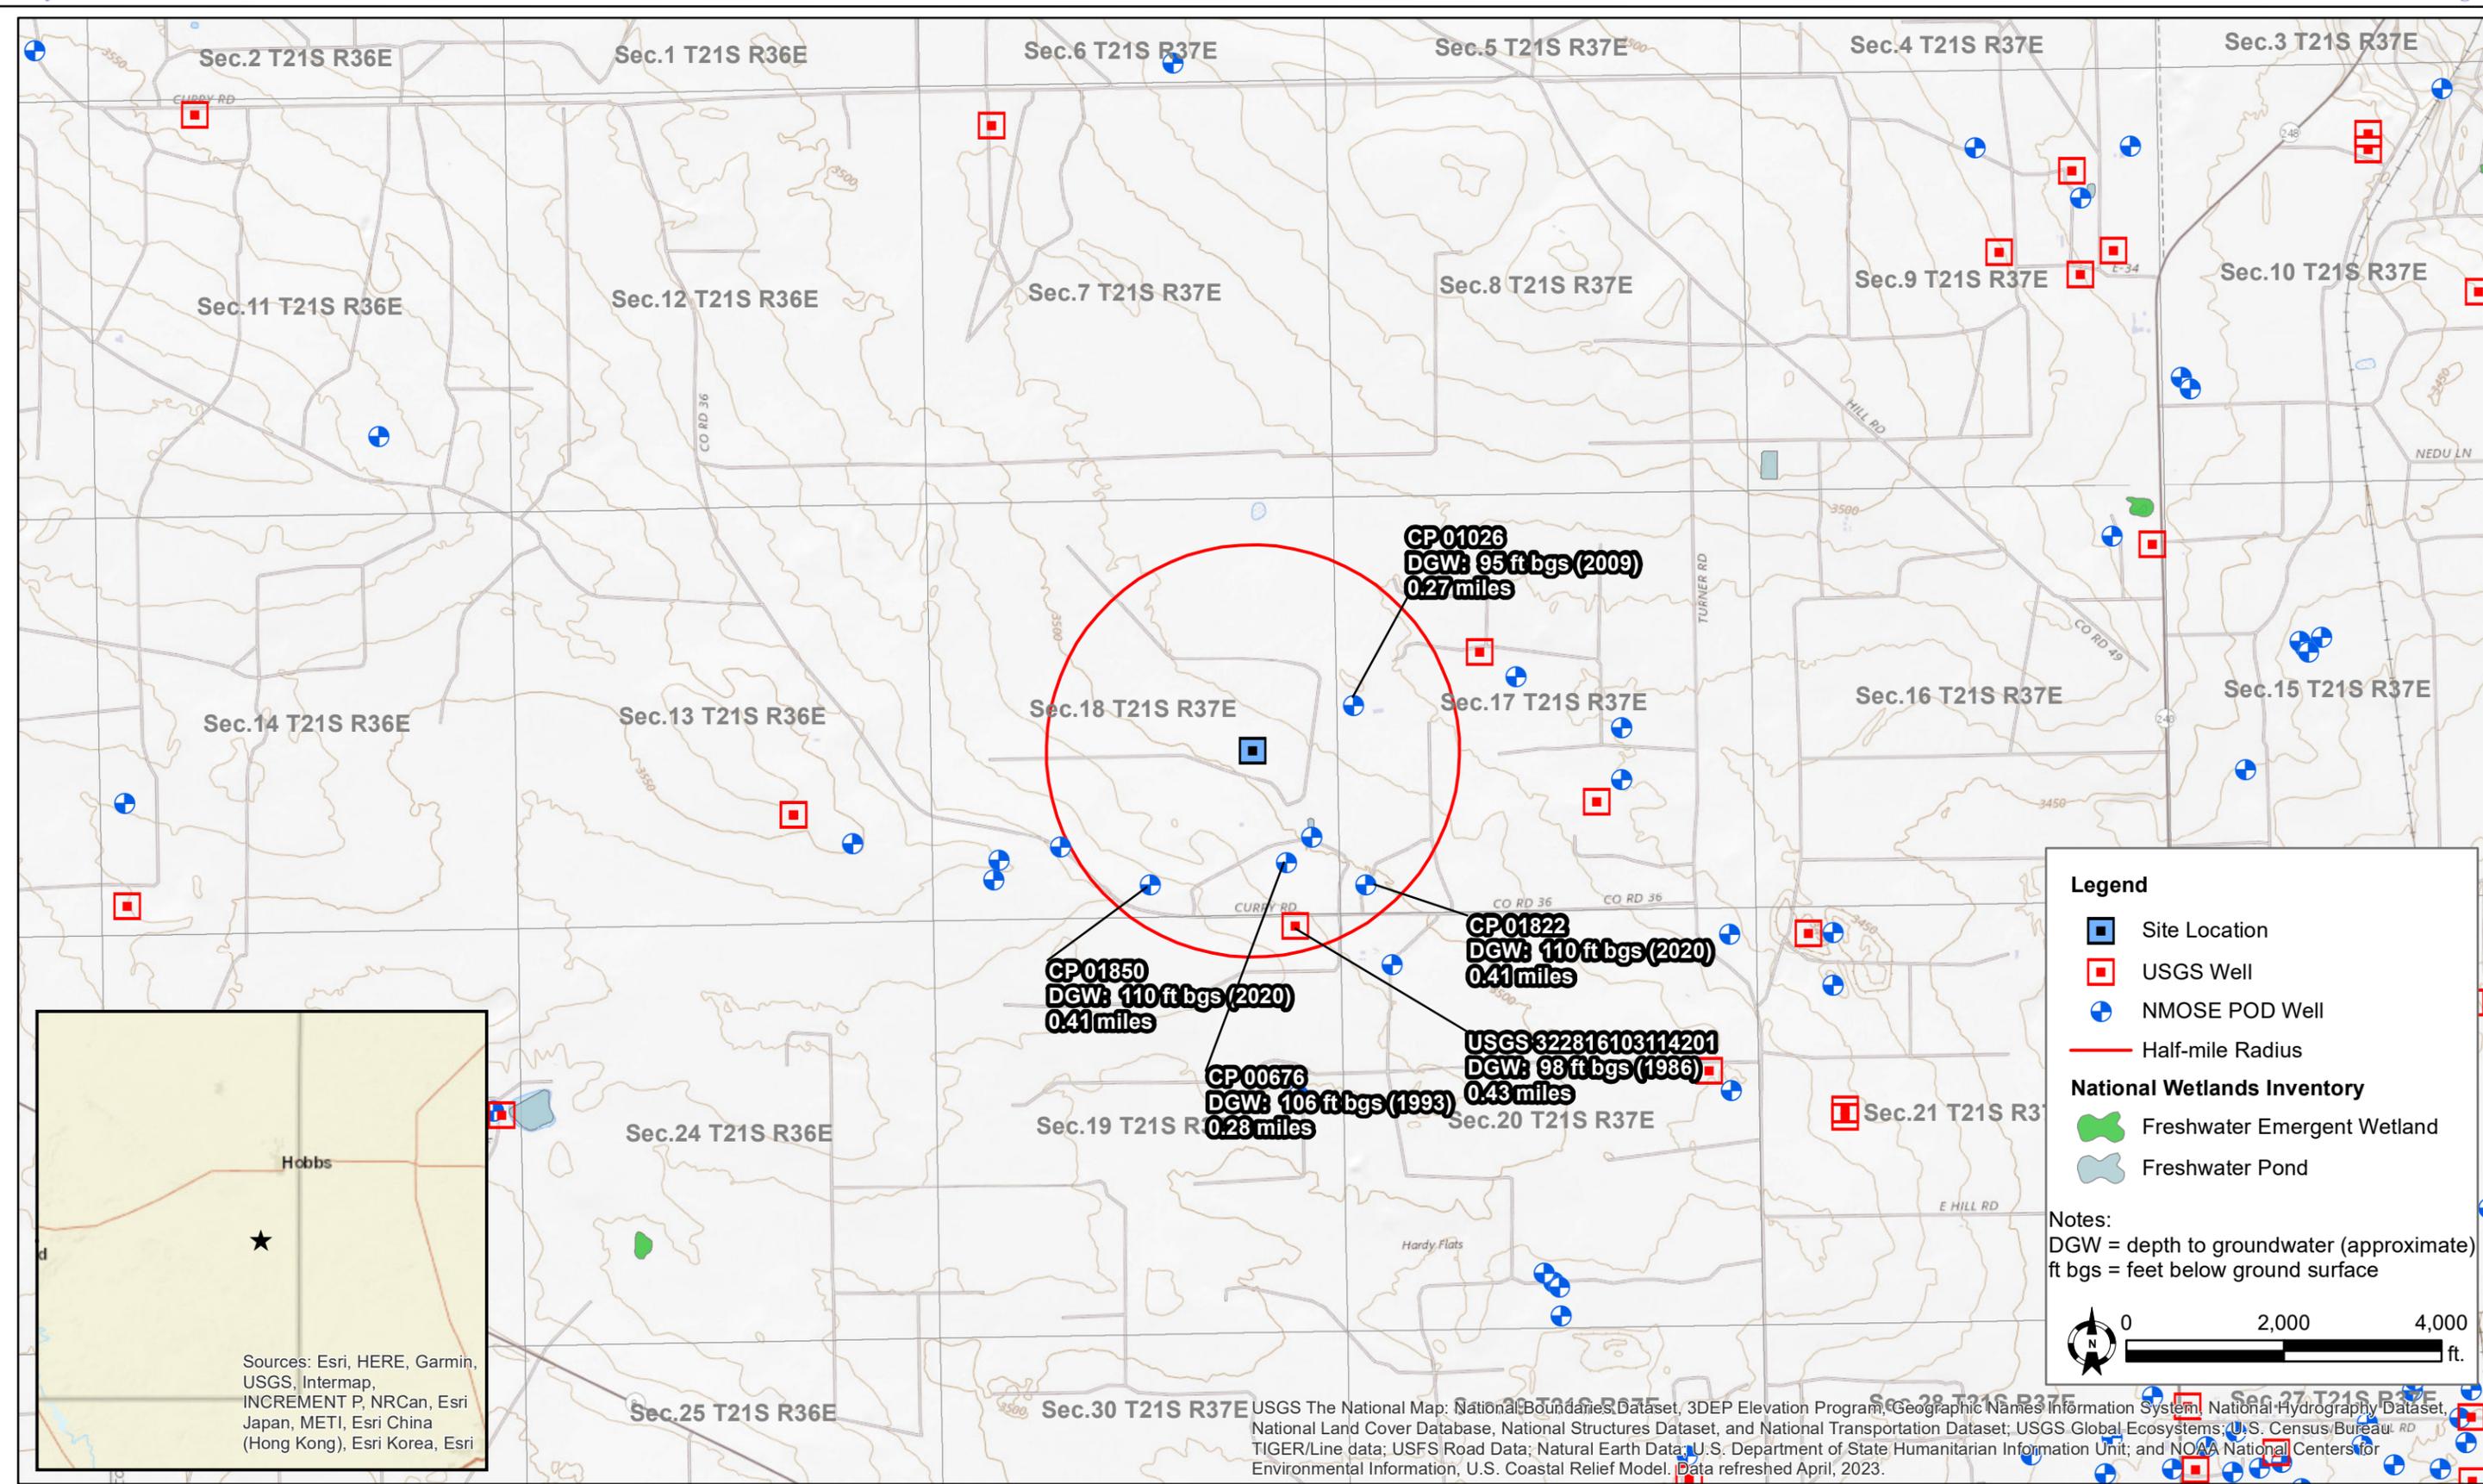
Figure
 1

The nearest potable water well is NMOSE POD CP 01026. The well is located 0.27 miles (or approximately 1,425 feet) from the site. The well's current use is unknown. The location of POD CP 01026 is shown on the attached Figure 1.

Site Location & Groundwater
 Map

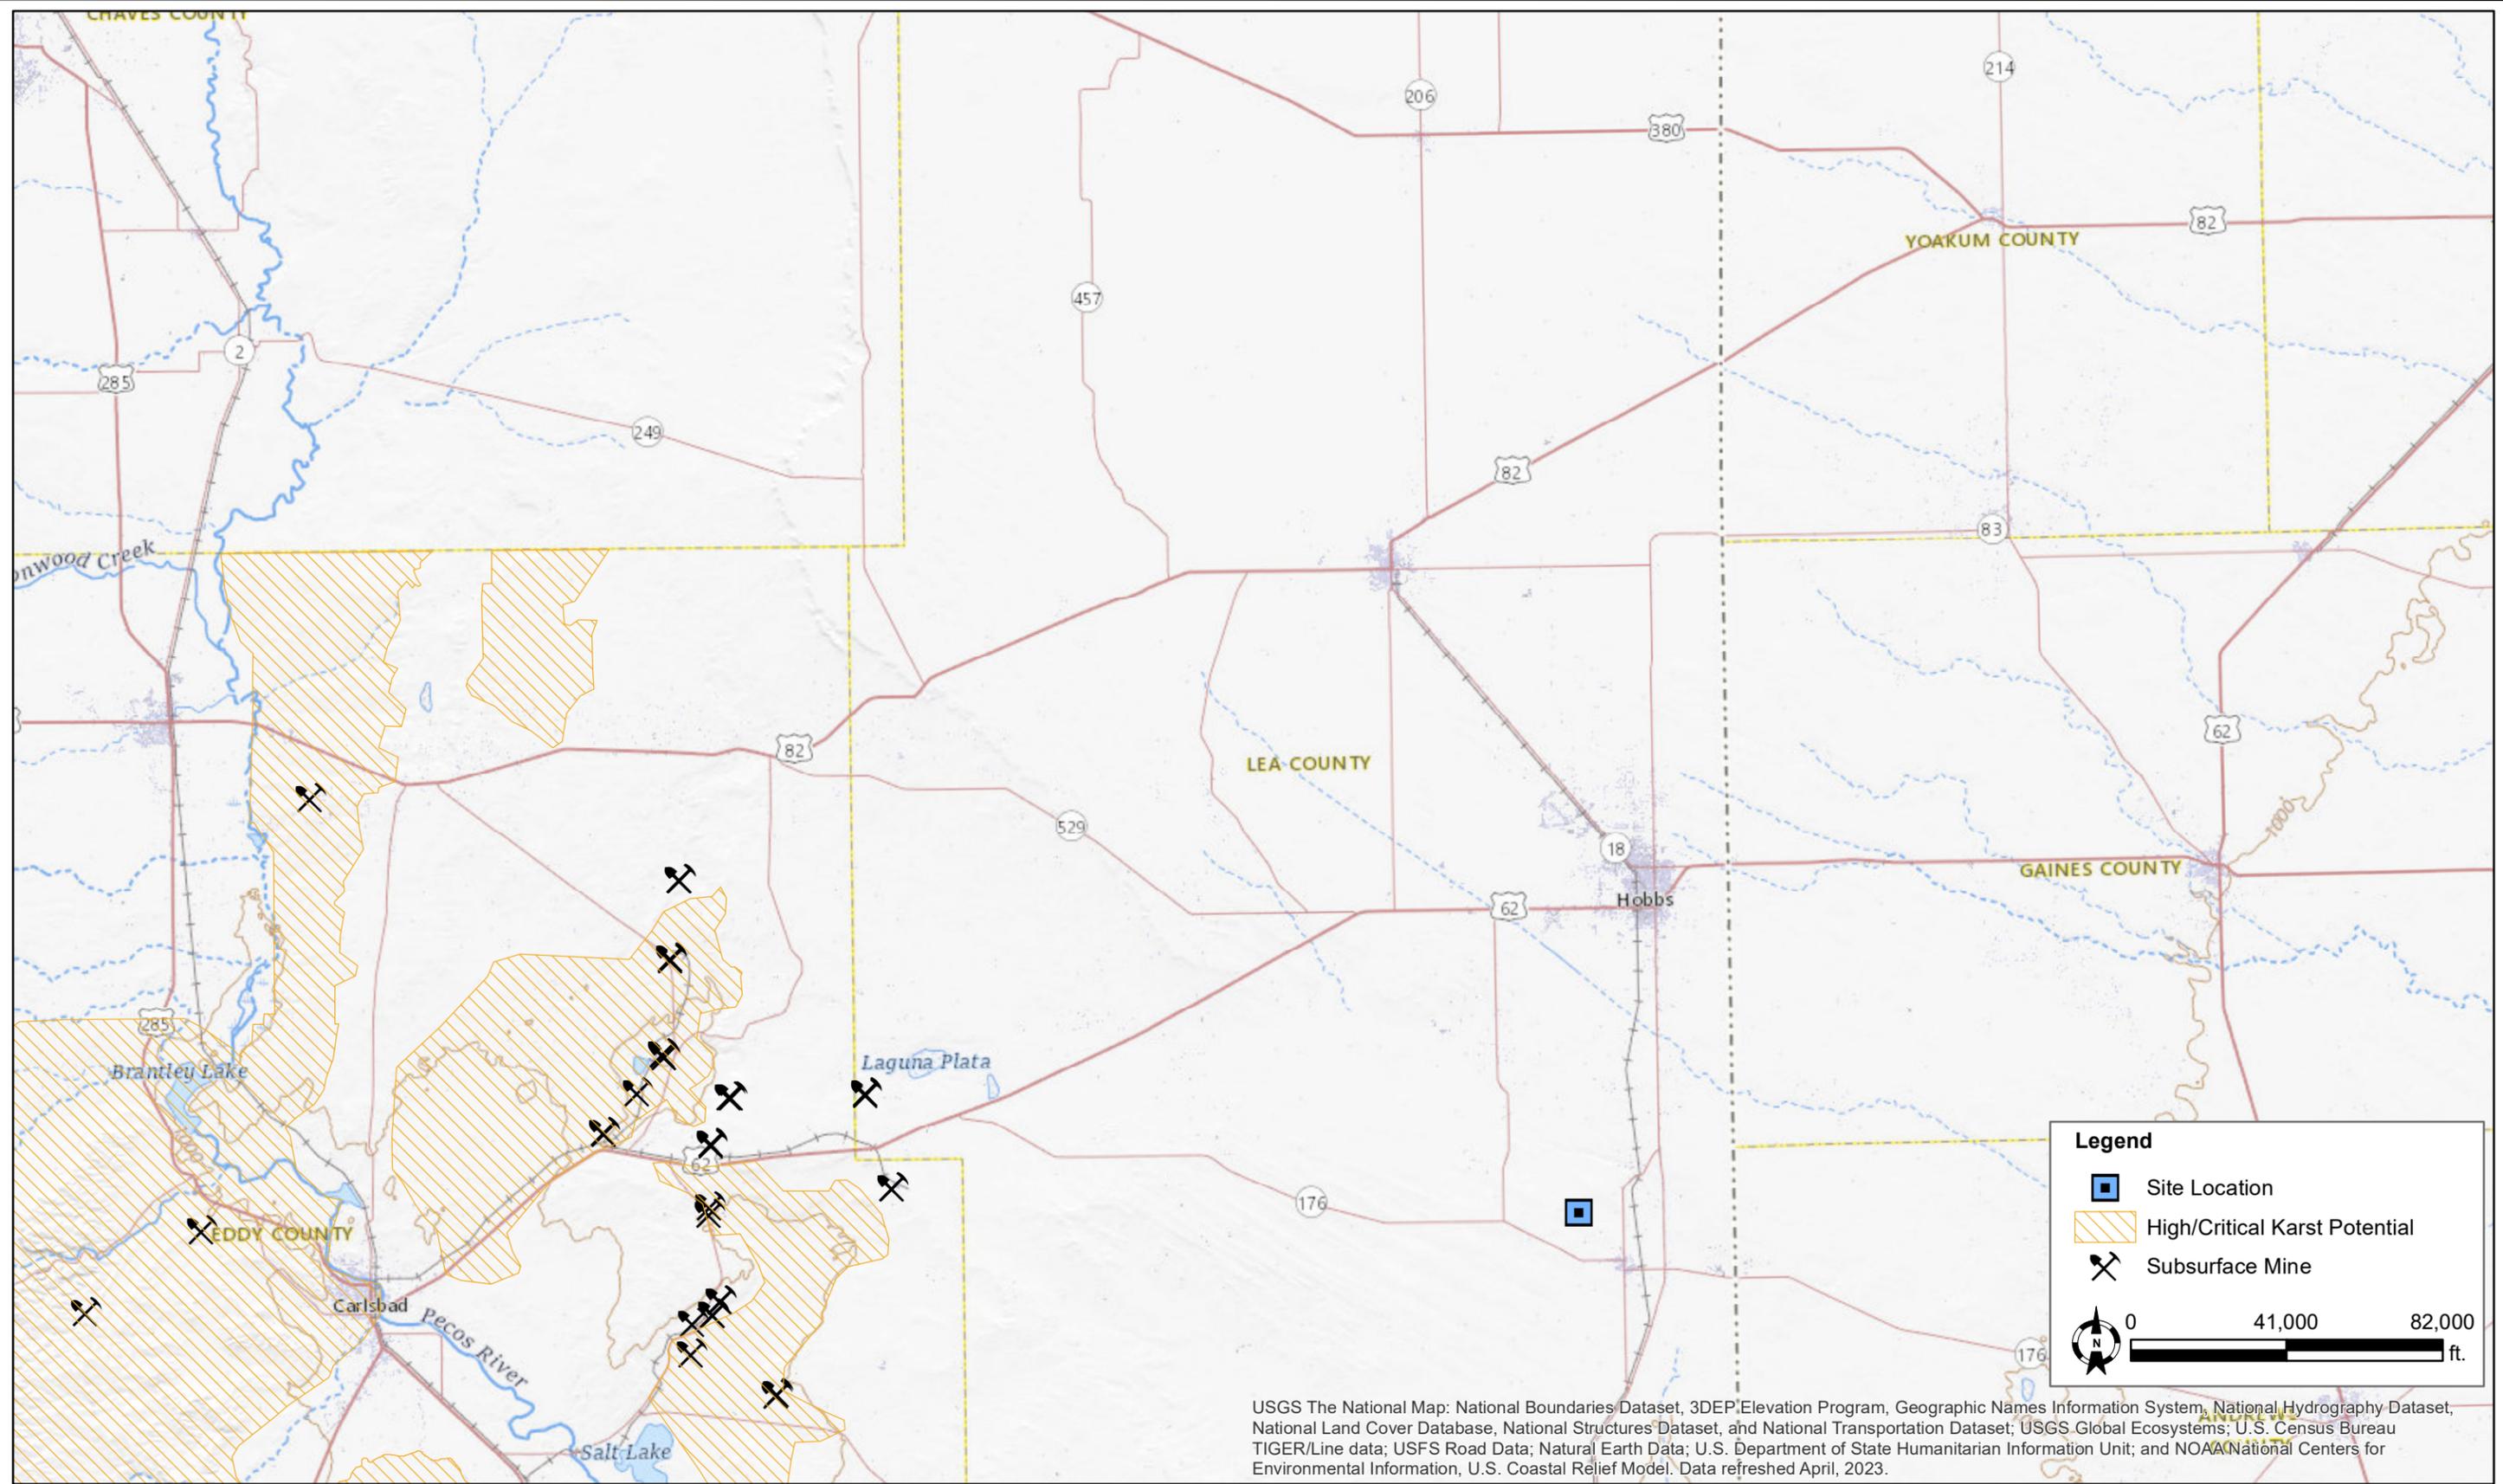
Figure
2

Areas of high/critical karst and subsurface mine locations are illustrated on Figure 2.

Karst Potential & Subsurface
 Mine Map

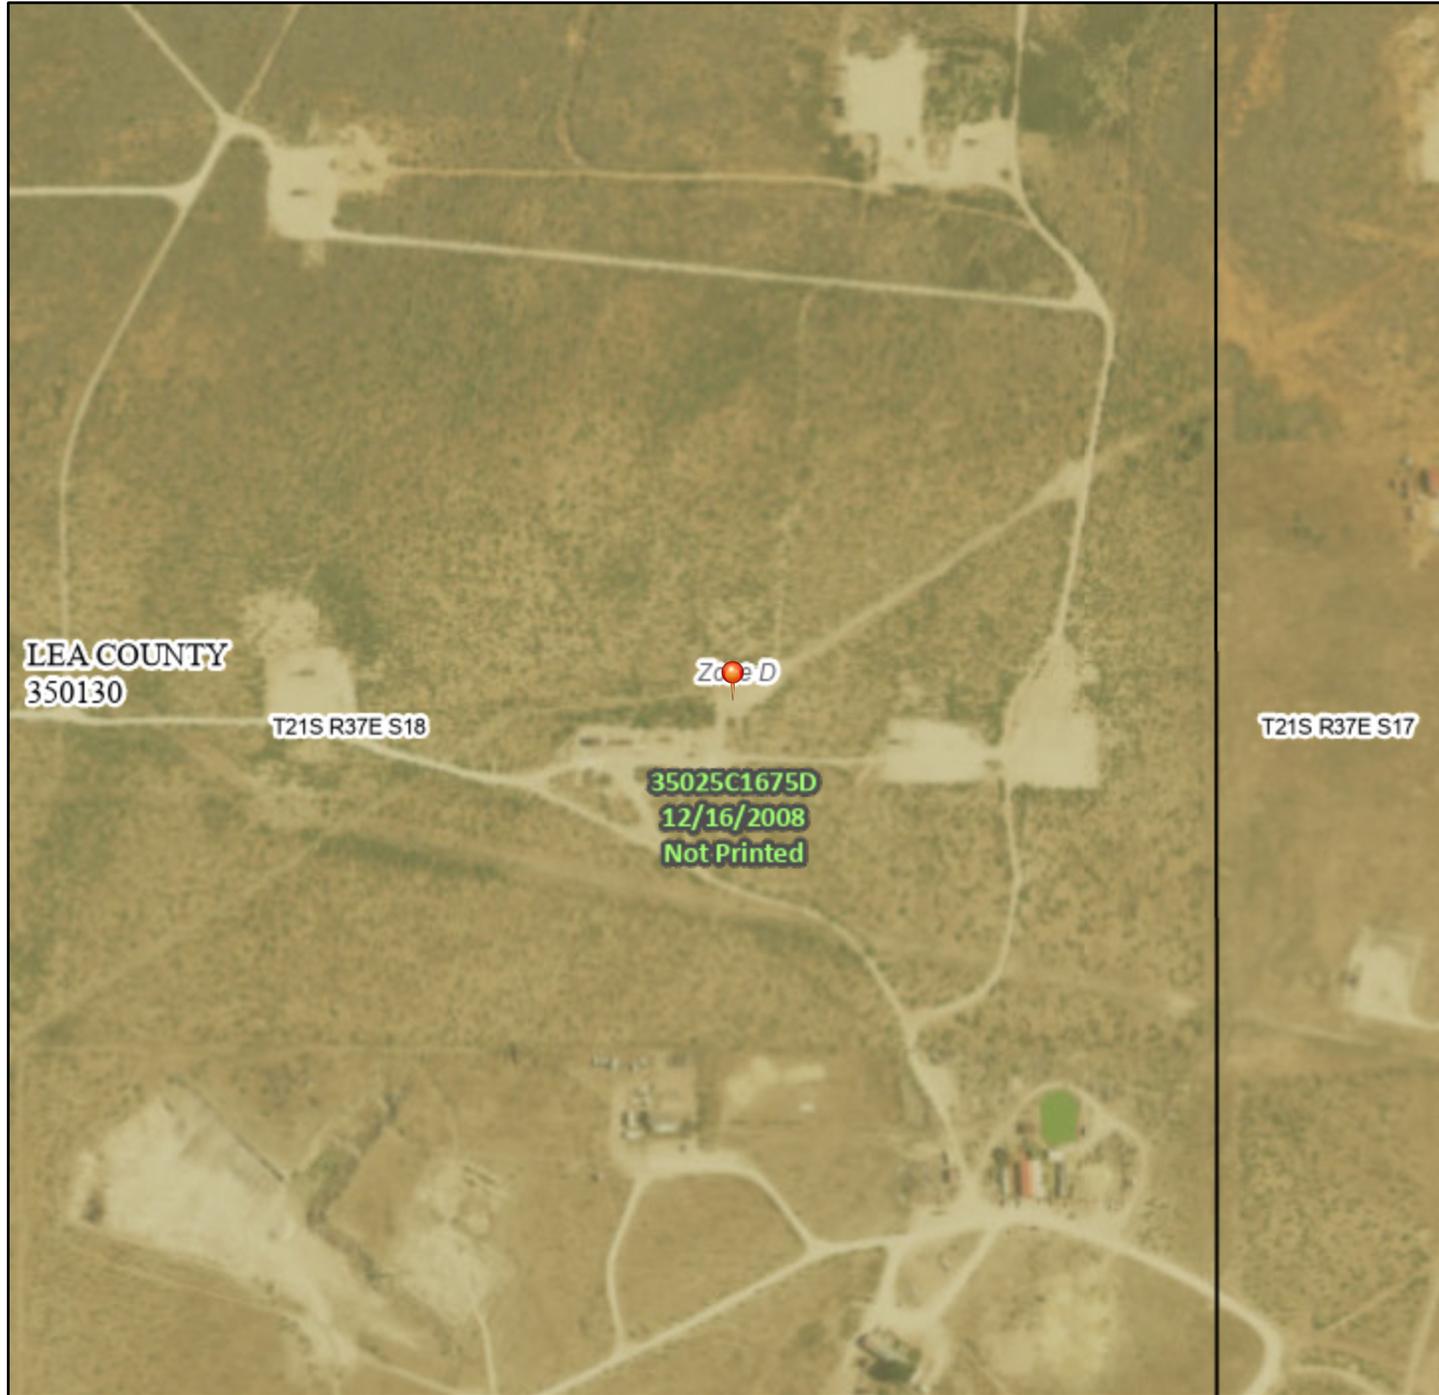
Figure 4

Review of flood map data published by the Federal Emergency Management Agency (FEMA) indicates the site is not located within a 100-year floodplain. A copy of the FEMA FIRMet Map can be found attached as Figure 4.

National Flood Hazard Layer FIRMette

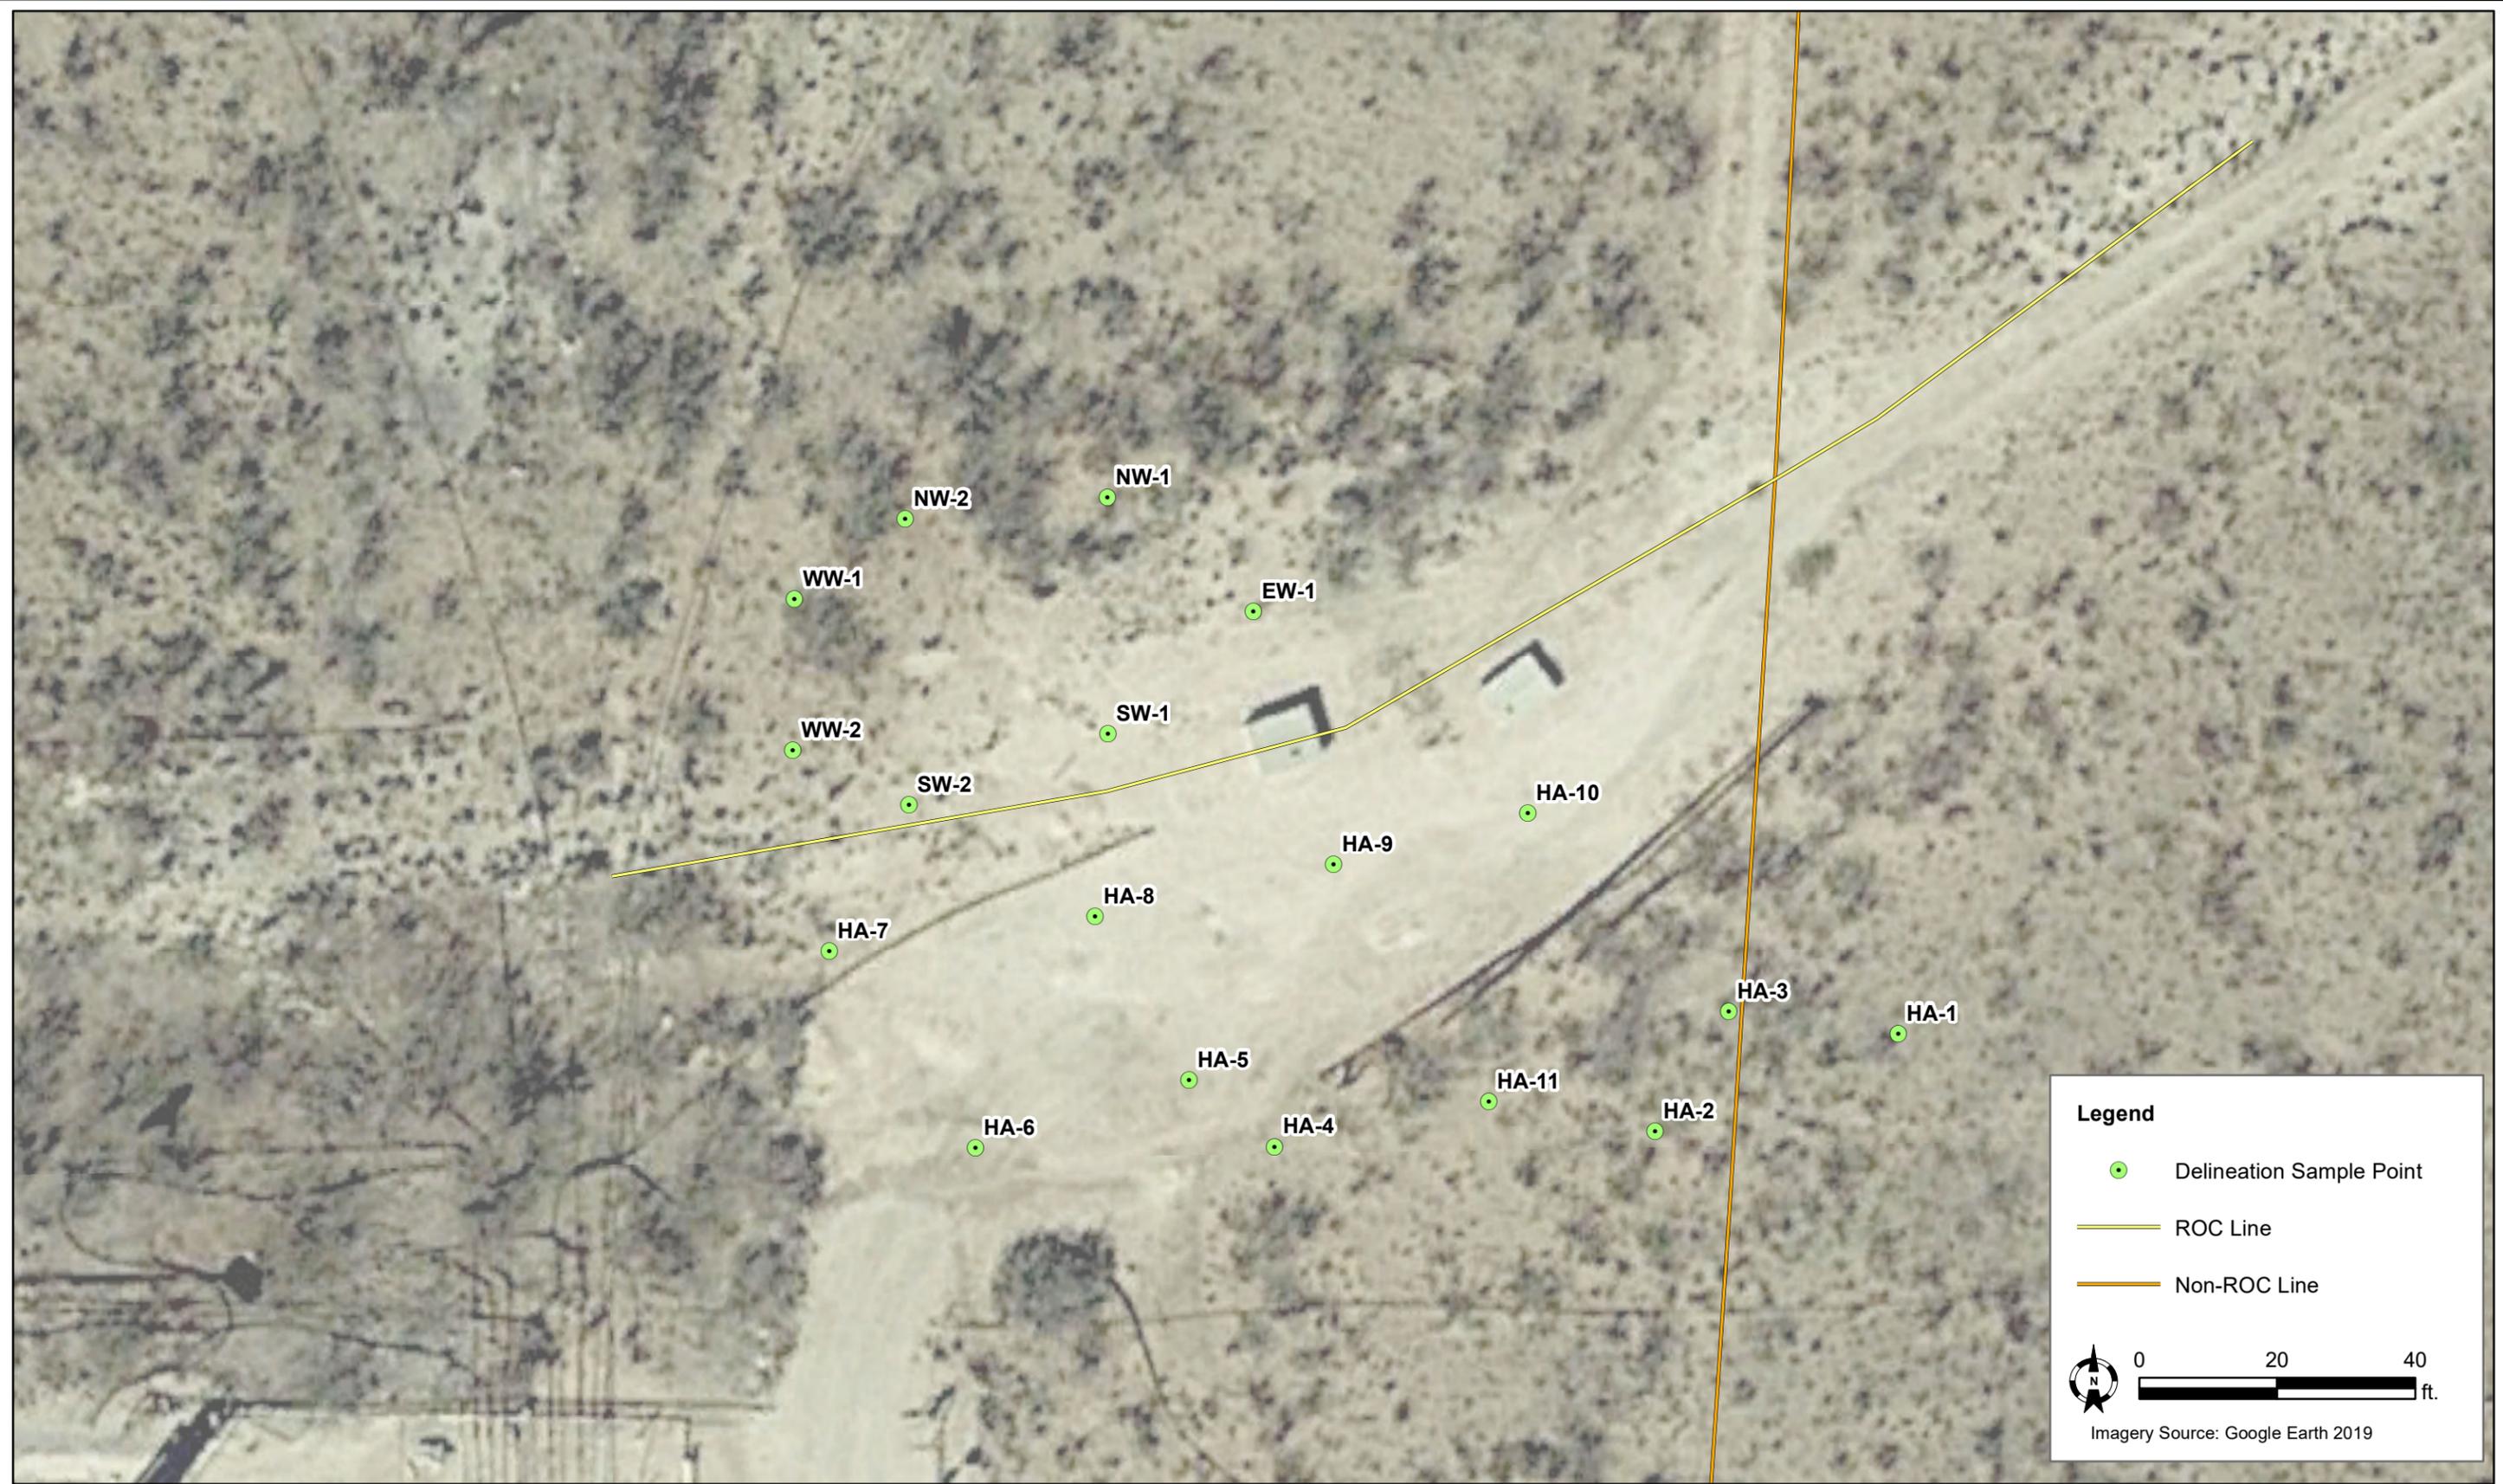
Figure 5

Delineation Overview Map
