Remediation Summary and Closure Request

**BTA Oil Producers, LLC
State JB Com #1
Eddy County, New Mexico
Unit Letter "L", Section 32, Township 23 South, Range 28 East
Latitude 32.258969 North, Longitude 104.116709 West
NMOCD Incident # NRM1935343091**

April 2024

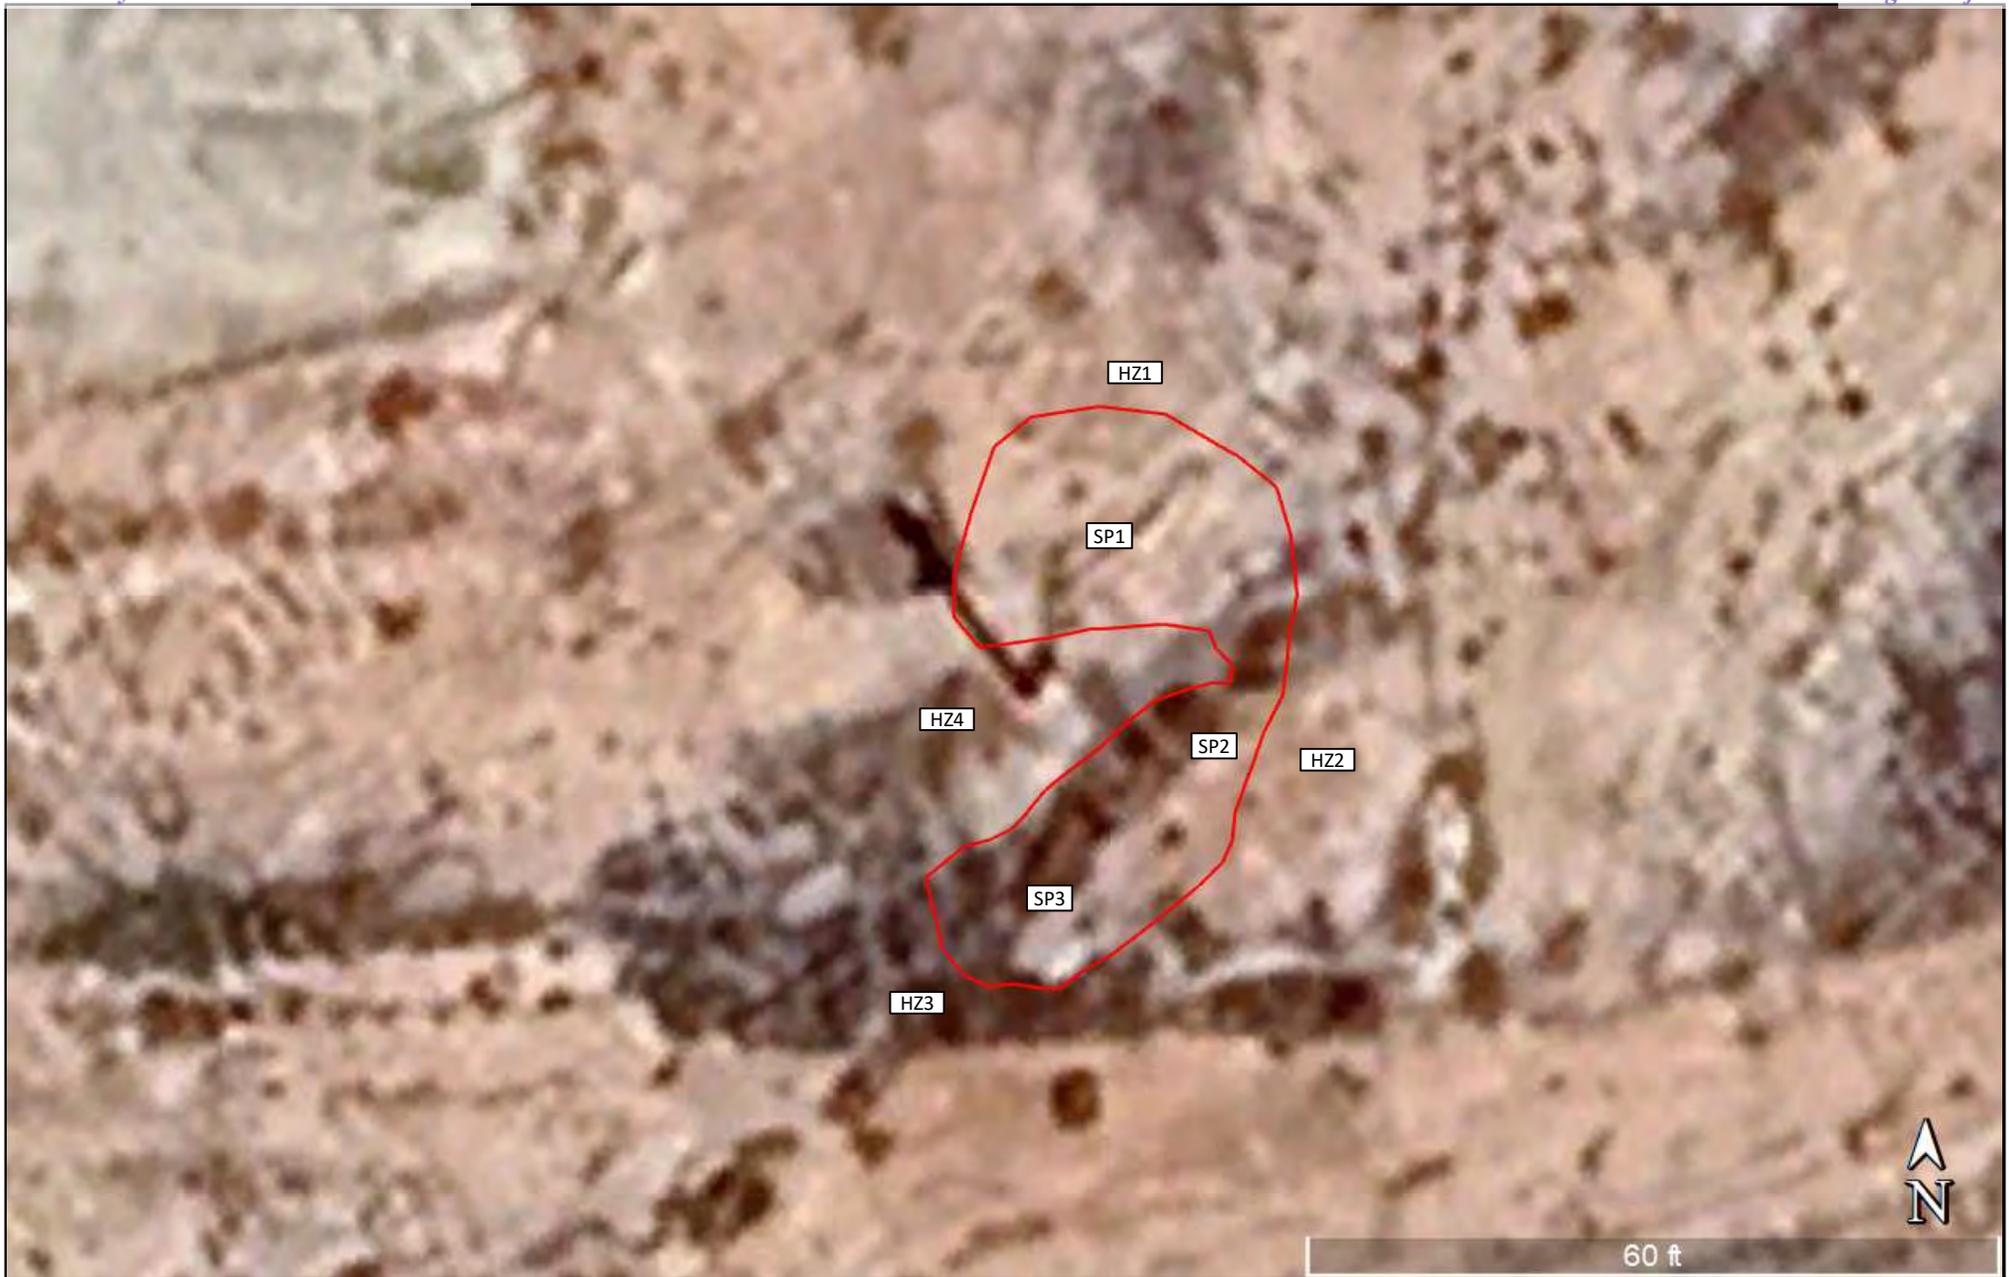
Figure 4
Delineation Sample Map
BTA Oil Producers, LLC
State JB Com #1
GPS: 32.258969, -104.116709
Eddy County

Based on field observations and field test data noted above and provided in Attachment IV, twenty-three representative soil samples were selected for laboratory analysis. Delineation soil samples SP1 through SP3, HZ1 through HZ4, were submitted to the laboratory for analysis of BTEX, TPH, and chloride. Laboratory analytical results indicated contaminant concentrations were below the NMOCD Closure Criteria in each of the submitted samples, with the exception of SP1 and SP2, at one foot through four feet bgs, and SP3, at Surface through four feet bgs, which exhibited chloride concentrations in excess of NMOCD Closure Criteria.

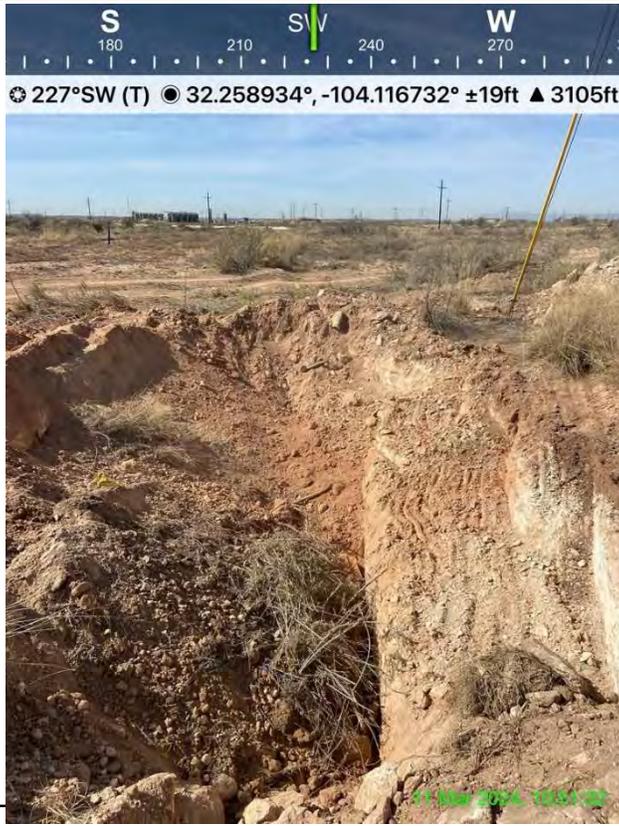
Photo: 11 **Description:** Backfilling

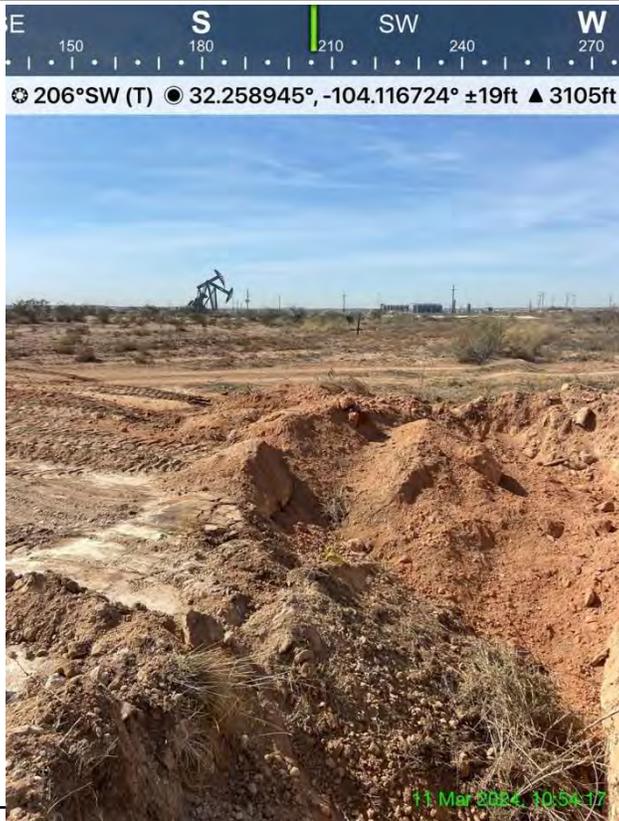
Photo: 12 **Description:** Backfilling
