May 6, 2024

**Re: Revised Remediation Work Plan ADDENDUM
ConocoPhillips Company (Heritage COG Operating, LLC)
Way South State Com #001H Tin Horn Release
Unit Letter A, Section 30, Township 26 South, Range 28 East
Eddy County, New Mexico
Incident ID# nAB1821441824
Landowner: NMSLO**

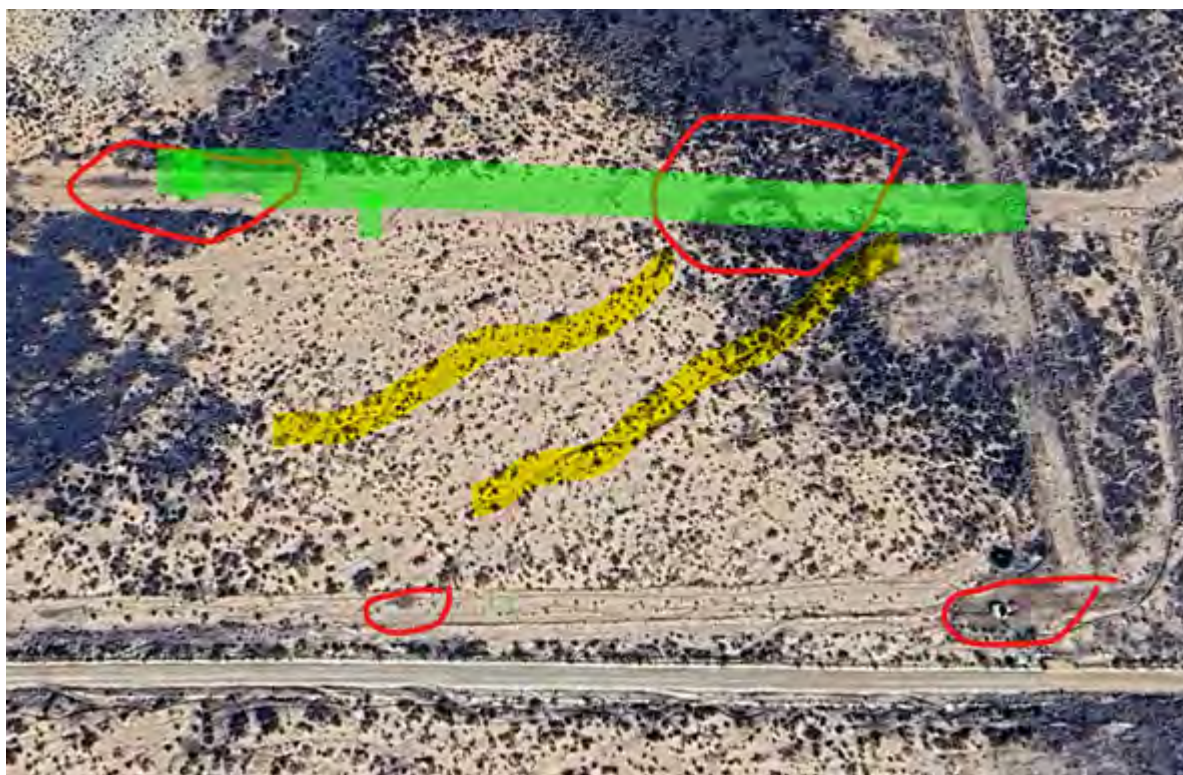
Our inspectors confirmed that the proposed background sample location will be acceptable. They also confirmed that the area highlighted in green is indeed a ROW, but they were unable to determine who's right of way it is. Does your team happen to have information on this ROW? We were able to determine that the areas of concern (red) were likely from recent precipitation events.

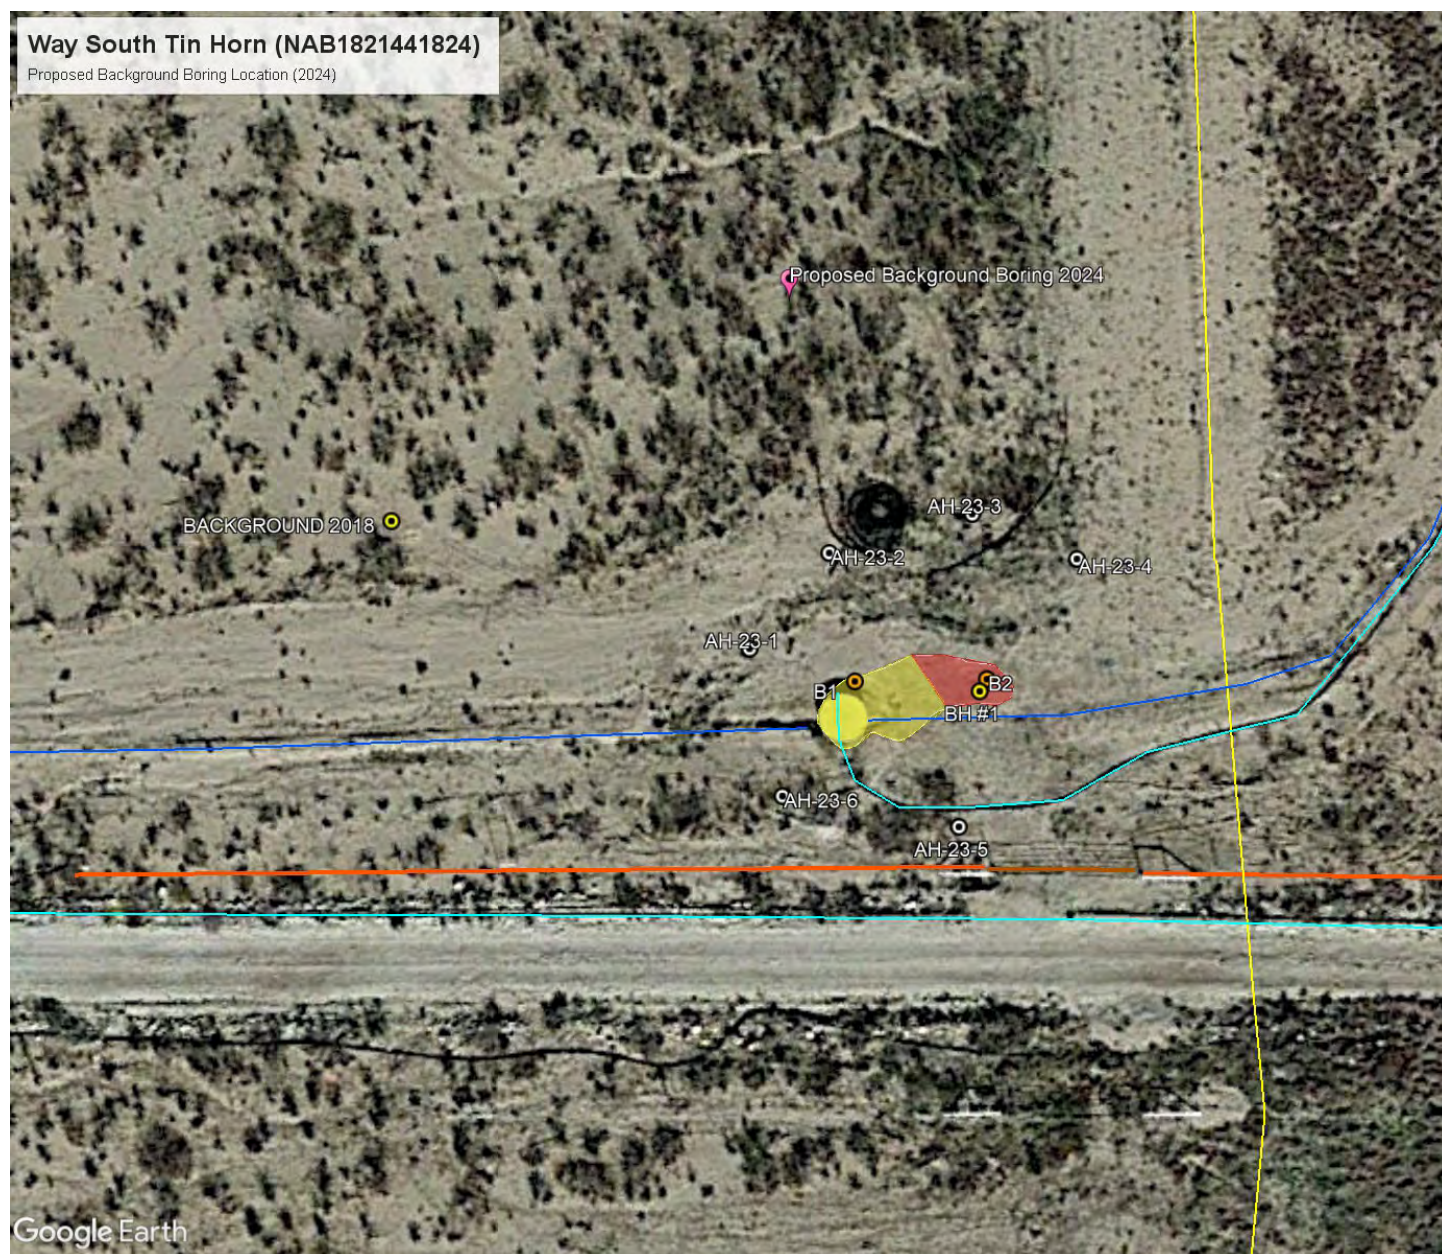
After review of the site conditions in the vicinity of the tin horn and the right-of-way, a location approximately 100 feet due north of the release extent (presented in the image below) was selected for the background boring. That location

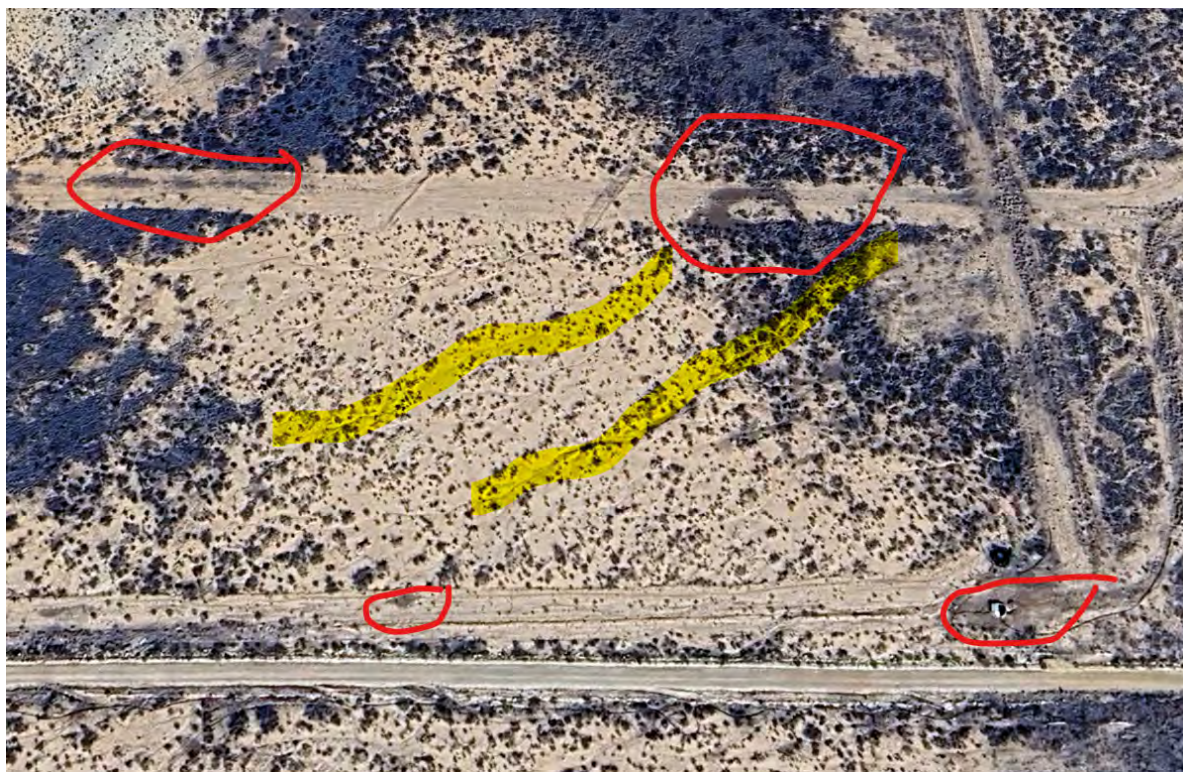
Thank you for submitting the subject workplan for review. ECO has reviewed the workplan and NMOCD comments. We do agree with NMOCD and would like to witness a new background soil boring. However, we believe it would be more beneficial to determine background chlorides by selecting a new sample location, not near the 2018 boring. We have also opened the discussion with NMOCD regarding the soil boring location. ECO has concerns about selecting a new sample point due the erosional features coming off the ROW north of the spill location which appears to have had releases along it's path also.

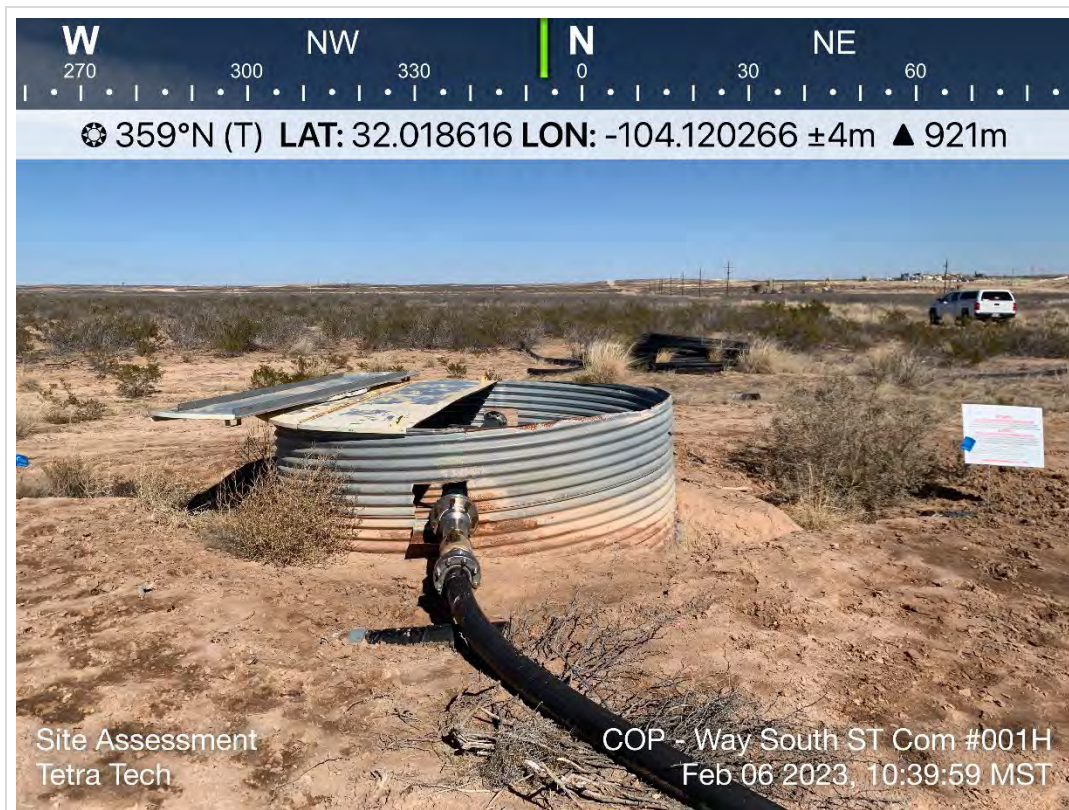
TETRA TECH, INC. PROJECT NO. 212C-MD-02994	DESCRIPTION	View north. View of tin horn and surface polyline.	1
	SITE NAME	Way South State Com #001H Release	2/6/2023

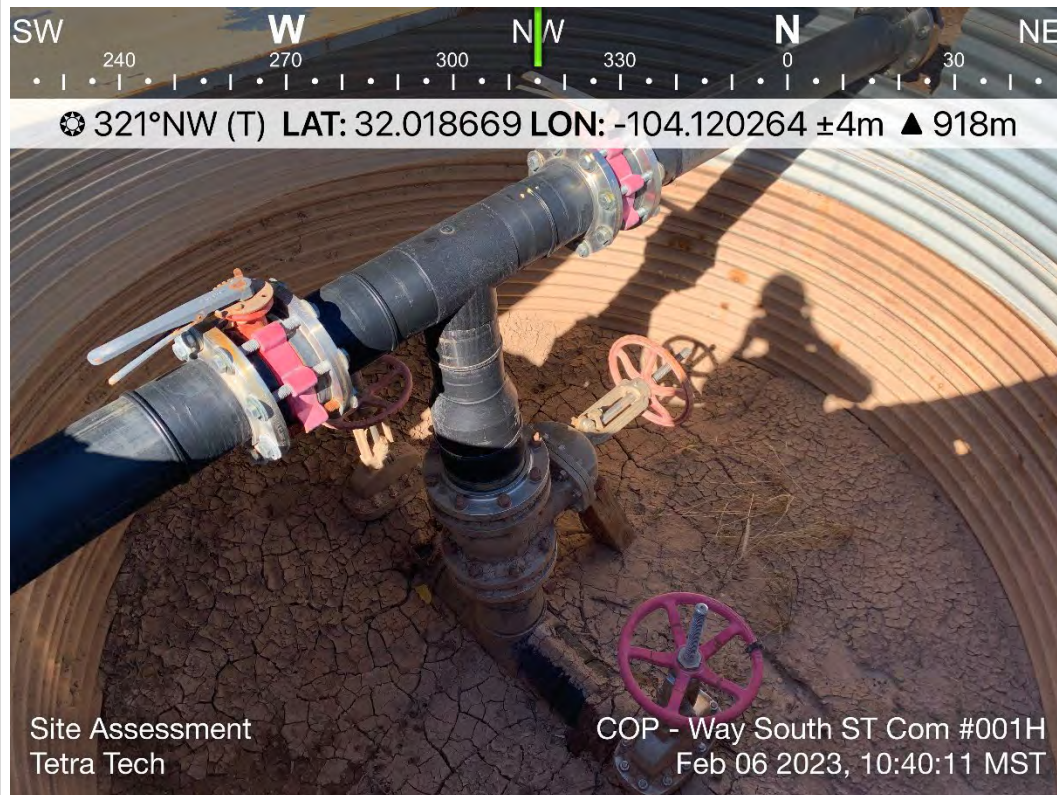
TETRA TECH, INC. PROJECT NO. 212C-MD-02994	DESCRIPTION	View northwest. View of inside the tin horn.	2
	SITE NAME	Way South State Com #001H Release	2/6/2023

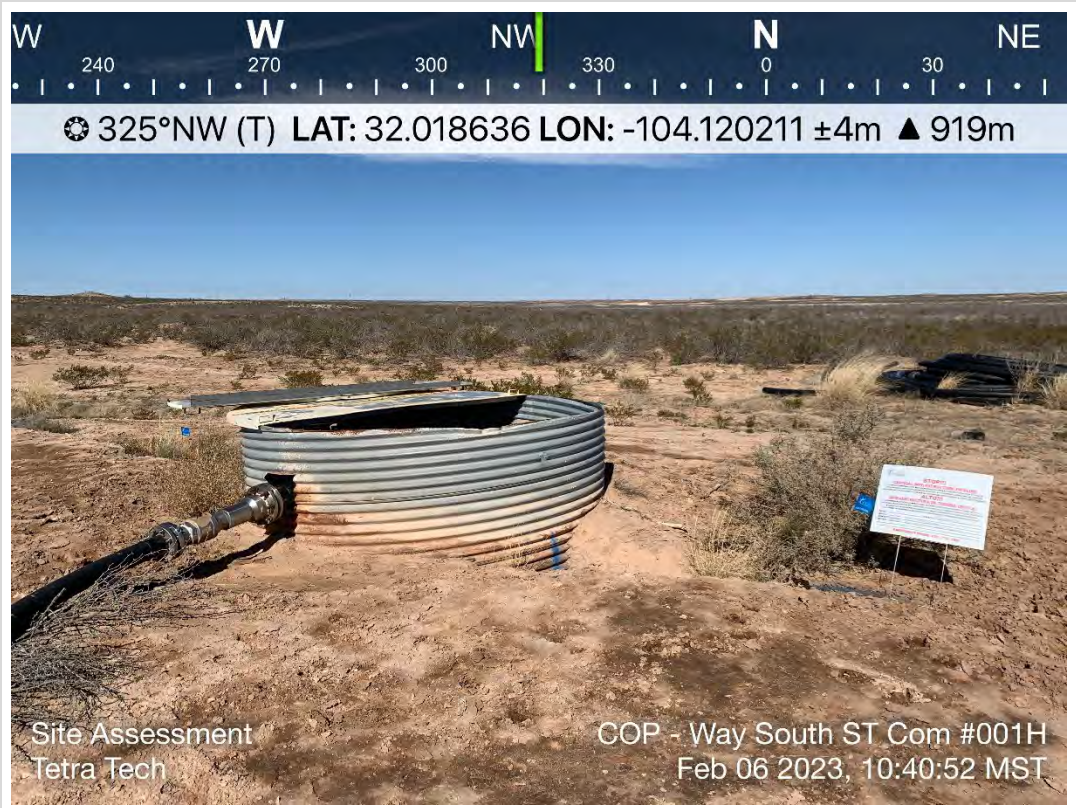
TETRA TECH, INC. PROJECT NO. 212C-MD-02994	DESCRIPTION	View northwest. View of tin horn and surface polyline. View of material and Solaris signage.	3
	SITE NAME	Way South State Com #001H Release	2/6/2023

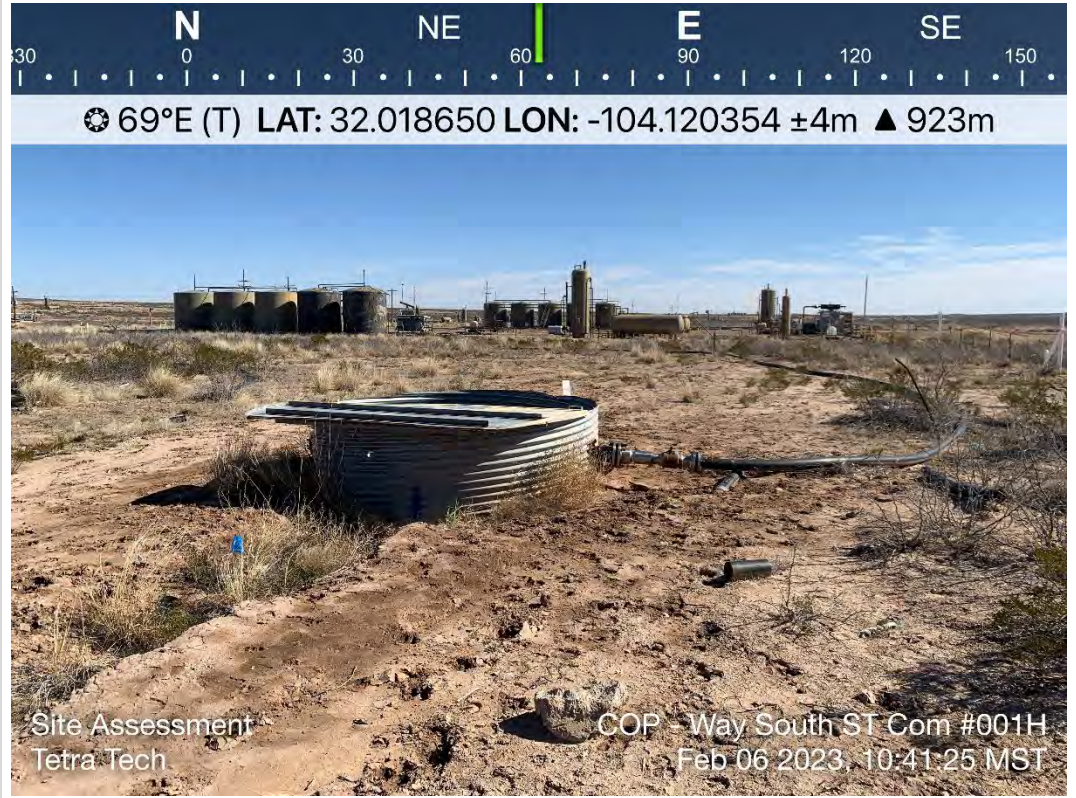
TETRA TECH, INC. PROJECT NO. 212C-MD-02994	DESCRIPTION	View northeast. View of tin horn and Way South State Com Tank battery.	4
	SITE NAME	Way South State Com #001H Release	2/6/2023

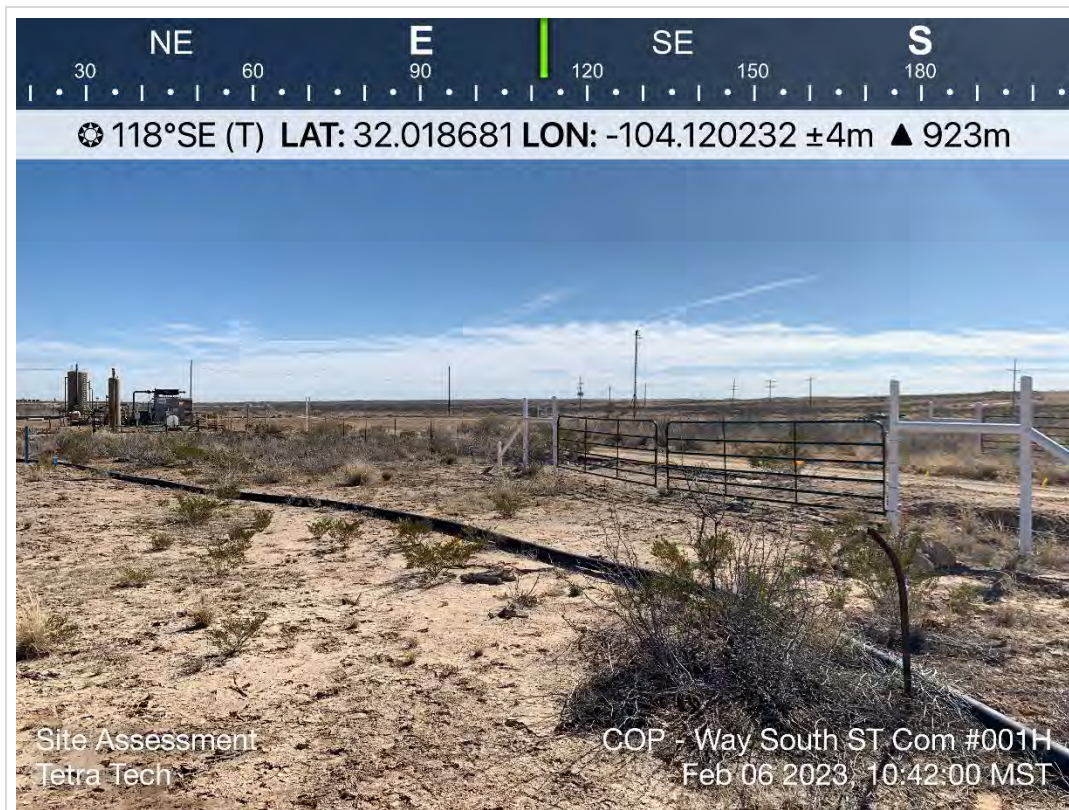
TETRA TECH, INC. PROJECT NO. 212C-MD-02994	DESCRIPTION	View east. View of gate and surface poly line.	5
	SITE NAME	Way South State Com #001H Release	2/6/2023

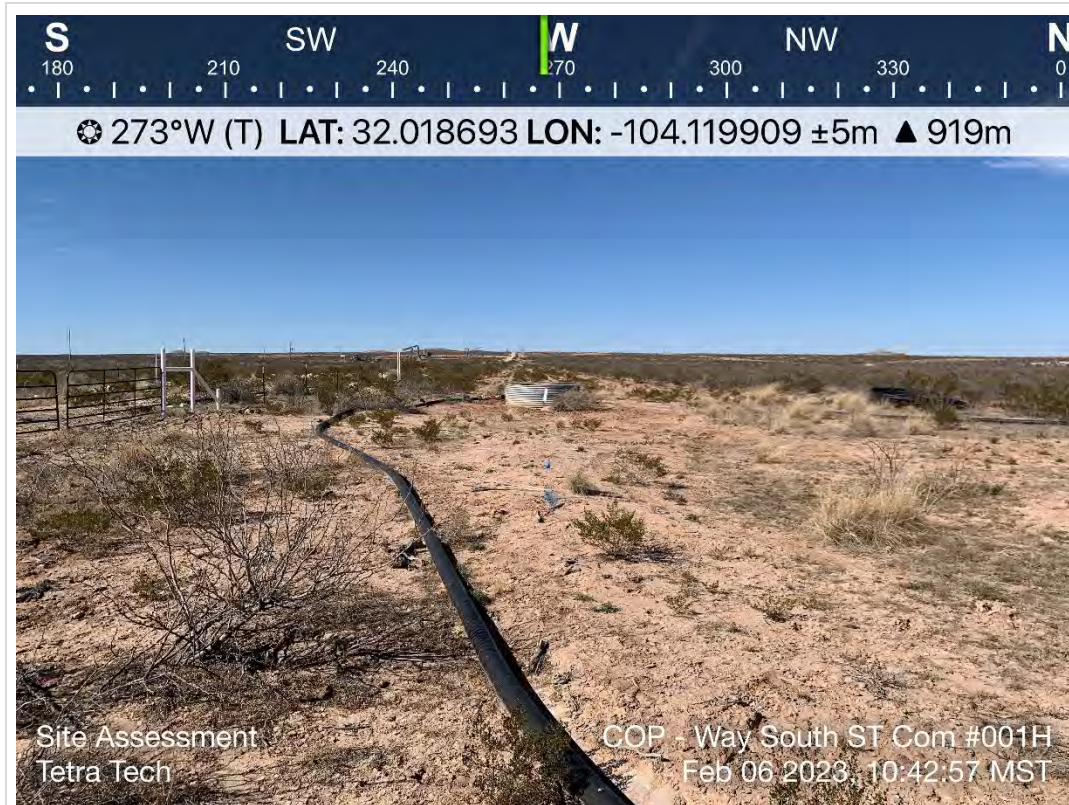
TETRA TECH, INC. PROJECT NO. 212C-MD-02994	DESCRIPTION	View west. View of tin horn and surface poly line.	6
	SITE NAME	Way South State Com #001H Release	2/6/2023

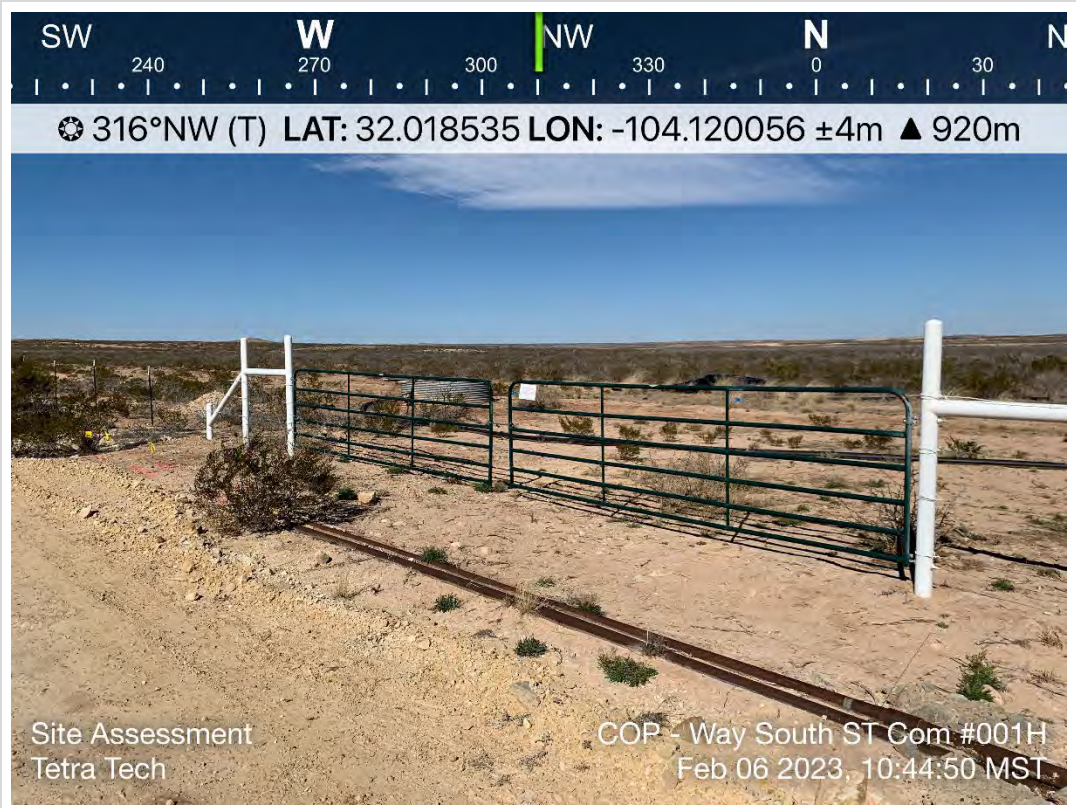
TETRA TECH, INC. PROJECT NO. 212C-MD-02994	DESCRIPTION	View northwest. View of gate and tin horn. Steel surface lines visible.	7
	SITE NAME	Way South State Com #001H Release	2/6/2023

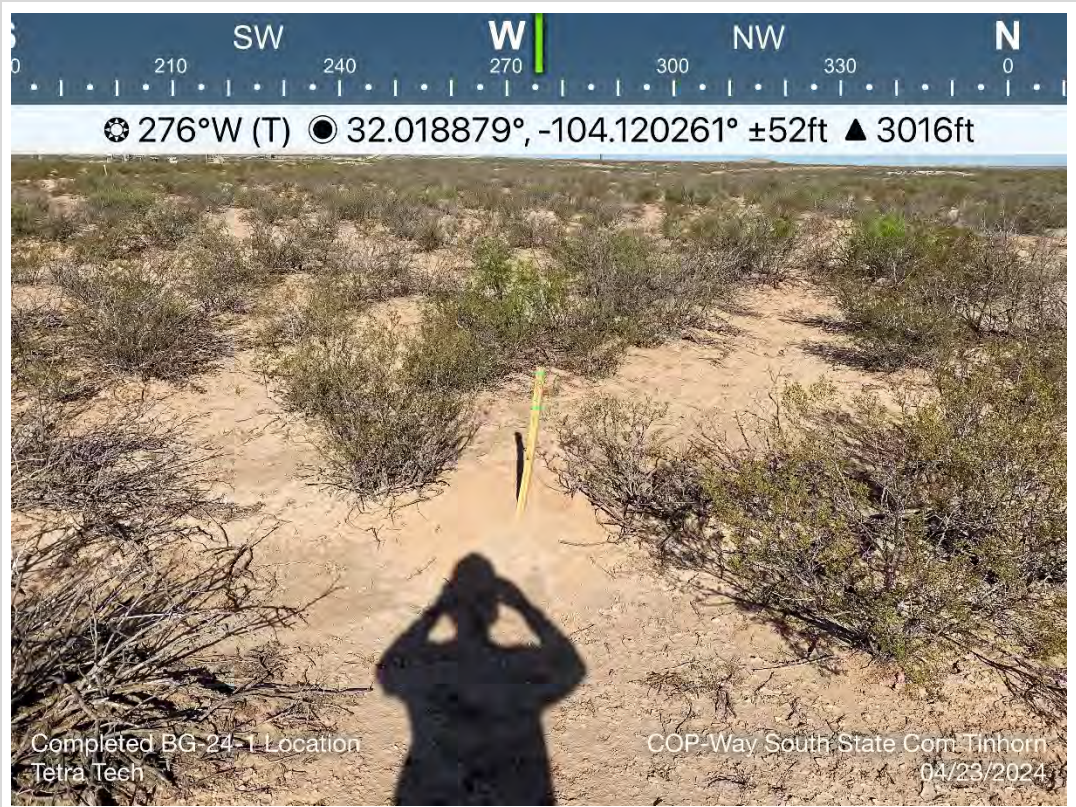
TETRA TECH, INC. PROJECT NO. 212C-MD-02994	DESCRIPTION	View west. View of completed background boring location BG-24-1.	8
	SITE NAME	Way South State Com #001H Release	4/23/2023

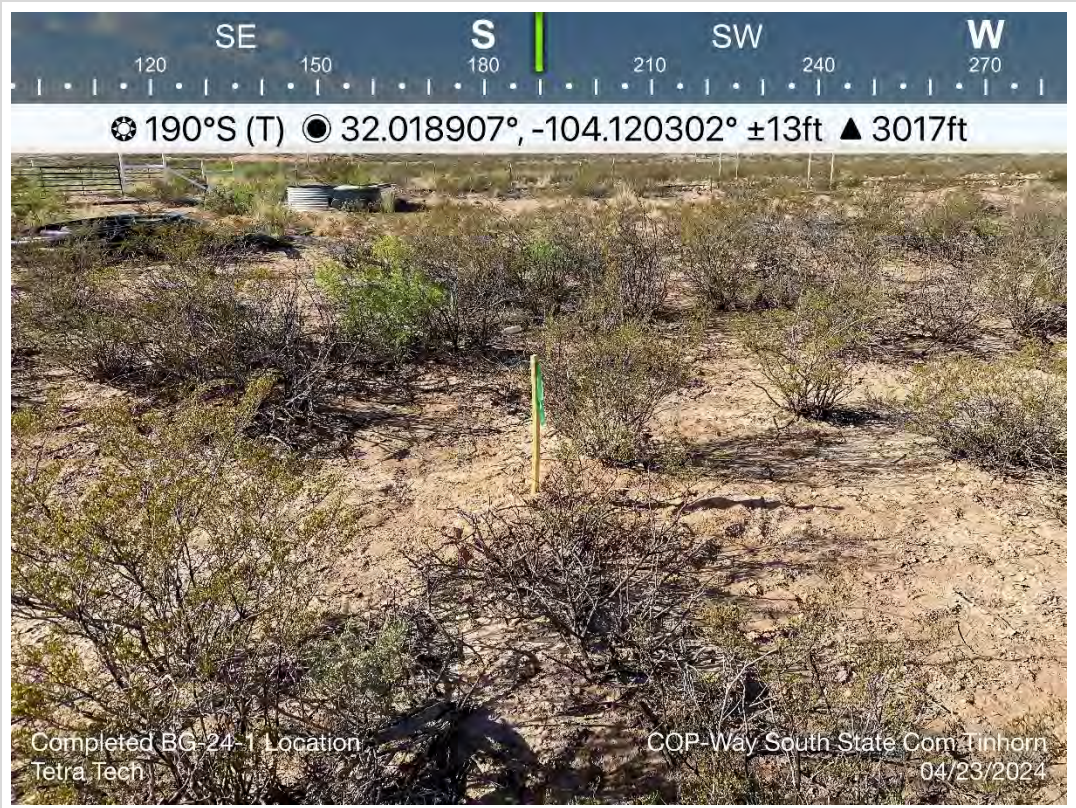
TETRA TECH, INC. PROJECT NO. 212C-MD-02994	DESCRIPTION	View south. View of completed background boring location BG-24-1.	9
	SITE NAME	Way South State Com #001H Release	4/23/2023

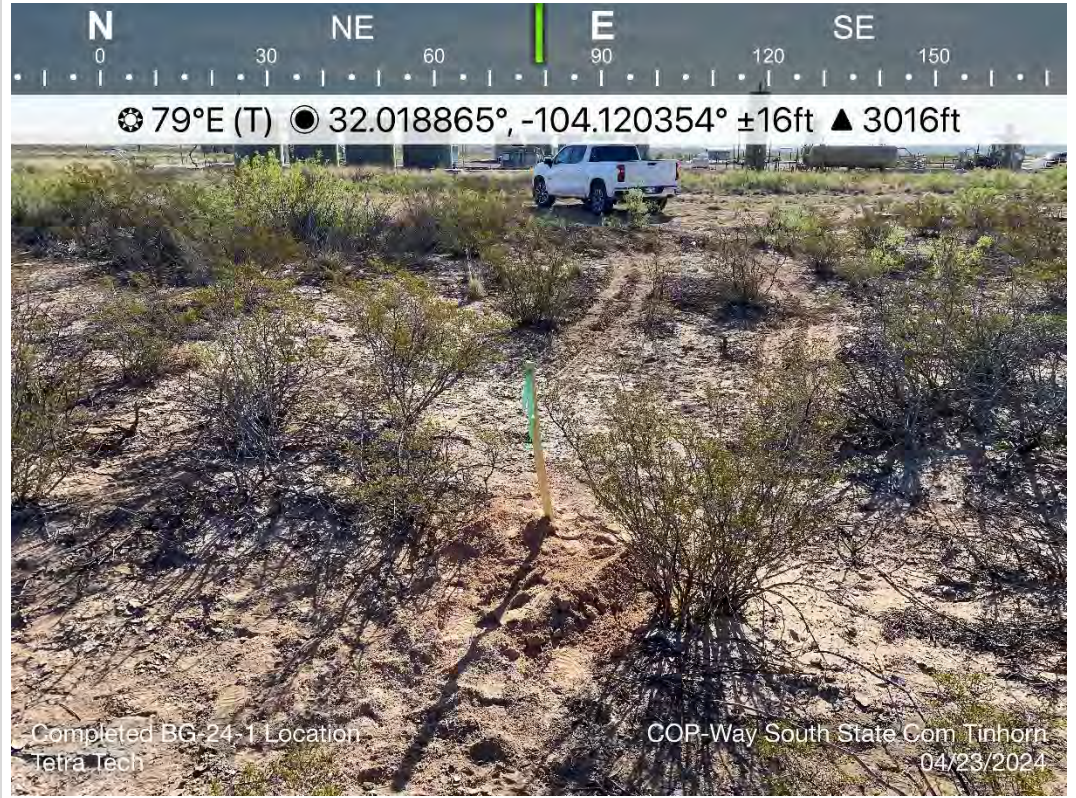
TETRA TECH, INC. PROJECT NO. 212C-MD-02994	DESCRIPTION	View east. View of completed background boring location BG-24-1.	10
	SITE NAME	Way South State Com #001H Release	2/6/2023

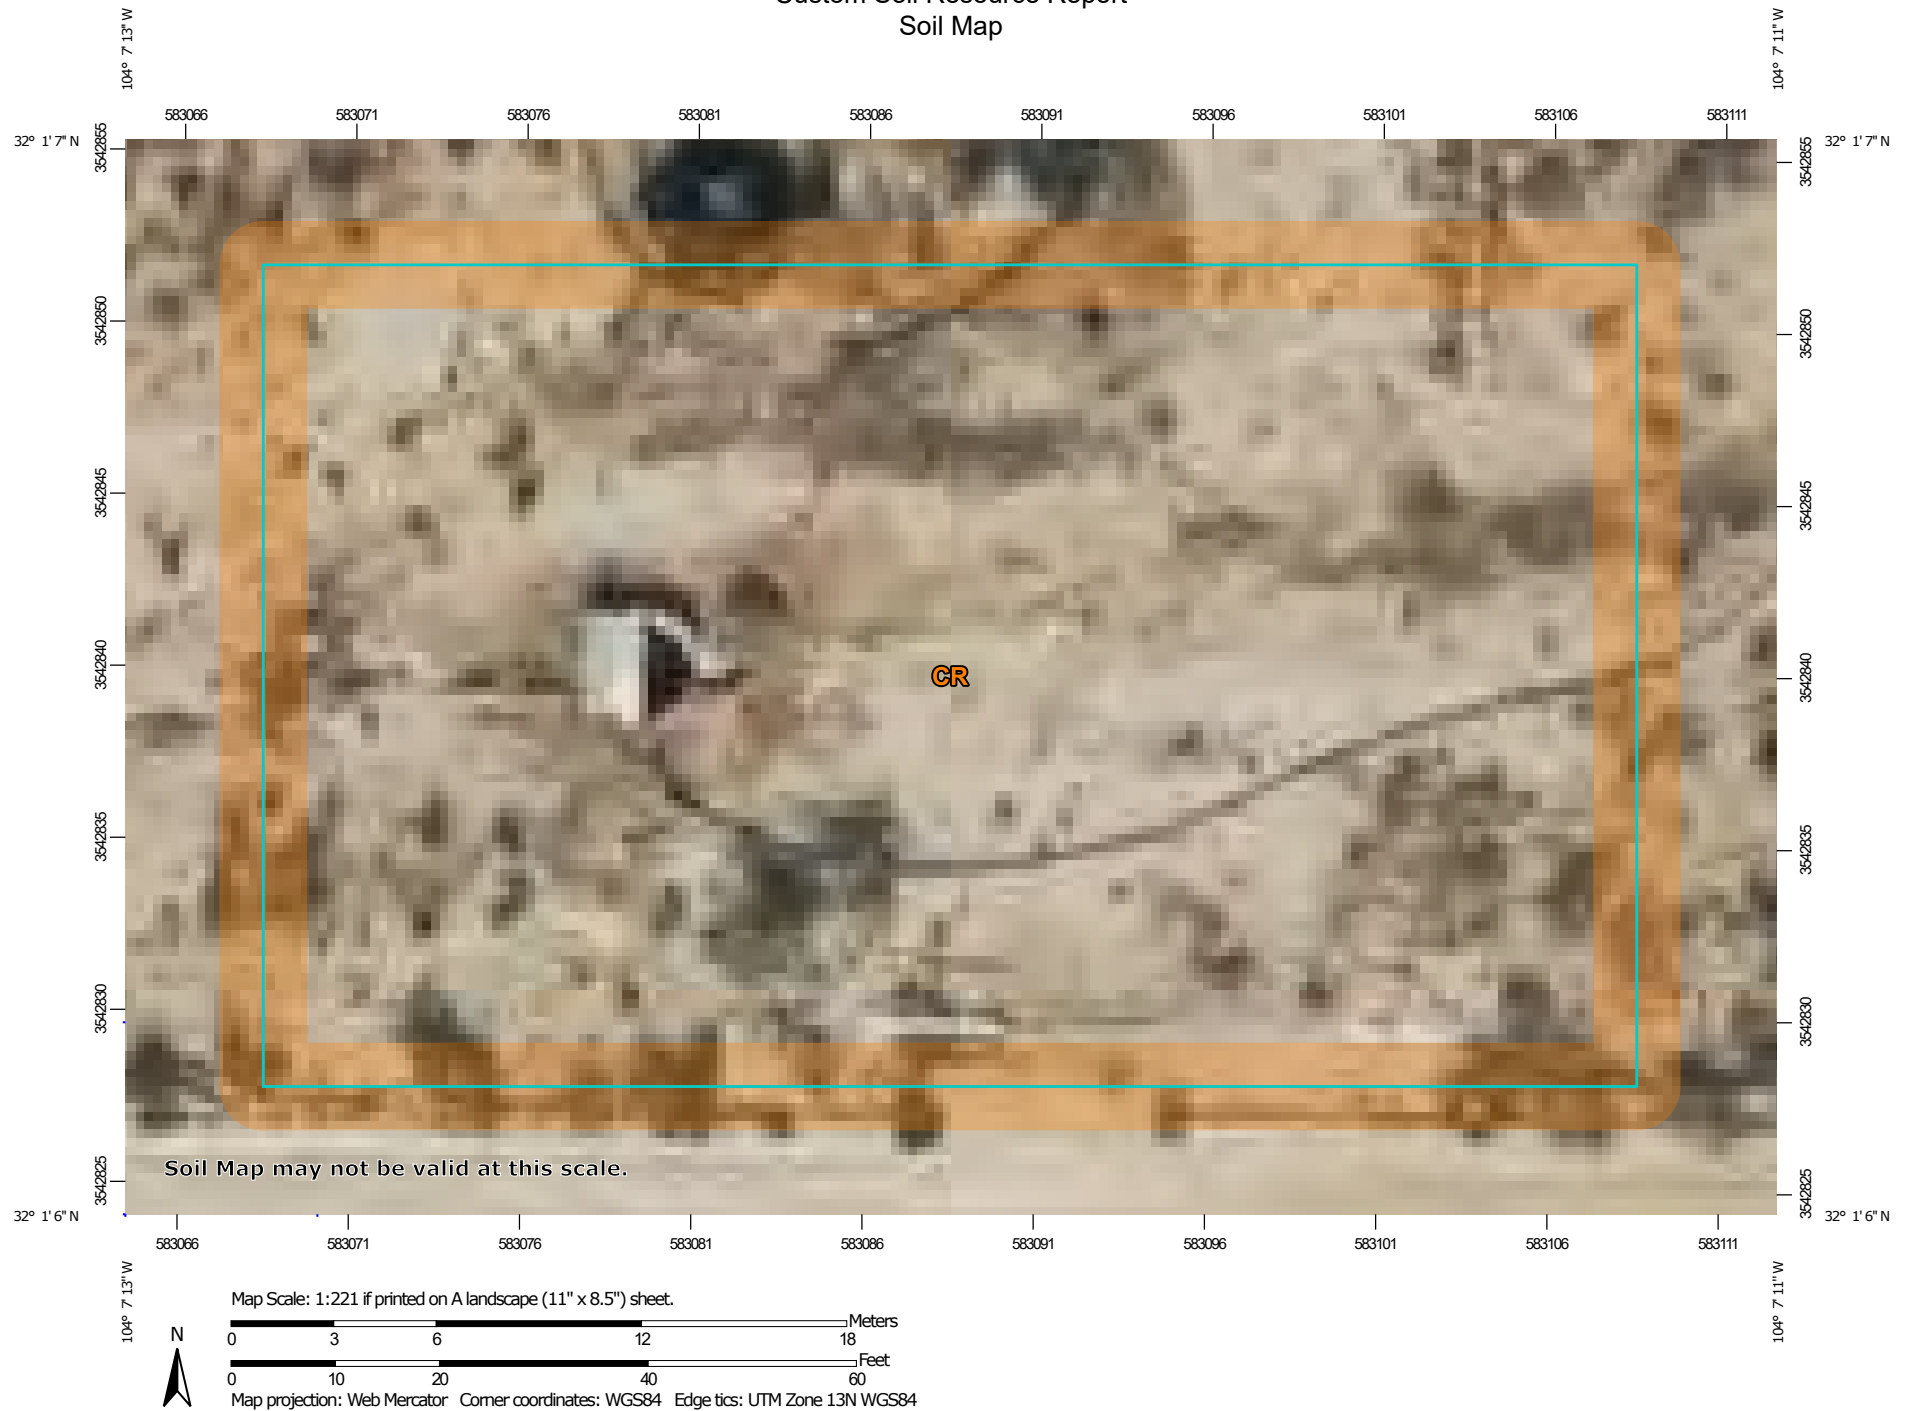
Custom Soil Resource Report
Soil Map

The soil map section includes the soil map for the defined area of interest, a list of soil map units on the map and extent of each map unit, and cartographic symbols displayed on the map. Also presented are various metadata about data used to produce the map, and a description of each soil map unit.
