Remediation Summary & Soil Closure Request

Spur Energy Partners, LLC Patton 5 Fee #008H Battery

Eddy County, New Mexico
Unit Letter M, Section 5, Township 19 South, Range 26 East
Latitude 32.683693 North, Longitude 104.411751 West
NMOCD Reference No. nAPP2318130041

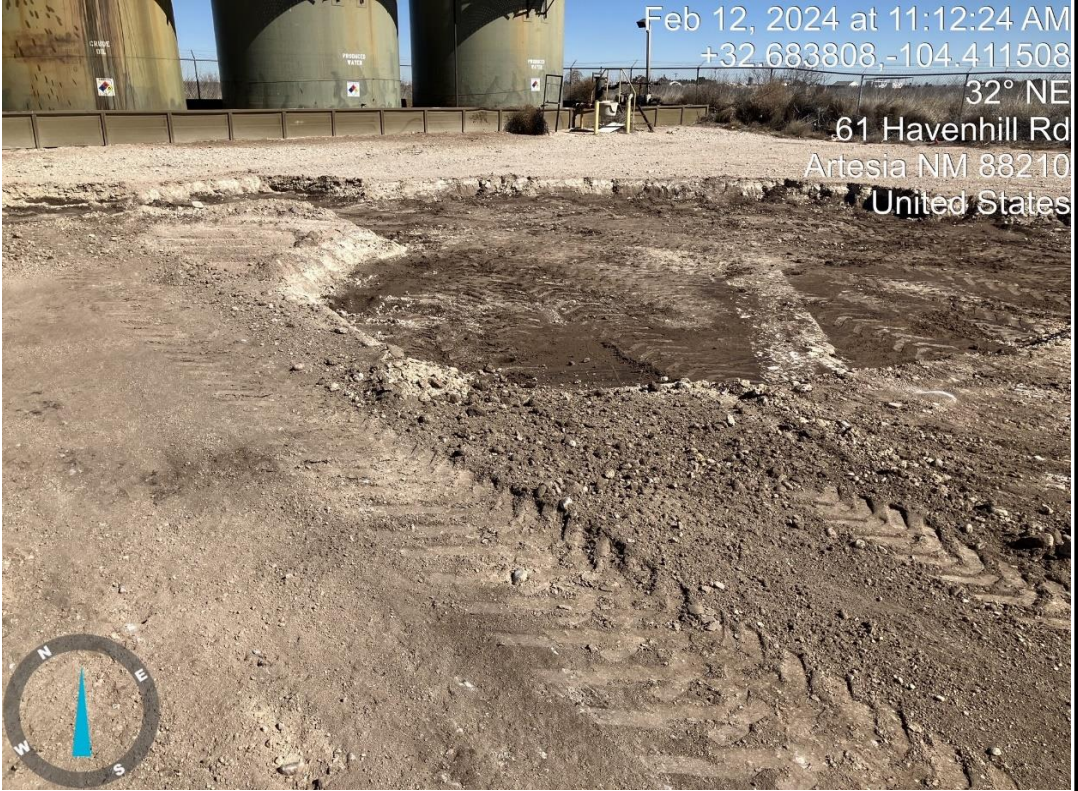
Photo Number: 6	<div>Feb 12, 2024 at 11:12:24 AM +32.683808, -104.411508 32° NE 61 Havenhill Rd Artesia NM 88210 United States</div>

<p>A photograph showing a large, open excavation site in the foreground, with a dirt and gravel surface. In the background, several large, cylindrical industrial storage tanks are visible, along with a metal framework structure. A compass rose in the bottom left corner indicates North is towards the top of the image.</p>
Photo Direction: North-Northeast	
Photo Description: View of open excavation.

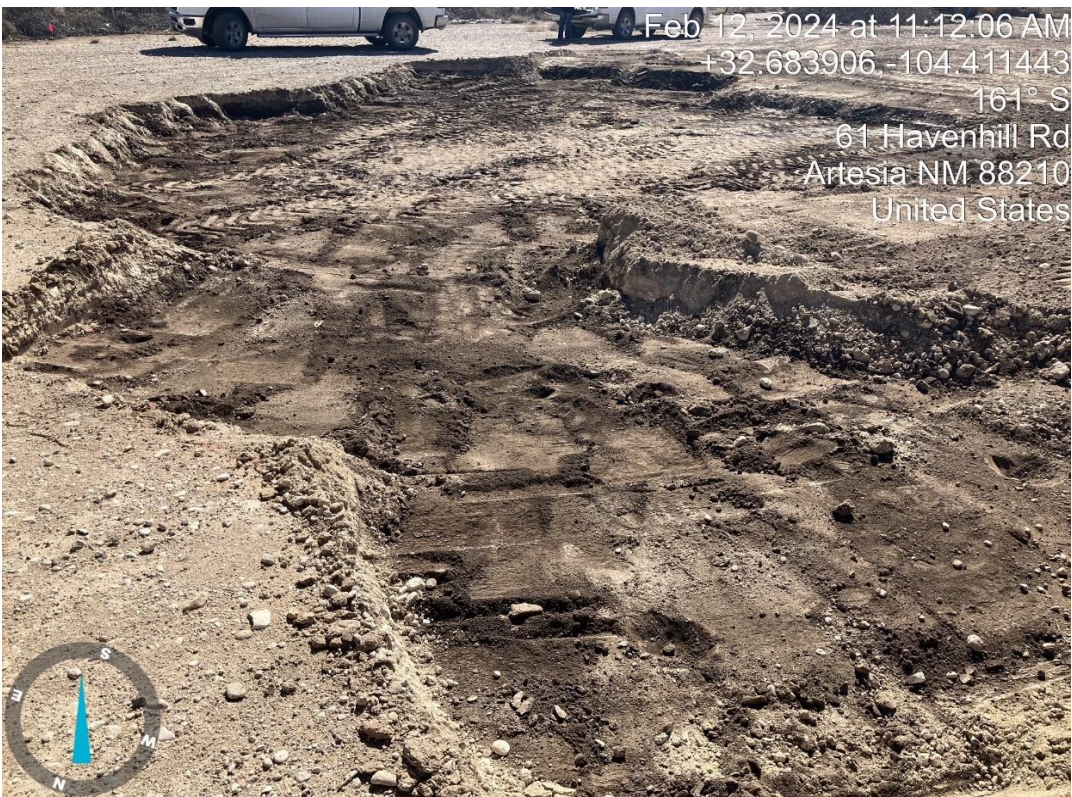
Photo Number: 7

<p>Feb 12, 2024 at 11:12:06 AM +32.683906, -104.411443 161° S 61 Havenhill Rd Artesia NM 88210 United States</p>
Photo Direction: South-Southeast	
Photo Description: View of open excavation.

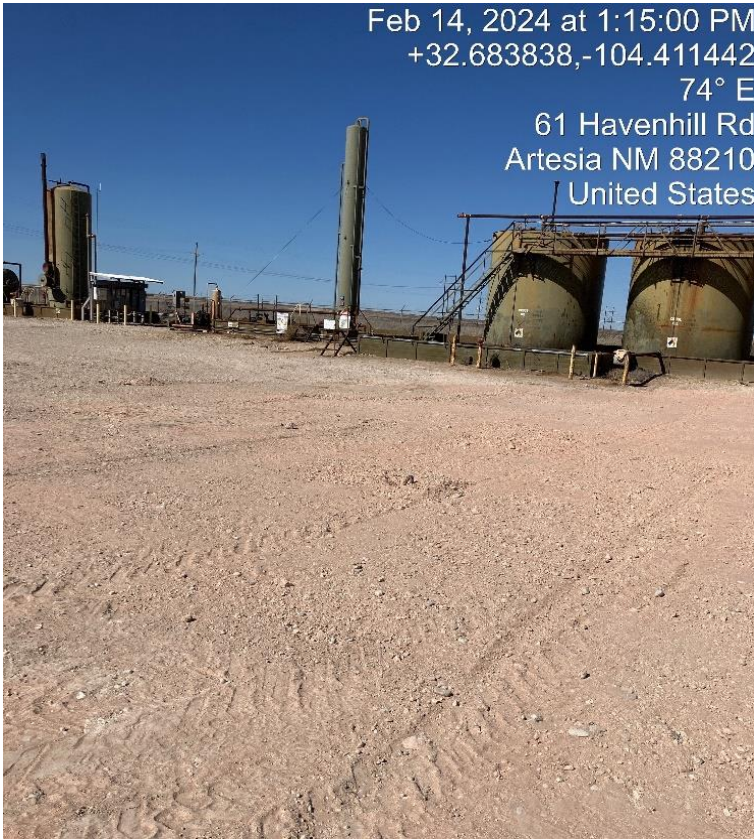
Photo Number: 8

<p>Feb 14, 2024 at 1:15:00 PM +32.683838, -104.411442 74° E 61 Havenhill Rd Artesia NM 88210 United States</p>
Photo Direction: North-Northwest	
Photo Description: View of remediated area after backfill and grading.

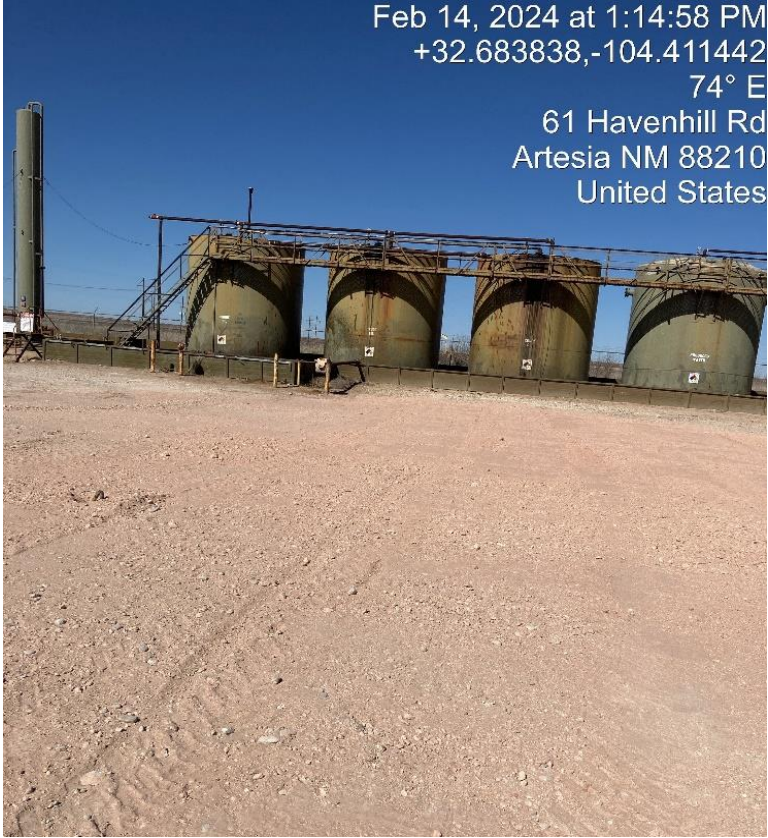
Photo Number: 9

<p>Feb 14, 2024 at 1:14:58 PM +32.683838,-104.411442 74° E 61 Havenhill Rd Artesia NM 88210 United States</p>
Photo Direction: North	
Photo Description: View of remediated area after backfill and grading.

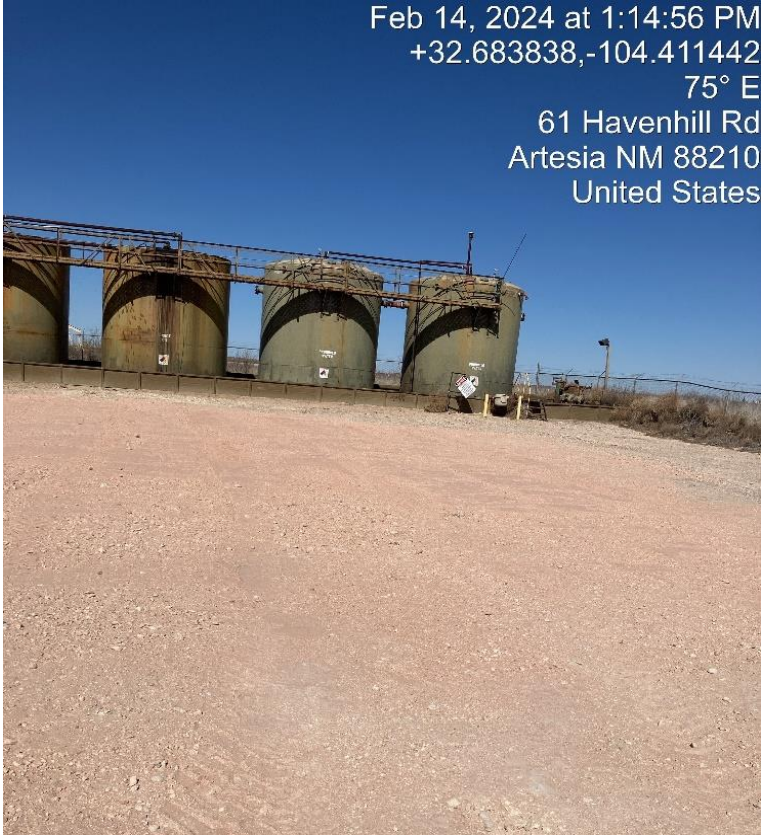
Photo Number: 10

<p>Feb 14, 2024 at 1:14:56 PM +32.683838,-104.411442 75° E 61 Havenhill Rd Artesia NM 88210 United States</p>
Photo Direction: North	
Photo Description: View of remediated area after backfill and grading.
