**RE: Liner Inspection and Closure Report**  
**MC State #005 Battery**  
**API No. N/A**  
**GPS: Latitude 32.81970 Longitude -104.14630**  
**UL- J, Section 23, Township 17S, Range 28E**  
**NMOCD Reference No. NAPP2317038502**

Spur Energy Partners (Spur) has contracted Pima Environmental Services, LLC (Pima) to perform a liner inspection and prepare this closure report for the release of produced water that happened on the MC State #005 Battery (MC). The incident, assigned Incident ID NAPP2317038502 by the New Mexico Oil Conservation Division (NMOCD), was initially reported through a C-141 submitted on June 19, 2023.

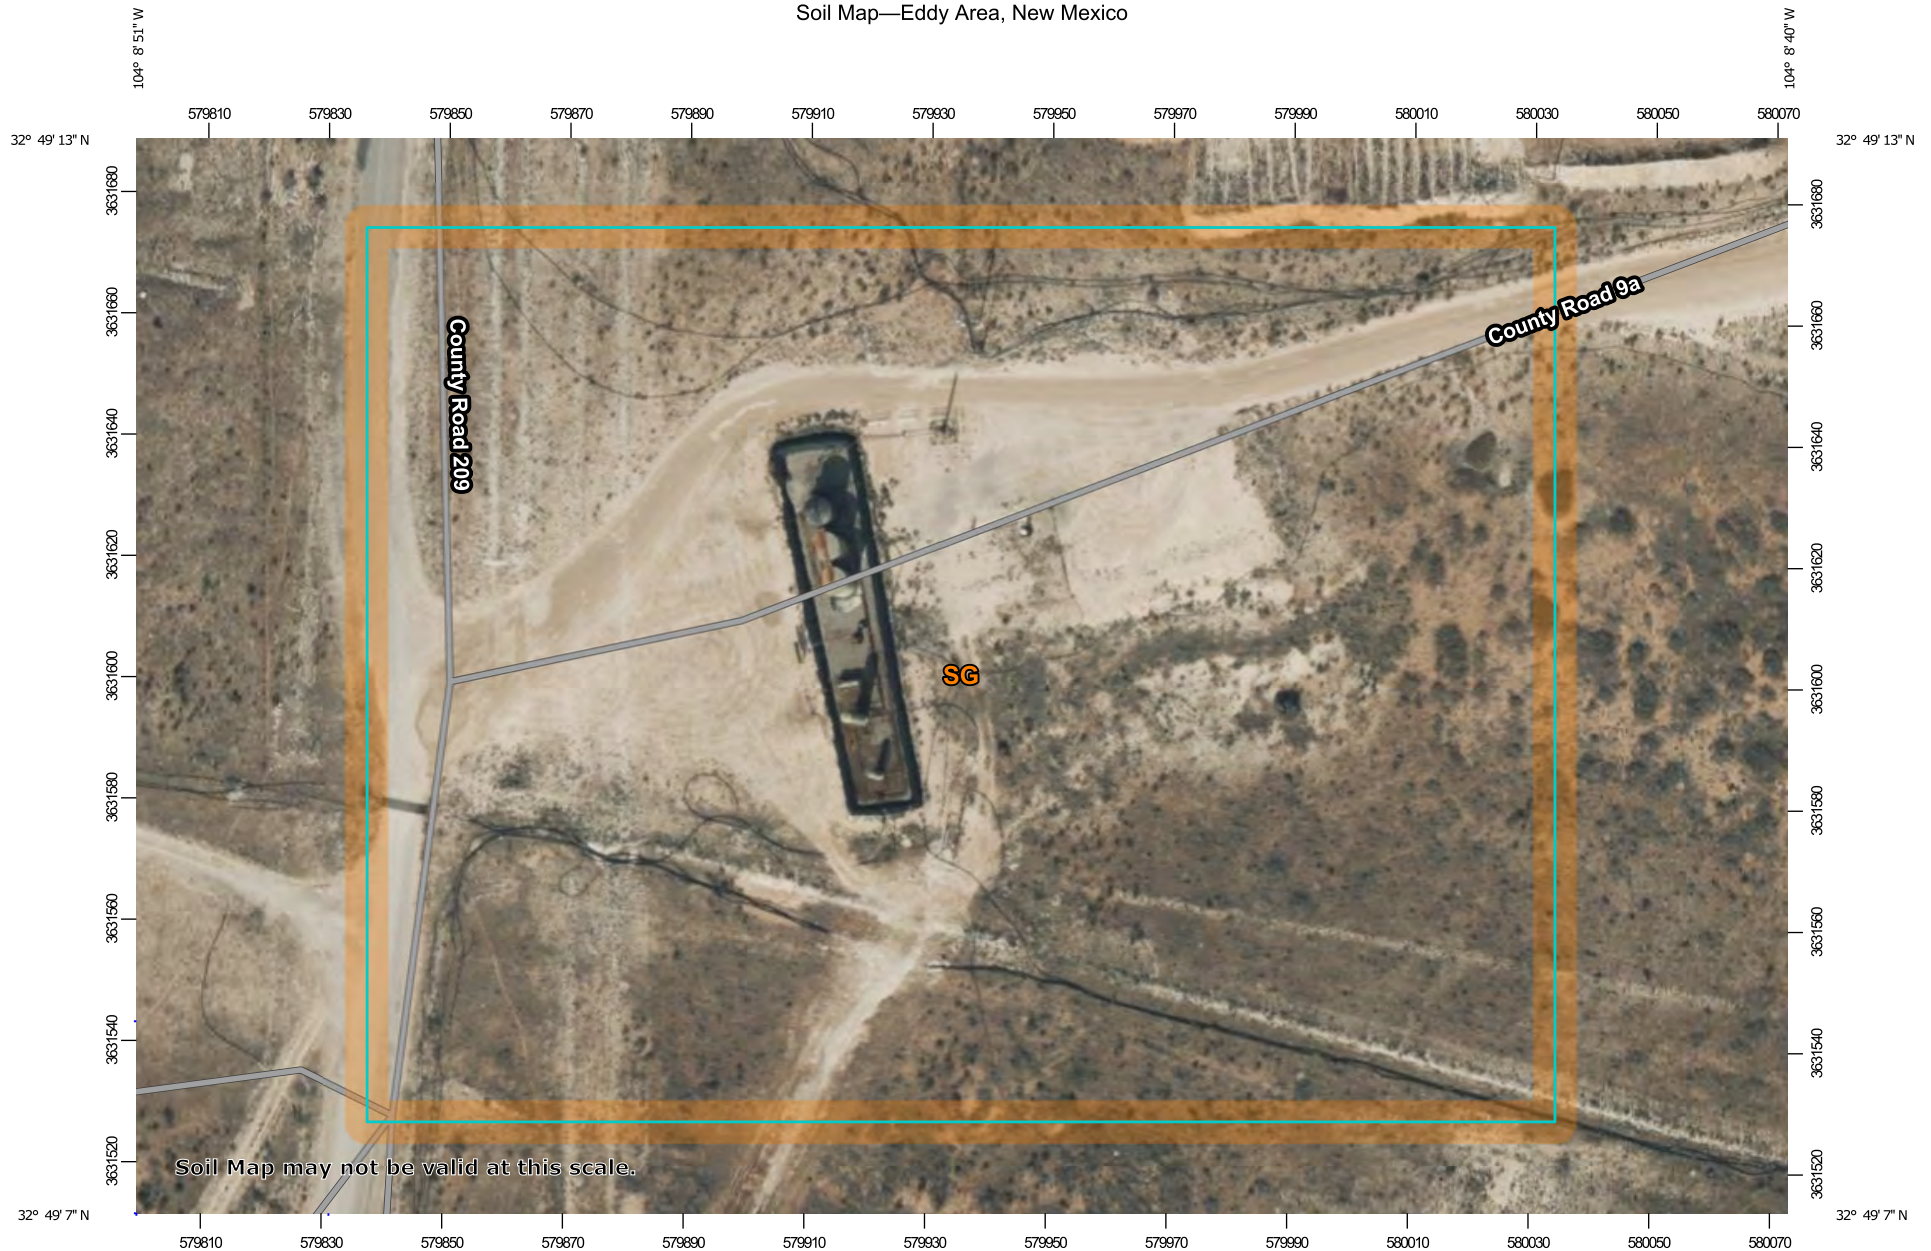
Soil Map—Eddy Area, New Mexico

Soil Map may not be valid at this scale.

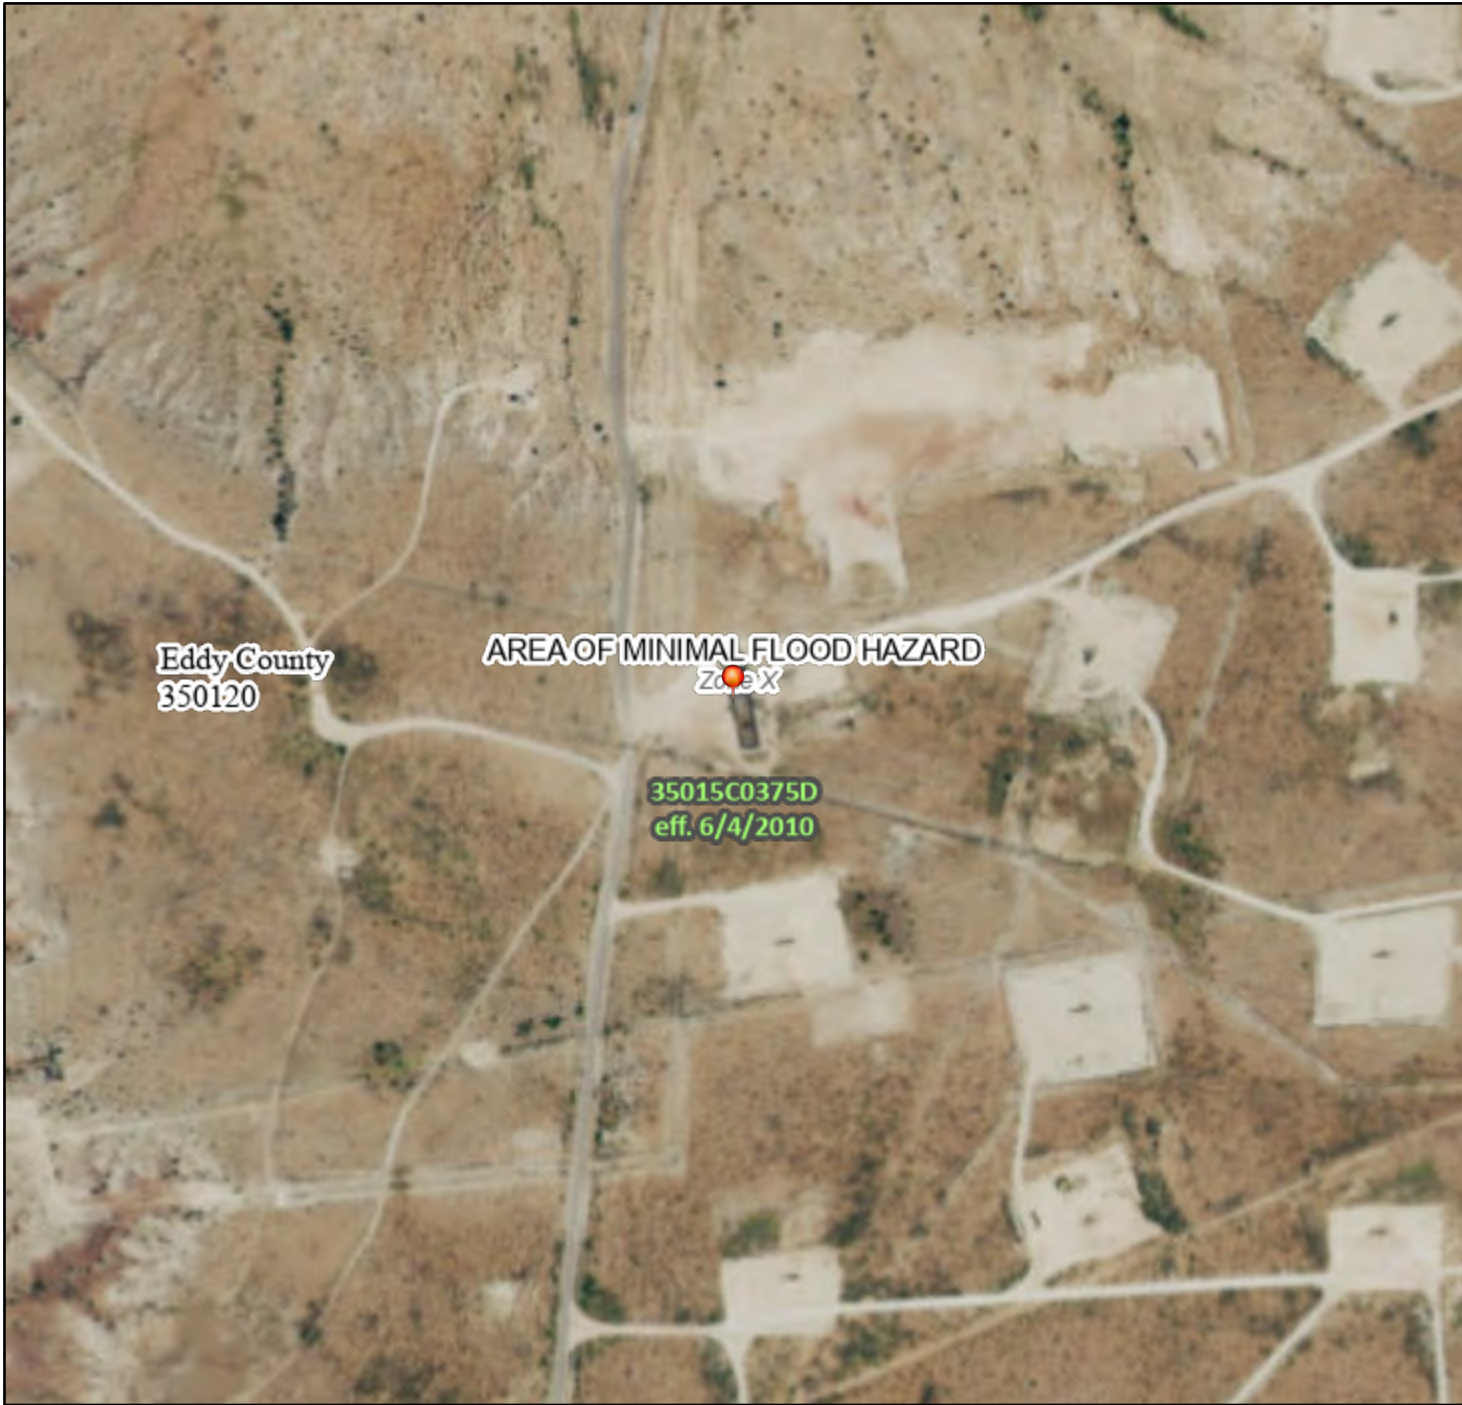
# National Flood Hazard Layer FIRMette

The flood hazard information is derived directly from the authoritative NFHL web services provided by FEMA. This map was exported on 7/5/2023 at 2:41 PM and does not reflect changes or amendments subsequent to this date and time. The NFHL and effective information may change or become superseded by new data over time.

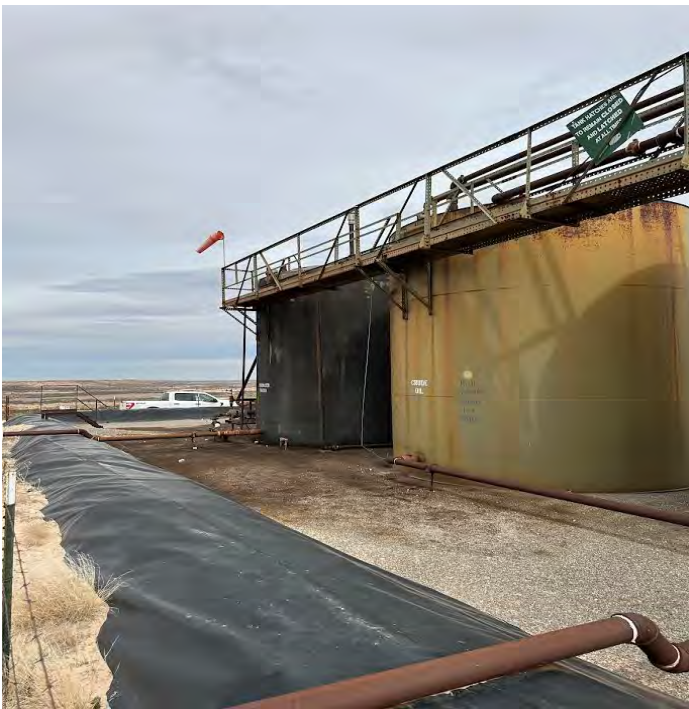
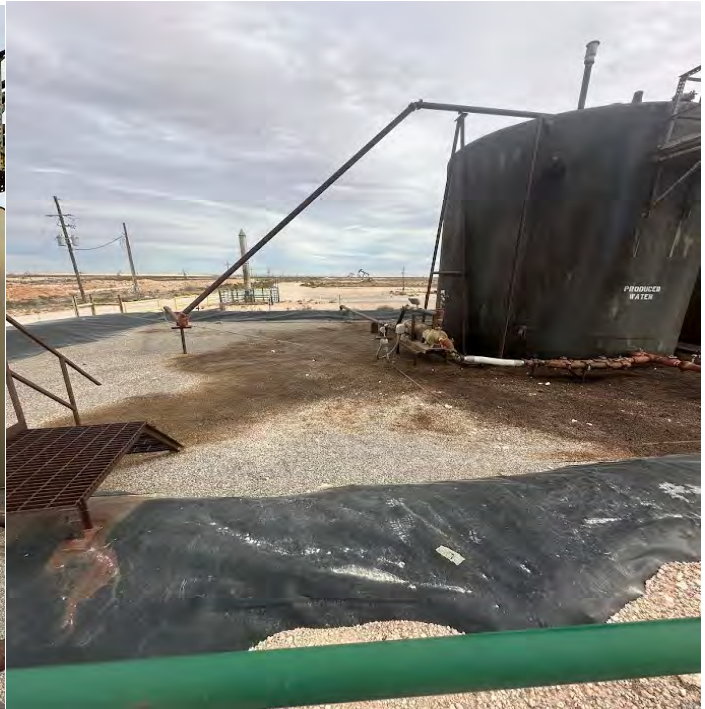
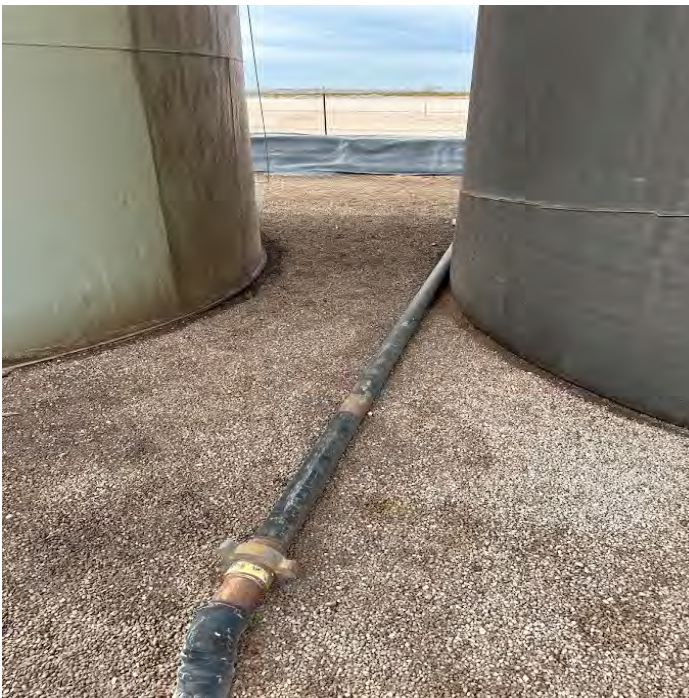
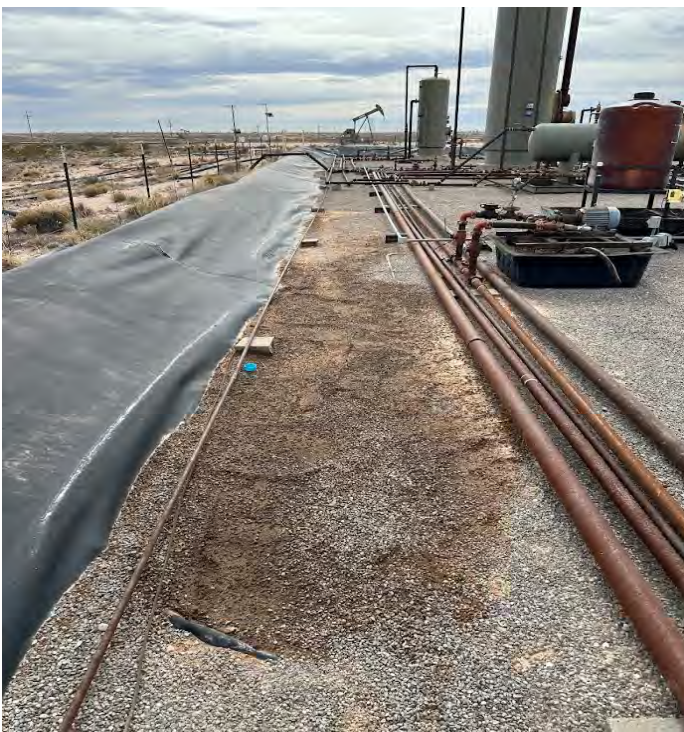
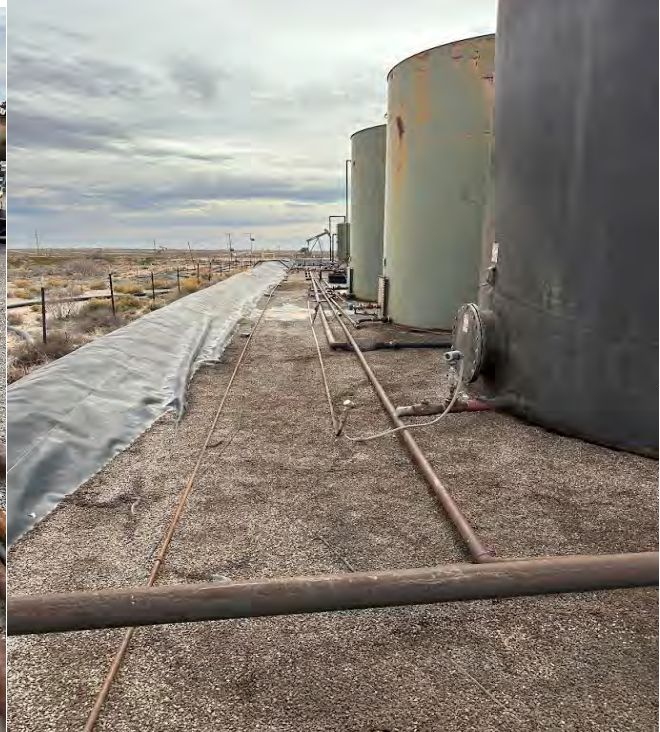
#### PRE REMEDIATION-

**NAPP2317038502:** On June 17, 2023, a disconnection in the transfer pump resulted in the tank overflowing, releasing approximately 56 barrels of produced water. The majority of the spill was contained within the lined containment, with a minor overflow onto the engineered pad. Successful remediation efforts facilitated the recovery of approximately 45 barrels of produced water, while the remaining 11 barrels were effectively retrieved using a vacuum truck. The impacted area outside the lined containment measured approximately 900 square feet.

From February 7 to February 14, 2024, Pima deployed its workforce to the MC site with the objective of excavating the affected region. The excavation involved a comprehensive scrape of the stained area through overlapping soil samples S1 to S3, reaching a depth of 2-3 inches below ground surface (bgs). Concurrently, a hand shoveling crew removed the impacted gravel within the lined containment. The affected area within the lined containment spanned approximately 700 square feet, resulting in the removal of approximately 6 cubic yards of contaminated material. Outside the lined containment, the stained area measured around 900 square feet, and approximately 5.6 cubic yards of material were extracted. All contaminated materials were safely transported to Lea Land, an NMOCD-approved disposal facility.

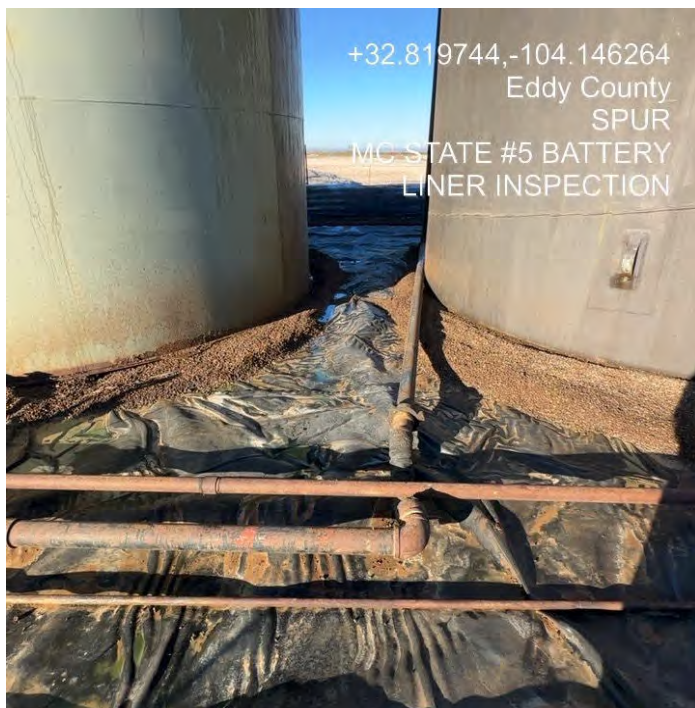
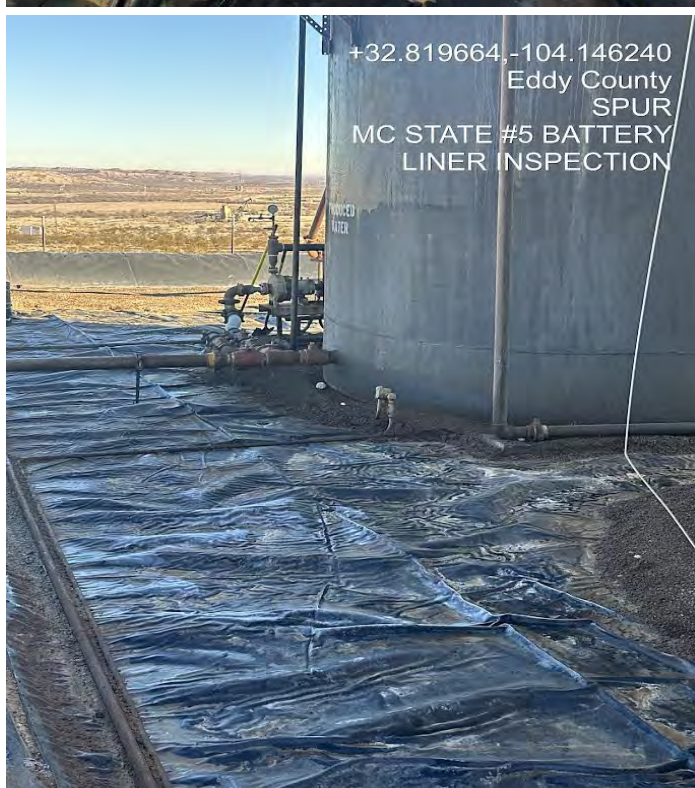
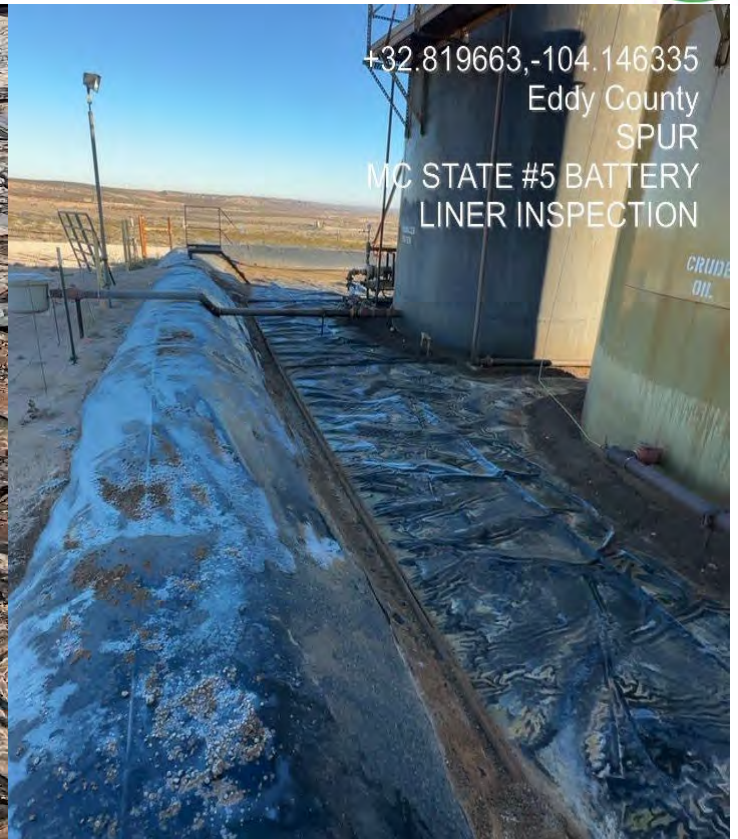
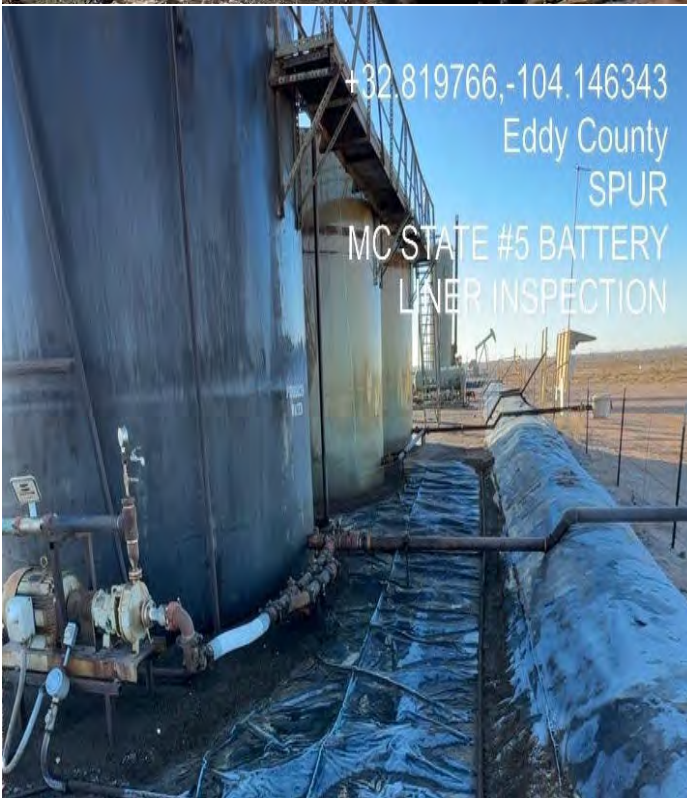
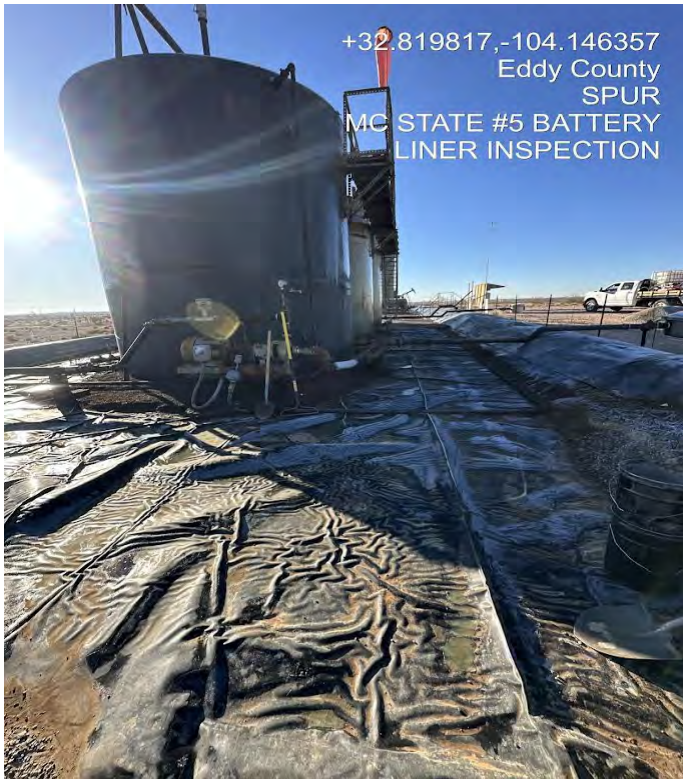
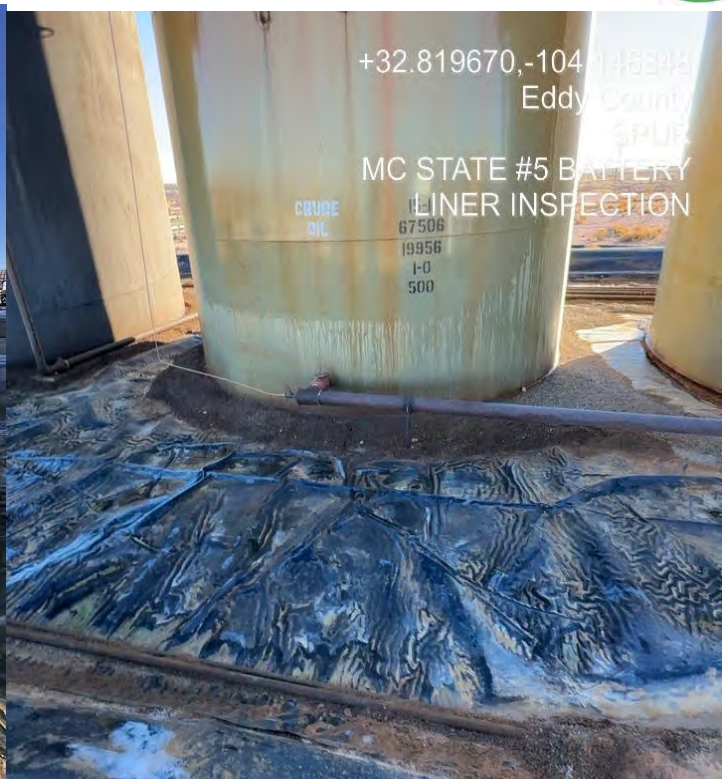
#### LINER INSPECTION-

On February 14, 2024, Pima Environmental conducted a liner inspection at this location. We concluded that this liner and containment maintained its integrity and was able to retain the fluids. The liner inspection form and photographic documentation can be found in Appendix C.

Visualization	Yes	No	Comments
Is there a tear in the liner?		X	
Are there holes in the liner?		X	
Is the liner retaining any fluids?	X		The inspection images of the liner reveal residual fluid resulting from the remediation event involving power washing.
Does the liner have integrity to contain a leak?	X

Following the removal of all contaminated gravel within the affected region inside the lined containment, a power washer was employed to clean any remaining oil or residue from the exposed plastic liner. A vacuum truck was utilized to extract the standing fluid, and this procedure was repeated until all oil residue was effectively eliminated. Subsequently, the area underwent inspection for tears and rips, and clean gravel was transported in to replace the impacted section.
