Re: Site Assessment, Remediation, and Closure Report
SV Big Bertha #001
API No. 30-025-33883
GPS: Latitude 32.9383888 Longitude -103.3277969
UL "F.," Sec. 11, T16S, R36E
Lea County, NM
NMOCD Ref. No. nGRL0902751331

Armstrong Energy Corporation have contracted Pima Environmental Services LLC (Pima) to perform a spill assessment, remediation activities, and submit this closure report for a produced water release that occurred at the SV Big Bertha #001. The initial C-141 was submitted on October 28th, 2022 (Appendix C). This incident was assigned Incident ID nGRL0902751331, by the New Mexico Oil Conservation Division (NMOCD).

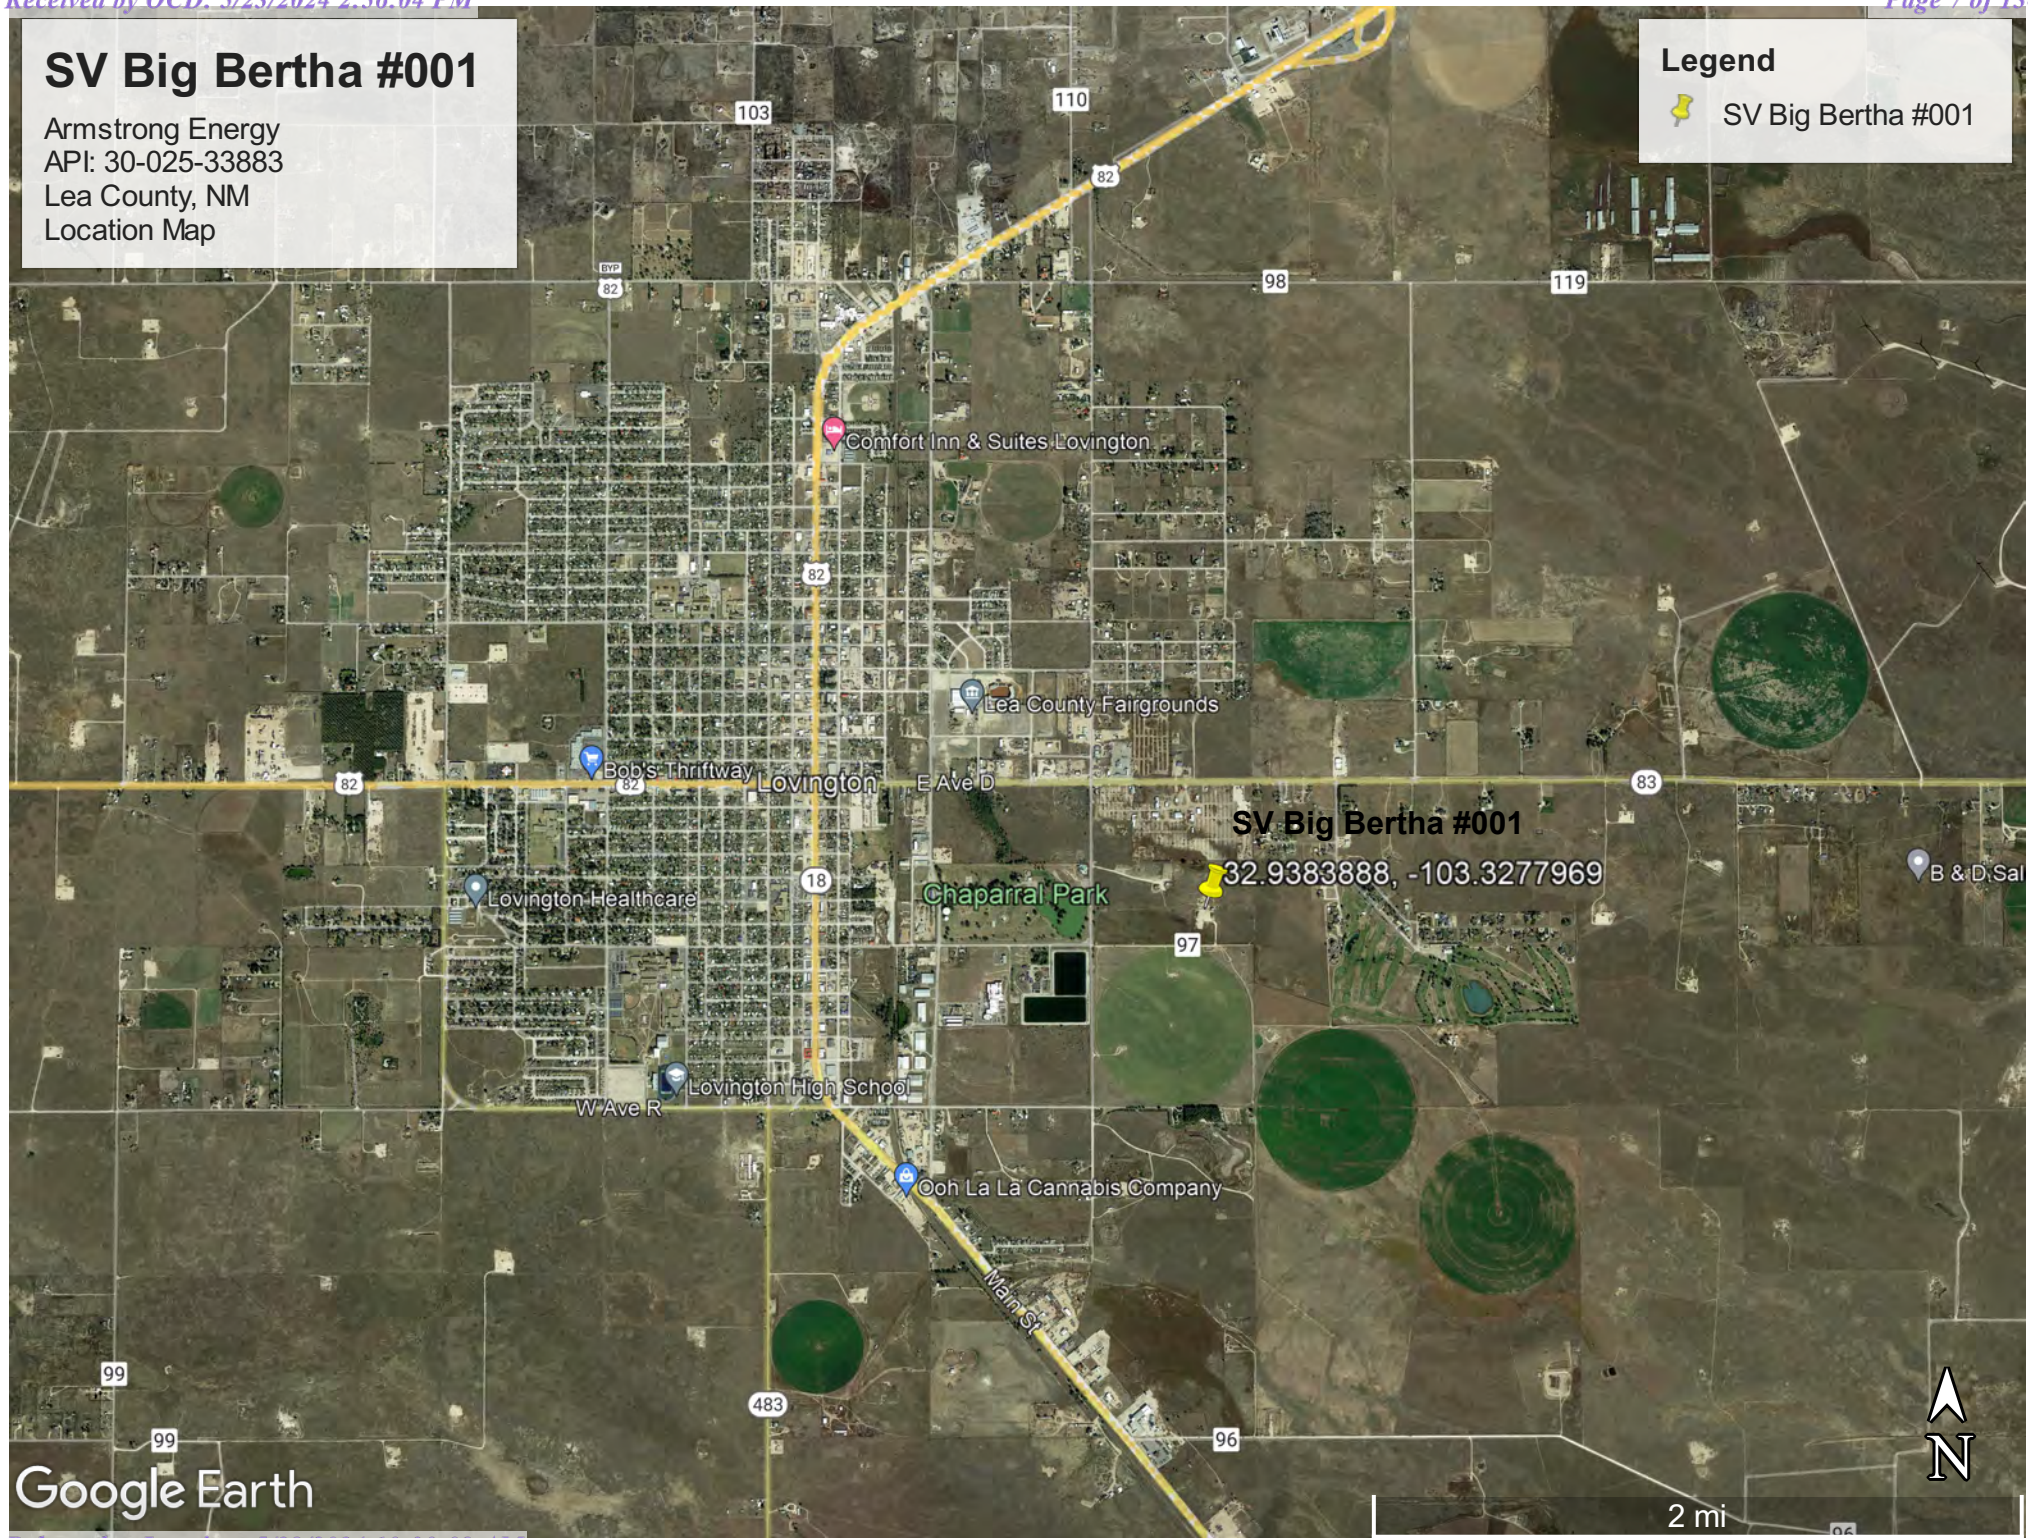
Armstrong Energy
API: 30-025-33883
Lea County, NM
Topographic Map

Based on the well water data from the New Mexico Office of the State Engineer, the depth to the nearest groundwater in this vicinity (L 14587 POD 1) measures 85 feet below grade surface (BGS), positioned roughly 0.35 miles away from the Big Bertha, drilled on November 23rd, 2019. Conversely, as per the United States Geological Survey well water data, the nearest groundwater depth (USGS 32564210319701) in this region is recorded at 69 feet BGS, situated approximately 0.67 miles away from the Big Bertha, with the last gauge conducted on January 15, 1962. For detailed references to water surveys and the precise locations of water wells, please refer to Appendix A, inclusive of the relevant maps. Notably, the Big Bertha is situated within an area with a low potential for karst, as illustrated in Figure 3. Additionally, a comprehensive Topographic Map is available for reference in Figure 2.

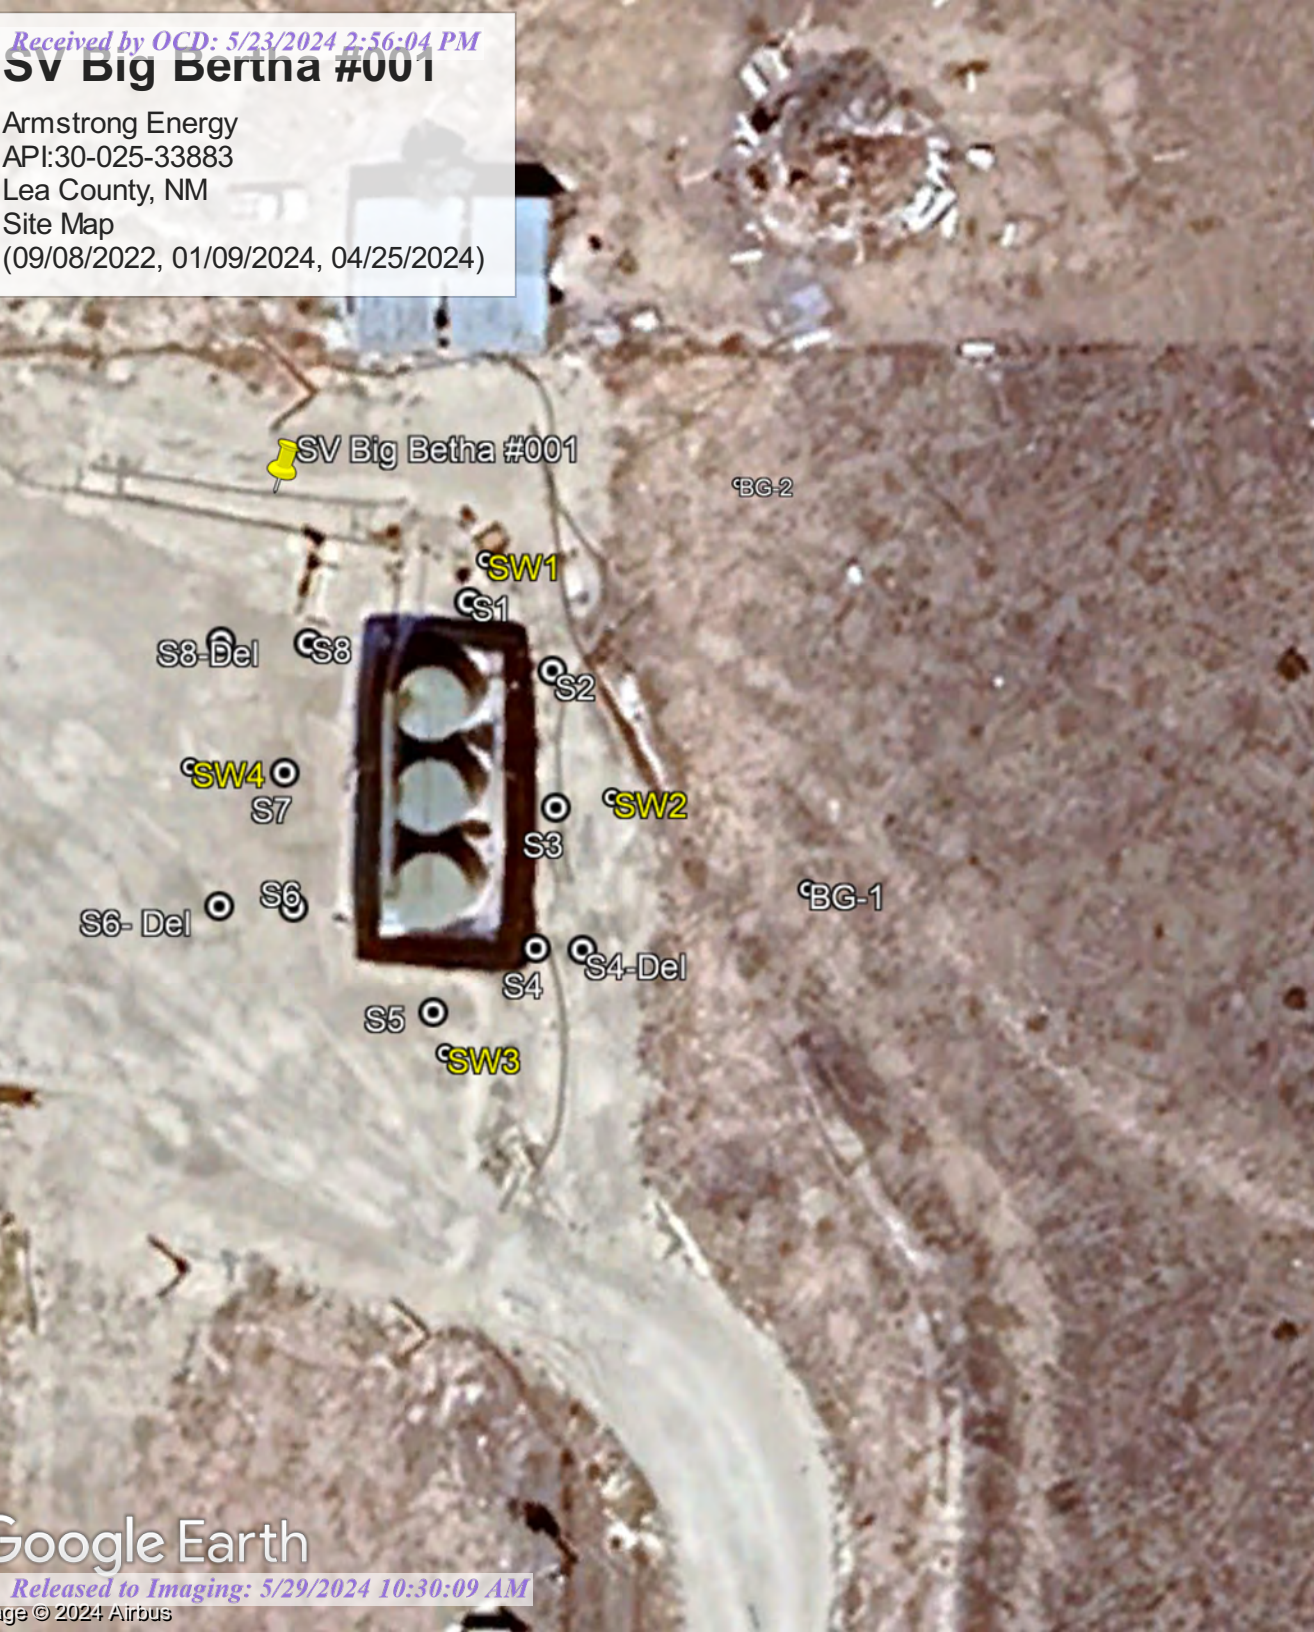
Armstrong Energy
API:30-025-33883
Lea County, NM
Site Map
(09/08/2022, 01/09/2024, 04/25/2024)

After conducting additional horizontal and vertical delineation samples, it has been established that all soil samples are below the NMOCD closure criteria. They meet the reclamation standard 19.15.29.13 NMAC or the OCD-approved background values for the upper 4 feet of the impacted area. The total sampled area showing levels exceeding the reclamation standard measured roughly 2,000 square feet. We respectfully request a variance in the sampling protocol, transitioning from 200 square feet to 400 square feet. Under this revised protocol, soil samples S8, S7, S6, S5, and S4 collectively represent one sample per every 400 square feet of the surrounding area. The locations of all soil samples collected on September 8, 2022, January 9, 2024, and April 25, 2024, are depicted in the Site Map provided in Figure 4.

On September 8, 2022, Pima Environmental deployed personnel to the site to evaluate the affected area situated within the lined containment and the adjacent areas. Given the unidentified nature of the release, Pima conducted sampling across the zone from the release point and collected samples around the containment to ascertain the potential presence of residual contamination. A total of eight sample points (S1-S8) were gathered at depths of 1 and 2 feet to establish vertical delineation. Similarly, soil samples (SW1-SW4) were obtained at a superficial depth as well as one foot below ground surface (bgs.) to establish horizontal delineation. As OSE POD (L 14587 POD1) was detected within half a mile and no older than 25 years, only the section surrounding soil sample S-7 necessitated additional remediation. The results from the laboratory analysis for this sampling event are outlined in the following data table, while a detailed laboratory report can be accessed in Appendix E.

Following a prior rejection of this report, it was determined that additional delineation samples were necessary. On January 9th, 2024, subsequent to submitting a 48-hour sampling notification, Pima Environmental replicated the areas previously sampled and obtained a total of 14 additional soil samples for field screening analysis. Chloride levels in all soil samples were examined using a titration method, while hydrocarbons were assessed through the utilization of a PID (Photoionization detector). Comprehensive information on soil samples, depths, and field screening results is available in the ensuing data table. Appendix E contains the hard copy of our technicians' field screen document.

Furthermore, on April 25, 2024, after a 48-hour sampling notice, Pima Environmental gathered extra horizontal delineation points for soil samples S4, S6, and S8 as per the request of NMOCD. These supplementary horizontal delineation samples were acquired to fulfill the criteria specified in 19.15.29.11 NMAC. The results of the laboratory analysis for this sampling event are detailed in the subsequent data table, with a comprehensive laboratory report available in Appendix E.

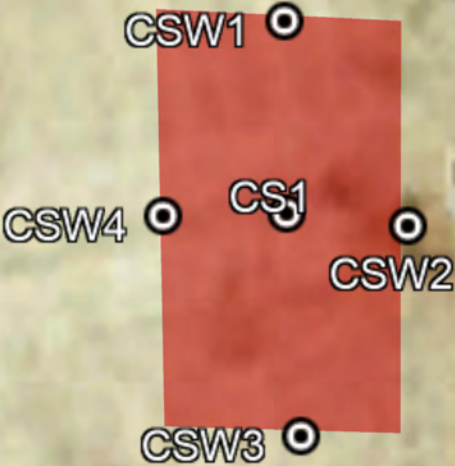
Armstrong Energy
API:30-025-33883
Lea County, NM
(10/14/2022) Confirmation Map

On October 14, 2022, subsequent to the submission of the 48-hour notification (refer to Appendix C), Pima proceeded with the collection of confirmation samples. These samples encompassed one bottom sample (CS1) and four side wall samples (CSW1-CSW4), gathered from the bottom of the excavation to the surface to ensure a thorough sampling of the side walls. Each confirmation sample constituted a five-point composite sample, complying with the 200 square foot rule outlined by the NMOCD. The detailed

laboratory results for this sampling event are included in the accompanying data table. Furthermore, a site map illustrating this confirmation sampling event is available in Figure 5.

On October 12, 2022, Pima deployed personnel and equipment to initiate remedial activities. The targeted zone, including soil sample location S-7, was excavated to a depth of two feet below ground surface (Bgs) using a skid steer. The excavated area encompasses approximately 392 square feet. All contaminated soil was thoroughly extracted and subsequently transported to a landfill approved by the NMOCD for proper disposal. Detailed photographic documentation is available in Appendix D.

Once it was confirmed that all contaminated soil had been removed, clean material was brought in and used to backfill the affected area, restoring it to its original contour.

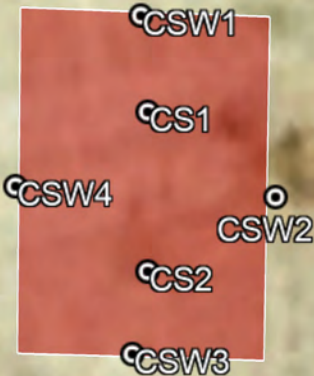
Armstrong Energy
API:30-025-33883
Lea County, NM
(01/09/2024) Confirmation Map

In response to a prior rejection of this report, further confirmation samples were gathered to conclusively ensure the absence of any remaining contamination in the previously excavated area. On January 9th, 2024, following the submission of a 48-hour sampling notification, Pima Environmental collected two bottom composite samples. Each sample comprised a 5-point composite of the bottom section previously excavated. Additionally, four composite side wall samples were collected, spanning the full depth of the excavation from the bottom to the surface, ensuring comprehensive sampling of the side walls. The comprehensive laboratory results for this sampling event are presented in the accompanying data table. Additionally, a detailed confirmation site map can be referenced in Figure 6. Complete laboratory reports can be found in Appendix E.

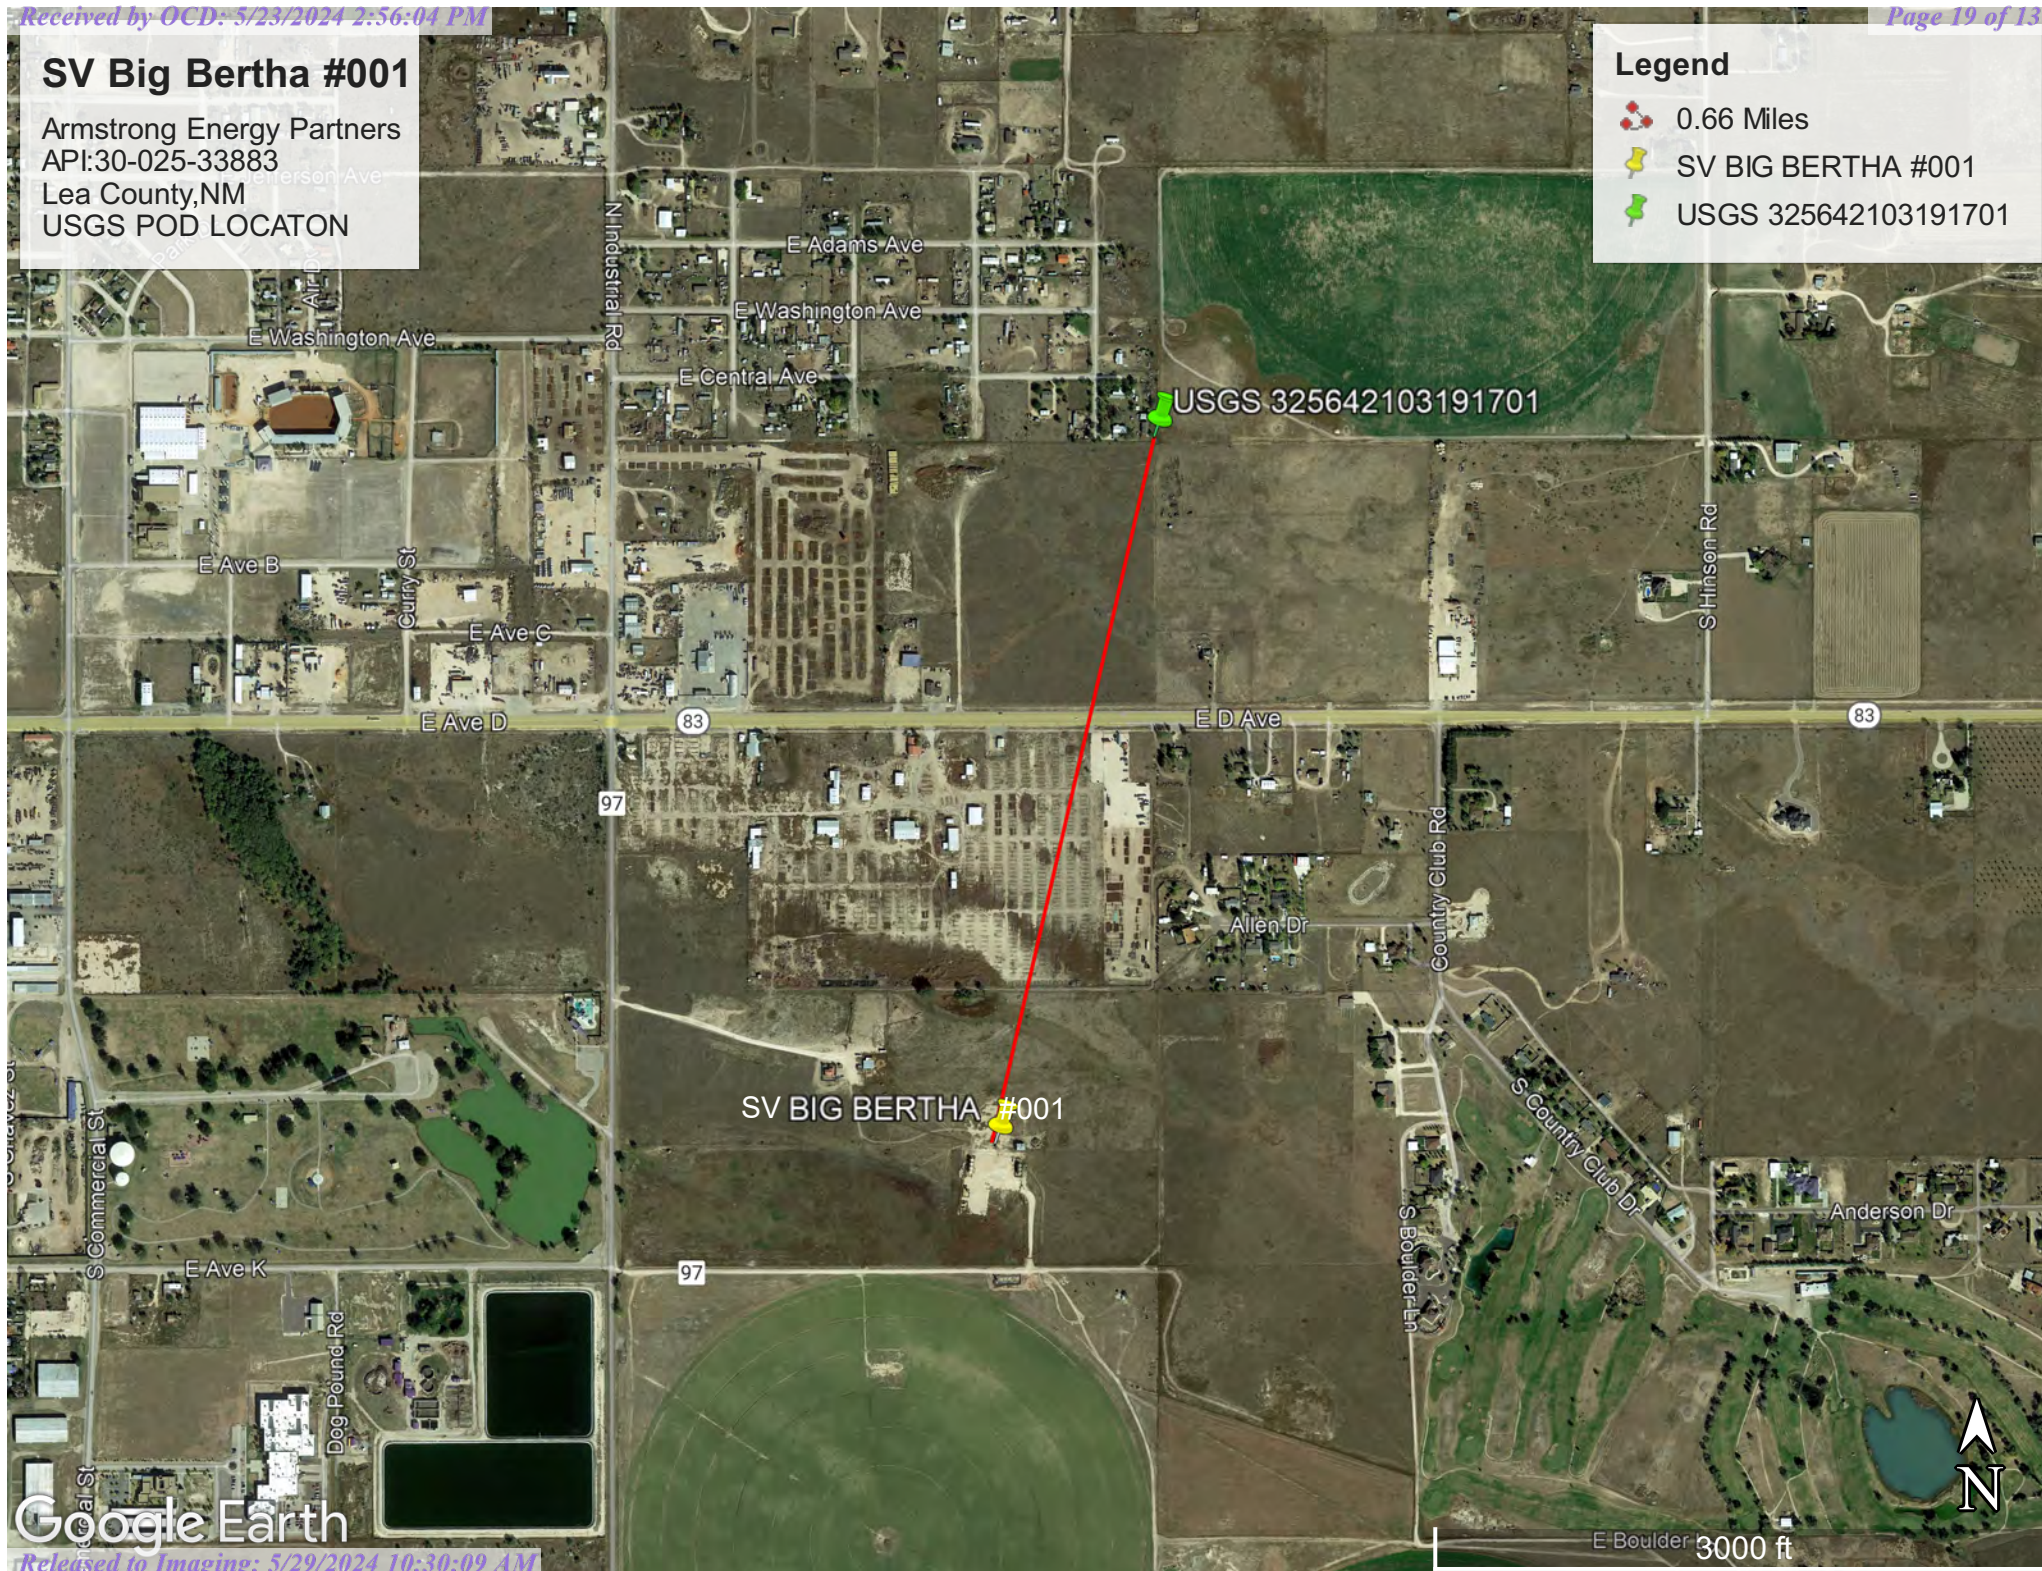
SV Big Bertha #001

Armstrong Energy
API: 30-025-33883
Lea County, NM
Surface Water Map

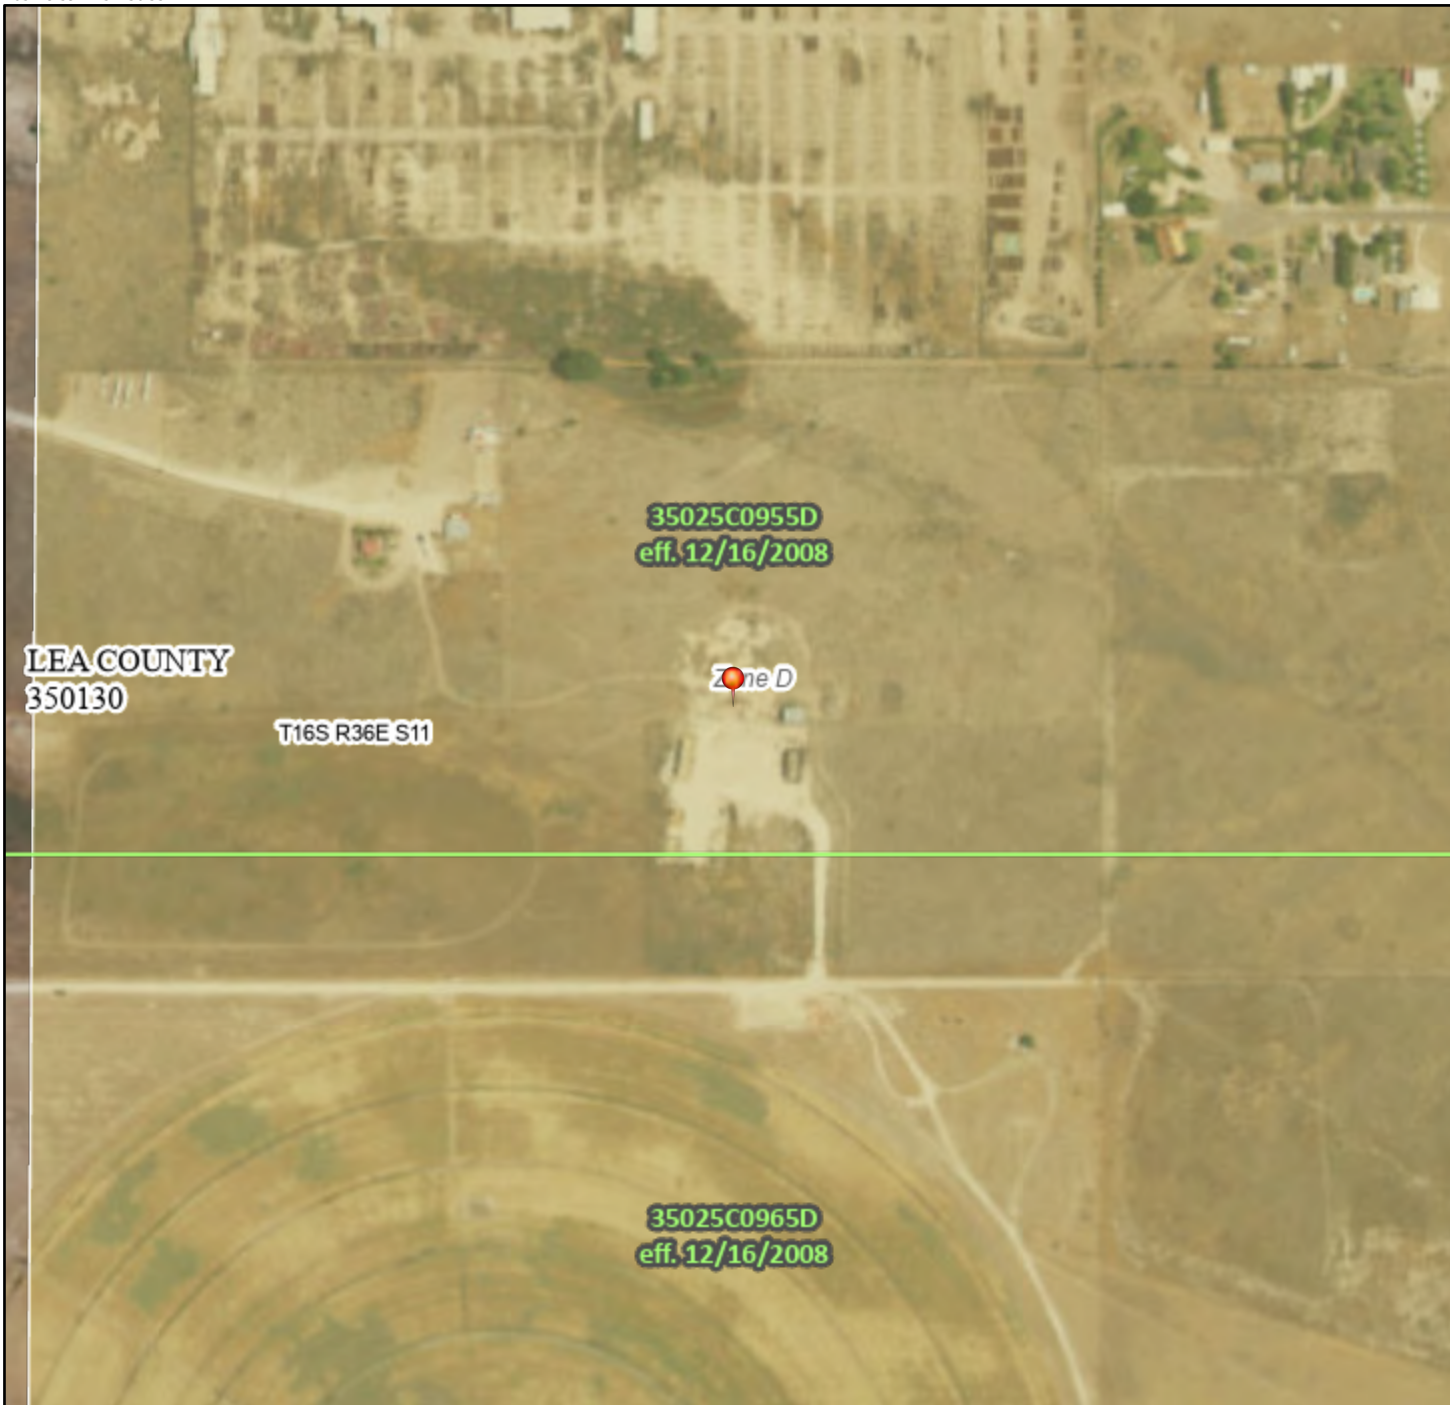
National Flood Hazard Layer FIRMMette

The flood hazard information is derived directly from the authoritative NFHL web services provided by FEMA. This map was exported on 9/21/2022 at 4:02 PM and does not reflect changes or amendments subsequent to this date and time. The NFHL and effective information may change or become superseded by new data over time.
