**Re: Remediation/Reclamation Report and Closure Request
Maverick Permian, LLC
Philmex #15 Flowline Release
Unit Letter H/I, Section 33, Township 17 South, Range 35 East
Lea County, New Mexico
Incident ID# nJXK1532944122**

Remediation, Closure, and Reclamation Report
 Maverick Permian, LLC
 Philmex 15 Flowline Surface Remediation
 Incident ID# nJXK1532944122

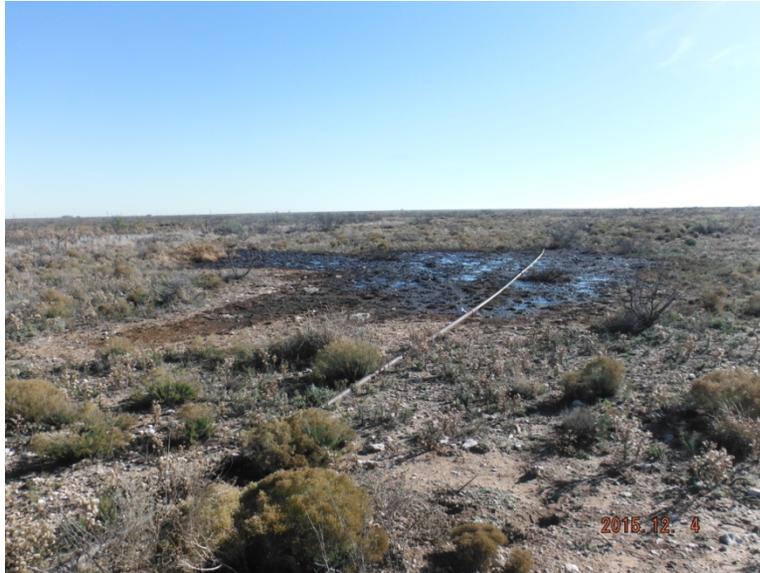
Initial release, facing northeast

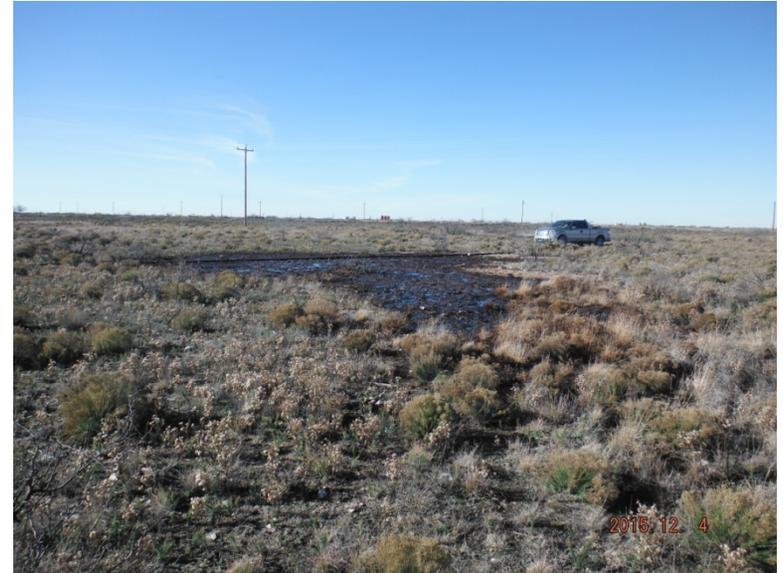
Initial release, facing southwest

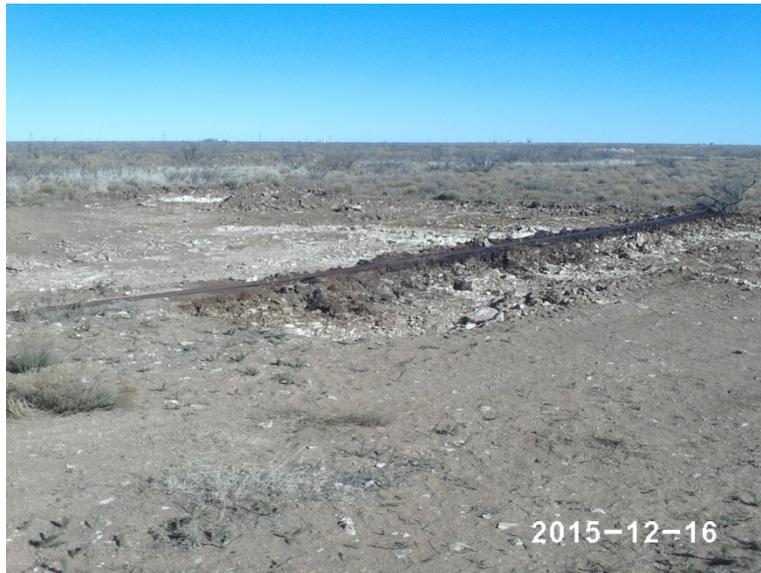
Top 1' removed, facing northeast

Basin photographs taken on December 16, 2015, indicate evidence of remedial actions taken at the. The photograph captions in the CAP indicate that the top 1 foot bgs of soil in the release footprint was removed shortly following the initial assessment activities. Historical aerial imagery from February 2017 indicates an area of disturbed soils that is larger than the release footprint as shown in **Figure 3**. On behalf of COP, Tetra Tech conducted a visual Site inspection in July 2020 to evaluate current conditions at the Site. A lack of vegetative cover was noted in the observed excavated area. Photographic documentation of the visual Site inspection is included in **Attachment 3**.

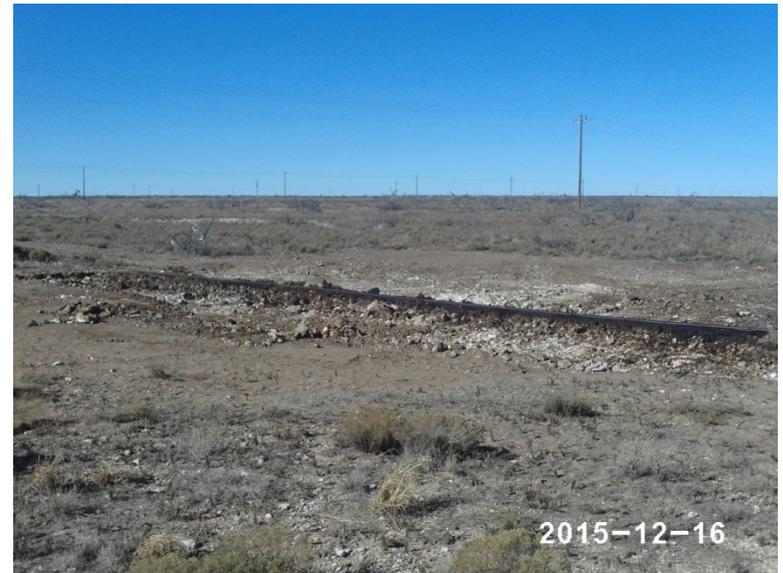
Top 1' removed, facing northwest

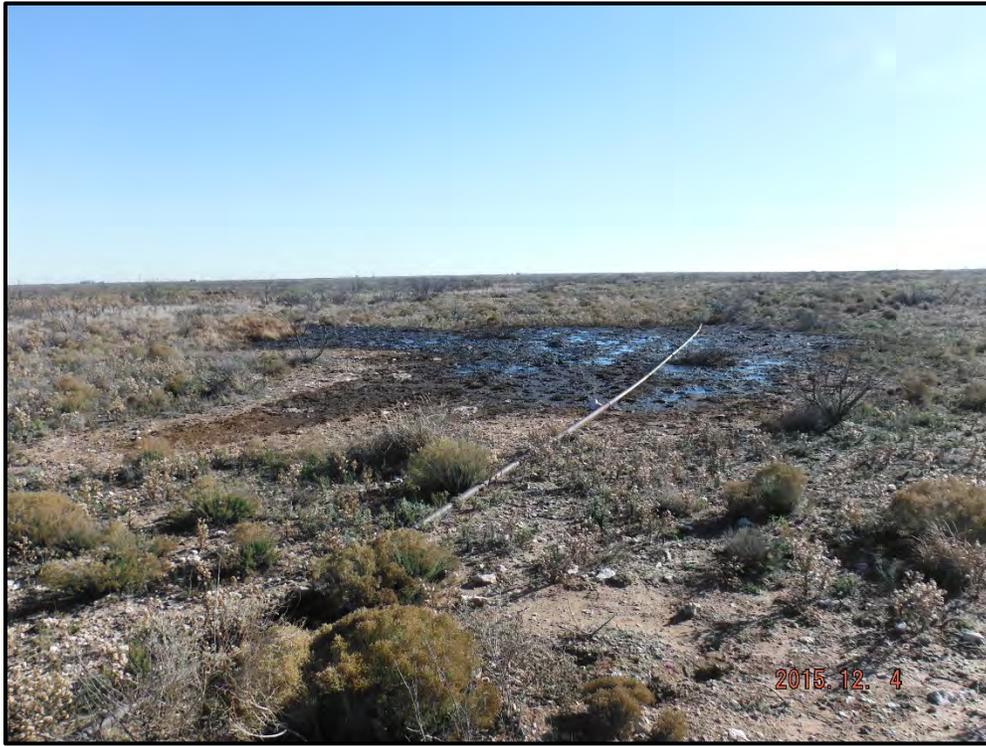
TETRA TECH, INC. PROJECT NO. 212C-MD-02334	DESCRIPTION	View facing northeast of flowline release. (Basin, 2015)	1
	SITE NAME	Philmex #15 Flowline Release	12/4/2015

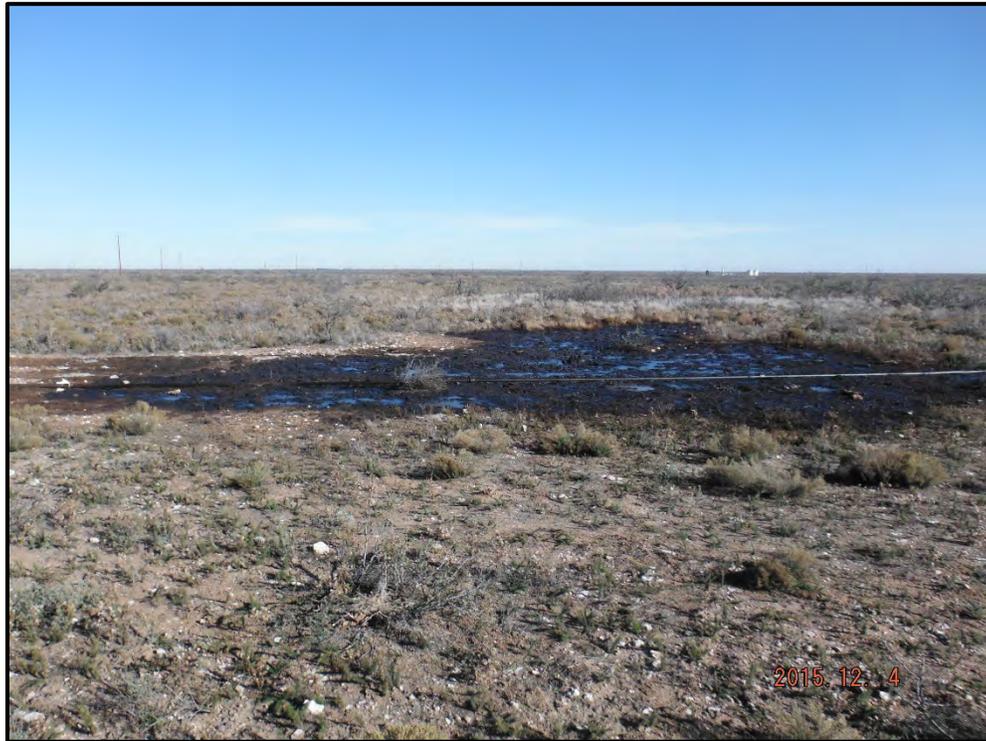
TETRA TECH, INC. PROJECT NO. 212C-MD-02334	DESCRIPTION	View facing north of flowline release. (Initial Site Visit)	2
	SITE NAME	Philmex #15 Flowline Release	12/4/2015

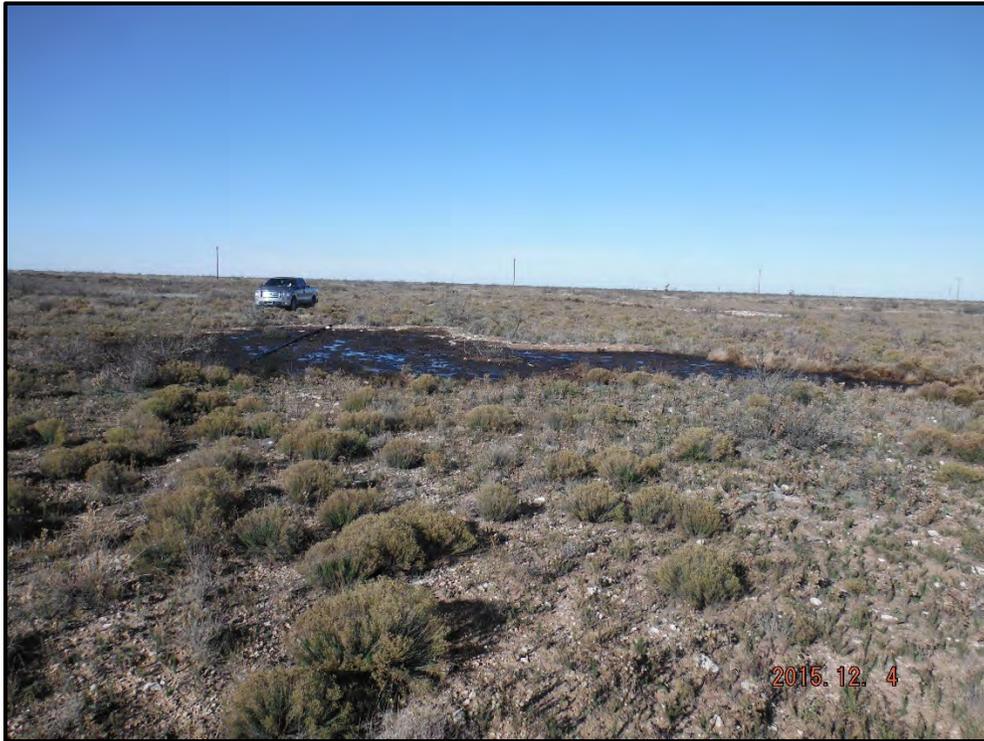
TETRA TECH, INC. PROJECT NO. 212C-MD-02334	DESCRIPTION	View facing west of flowline release. (Initial Site Visit)	3
	SITE NAME	Philmex #15 Flowline Release	12/4/2015

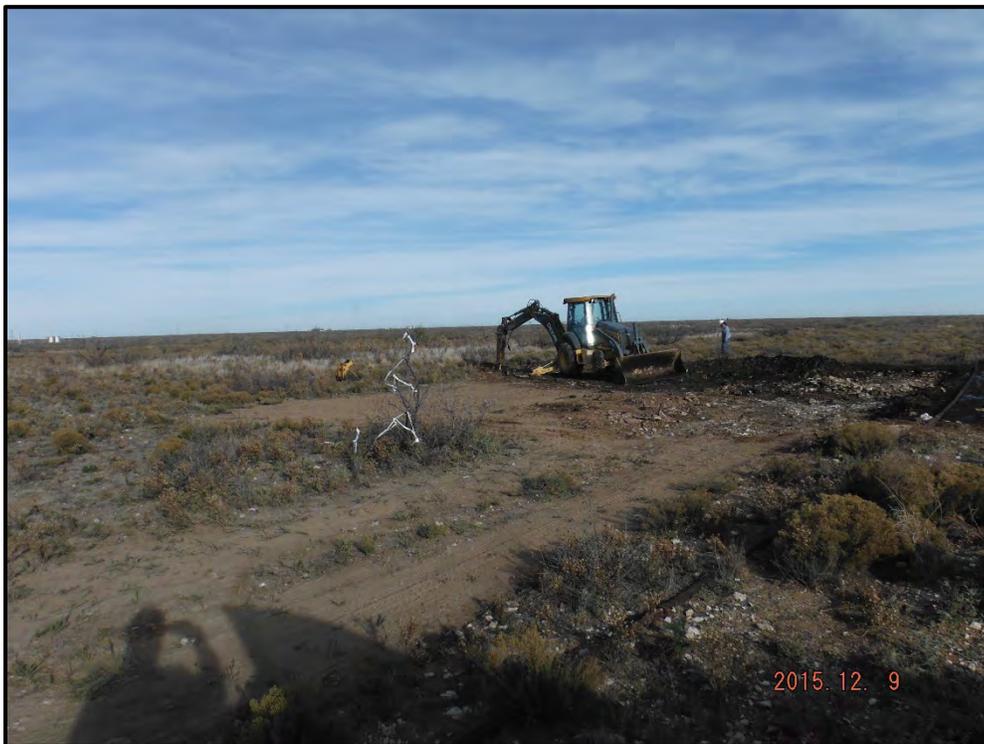
TETRA TECH, INC. PROJECT NO. 212C-MD-02334	DESCRIPTION	Overview of flowline release excavation activities.	4
	SITE NAME	Philmex #15 Flowline Release	12/9/2015

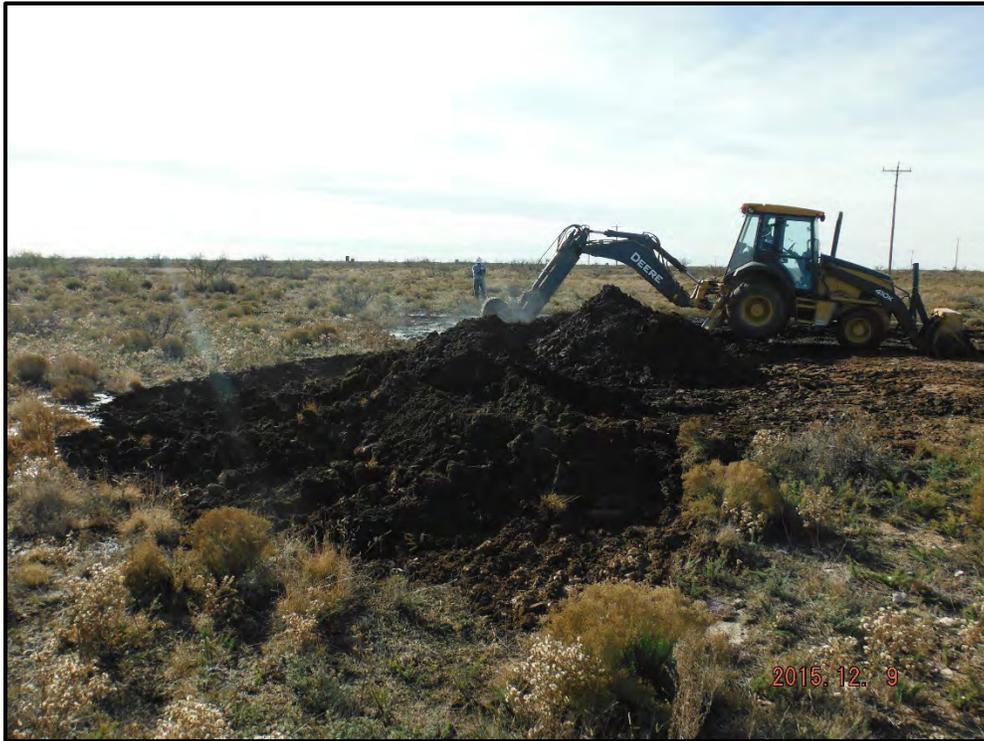
TETRA TECH, INC. PROJECT NO. 212C-MD-02334	DESCRIPTION	Overview of excavation activities.	5
	SITE NAME	Philmex #15 Flowline Release	12/9/2015

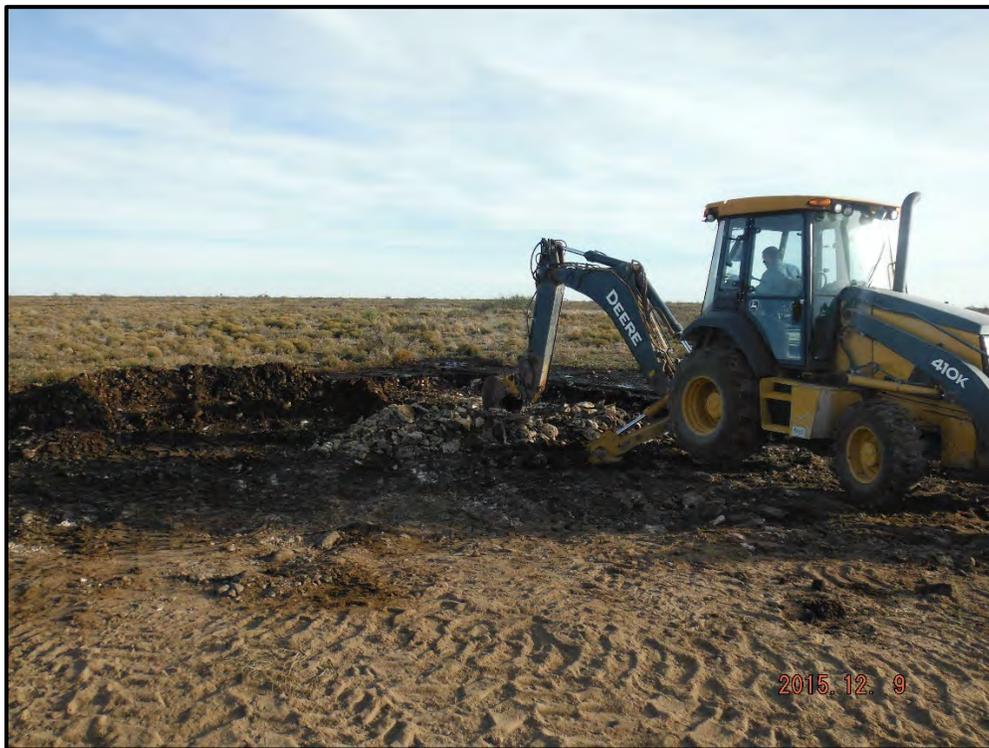
TETRA TECH, INC. PROJECT NO. 212C-MD-02334	DESCRIPTION	View facing northwest of excavation activities in the flowline release area.	6
	SITE NAME	Philmex #15 Flowline Release	12/9/2015

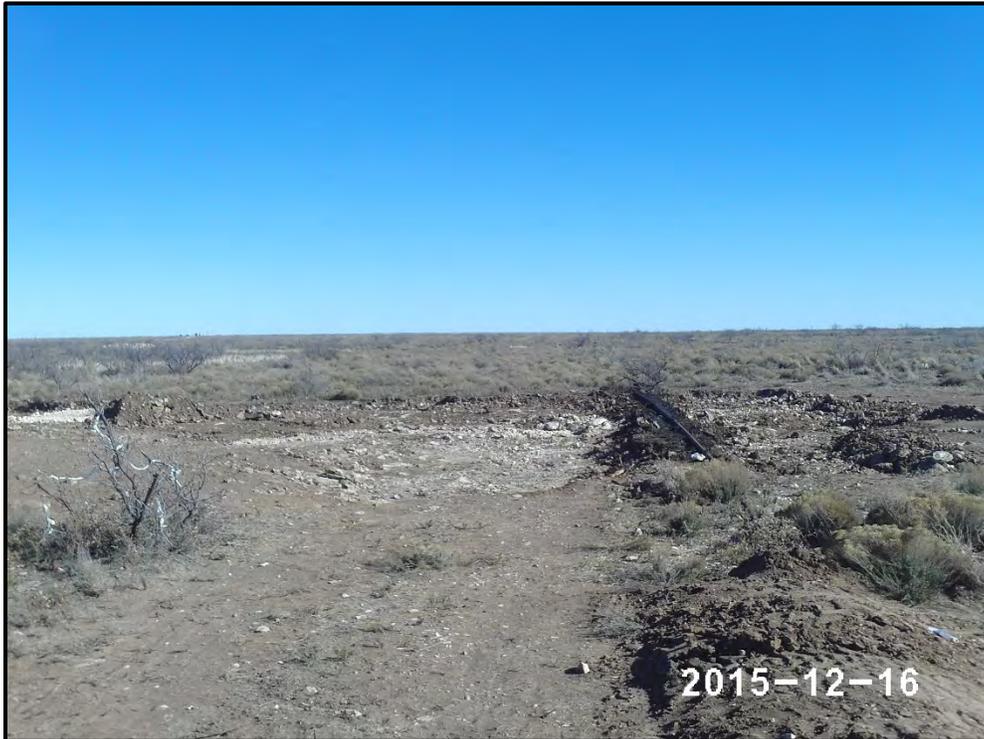
TETRA TECH, INC. PROJECT NO. 212C-MD-02334	DESCRIPTION	Overview of flowline release excavation area.	7
	SITE NAME	Philmex #15 Flowline Release	12/16/2015

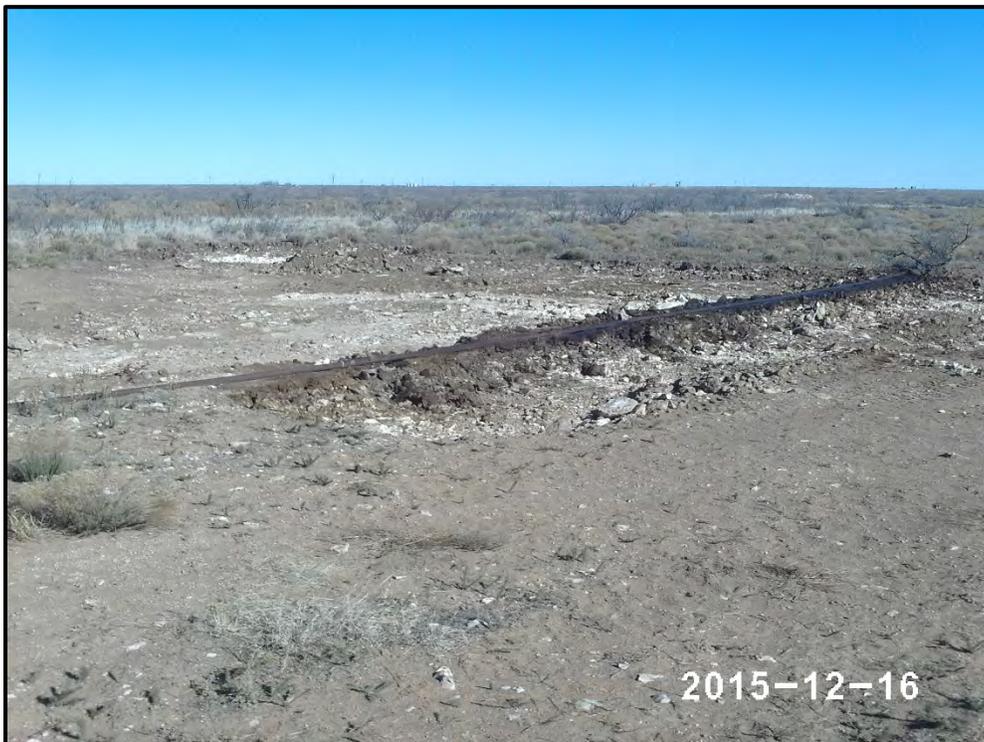
TETRA TECH, INC. PROJECT NO. 212C-MD-02334	DESCRIPTION	Overview of flowline release excavation area (note flowline in place).	8
	SITE NAME	Philmex #15 Flowline Release	12/16/2015

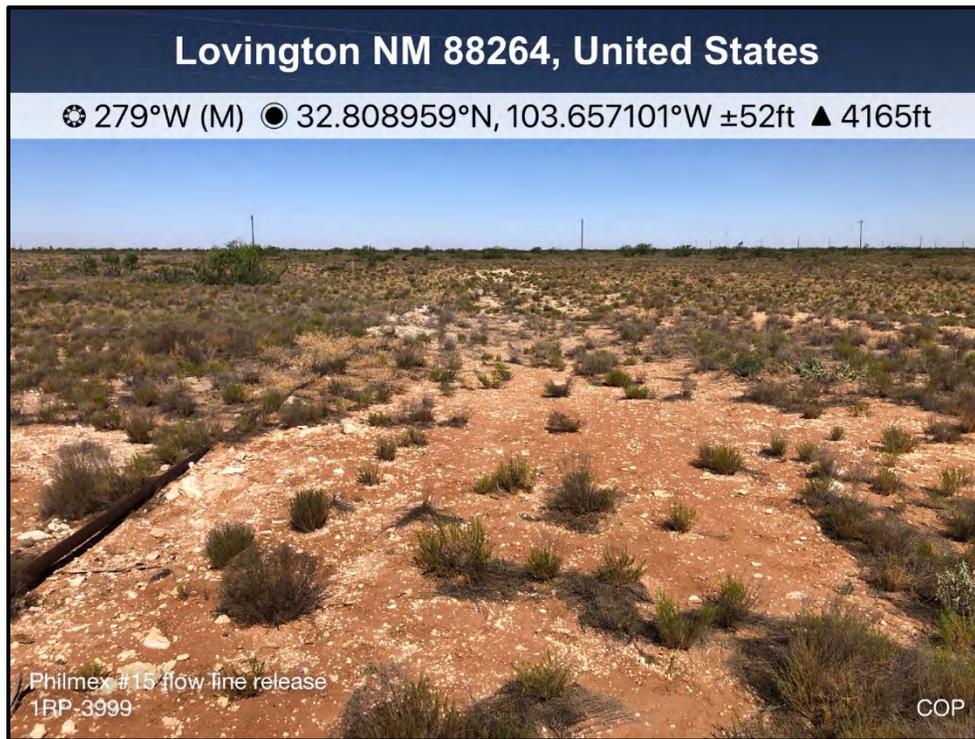
TETRA TECH, INC. PROJECT NO. 212C-MD-02334	DESCRIPTION	View facing west of the former flowline release area.	9
	SITE NAME	Philmex #15 Flowline Release	6/9/2020

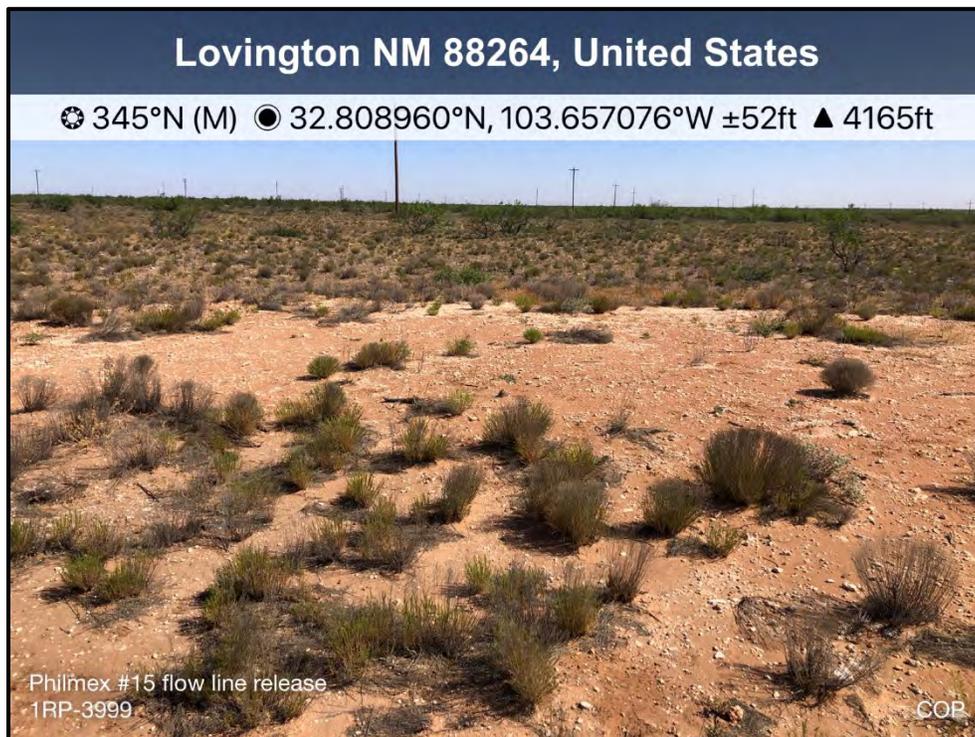
TETRA TECH, INC. PROJECT NO. 212C-MD-02334	DESCRIPTION	View facing northwest of the former flowline release area.	10
	SITE NAME	Philmex #15 Flowline Release	6/9/2020

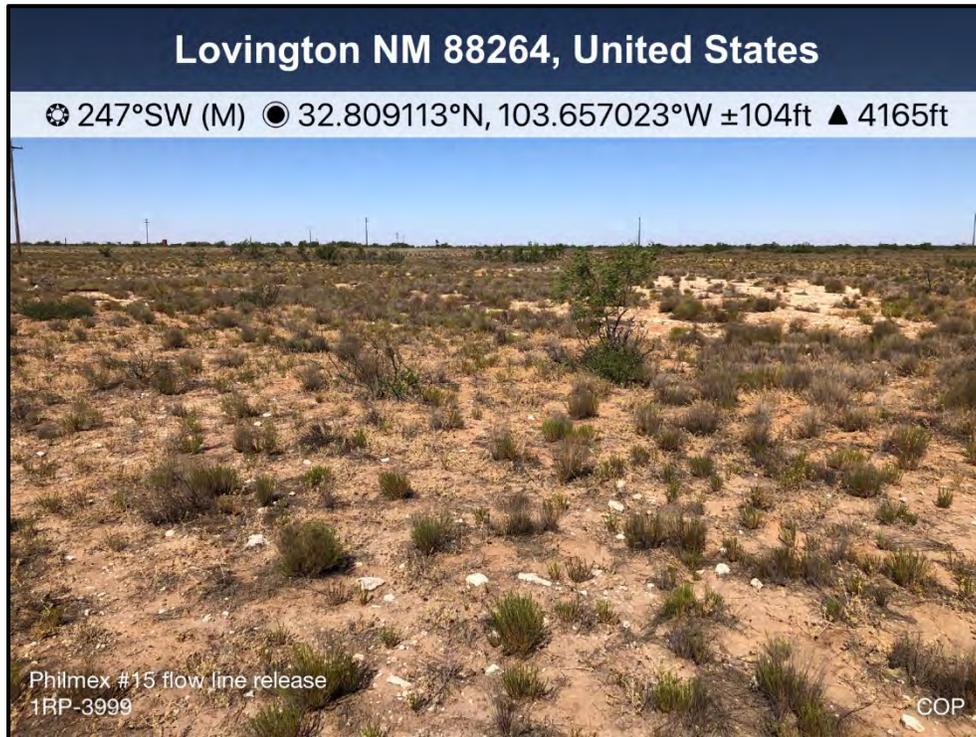
TETRA TECH, INC. PROJECT NO. 212C-MD-02334	DESCRIPTION	View facing northwest of the former flowline release area.	13
	SITE NAME	Philmex #15 Flowline Release	6/9/2020

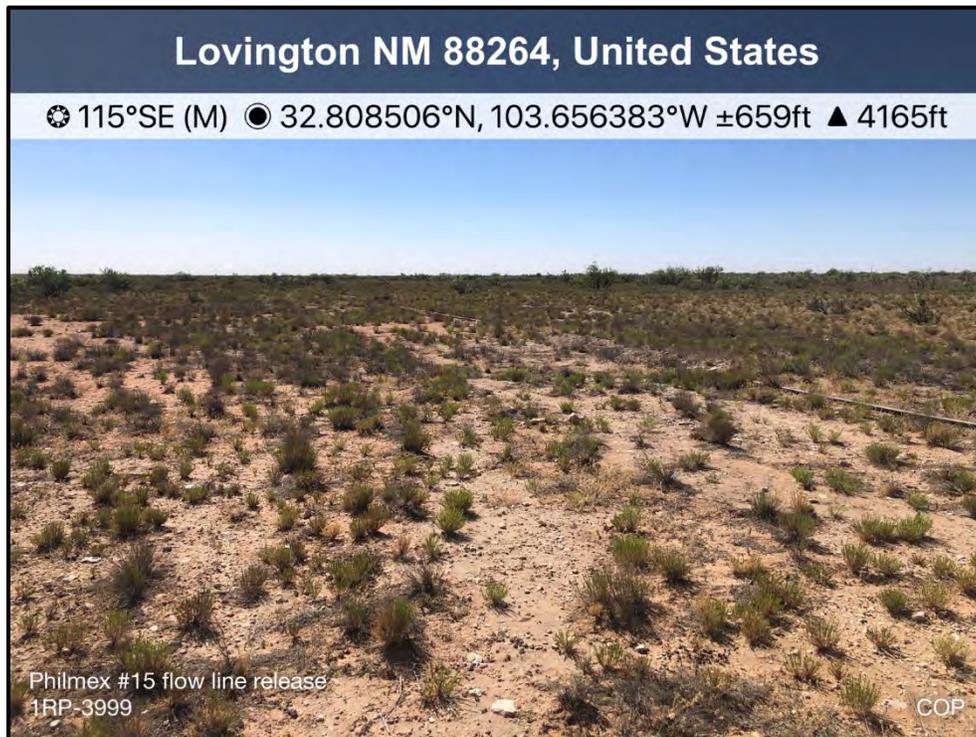
TETRA TECH, INC. PROJECT NO. 212C-MD-02334	DESCRIPTION	View facing east of the former flowline release area.	14
	SITE NAME	Philmex #15 Flowline Release	6/9/2020
