**Re: Closure Request
PLU 21 Brushy Draw CTB
Incident Number nAPP2405336143
Eddy County, New Mexico**

Ensolum, LLC (Ensolum), on behalf of XTO Energy, Inc. (XTO), has prepared this *Closure Request* to document site assessment, excavation, and soil sampling activities performed at the PLU 21 Brushy Draw CTB (Site). The purpose of the site assessment, excavation, and soil sampling activities was to address impacts to soil following a release of crude oil and produced water at the Site. Based on excavation activities and soil sample laboratory analytical results, XTO is submitting this *Closure Request*, describing remediation that has occurred, requesting a closure criteria variance, and requesting no further remediation for Incident Number nAPP2405336143.

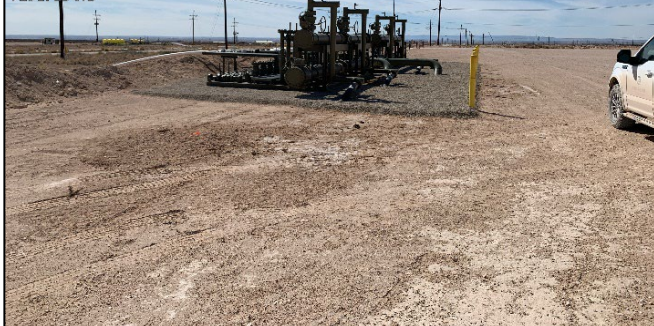
Photograph: 1 Date: 3/5/2024
 Description: Site assessment, release extent area.
 View: West

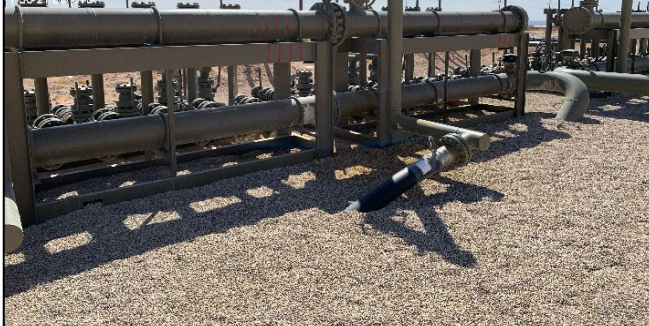
Photograph: 2 Date: 3/5/2024
 Description: Site assessment, release point area.
 View: Southwest

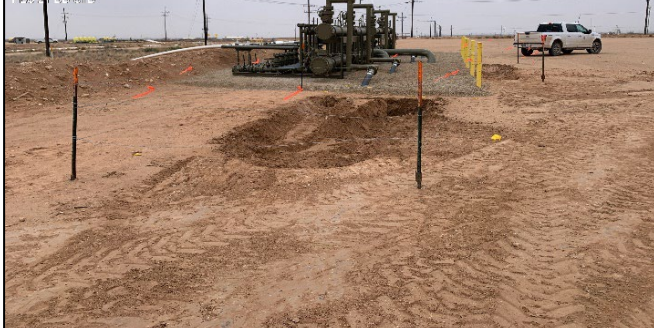
Photograph: 3 Date: 3/15/2024
 Description: Final excavation extent.
 View: West

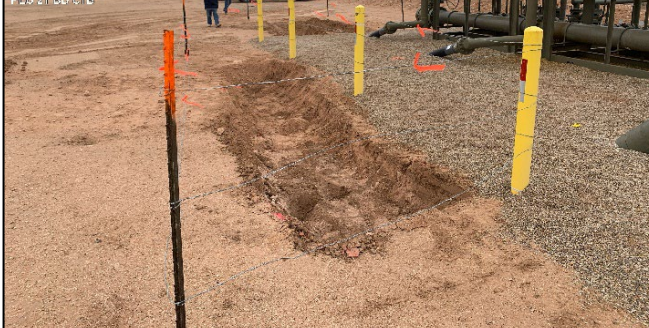
Photograph: 4 Date: 3/15/2024
 Description: Final excavation extent.
 View: East
