Remediation Plan

Remediation Summary

Mewbourne Oil Company Red Hills Recycle Pond Facility

Lea County, New Mexico
Unit Letter "J", Section 16, Township 26 South, Range 32 East
Latitude 32.0397980 North, Longitude 103.675828 West
NMOCD Reference No. nAPP2124632147

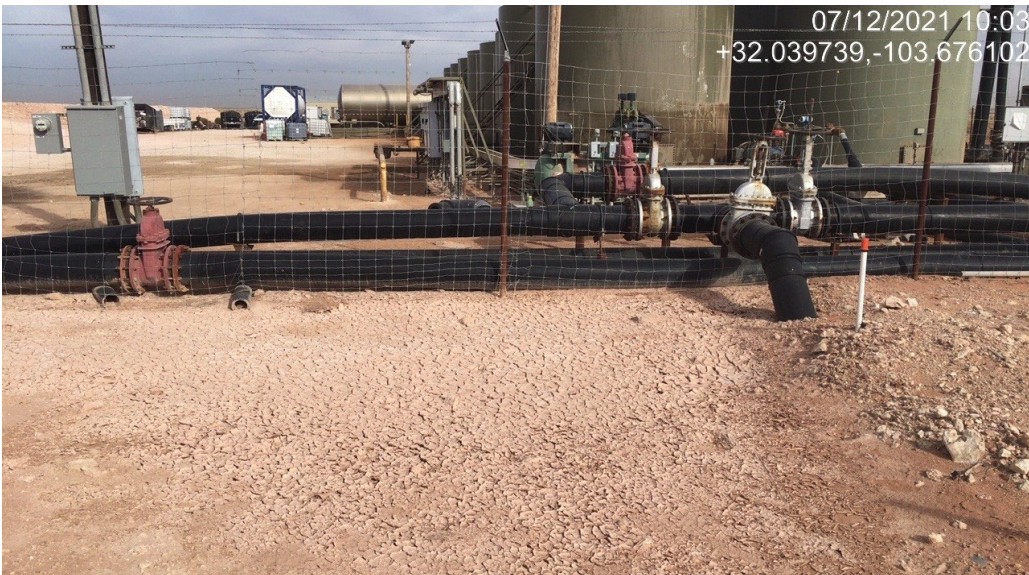
Photo Number: 1

Date: 7/12/2021	
Photo Direction: North	
Coordinates: 32.039739,-103.676102	
Photo Description:	
View of the affected area.

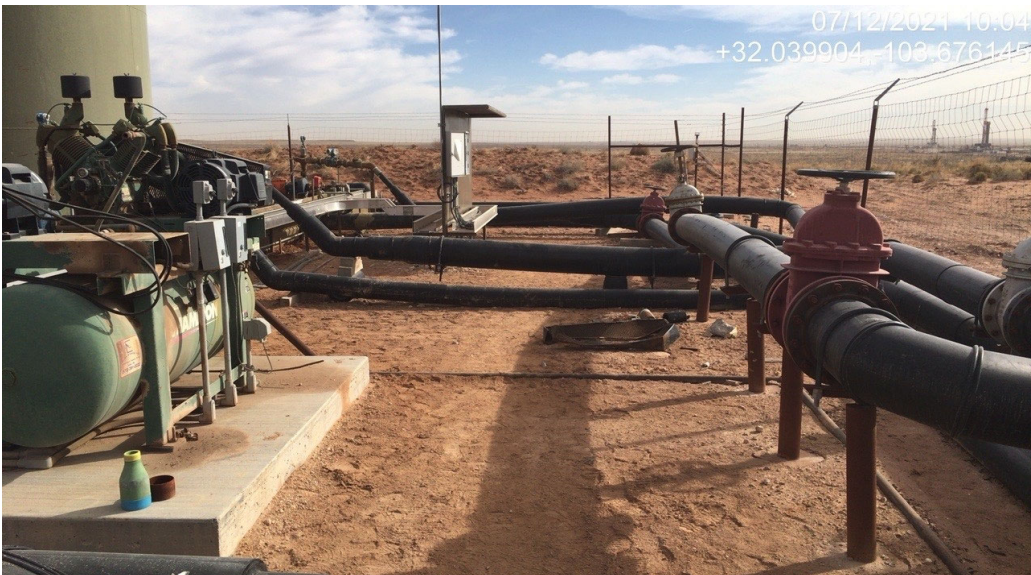
Photo Number: 5

Date: 7/12/2021	
Photo Direction: South	
Coordinates: 32.039904,-103.676145	
Photo Description: View of the affected area.

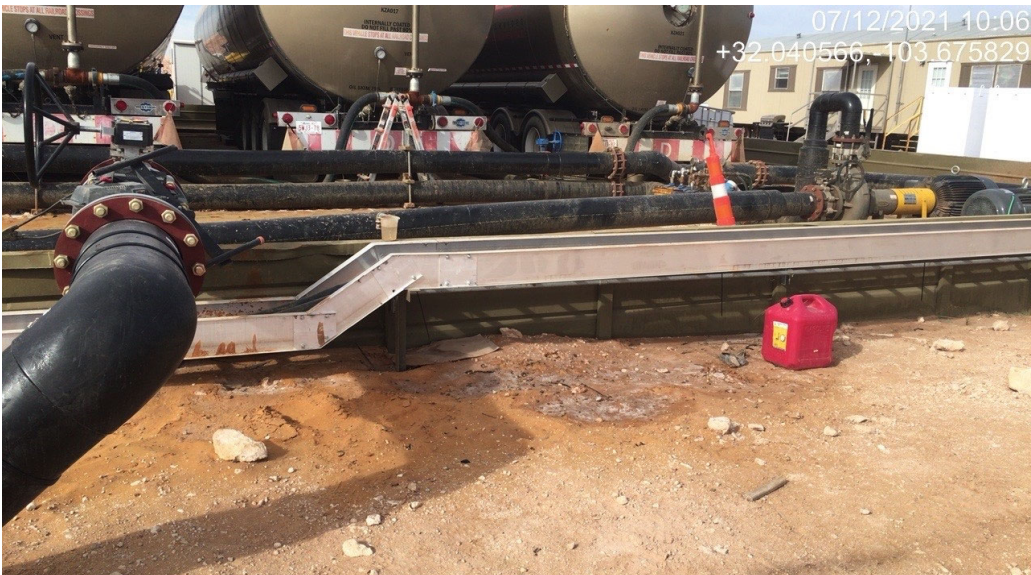
Photo Number: 6

Date: 7/12/2021	
Photo Direction: South	
Coordinates: 32.040566,-103.675829	
Photo Description: View of the affected area.

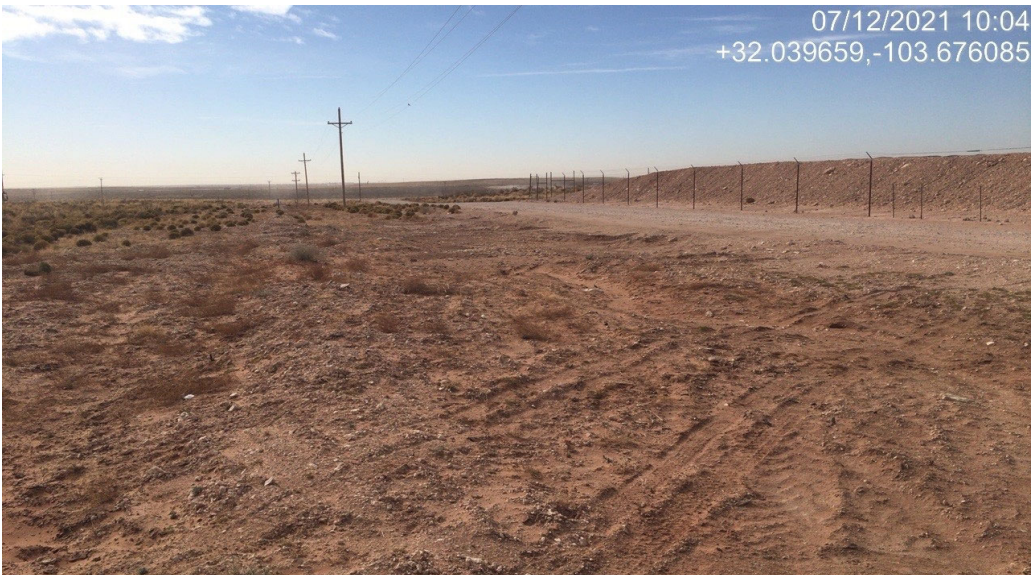
Photo Number: 7

<p>07/12/2021 10:04 +32.039659,-103.676085</p>
Date: 7/12/2021	
Photo Direction: South	
Coordinates: 32.039659,-103.676085	
Photo Description:	
View of the affected area.

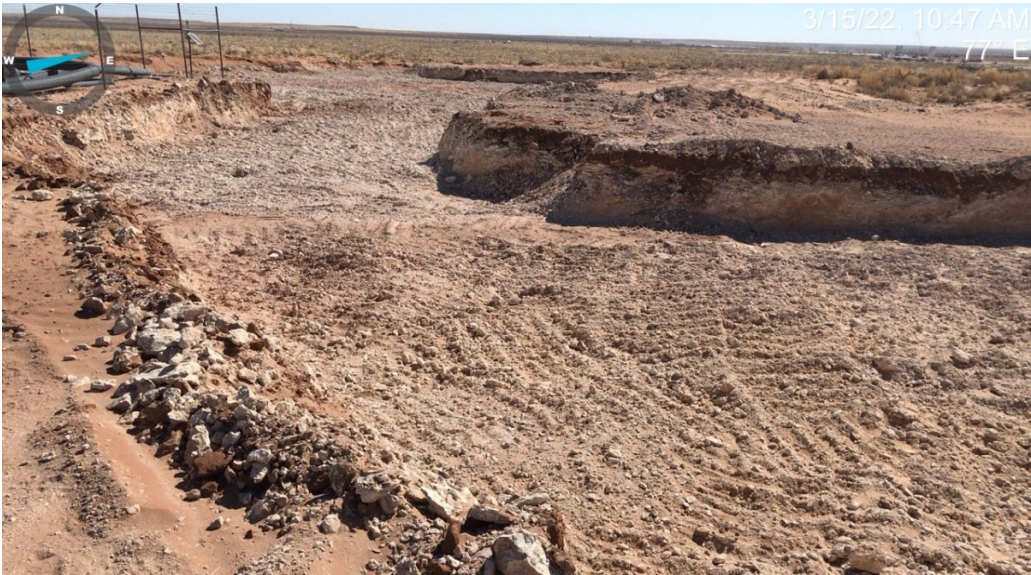
Photo Number: 8

<p>3/15/22, 10:47 AM 77° E</p>
Date: 3/15/2022	
Photo Direction: East	
Coordinates: 32.039770, -103.676123	
Photo Description:	
View of the excavated area.

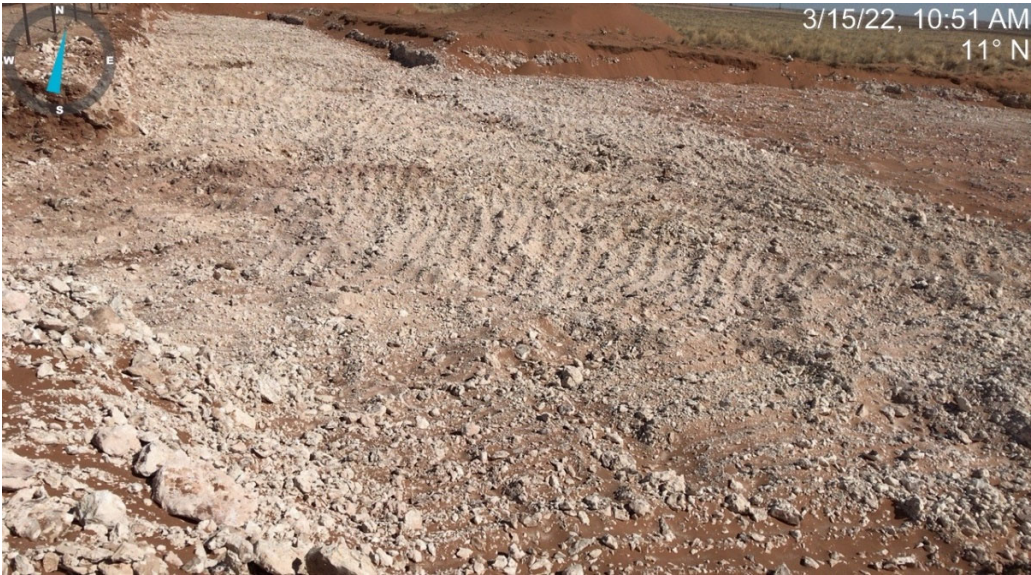
Photo Number: 10

Date: 3/15/2022	
Photo Direction: North	
Coordinates: 32.039875, -103.675798	
Photo Description: View of the excavated area.

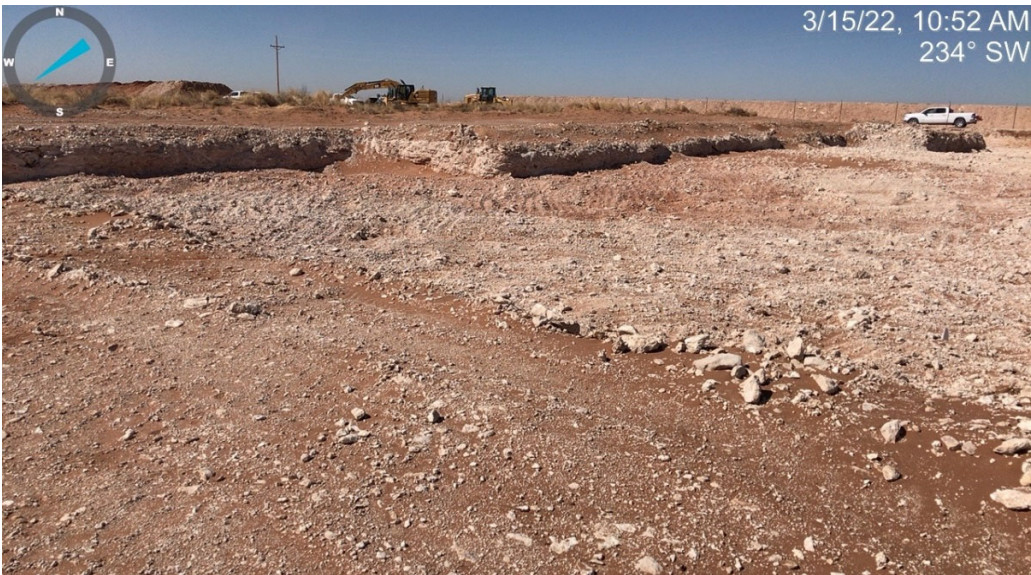
Photo Number: 11

A photograph showing a wide, flat, excavated area of reddish-brown soil and gravel. In the background, there are some structures and a white pickup truck. A compass rose in the top left corner indicates the direction is Southwest. The timestamp in the top right corner reads "3/15/22, 10:52 AM 234° SW".
Date: 3/15/2022	
Photo Direction: Southwest	
Coordinates: 32.039784, -103.675357	
Photo Description:	
View of the excavated area.

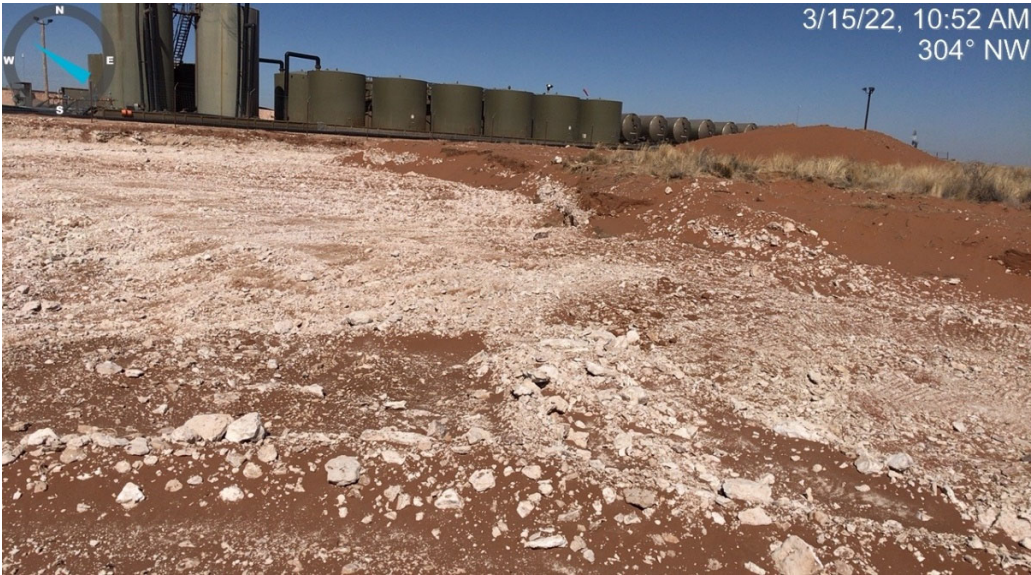
Photo Number: 12

A photograph showing a wide, flat, excavated area of reddish-brown soil and gravel. In the background, there are several large green storage tanks and some structures. A compass rose in the top left corner indicates the direction is Northwest. The timestamp in the top right corner reads "3/15/22, 10:52 AM 304° NW".
Date: 3/15/2022	
Photo Direction: Northwest	
Coordinates: 32.039612, -103.675372	
Photo Description:	
View of the excavated area.

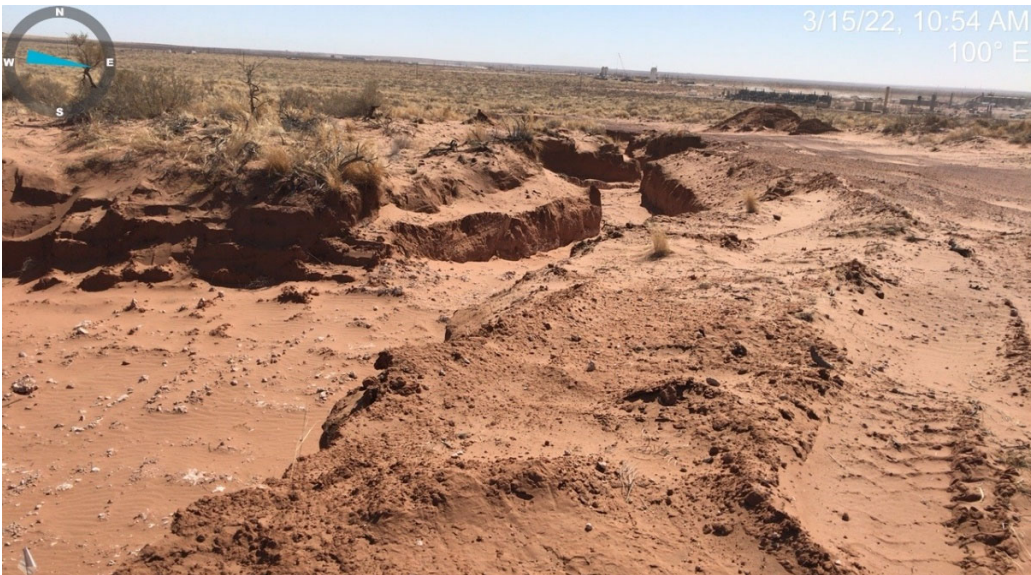
Photo Number: 13

Date: 3/15/2022	
Photo Direction: East	
Coordinates: 32.039855, -103.675144	
Photo Description:	
View of the excavated area.

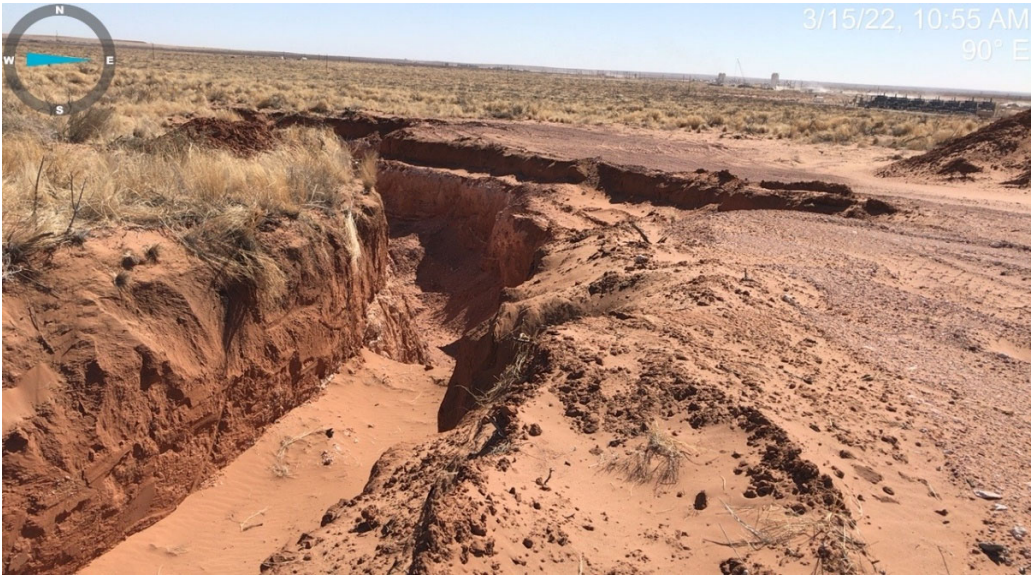
Photo Number: 14

Date: 3/15/2022	
Photo Direction: East	
Coordinates: 32.039803, -103.674826	
Photo Description:	
View of the excavated area.

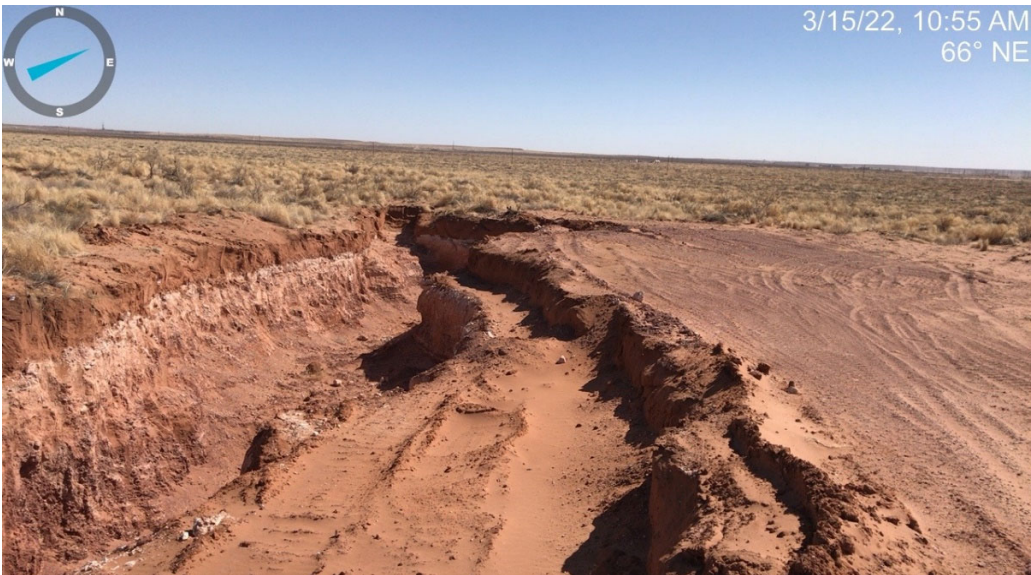
Photo Number: 15

Date: 3/15/2022	
Photo Direction: East-Northeast	
Coordinates: 32.039531, -103.674077	
Photo Description:	
View of the excavated area.

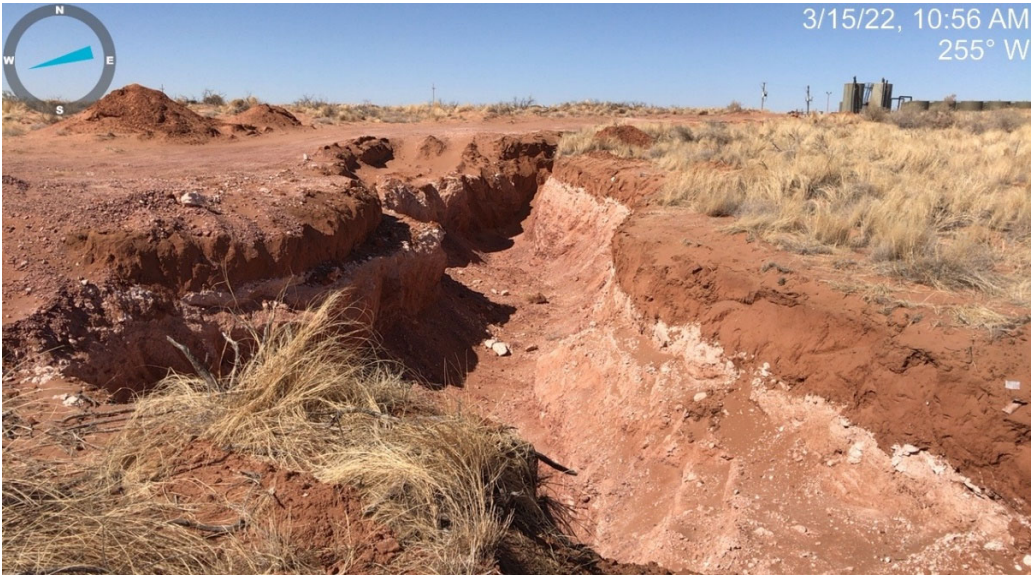
Photo Number: 16

Date: 3/15/2022	
Photo Direction: West	
Coordinates: 32.039575, -103.673456	
Photo Description:	
View of the excavated area.

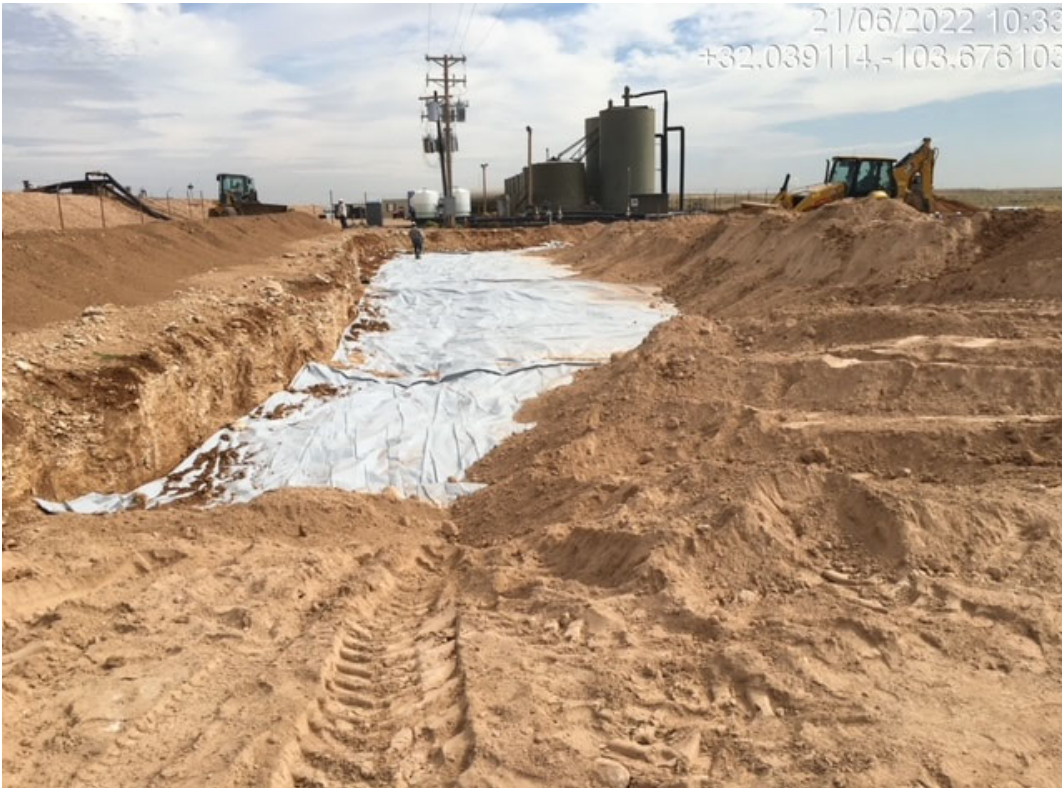
Photo Number: 17

Date: 6/21/2022	
Photo Direction: North	
Coordinates: 32.039114, -103.676103	
Photo Description:	
View of liner installation.

On June 21, 2022, upon receiving NMOCD approval of the *Remediation Summary, Variance & Deferral Request*, a 20-mil polyurethane liner was installed on the floor of the excavation atop impacted soil affected above the NMOCD Closure Criteria in the areas by sample points FS1, FS2, and SP1 through SP5. The liner was sloped to facilitate shedding of moisture outside the footprint of the excavation and the maximum horizontal extent of in-situ impacted soil. During the installation of the liner, an approximate 6-inch layer of pad material was installed both above and below the liner in an effort to maintain its integrity during backfilling activities. This engineered control is designed to inhibit the vertical migration of chloride contamination remaining in-situ.

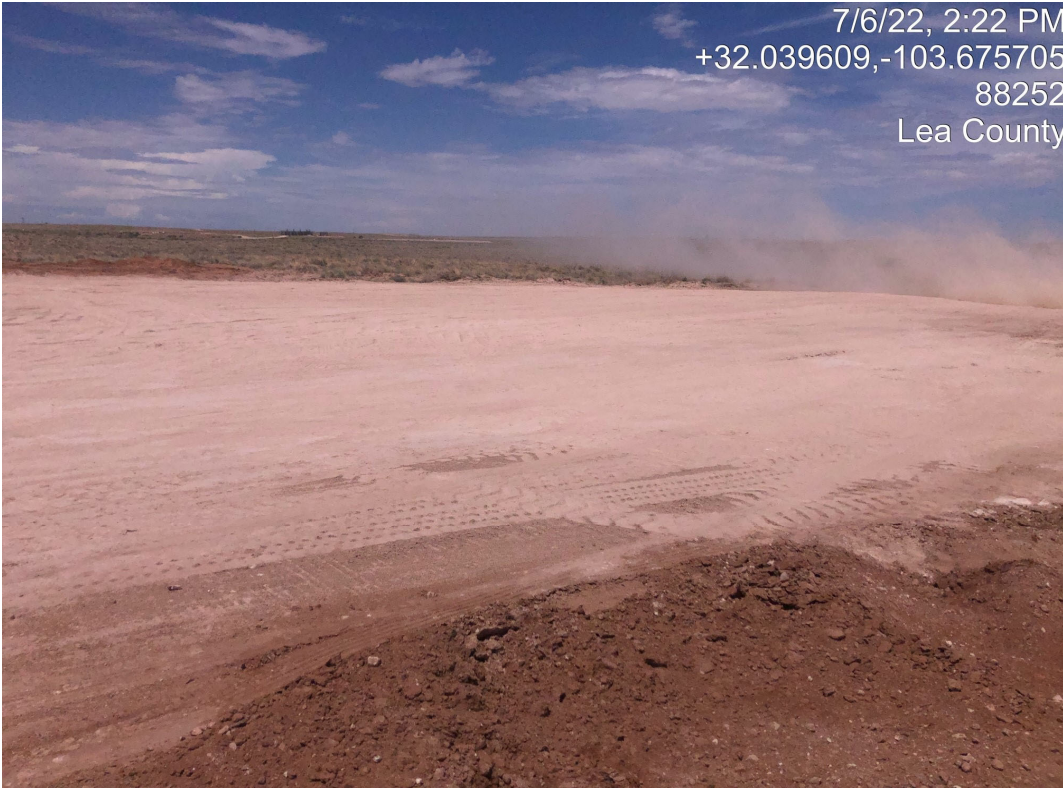
Photo Number: 20

Date: 7/6/2022	
Photo Direction: Northeast	
Coordinates: 32.039609, -103.675705	
Photo Description:	
View of the remediated area after backfilling and regrading.

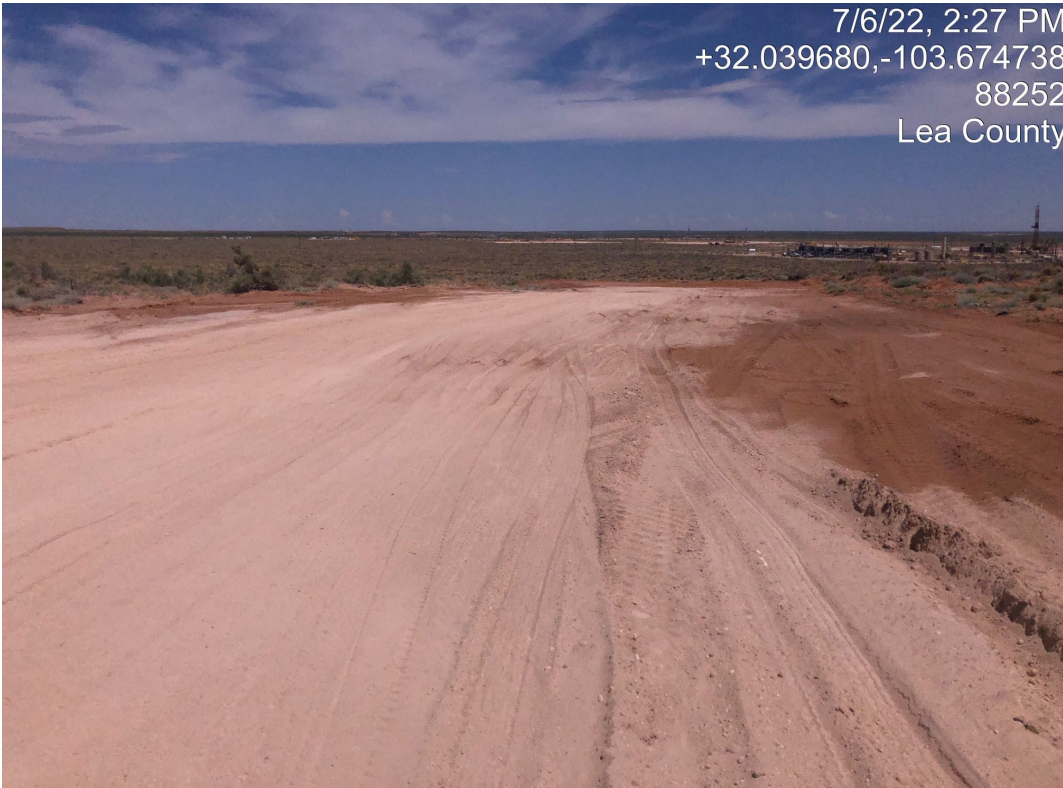
Photo Number: 21

<p>7/6/22, 2:27 PM +32.039680,-103.674738 88252 Lea County</p>
Date: 7/6/2022	
Photo Direction: Southeast	
Coordinates: 32.039680, -103.674738	
Photo Description:	
View of the remediated area after backfilling and regrading.

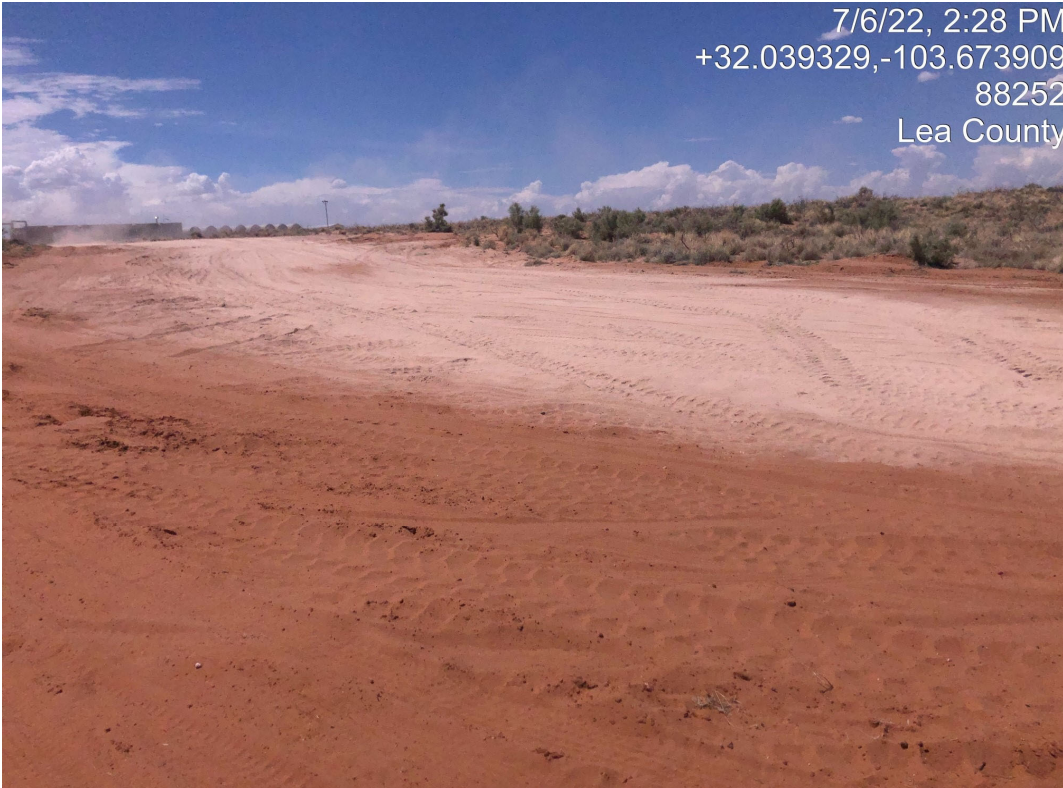
Photo Number: 22

<p>7/6/22, 2:28 PM +32.039329,-103.673909 88252 Lea County</p>
Date: 7/6/2022	
Photo Direction: Northwest	
Coordinates: 32.039329, -103.673909	
Photo Description:	
View of the remediated area after backfilling and regrading.

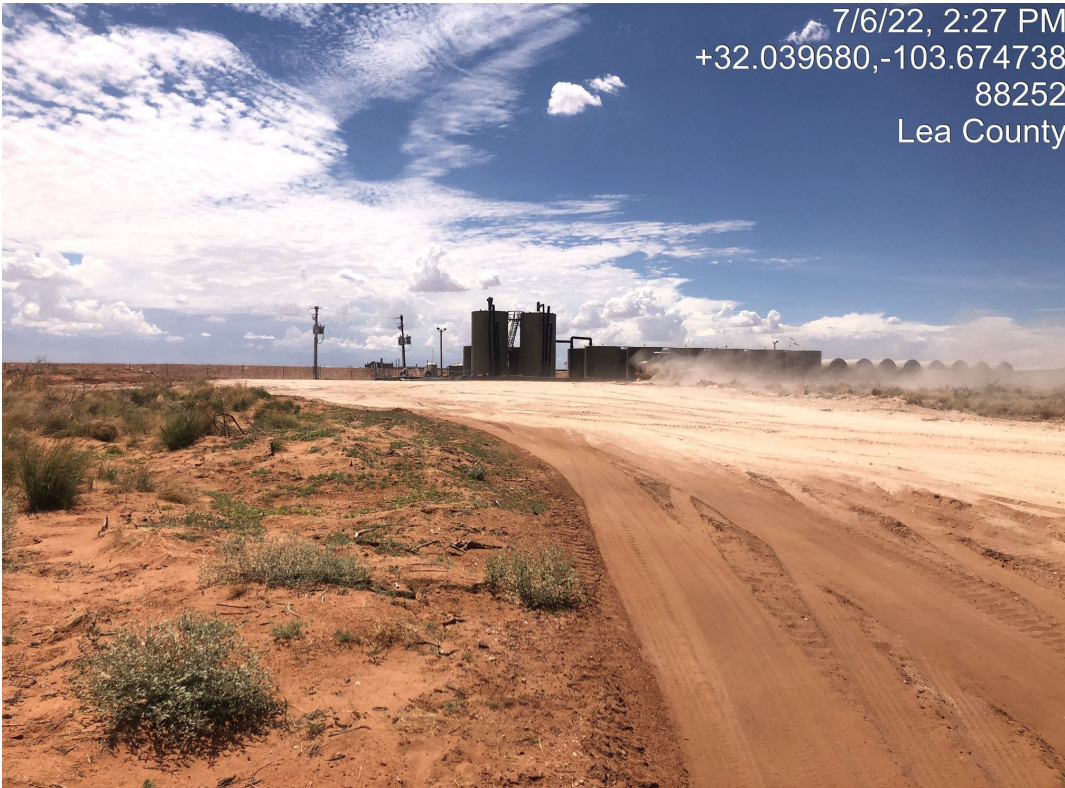
Photo Number: 23

<p>7/6/22, 2:27 PM +32.039680,-103.674738 88252 Lea County</p>
Date: 7/6/2022	
Photo Direction: Northwest	
Coordinates: 32.039680, -103.674738	
Photo Description:	
View of the remediated area after backfilling and regrading.

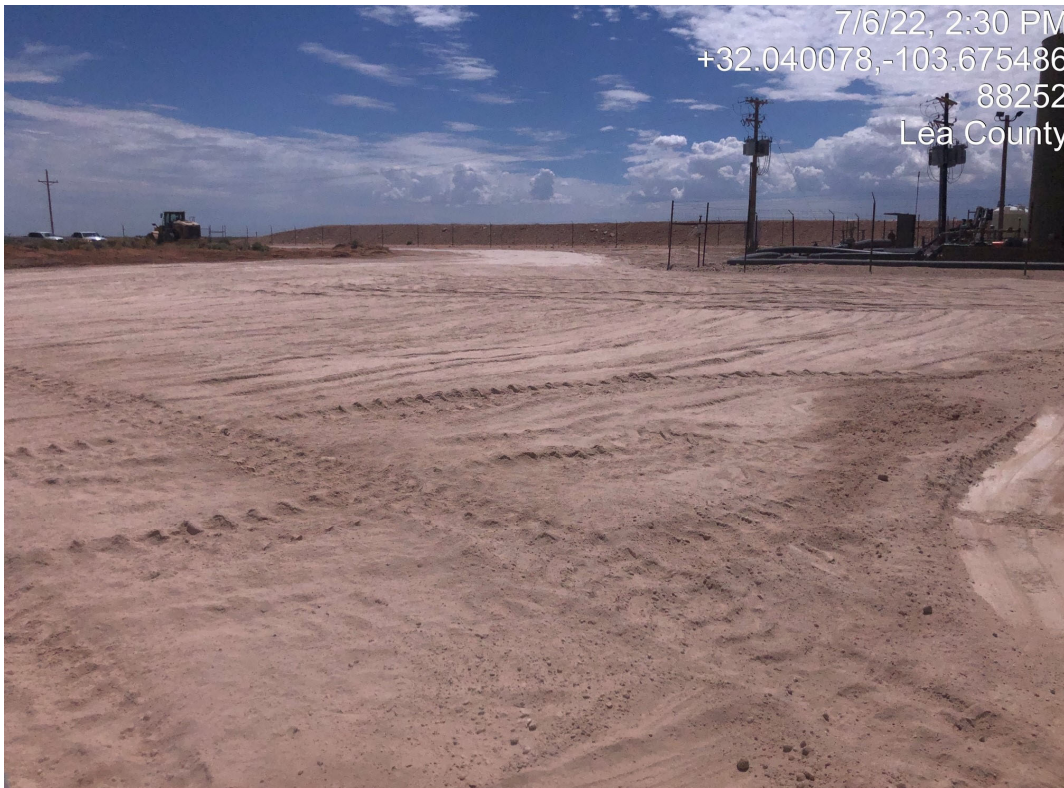
Photo Number: 25

<p>7/6/22, 2:30 PM +32.040078,-103.675486 88252 Lea County</p>
Date: 7/6/2022	
Photo Direction: Southwest	
Coordinates: 32.040078, -103.675486	
Photo Description:	
<p>View of the remediated area after backfilling and regrading.</p>

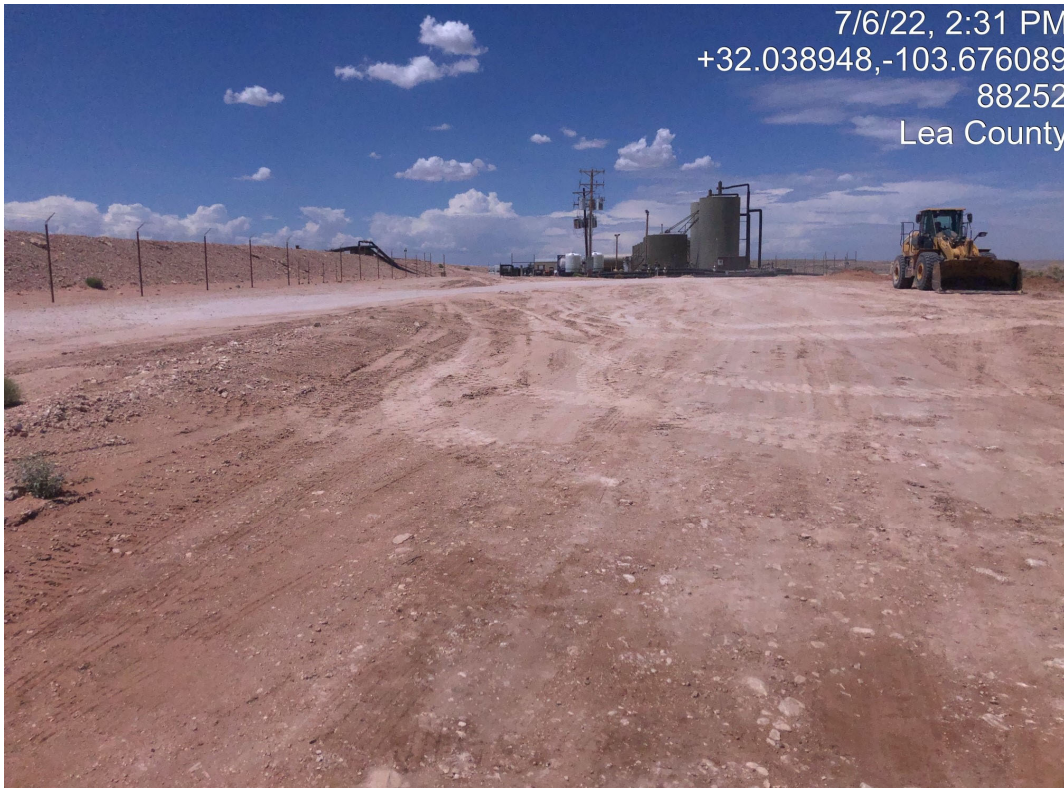
Photo Number: 26

<p>7/6/22, 2:31 PM +32.038948,-103.676089 88252 Lea County</p>
Date: 7/6/2022	
Photo Direction: North	
Coordinates: 32.038948, -103.676089	
Photo Description:	
<p>View of the remediated area after backfilling and regrading.</p>
