Re: Remediation Work Plan

Brookhaven Com B 3A
Hilcorp Energy Company
NMOCD Incident No: nAPP2404715996

Ensolum, LLC (Ensolum), on behalf of Hilcorp Energy Company (Hilcorp), presents this *Remediation Work Plan* (Work Plan) for a release at the Brookhaven Com B 3A natural gas production well (Site). The Site is located on New Mexico State Trust Land (STL), managed by the New Mexico State Land Office (NMSLO), in San Juan County, New Mexico, Unit O, Section 16, Township 31 North, Range 11 West (Figure 1). This Work Plan includes a summary of delineation activities performed at the Site and the proposed remediation of impacted soil originating from the release.

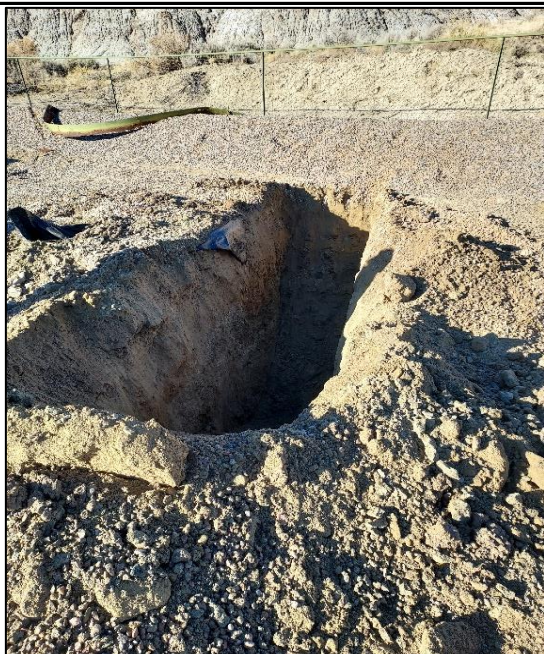
Photograph: 1
Description: Pothole PH01
View: West

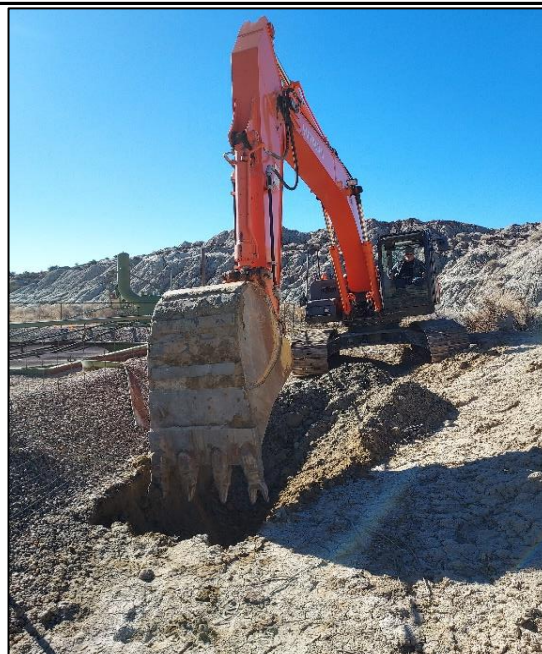
Photograph: 2
Description: Pothole PH02
View: South

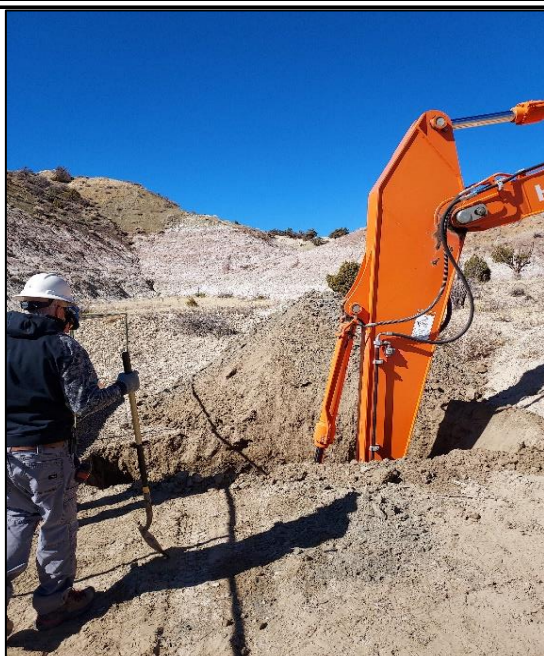
Photograph: 3
Description: Pothole PH06
View: West

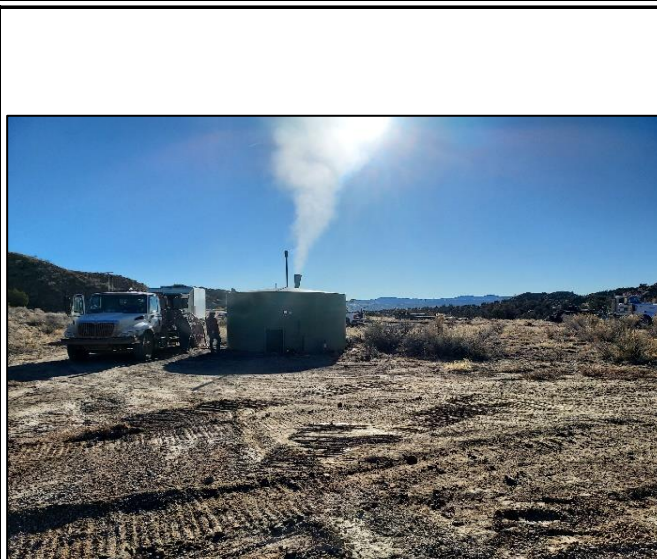
Photograph: 4
Description: Relining the condensate tank
View: East

On February 15, 2024, Hilcorp personnel discovered a release of 22 barrels (bbls) of condensate and 15 bbls of produced water at the Site. Specifically, while conducting a routine Site inspection, a Hilcorp operator observed a visibly impacted area (measuring approximately 5 feet by 10 feet) adjacent to a 286-bbl condensate aboveground storage tank (AST). Upon further inspection, it was determined two pinhole leaks had formed near the bottom weld on the west side of the AST due to corrosion. At that time, the AST was removed from service. The spilled fluids did not migrate horizontally outside of secondary containment; however, fluids were not recovered. The AST was subsequently recoated before placing back into service.
