Re: Scripps #4  
30-015-24880  
M-25-18S-26E  
Eddy County, NM  
nRM2030860417

EOG Resources, Inc. hereby submits the enclosed Closure Report for the above referenced incident. This report provides all site characterization and background information, as well as the remedial actions completed for the release which occurred on October 16, 2020.

**Scripps #4**  
**Closure Report**  
**30-015-24880**  
**M-25-18S-26E**  
**Eddy County, NM**  
**December 21, 2023**  
**nRM2030860417**

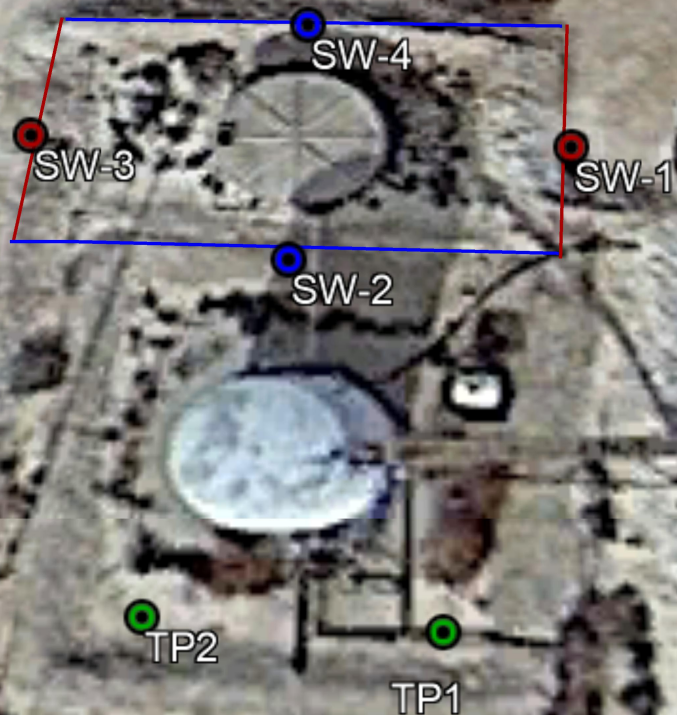
Sample Map

On August 2, 2021, GHD collected additional soil samples from the SW-1A and SW-4 sidewalls, as well as advancing 2 exploratory sample points (TP1-2 & TP2-2) on the other side of the battery which was not impacted by the release. Upon collection, samples were submitted to Hall Environmental Analysis Laboratory under strict chain-of-custody (COC) protocols for analyzation of BTEX (EPA Method 8021B), TPH (EPA Method 8015D) and chloride (EPA Method 300.0). The samples were collected and managed using standard QA/QC and chain-of-custody procedures.

The SW-1A sidewall analytical results indicated no further work required in this area as the most stringent closure criteria were met for NMAC 19.15.29.12 & 13. SW-4 indicated that further excavation would be required as TPH and Chloride results both remained above the required closure criteria.

GHD conducted further supervision of excavation activities in the SW-4 sidewall area, then on October 8, 2021, performed a resampling of the over-excavated sidewall. SW-4A was collected and submitted to Hall Environmental Analysis Laboratory under strict chain-of-custody (COC) protocols for analyzation of BTEX (EPA Method 8021B), TPH (EPA Method 8015D) and chloride

The SW-4A results indicated that further TPH exceedances still existed. However, the over-excavation activities had pushed the sidewall into the previous operator's production pit. This impacted area is governed by 19.15.30 NMAC and has had previous notification to NMOCD with an Abatement Plan previously enacted, nAUTOFAB000640. Further discussion of this Abatement Plan area is conducted in the nAUTOFAB000640 section below. All results associated with GHD confirmation sampling activities are included in Table 3 with sample locations attached as Figure 4.

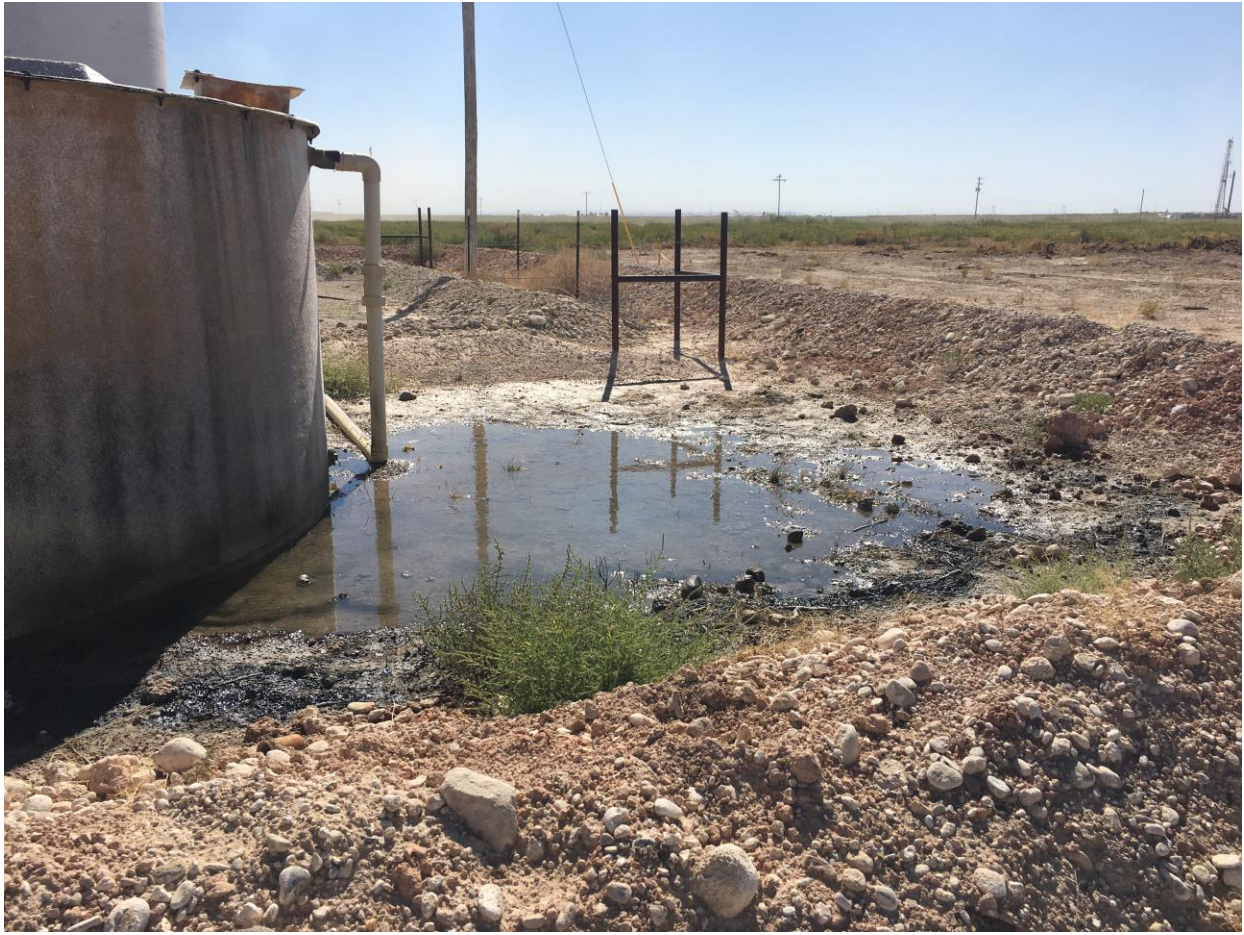
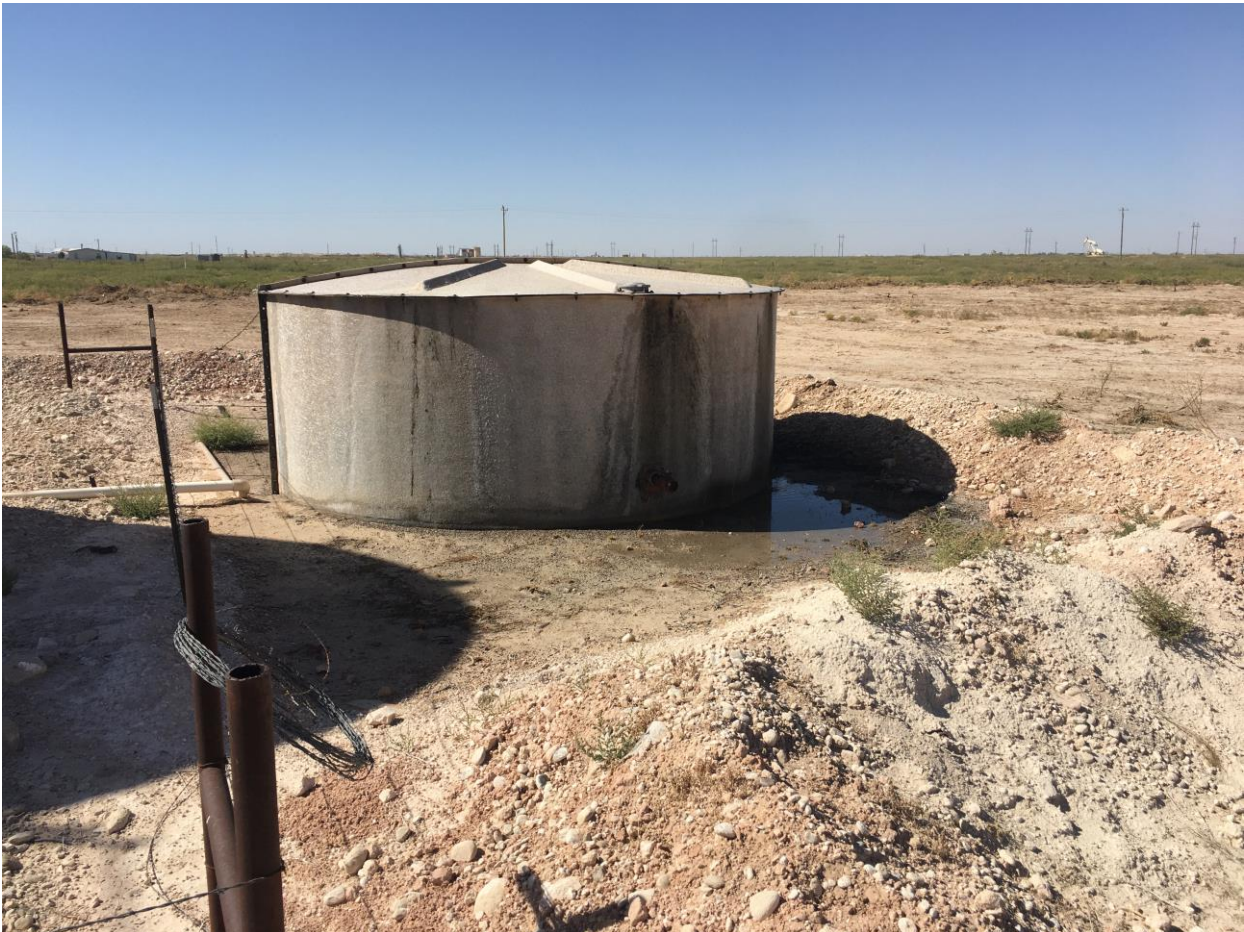
# Initial Release Photos

On October 16, 2020, EOG Resources, Inc. (EOG) discovered a release of 7 barrels of produced water at the Site due to a transfer pump failure which caused the 210 barrel (bbl) produced water tank to overflow. A vacuum truck was dispatched upon discovery which was able to recover 3 bbls of produced water. As indicated by the initial photographs attached in Appendix B, all released fluids were contained within the secondary berm which isolated the 210 bbl tank from the other storage/production equipment in the bulk area of the battery.

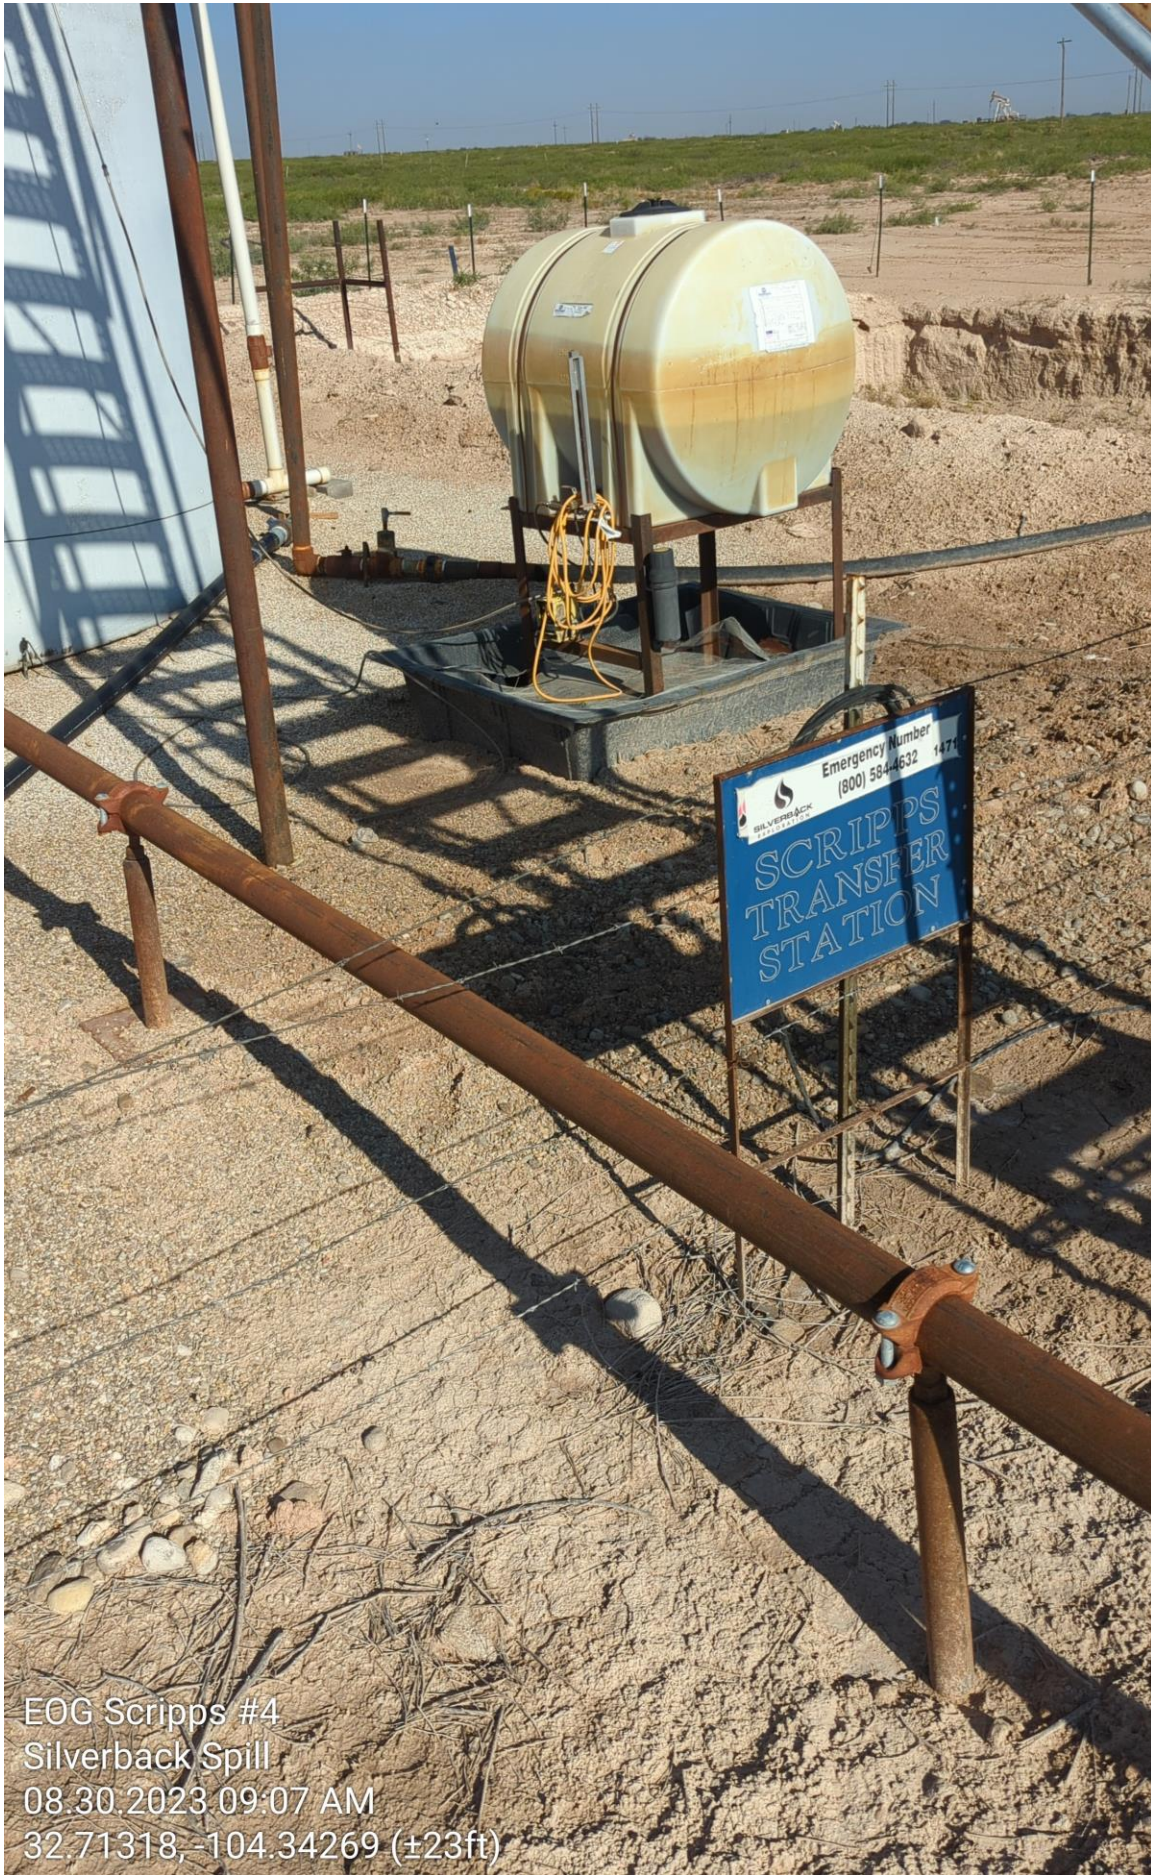
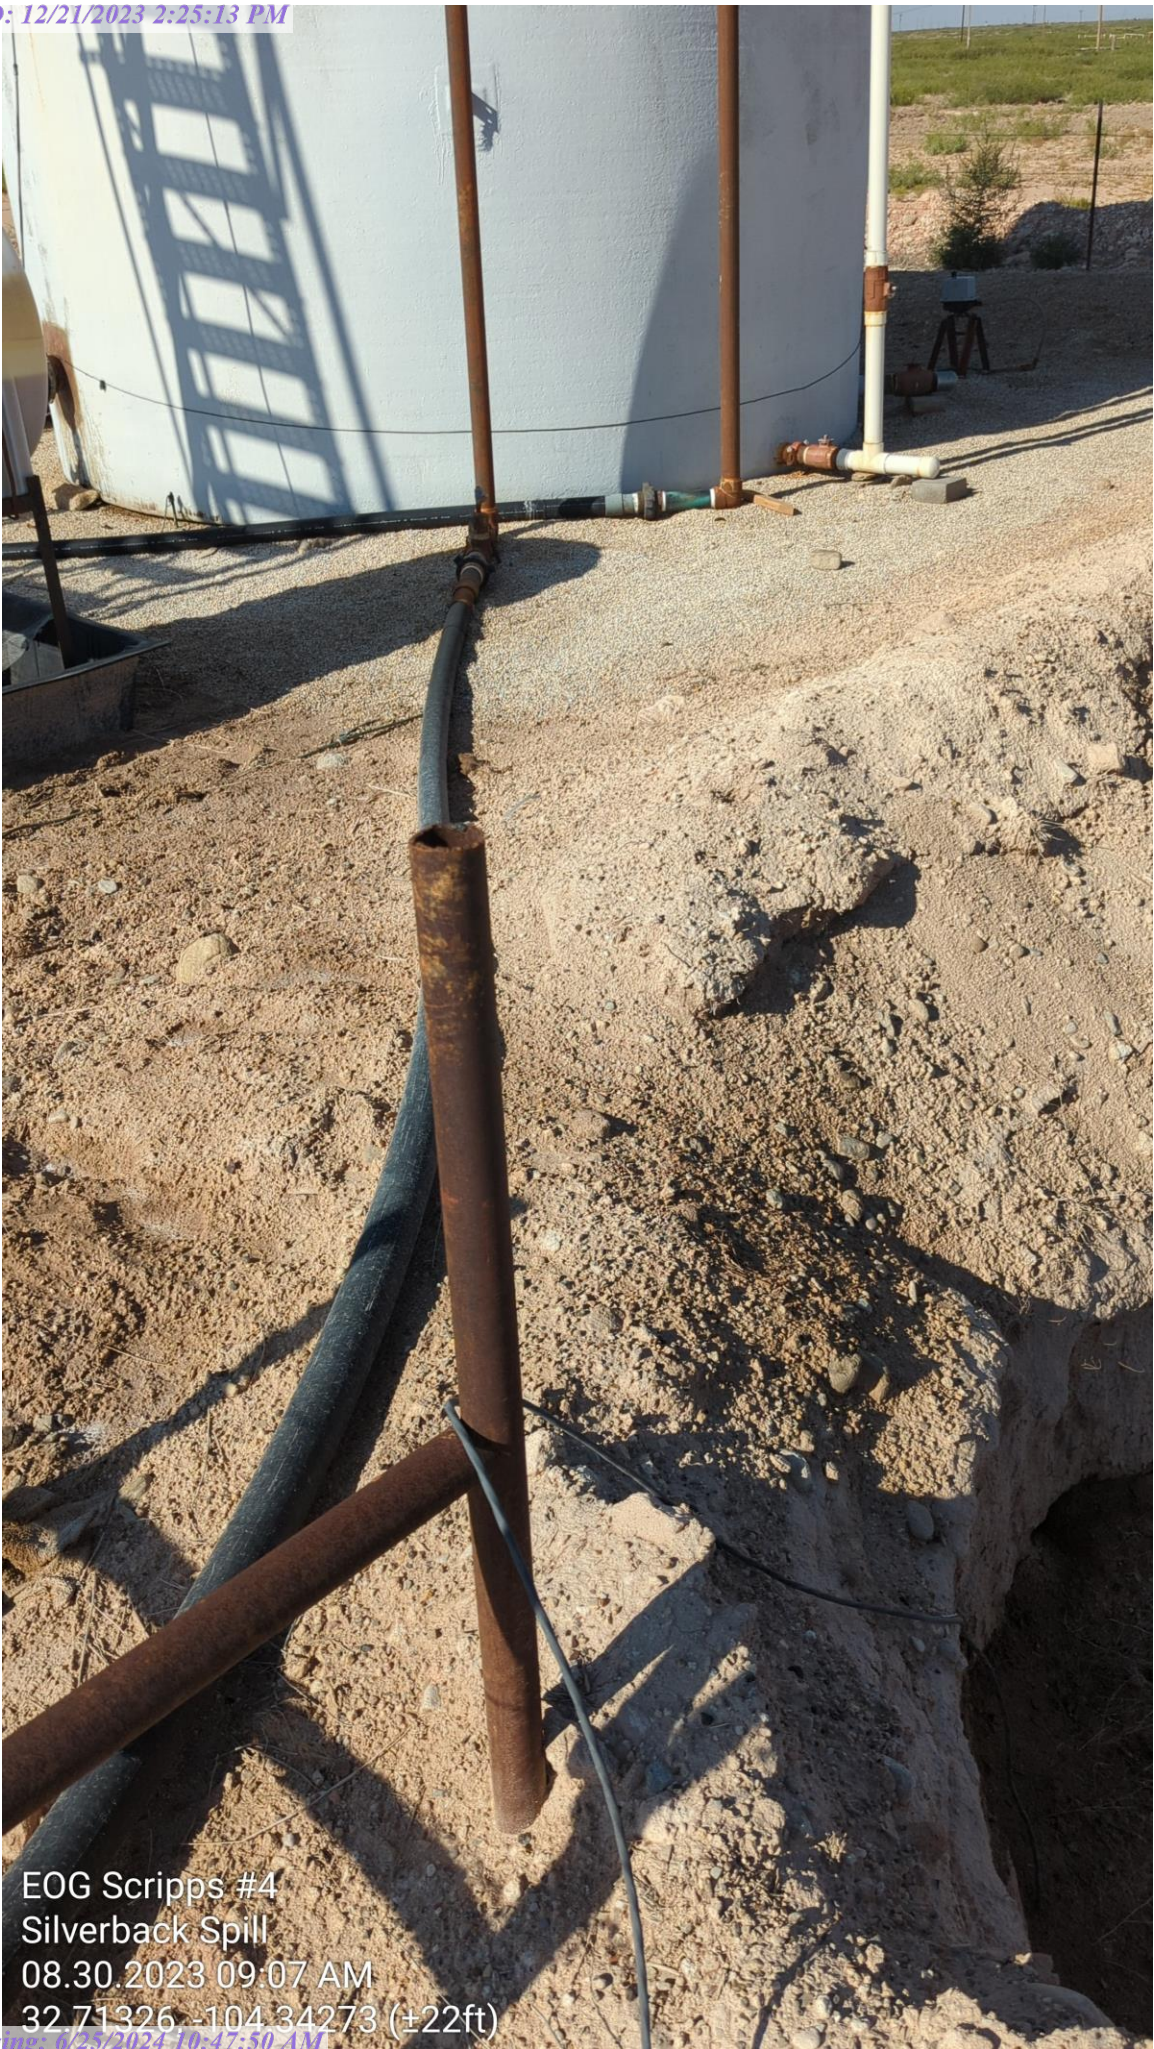
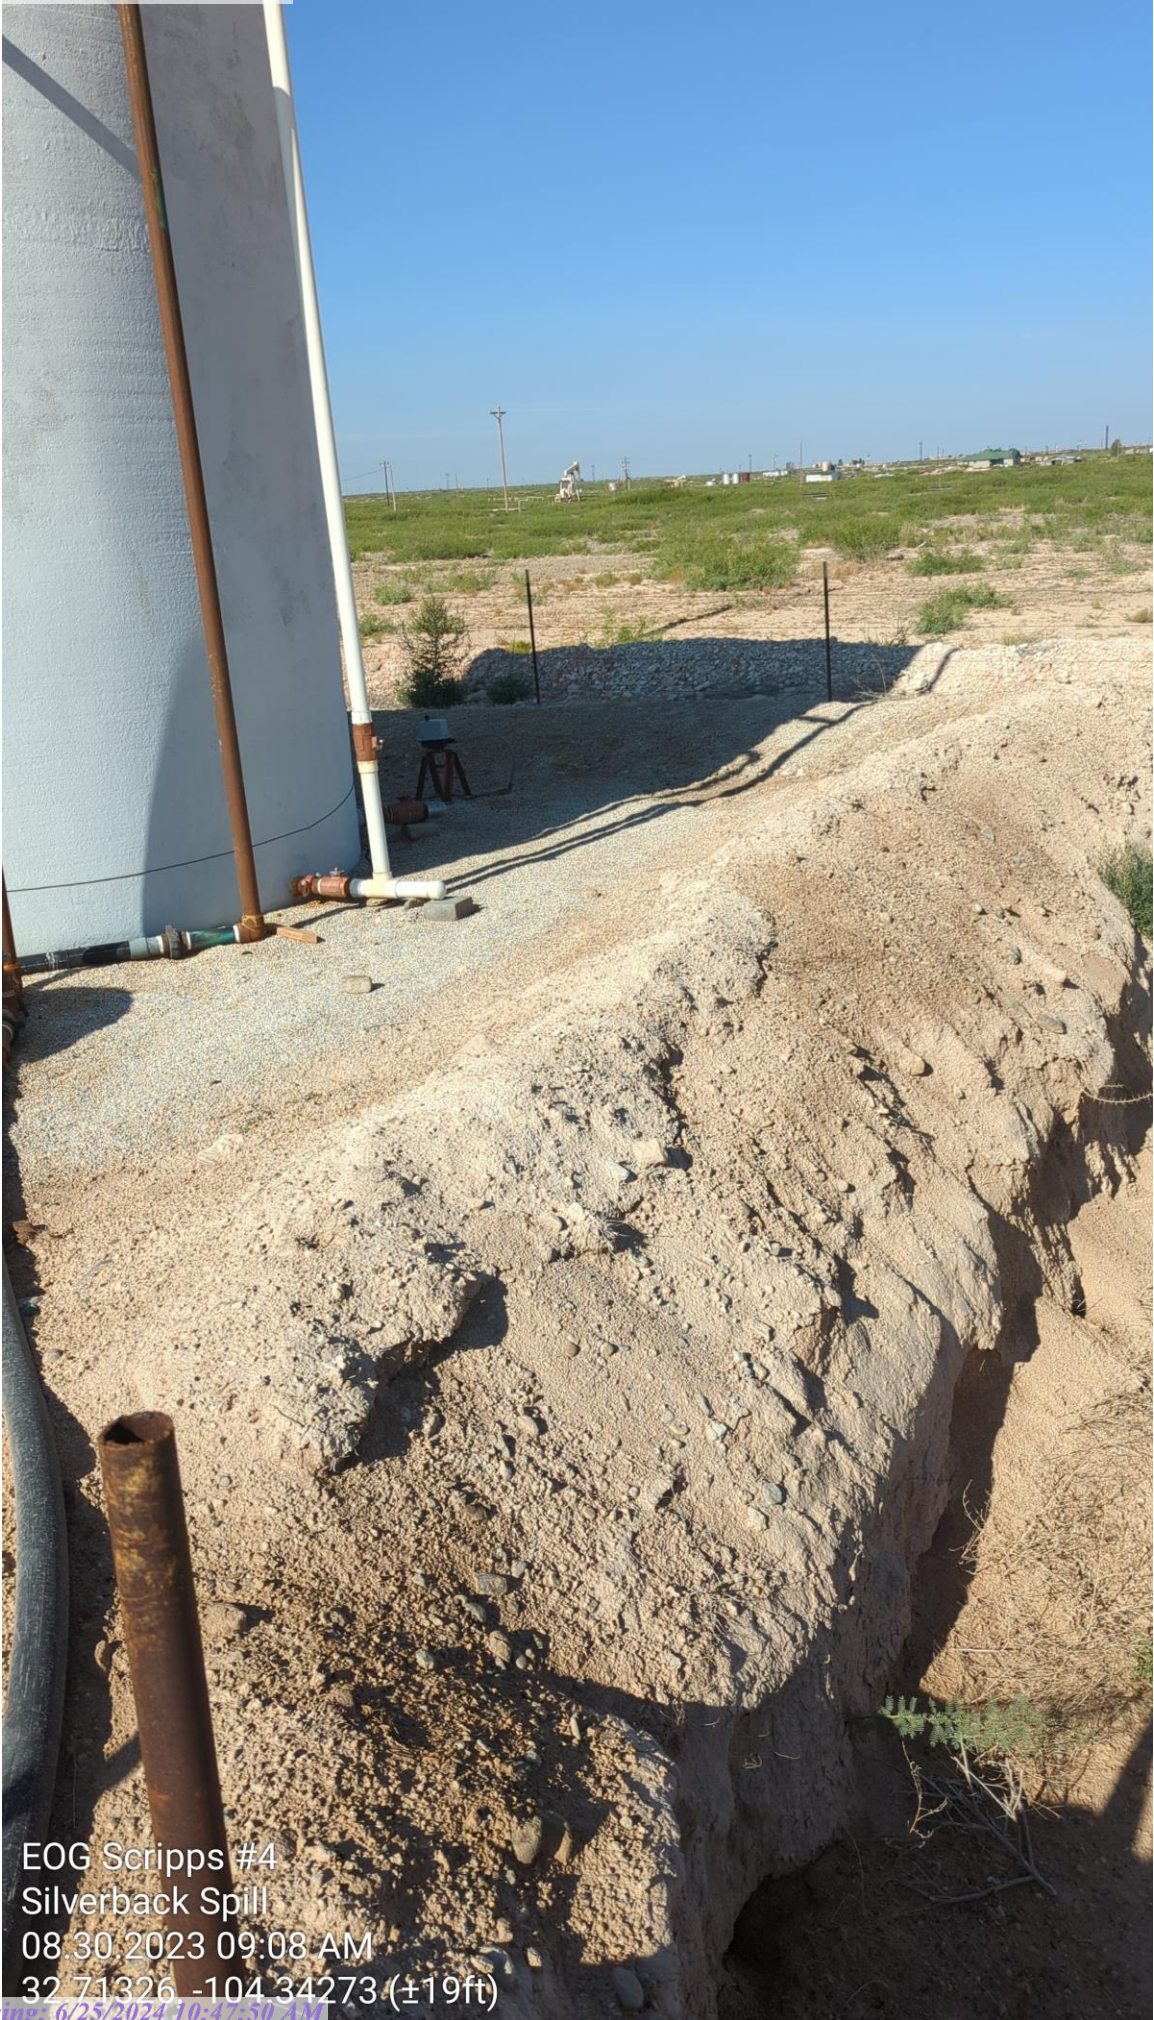
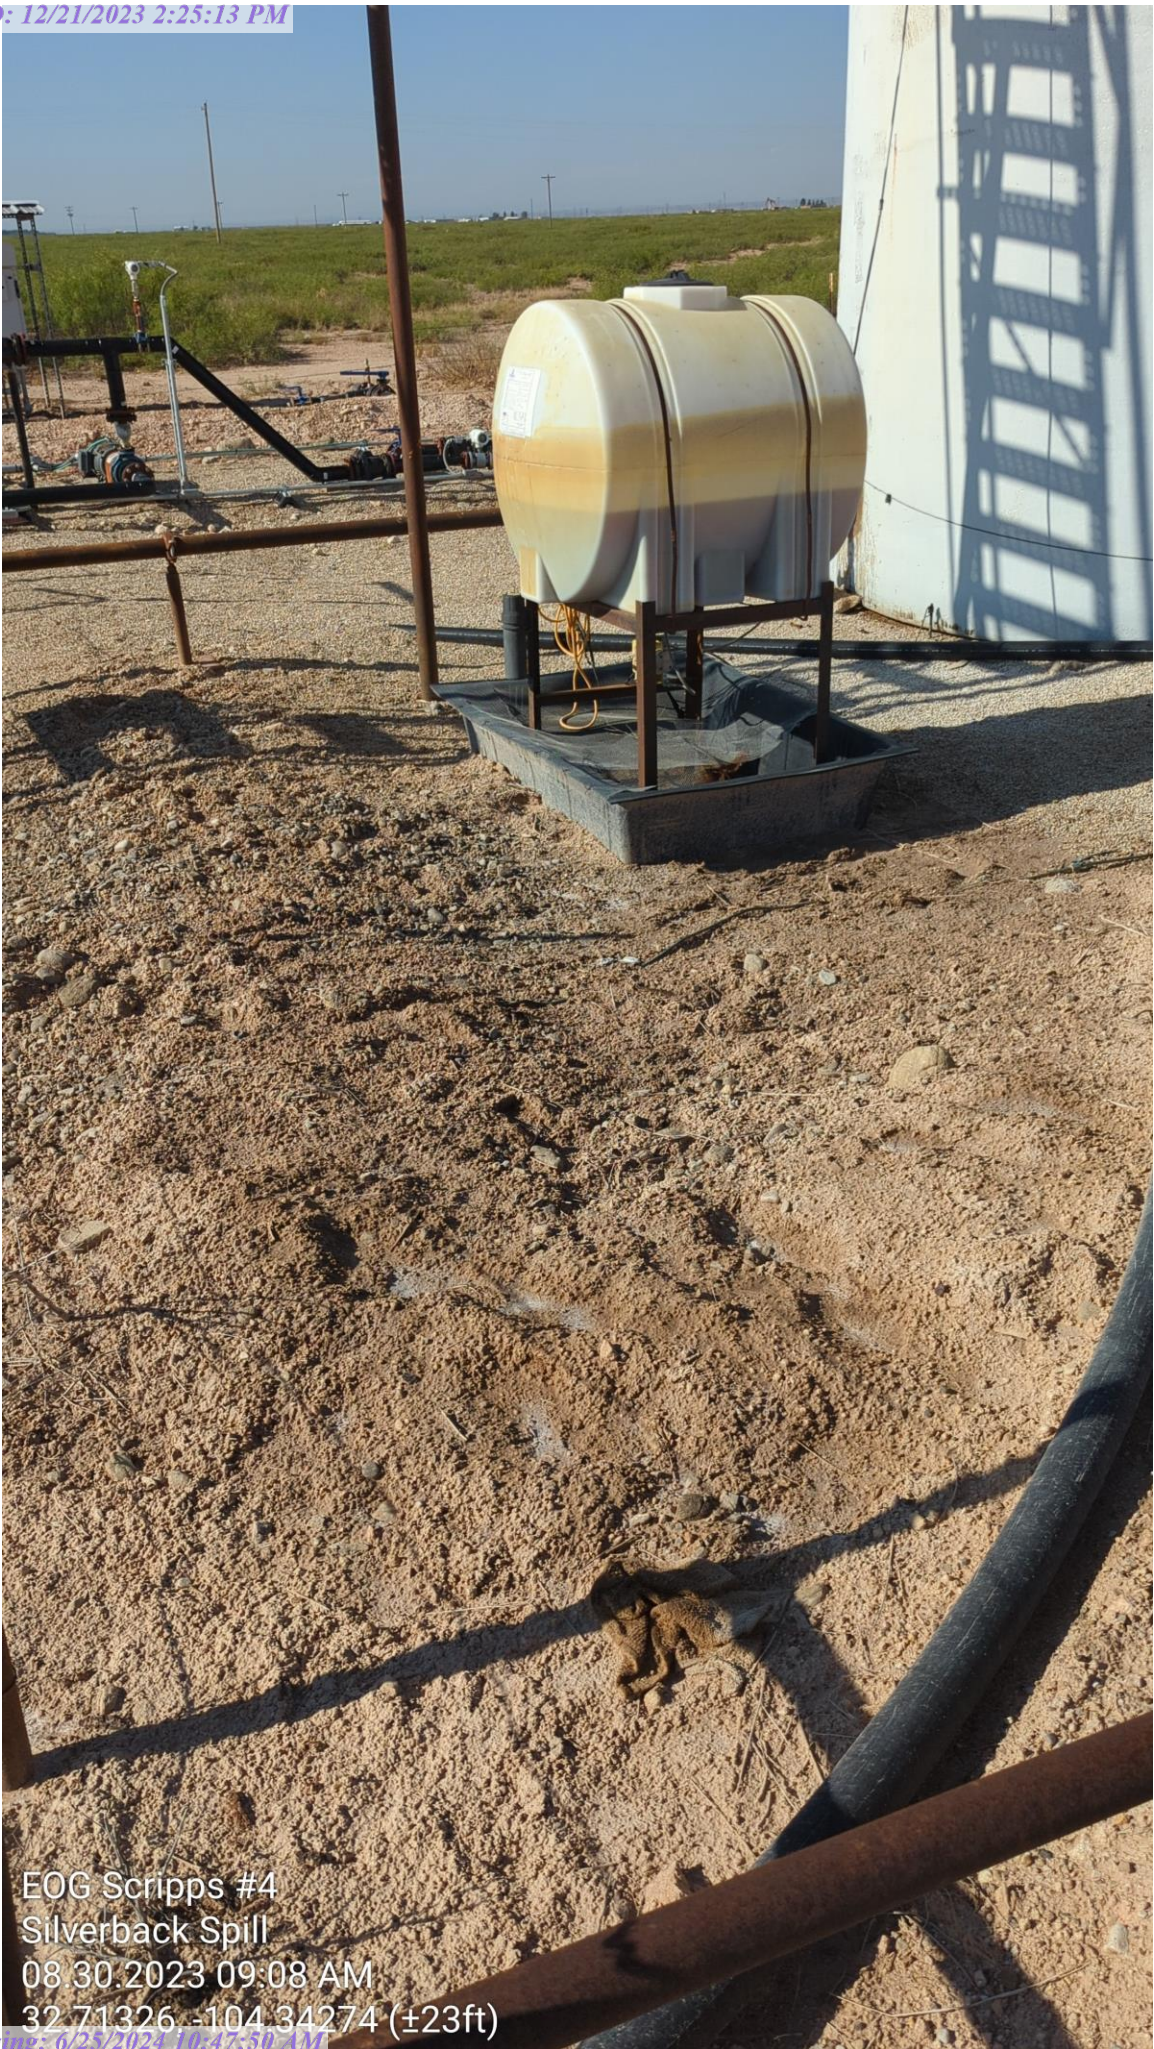
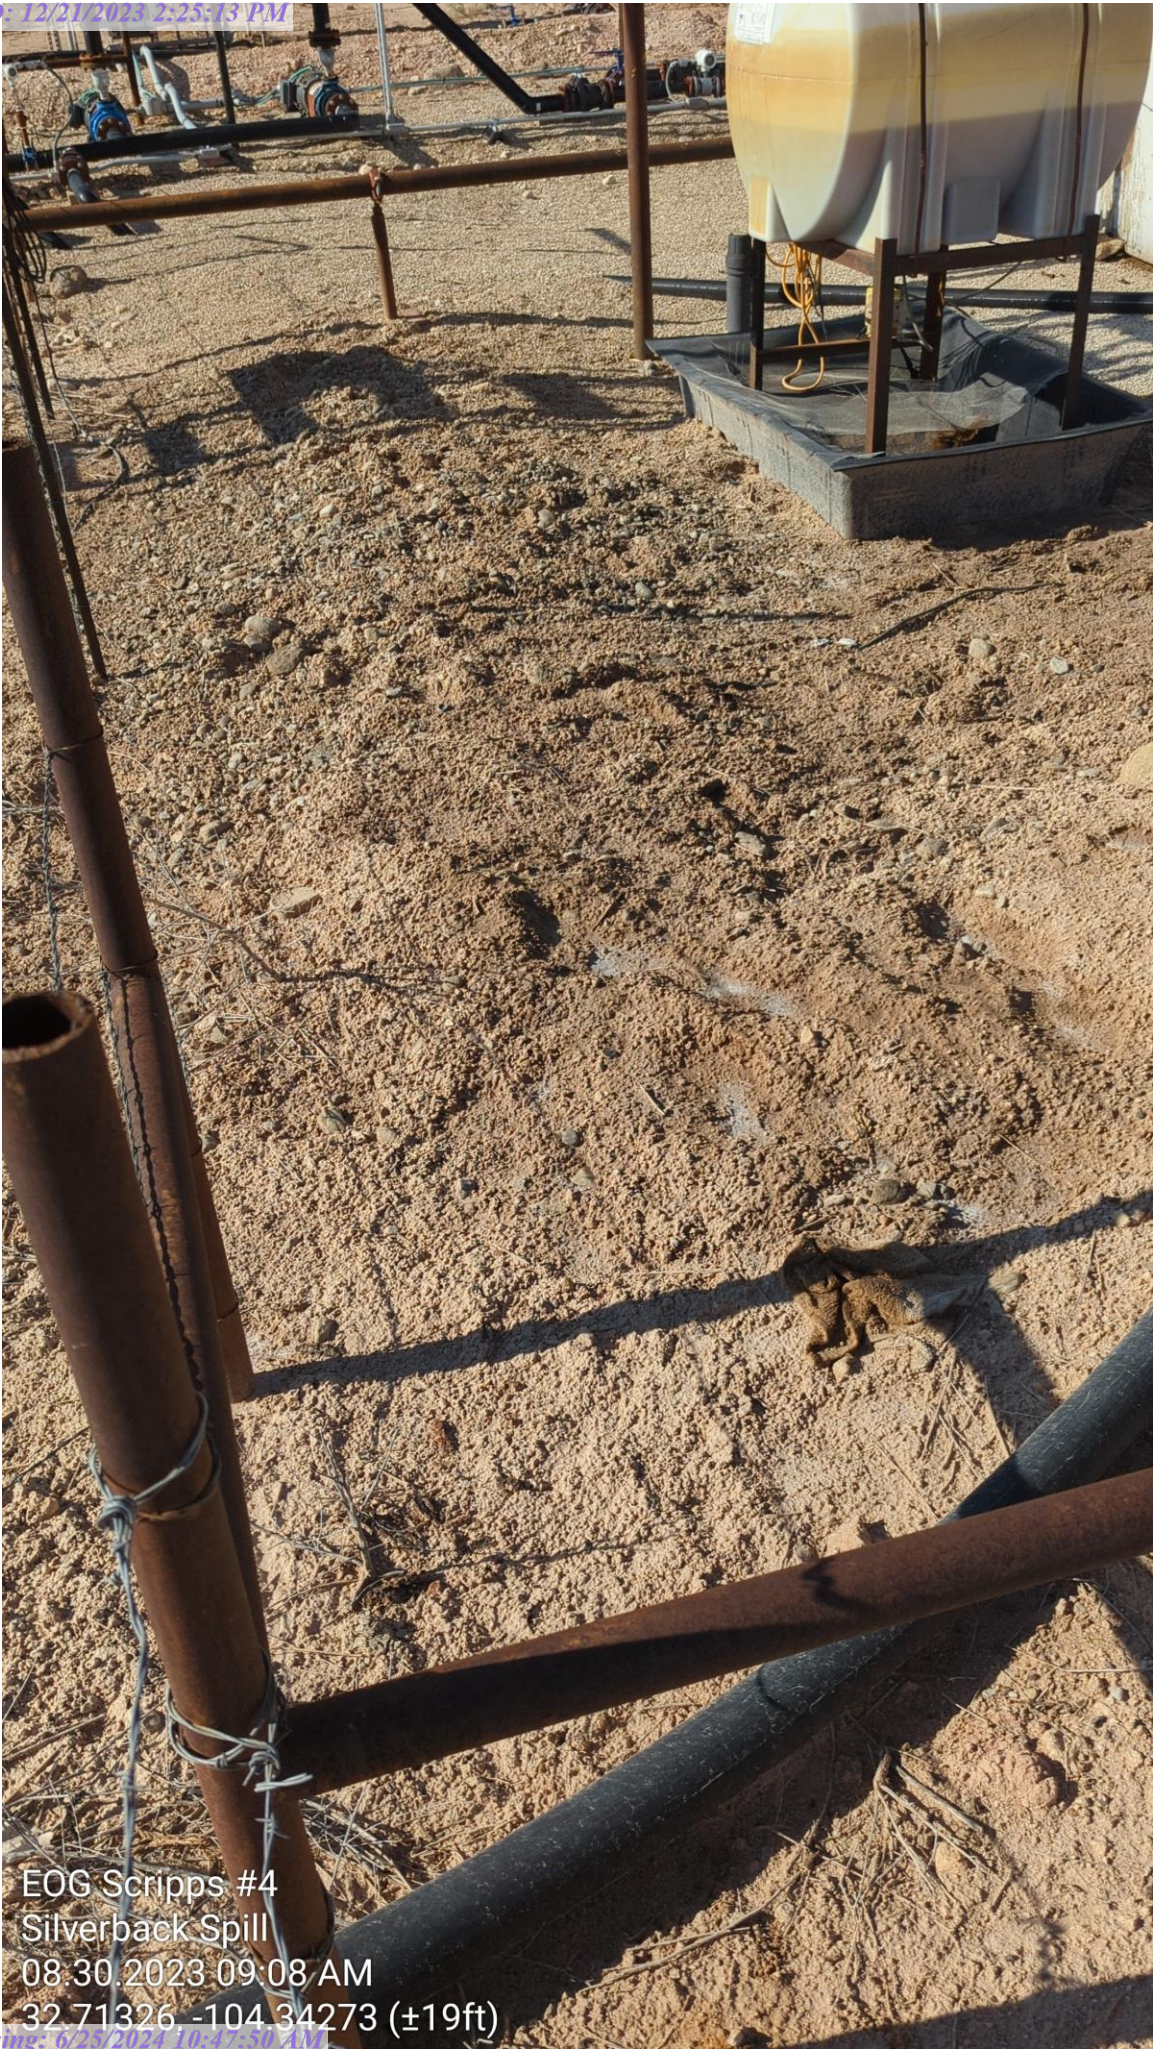
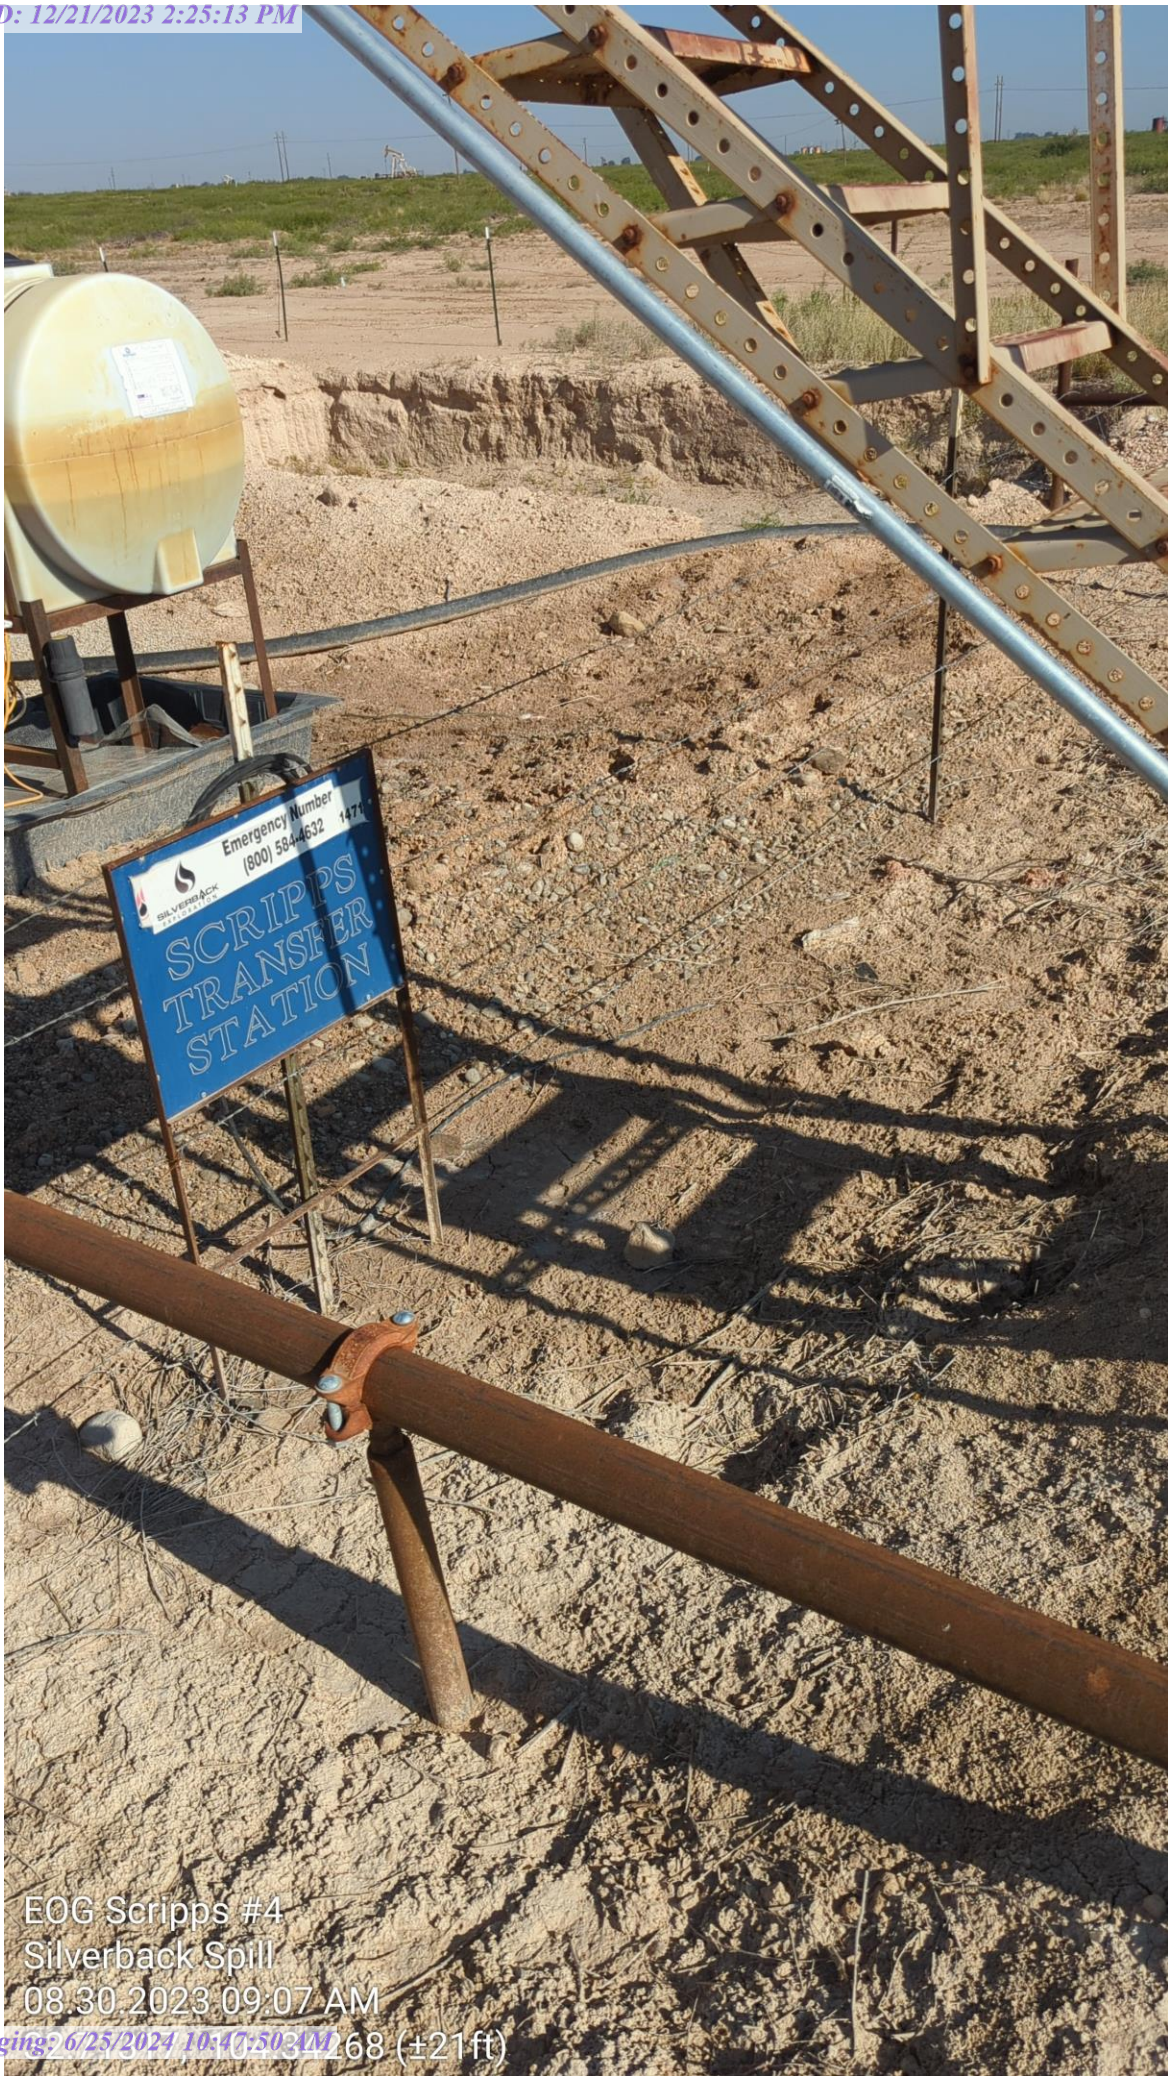
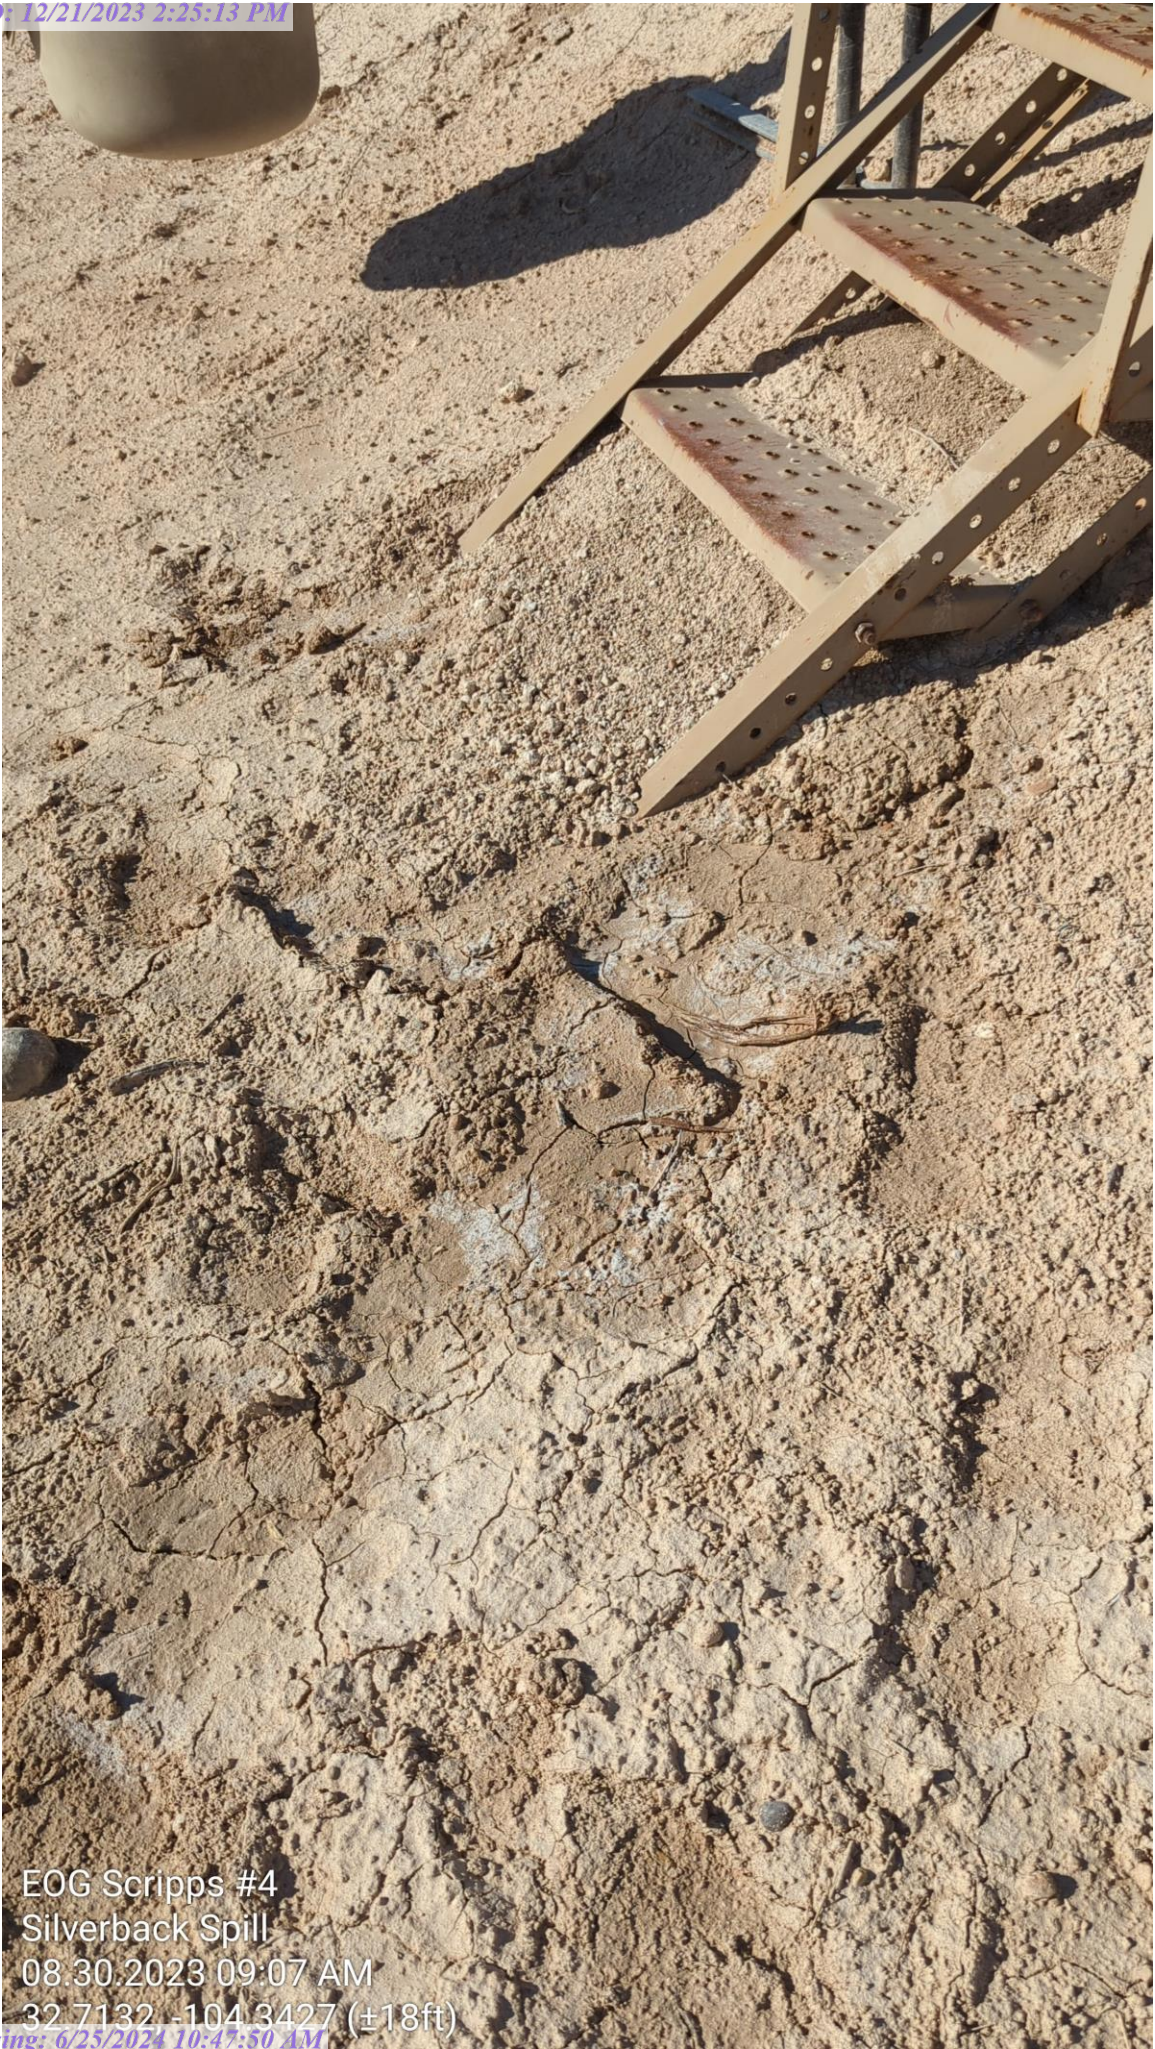
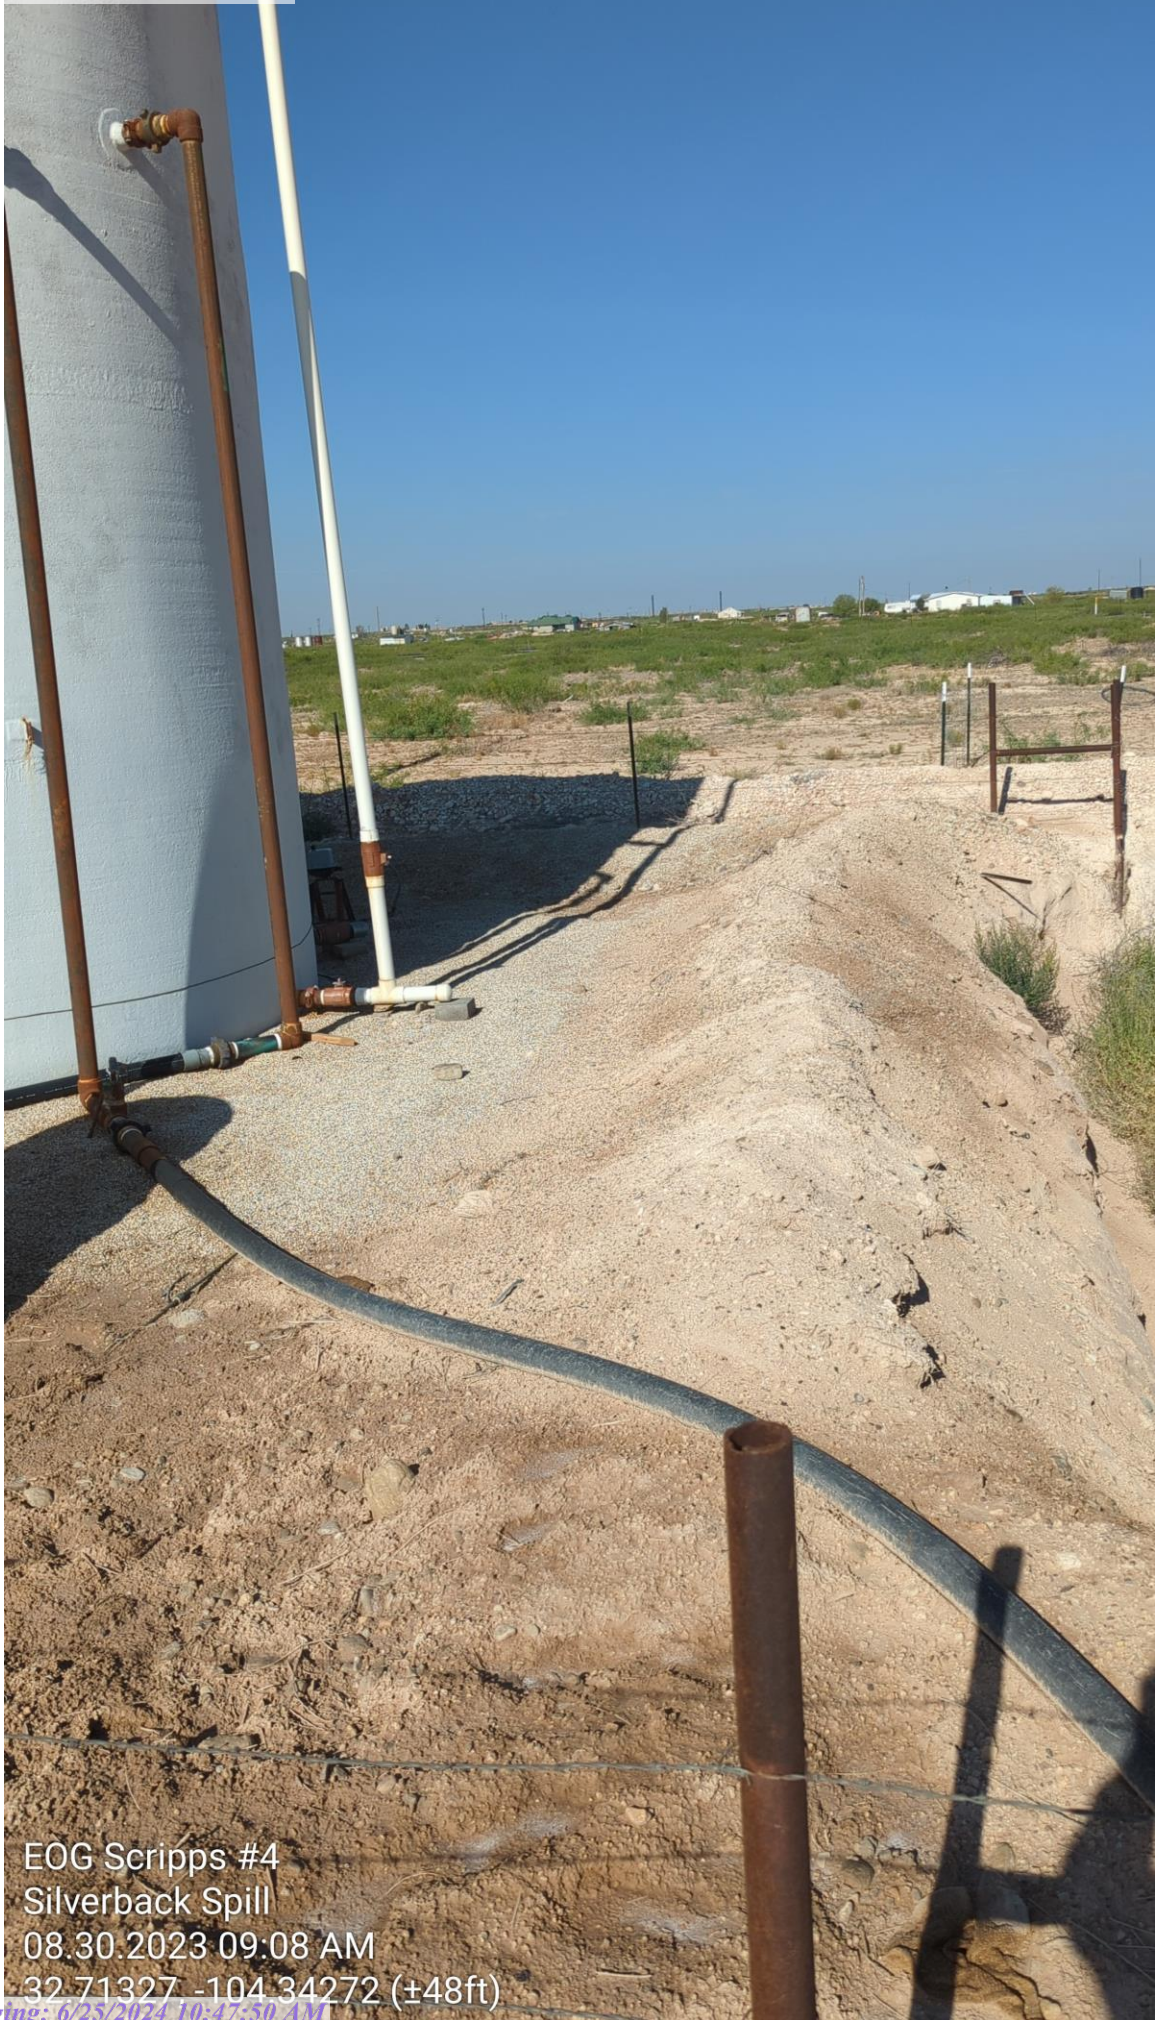
# Silverback Release Photos

On October 30, 2022, Silverback discovered a release at the site due to a failed tank inlet flow line. This failure resulted in an unknown volume of produced water to be released at the site. Silverback was able to recover 150 bbls of the released product according to the C-141 available on NMOCD's Online Imagery.

Based on a map of the release impact area provided to EOG by Silverback (Appendix C), impacts were sustained within the battery, on the production pad, and in pasture adjacent to the access road. Impacts within the battery are noted to have encroached upon the earthen berm installed on the south side of the nRM2030860417 excavation area, as well as along the east side of the remaining storage tank wrapping around to the south side of the production tank (GHD sample points TP1 and TP2). Photographs taken after EOG's discovery that release had occurred are attached in Appendix D. These photographs illustrate that the release impacted the southern sidewall of the excavation, as well as the other areas discussed above.
